Variable-Stiffness Composite Panels: Defect tolerance under in-plane tensile loading

Abstract

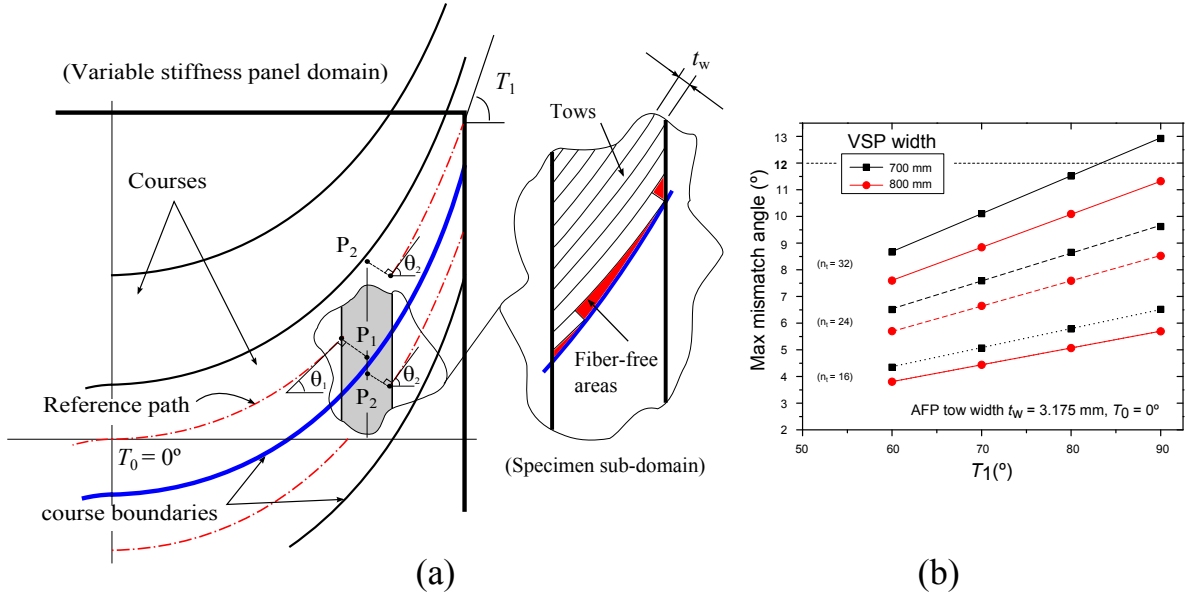
Figure 1: a) Tensile specimen sub-domain definition in a Variable Stiffness Panel. b) Maximum mismatch angle ($\theta_1 - \theta_2$) between the boundary of the courses for panels of 700 mm and 800 mm for $T_0 = 0^\circ$ and different T_1 values.

The test specimens for the experimental work reported in this paper have been designed to represent the ply discontinuities at the edges of adjacent courses in VSP configurations. Accordingly, each specimen represents a sub-domain of a whole panel, as shown in Fig. 1a. The maximum tow-angle mismatch ($\theta_1 - \theta_2$), represented in Fig. 1b for different VSP configurations with linear fiber-angle variations, is dependent on panel dimensions, course width (or number of tows per course, n_t) and fiber angles at the center (T_0) and at the edges of the panel (T_1) [3]. In Fig. 1b only those configurations with $T_0 = 0^\circ$ are considered, as these lead to the worst-case tow-angle mismatch scenarios. Likewise, a panel side of 700 mm in the direction of fiber-angle variation is considered as a limit case. For a panel smaller than this, the maximum variation between T_0 and T_1 would be bounded by the minimum machine turning radius in order to keep an acceptable laminate quality. Hence, a maximum theoretical mismatch angle of 13° is achieved. In reality, the angle $T_1 = 90^\circ$ is never achieved

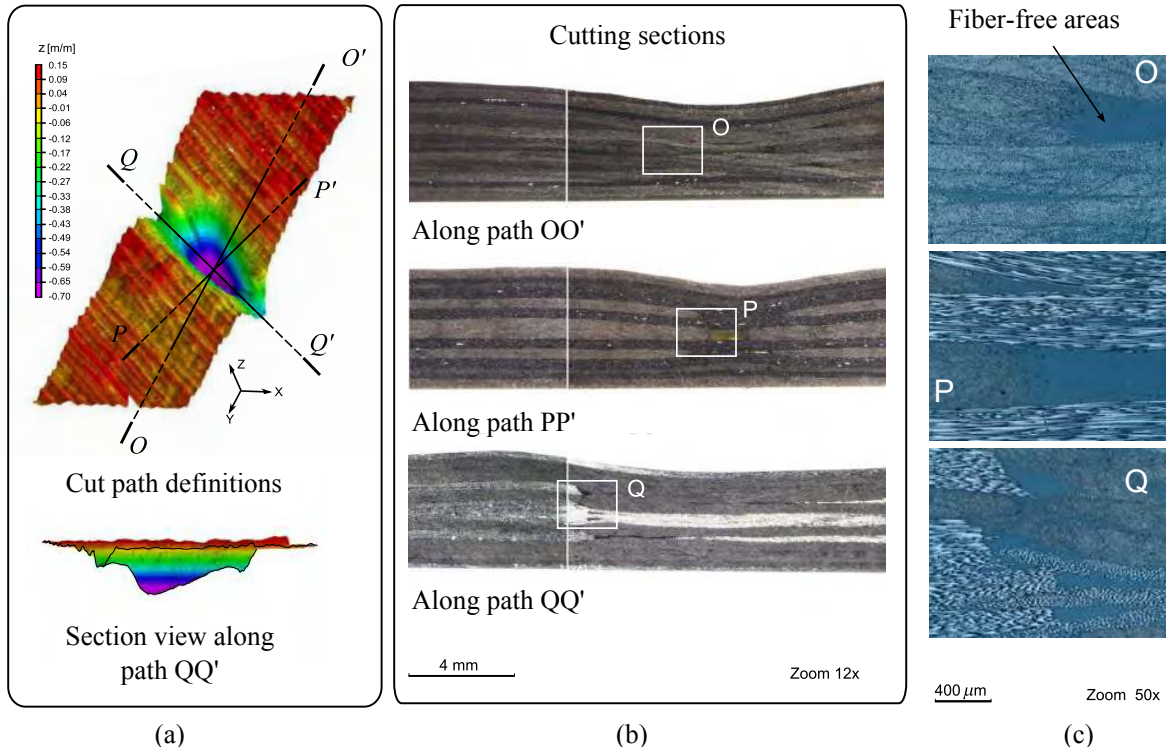
Figure 5: (a) Cut section definitions. (b) Different view for the configuration with tow-drop 0% coverage (magnification 12 \times). (c) Detailed gap micrography (magnification 50 \times).

In order to observe the extension of the rich-resin zones in the configuration with 0% gap coverage, three different sections have been analyzed along the specimen (see Fig. 5a). While it is true that, in the section QQ' , small dispersed gaps appear (see Fig. 5c, detail Q), in the sections OO' and PP' , all the gaps are clustered and concentrated. Here, the size of the gap defects is notable (see Fig. 5c, detail O and P), and the waving of the adjacent plies to fill the gap area is evident. The curvature of the plies is similar to the 100% gap coverage

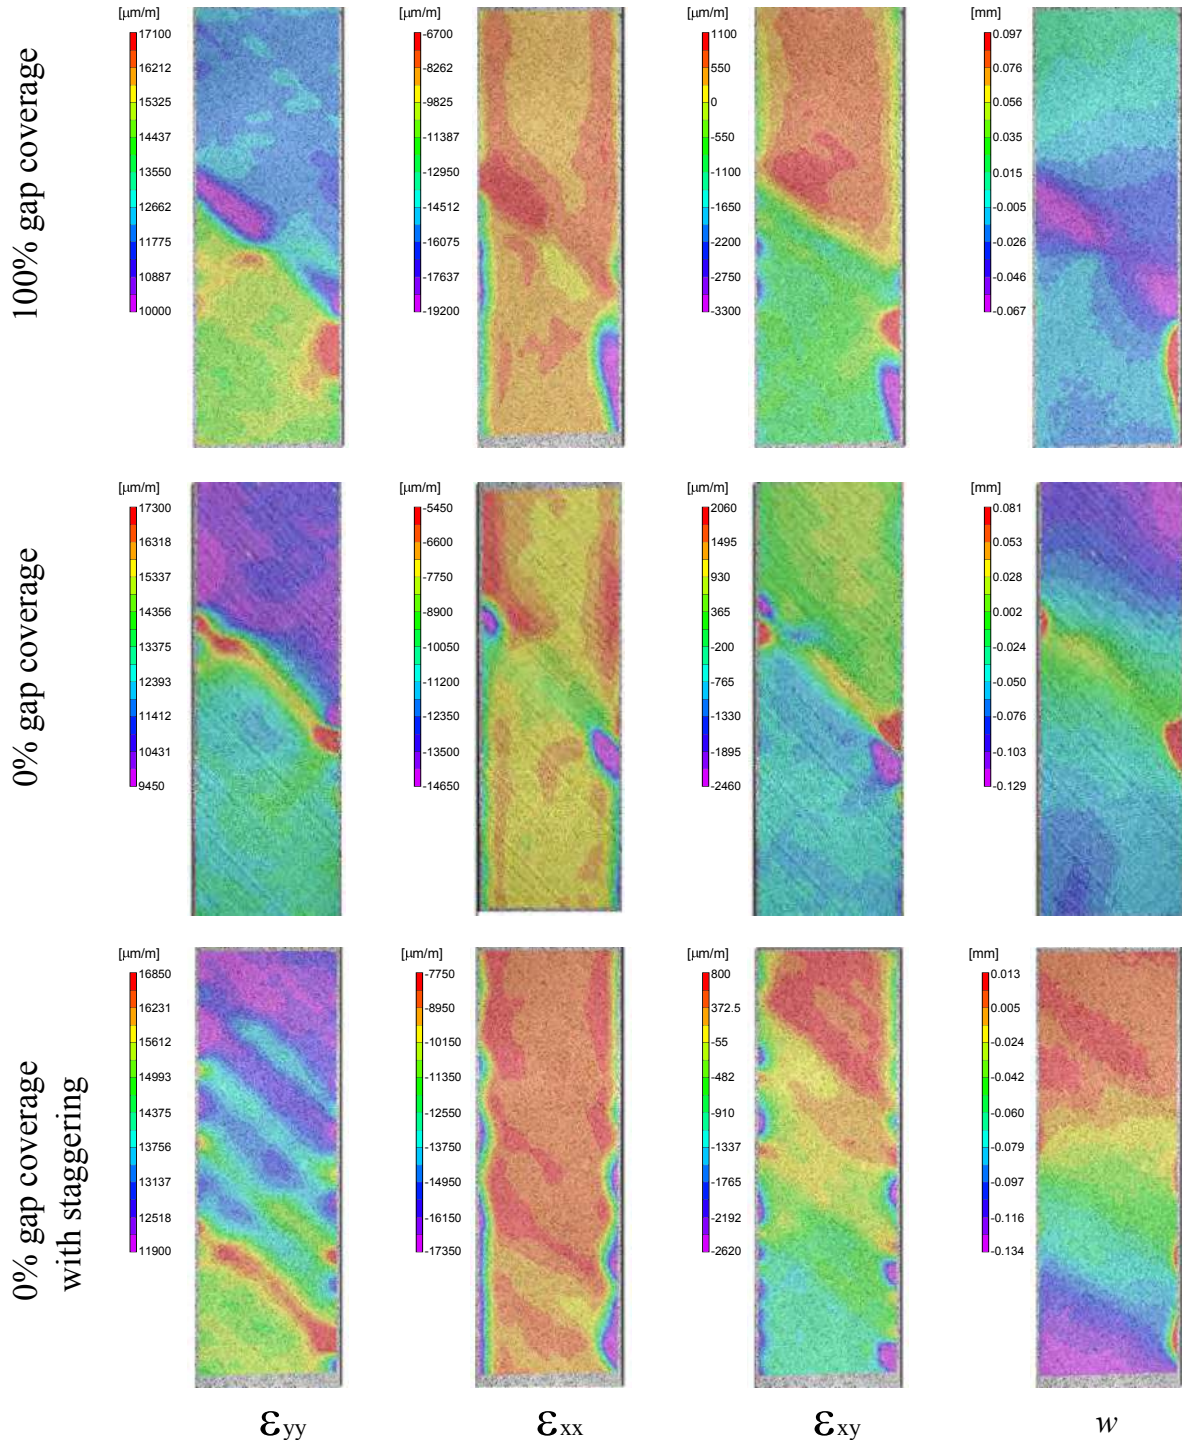
Figure 8: Strain field (ϵ) and out-of-plane displacement (w) comparison for un-notched tensile specimens on the outer layer at 45° just before final failure.

The first analyses were carried out by DIC at the moment just before the final failure of the specimens, in order to observe the influence of tow-drop defects on the strain field and on the out-of-plane displacement. Three specimens with tow-drop defects were selected, one for each configuration, and their behavior was compared. The longitudinal strain (ε_{yy}), transverse strain (ε_{xx}), shear strain (ε_{xy}) of the outer layer at 45° and displacement along the out-of-plane direction (w) throughout the survey area in question are shown in Fig. 8. In all cases analyzed, the load direction and the fiber direction at 0° corresponds to the vertical axis (y-direction). The fibers oriented at 51° are located below the defect zone. The strain variation due to the fiber angle discontinuity of ($51^\circ|39^\circ$) can easily be seen in the DIC representations. The strains concentrate in the vicinity of the defect areas which are critical zones for damage. On the one hand, in the case of 100% gap coverage, the longitudinal strains in the tow-drop area are lower than average strains resulting in overlapping and stiffer zones. On the other hand, in the configurations with 0% gap coverage, the defects result in material zones with lower stiffness and higher strain.

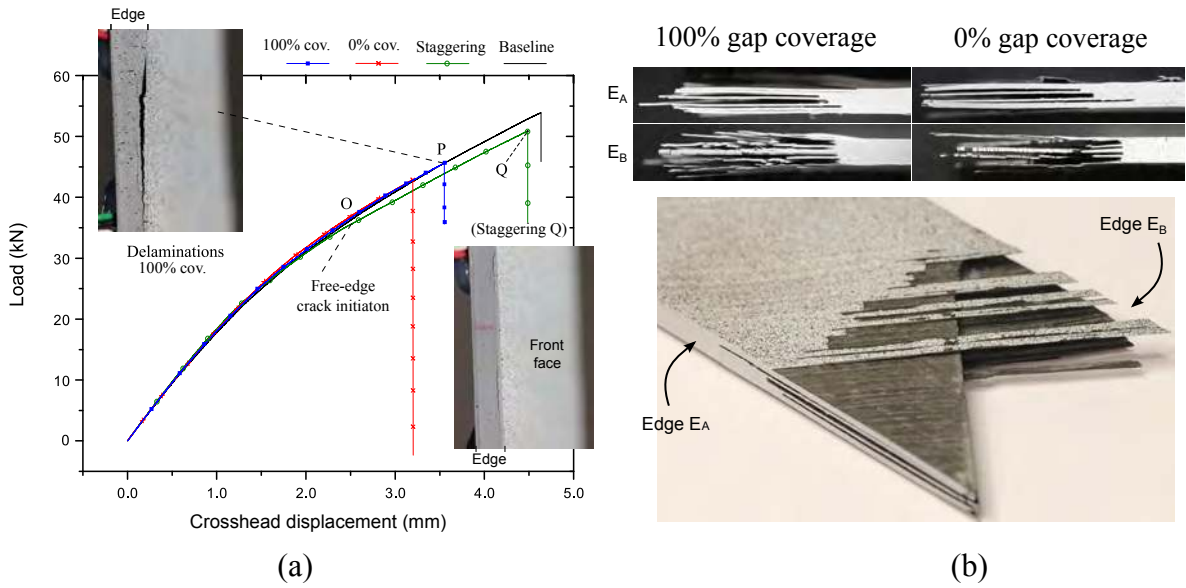
Figure 9: a) Comparison of load-crosshead displacement for different un-notched laminate configurations. (b) Delamination on tested specimen.

The analysis of the displacement (w) reveals delaminations near the edges of the specimens. In the non-staggered configurations, these delaminations are concentrated in the clustered regions of ply discontinuities. However, in the staggered specimens, the delaminations are less evident and distributed along the edge in different zones (see Fig. 9a).

For comparison purposes, the load-displacement curves for one specimen of each configuration are plotted in Fig. 9. The extensive non-linearity of the load-displacement curves prior to failure confirms a progressive loss of stiffness; probably as a result of both the appearance of matrix cracking in the off-axis layers, and the onset of delaminations across the tow-drop defect zones. Specimen collapse is caused by extensive fiber breakage.

In both of the non-staggered configurations, the edge photographs taken during the test reveal large free-edge delaminations in the zones with defects (Fig. 9a). For example, point O in Fig. 9a identifies the observable delamination onset on the free-edge for the configuration with 100% gap coverage, which advances up to point P where the specimen finally fails. This cracked zone coincides with the defect area. In such areas, the fiber angle discontinuities and the thickness variations increase the interlaminar stresses, which cause delaminations

in the free edges. Such stresses contribute to the weakening of the specimens. Hence, the failure of the plain tensile specimens begins at the edge and propagates along the defect. The staggered laminate configuration presents a structural behavior analogous to the baseline. Both lay-ups present similar observed free-edge delaminations. The crack delaminations are small and uniformly distributed across the edge of the laminate in comparison with the non-staggered configurations. In Fig. 9a, this failure mode is shown in the image taken just before final failure (point Q).

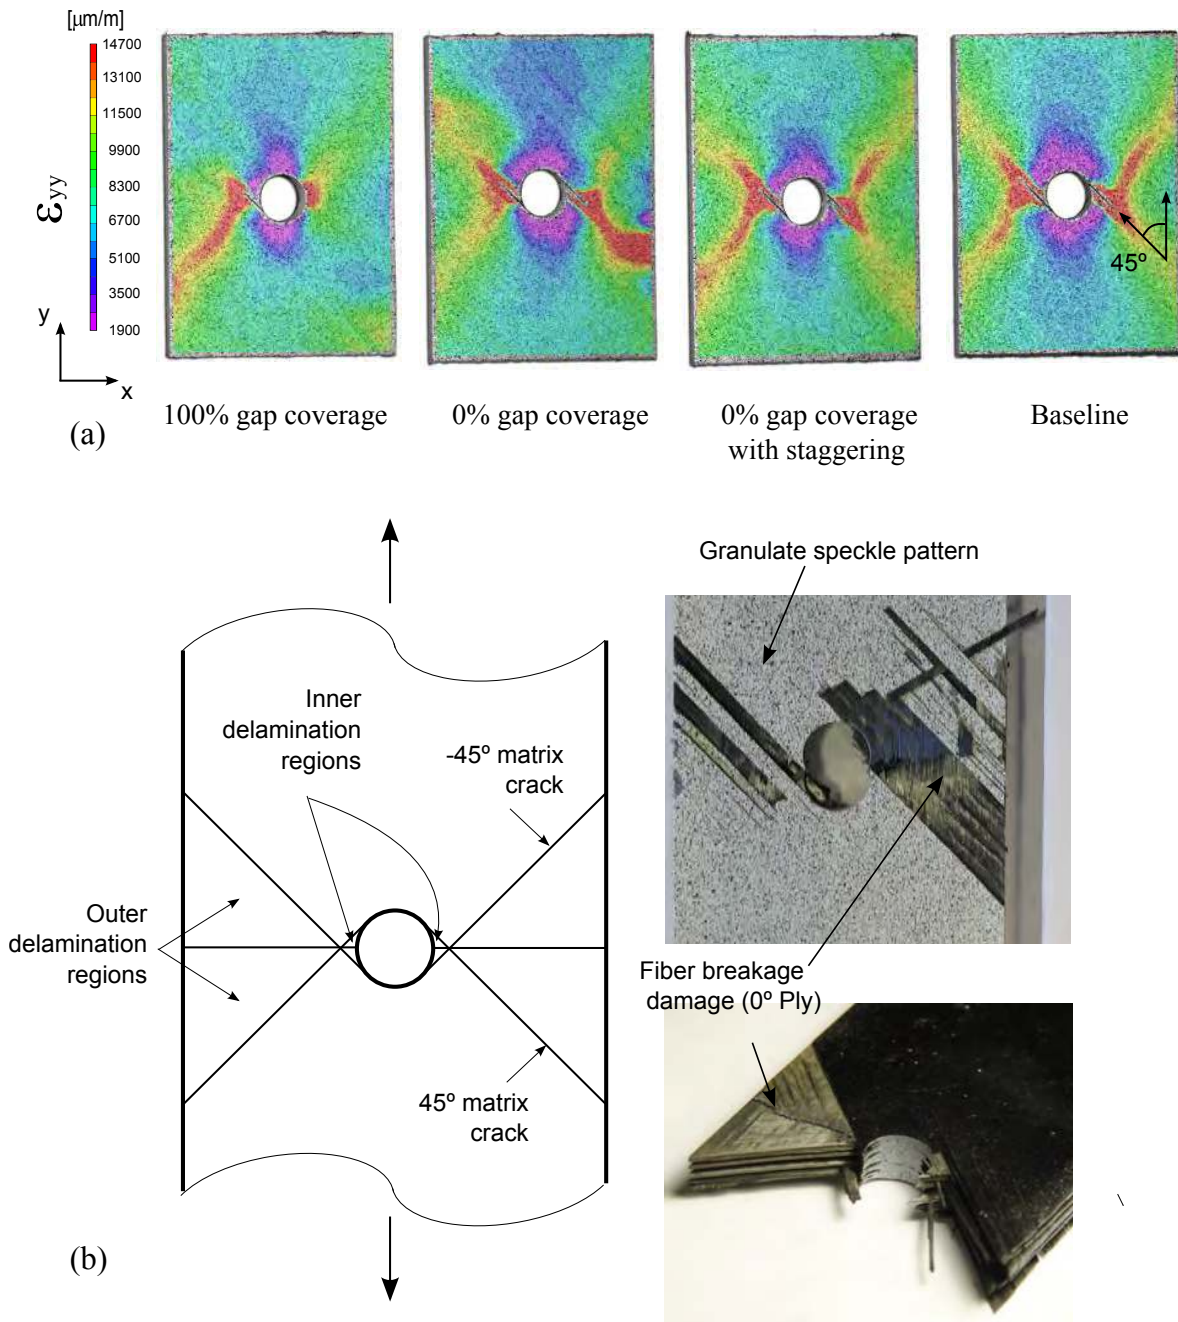
Figure 11: a) Longitudinal strain field for the outer layer of different OHT configurations just before final failure. b) Damage zones associated with the specimens.

The longitudinal strain field ε_{yy} for the outer layers at 45° of one test specimen, just before the final catastrophic failure, for each of the configurations tested are shown in Fig. 11. Here, the 45° matrix crack is clearly visible from the hole in the outer ply surface. This external damage is propagated asymmetrically across the width of the specimen to the specimen edges.
