Coseismic and monsoon-triggered landslide impacts on remote trekking infrastructure, Langtang Valley, Nepal

Quarterly Journal of Engineering Geology and Hydrogeology

J. N. Jones, M. Stokes, S. J. Boulton, G. L. Bennett & M. R. Z. Whitworth

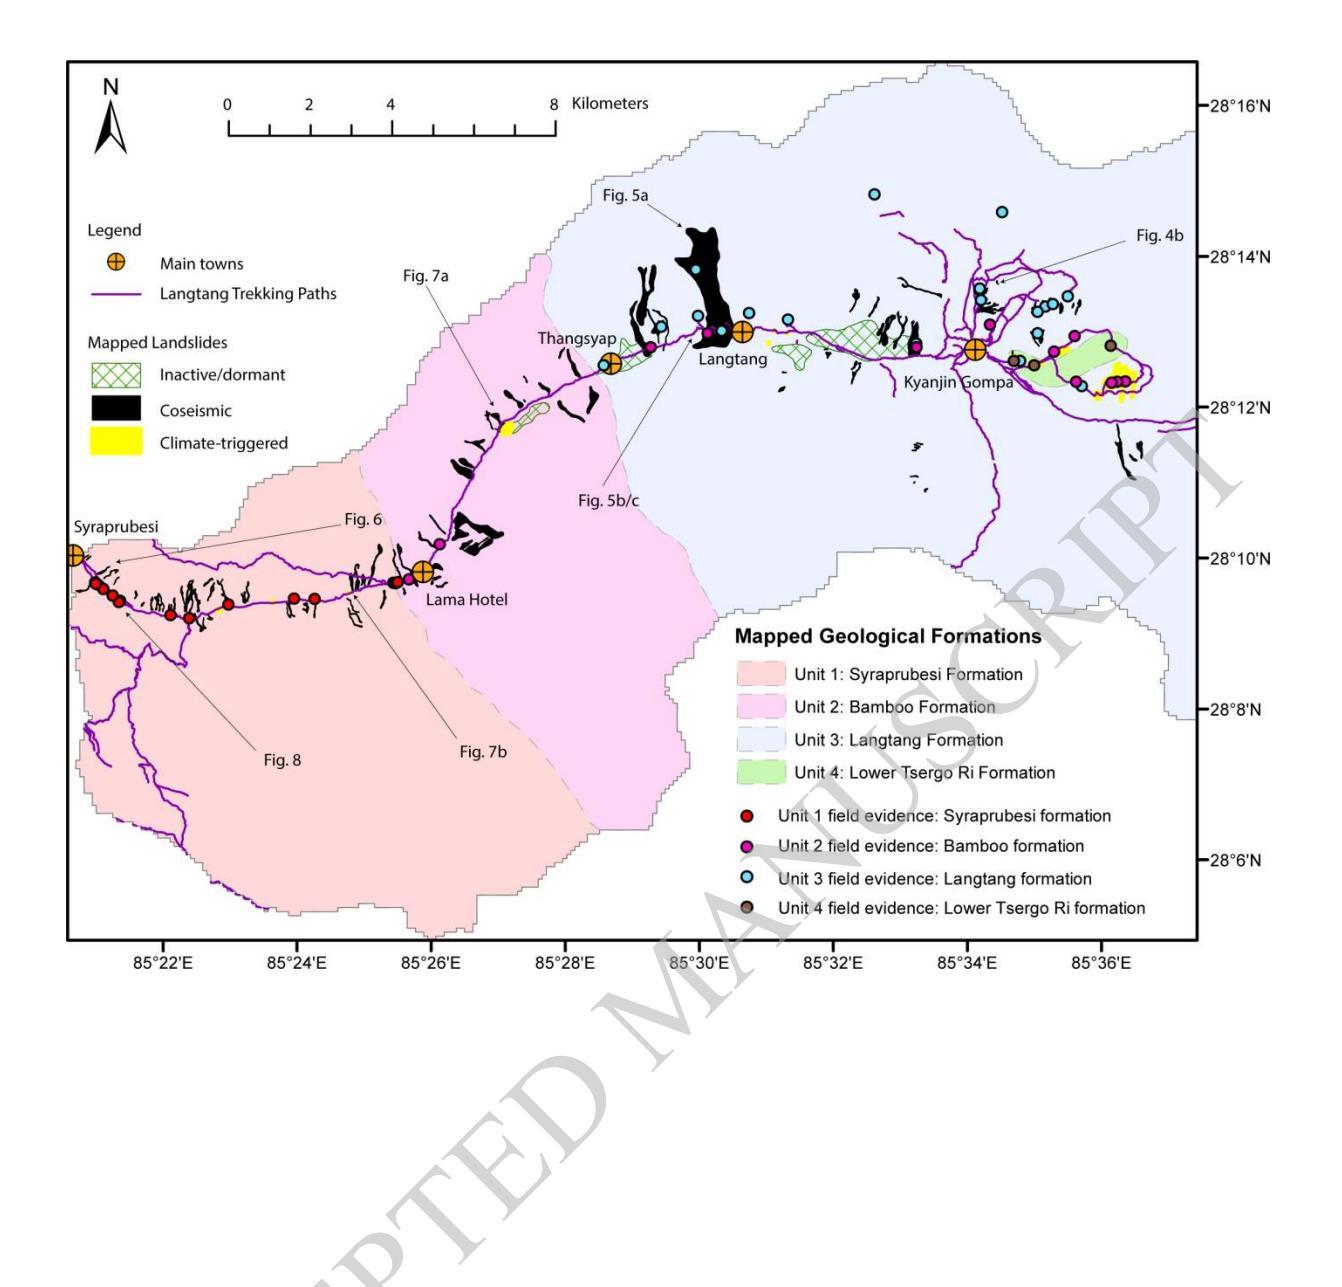
Fig. 2. Map of the lower portion of Langtang Valley that was the focus of the fieldwork. The main geological unit observations and estimated extents, towns, trekking routes and mapped landslides are displayed. The locations of the landslides in figures 4-8 are also highlighted.

Field data collection occurred along the main trekking routes in Langtang Valley between Syraprubesi and Kyanjin Gompa, a total distance of approximately 50 km (Fig. 2). An inventory including both

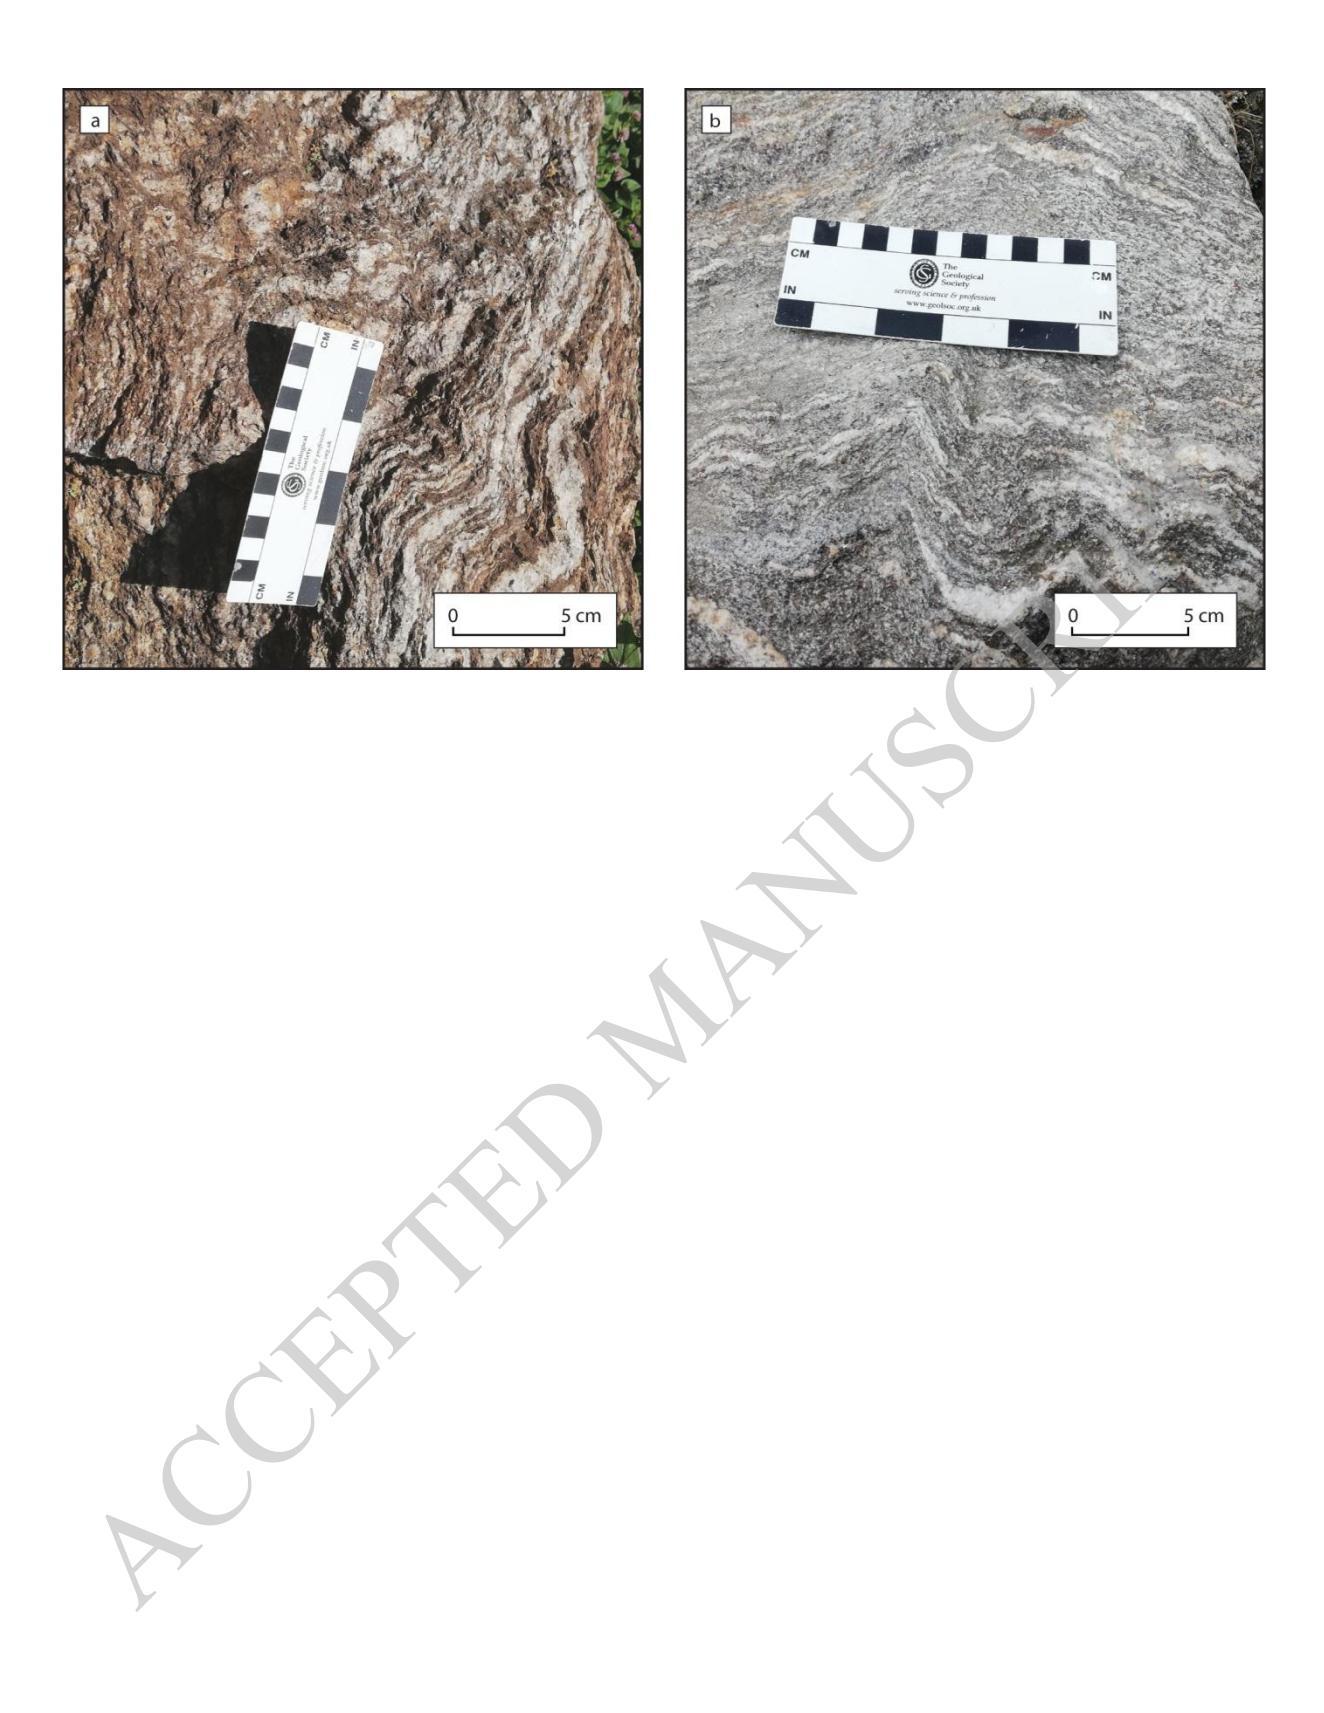
Fig. 3. (a) Example material of unit 1, a muscovite, biotite, plagioclase, quartz, garnet gneiss, termed here as the Syraprubesi Formation. Note the strong mylonitic fabric. (b) Example material of unit 2, a muscovite, biotite, plagioclase, quartz, tourmaline gneiss, termed here as the Bamboo Formation. Again, note the strong mylonitic fabric, and the dominance of quartz and biotite.

Four lithological units were identified within landslides across the valley. The first unit, termed here as the Syraprubesi Formation, is a gneiss dominated by muscovite, biotite and quartz, with subordinate components of plagioclase and garnet (e.g. Fig. 3a). This unit is medium- to coarsegrained, with average grain size of 0.3 - 3 cm. The minerals were generally platy, with elongated plagioclase orientated parallel to foliation and a strong mylonitic fabric. In-situ strength tests indicate that this unit is hard (50 - 100 MPa). The second unit, the Bamboo Formation, is a gneiss dominated by muscovite, biotite and quartz, with subordinate components of tourmaline (e.g. Fig. 3b). This unit was very similar to unit one, but with a larger average grain size of 1 - 3 cm, and with the addition of tourmaline. Unit two had a much higher proportion (60 - 70 %) of quartz and biotite compared to unit one, but maintained the mylonitic fabric. Strength tests suggest that unit two is very hard (100 - 250 MPa). Unit three, named the Langtang Formation, is a coarse-grained (2 - 6 cm) leucogranite, dominated by muscovite, tourmaline, epidote, and occasionally garnet (e.g. fig. 4a). Unit three was commonly found intruded into units two and four, and has a strength of 50 - 250 MPa. This unit was often observed in the source zones of earthquake triggered rockfalls (e.g. fig. 4b). We hypothesize that the discontinuities induced by the intruded leucogranite dykes and sills have reduced the shear strength of the bedrock, making failures in regions with this unit more likely. Unit four, termed here the Lower Tsergo Ri Formation, is a biotite, plagioclase, muscovite, quartz, semi-pelite schist (e.g. fig 4c). This unit was finer grained than the other units (average grainsize 0.25 - 1 cm) and had an estimated strength of 100 - 250 MPa. This unit was dark to light grey in colour and was frequently observed to be in contact with leucogranite.

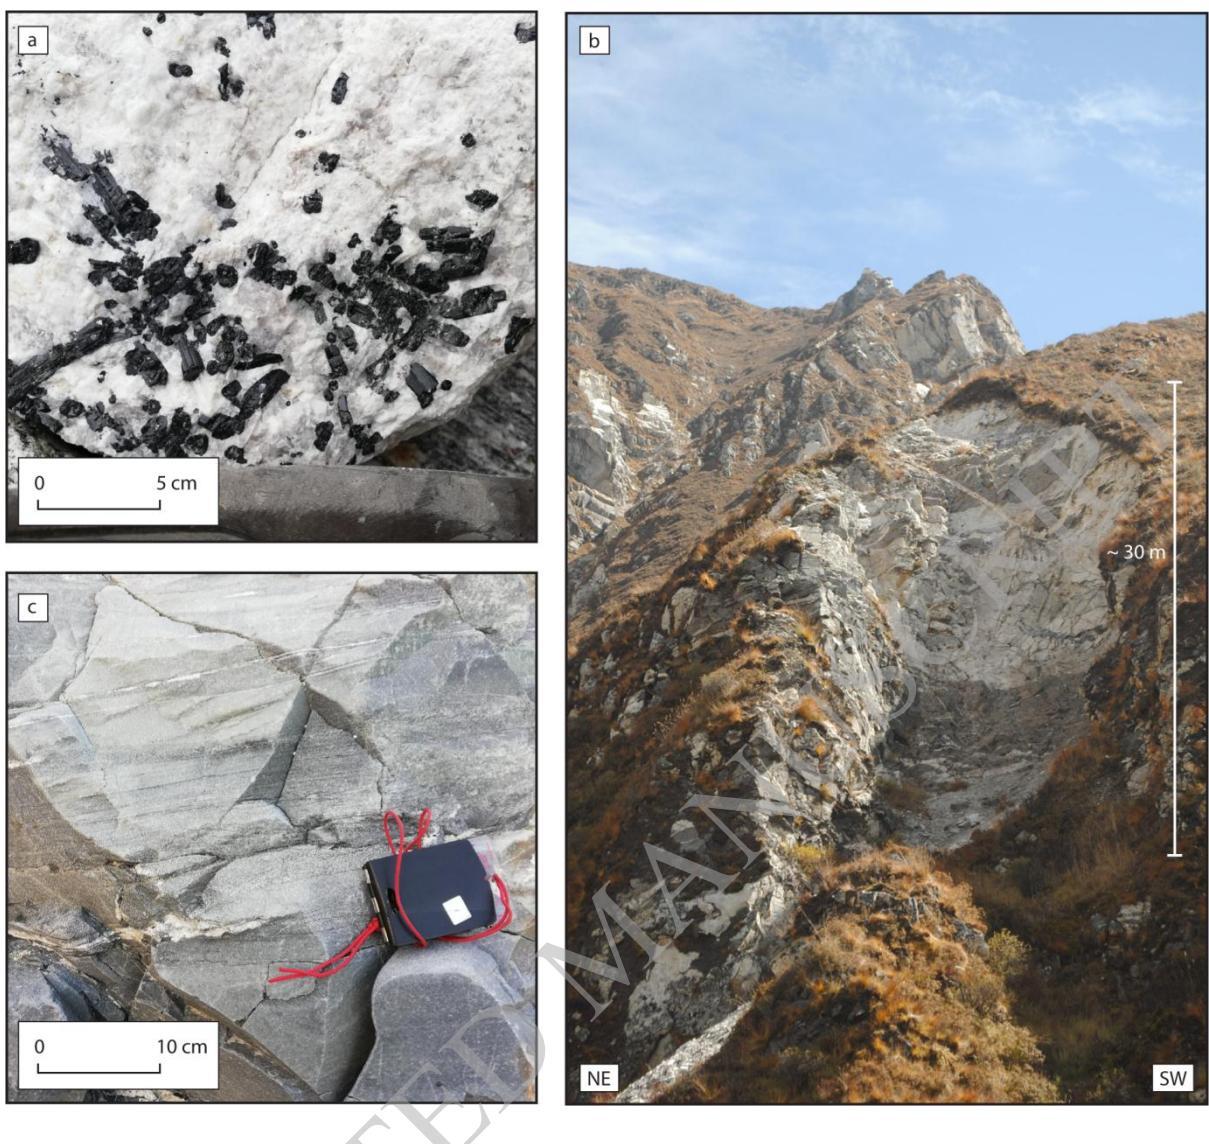
Fig. 4. (a) Example material of unit 3, a leucogranite with large, 1 - 5 cm, crystals of tourmaline, termed here as the Langtang formation. (b) A typical rockfall found in the eastern, higher elevation portions of Langtang Valley, with large intrusions of leucogranite within the bedrock of the scar. (c) Example material of unit 4, a finer grained, 0.25 - 1 cm, biotite, plagioclase, muscovite, quartz, semipelite schist, termed here as the Lower Tsergo Ri Formation.

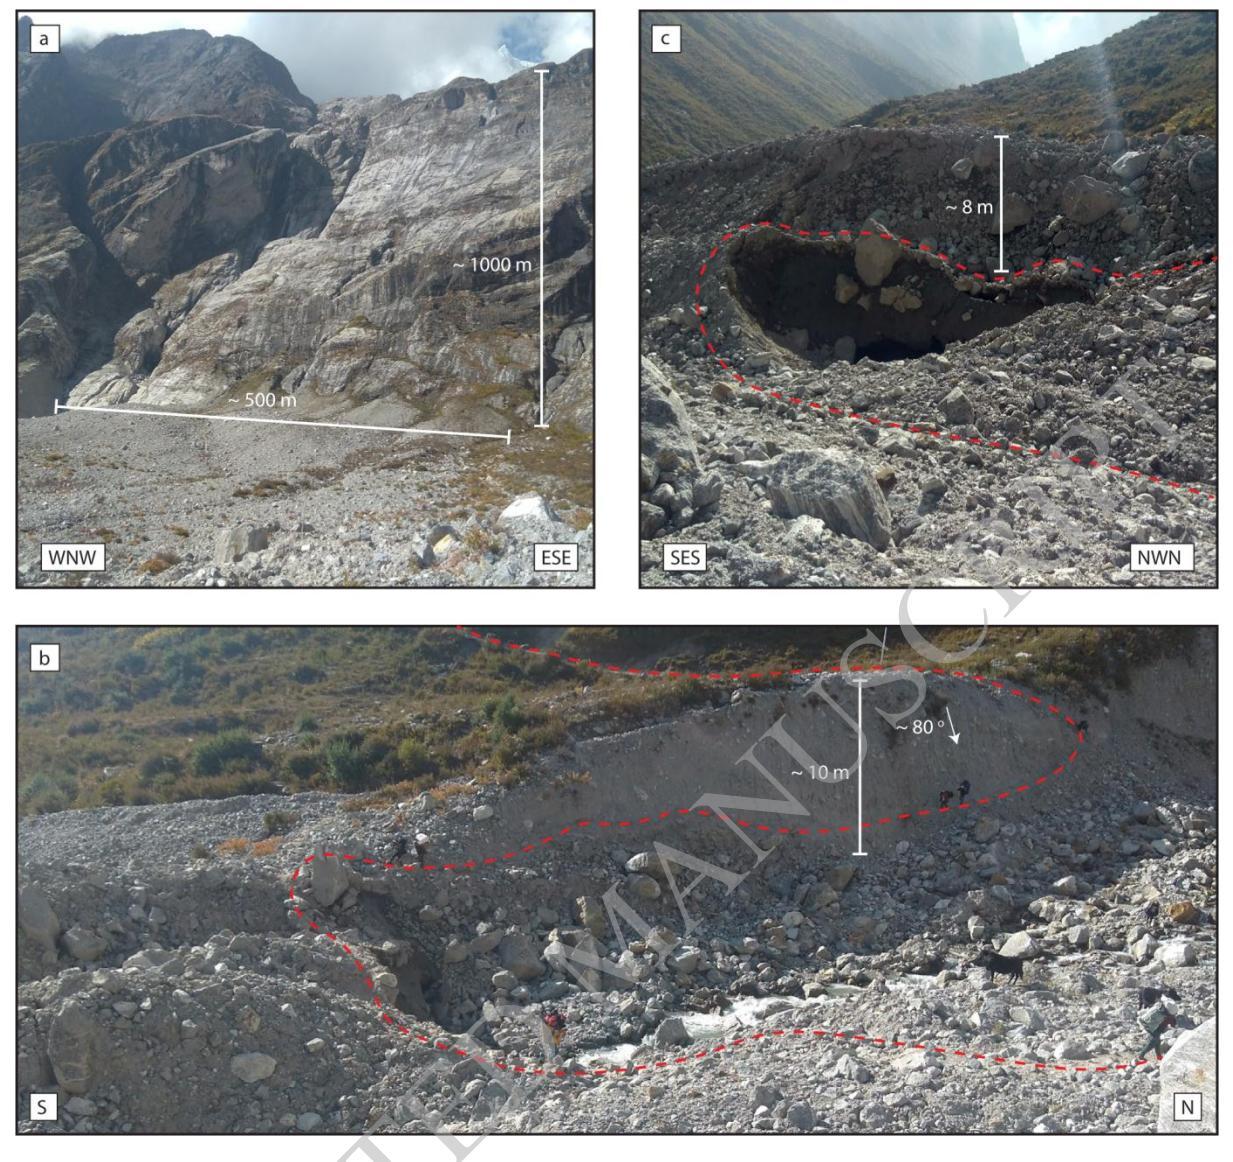
Fig. 5. (a) Front view of the Langtang Avalanche. Note the clear striations on the relatively smooth back-scar and change in slope of the back-scar which is indicative of a rotational element of movement. (b) A section of the Langtang Avalanche deposits that have been incised by a river. The precarious location of the new trekking route is shown by the red-dashed line. (c) A tunnel incised underneath the landslide deposits by a river. Red line indicates the current position of the trekking path over the top of the tunnel.

event completely buried a \sim 500 m long section of the main trekking path, which has since been reinstated over the landslide deposits. The material within the deposits is mostly gneisses (unit 2) and leucogranites (unit 3). Fig. 5b shows the position of the new trekking path at the point where a river has incised through the deposits. The path here is highly precarious, with some sections < 30 cm wide beneath a > 80 °, 10 m high slope of loose deposits, which are vulnerable to movement during a future trigger event. Furthermore, the path crosses over a narrow tunnel that has been created by the river (Fig. 5c). This portion of the deposits is unstable, and several boulders were witnessed falling from beneath the tunnel into the river. This demonstrates that the Langtang Avalanche is continuing to impact the safety and vulnerability of Langtang's trekking paths more than three years since the initial failure occurred.

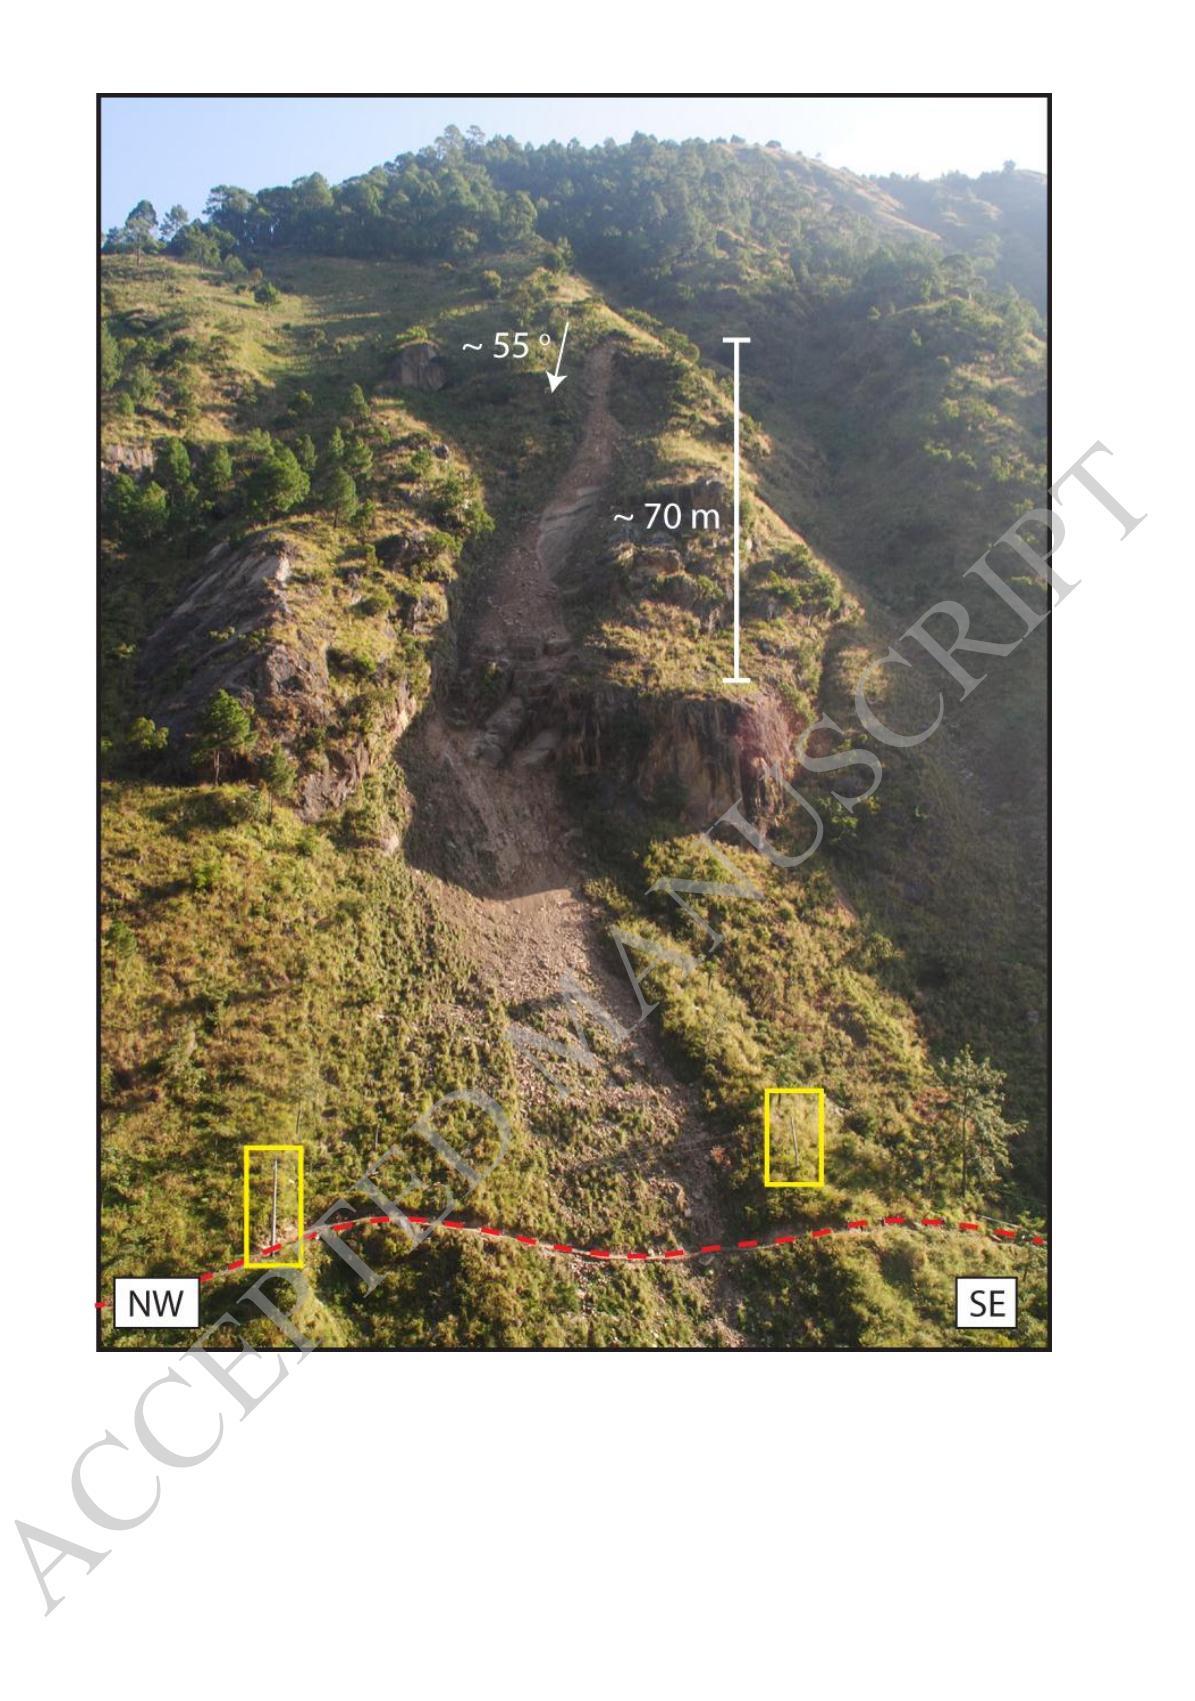
Fig. 6. Debris slide located ~4 km east of Syraprubesi. Red-dashed line indicates the main trekking path that has been impacted by the failure. The yellow boxes indicate the position of electricity / telegraph poles.

Whilst the Langtang Avalanche has undoubtedly had the greatest single impact on trekking infrastructure, the cumulative impacts of smaller, but more widespread, coseismic failures cannot be understated. For example, coseismic debris slides were pervasive along the lower, western portion of the valley. Fig. 6 shows a debris slide that initiated near the ridgeline of a > 55° hillslope covered by grassland in the lower slopes and trees and larger shrubs in the upper slopes. The bedrock geology of the scar of this failure is dominated by the gneisses of unit 1. However, as the failure is shallow (< 0.5 m), and has mostly disturbed the unconsolidated regolith material overlying the bedrock, it is defined as a debris slide rather than a rockslide. In terms of impact on trekking infrastructure, the localised runout of this failure resulted in only a small volume of material intersecting the path. However, more concerningly, it was observed that this debris slide came close to damaging several electricity pylons. These pylons connect to the new hydropower station near Kyanjin Gompa, and are a vital component of Langtang's energy infrastructure.

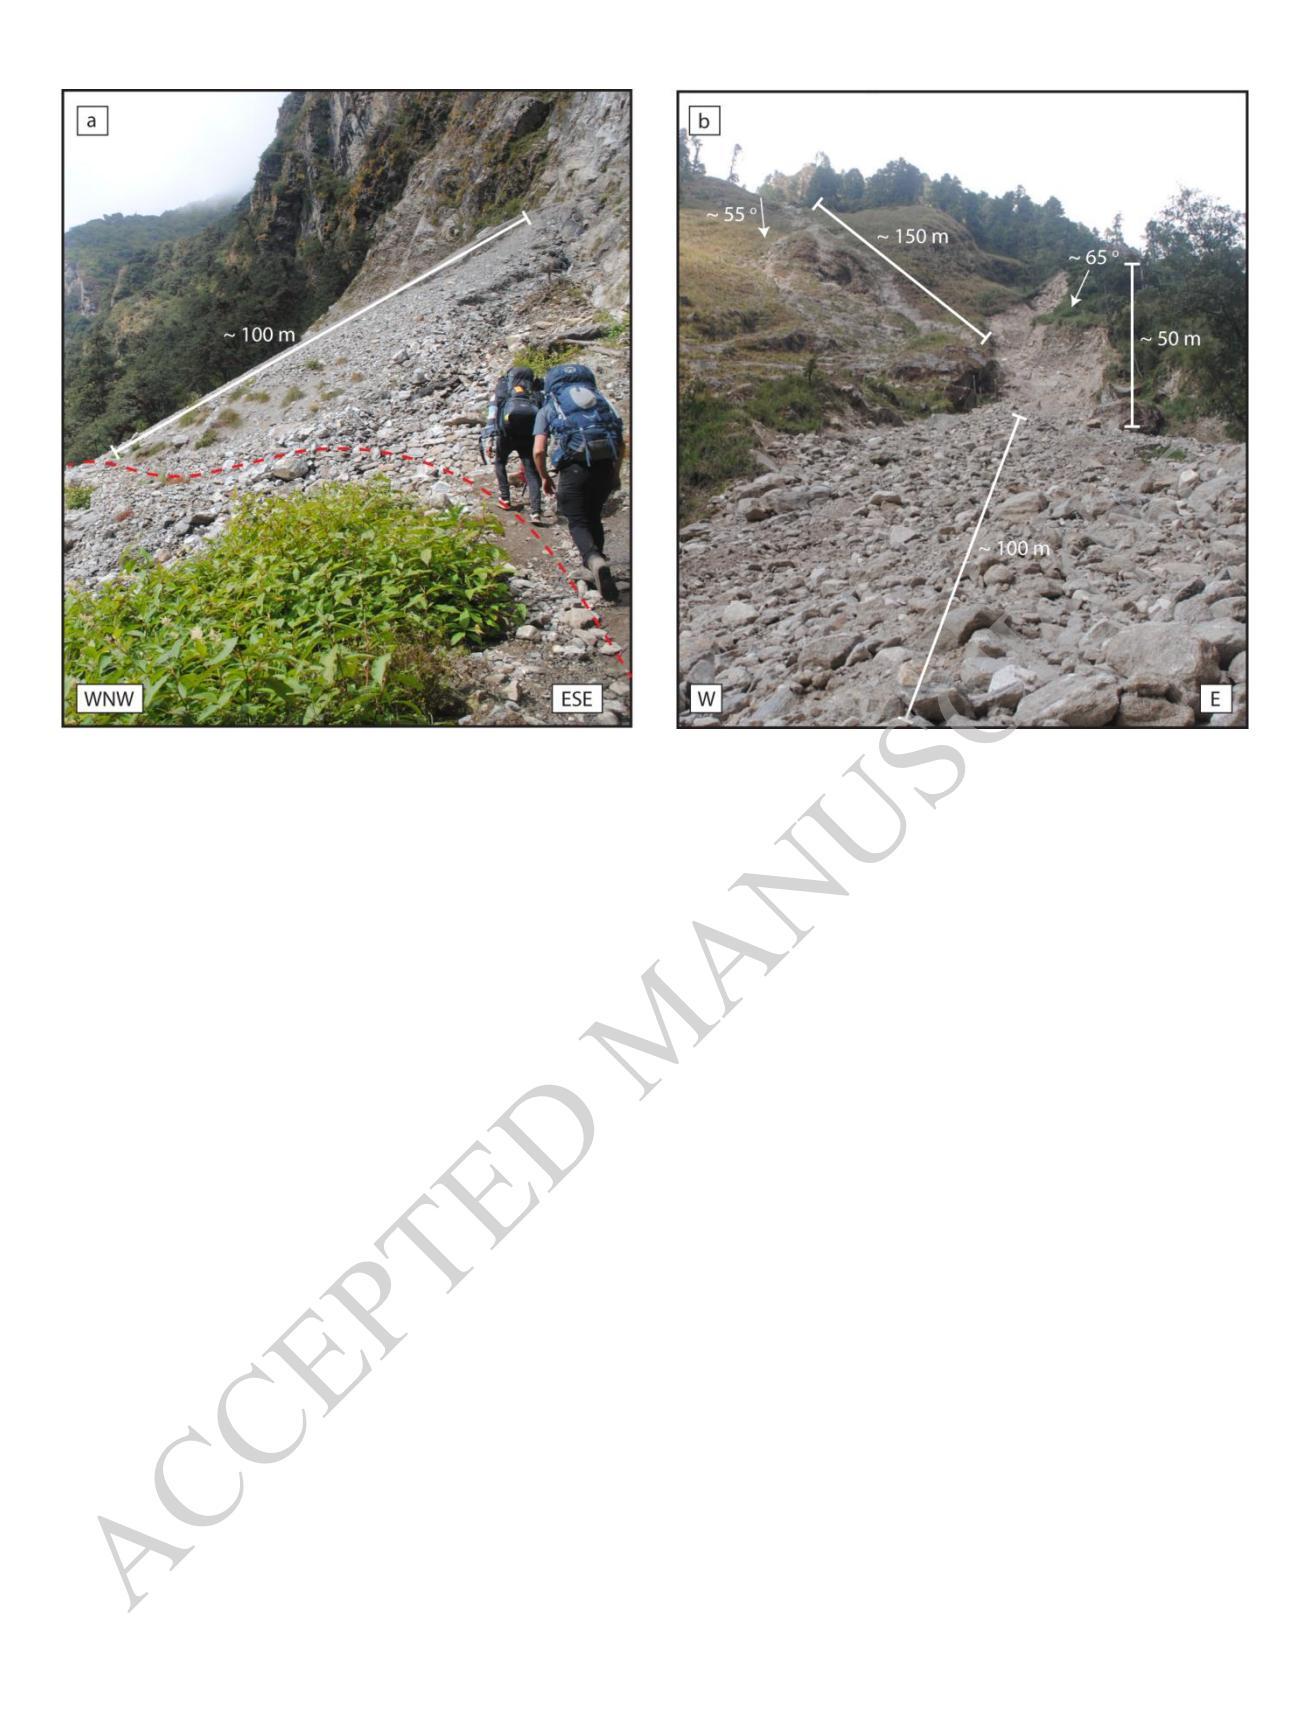
Fig. 7. (**a**) Debris fan of an unconstrained rockfall located ~ 4 km west of Thangsyap, which has intersected the trekking path (red-dashed line) below. (**b**) Debris fan of material from a debris flow and rock/debris fall that also intersected the trekking path (from where this photo was taken).

Unconstrained rockfalls were frequently observed to bury the main trekking route. Fig. 7a shows an example of such an event. The material in the deposits confirm that this failure occurred within the bedrock itself, which was composed of the unit 1 gneisses. The material from this failure buried a 30 m long segment of the trekking path, reportedly killing 30 people. This landslide demonstrates that even relatively small-scale events have the potential to cause loss of life when hazard overlaps with vulnerability. Since the initial failure, a new trekking path has been re-dug through the deposits, with no attempt at any mitigation against potential monsoonal reactivation of debris material. As such, this section of the path should be considered at high-risk of being damaged or blocked by reactivated landslide material in the future. Fig. 7b shows a debris fan from a combined rock/debris fall and a rock/debris flow. The source zones for the flow and the fall appear to be at major > 55 $^{\circ}$ and > 65 $^{\circ}$ breaks in slope. The path of the flow appears to have been controlled by the existing hillslope morphology, with a knoll splitting the flow into two channels just before the main rockfall debris fan. The flow travelled for ~200 m before joining the main debris fan, whilst the debris from the main rockfall travelled ~100 m. This failure totally buried a ~40 m section of the trekking path, and is reported to have killed 20 people. Similar to the previous examples, the position of the new trekking path now lies on top of the landslide deposits, with no measures aimed at moderating future instability. As such, this section of the path is again considered to be at high risk of being blocked, or otherwise impacted, by future reactivation of landside debris.

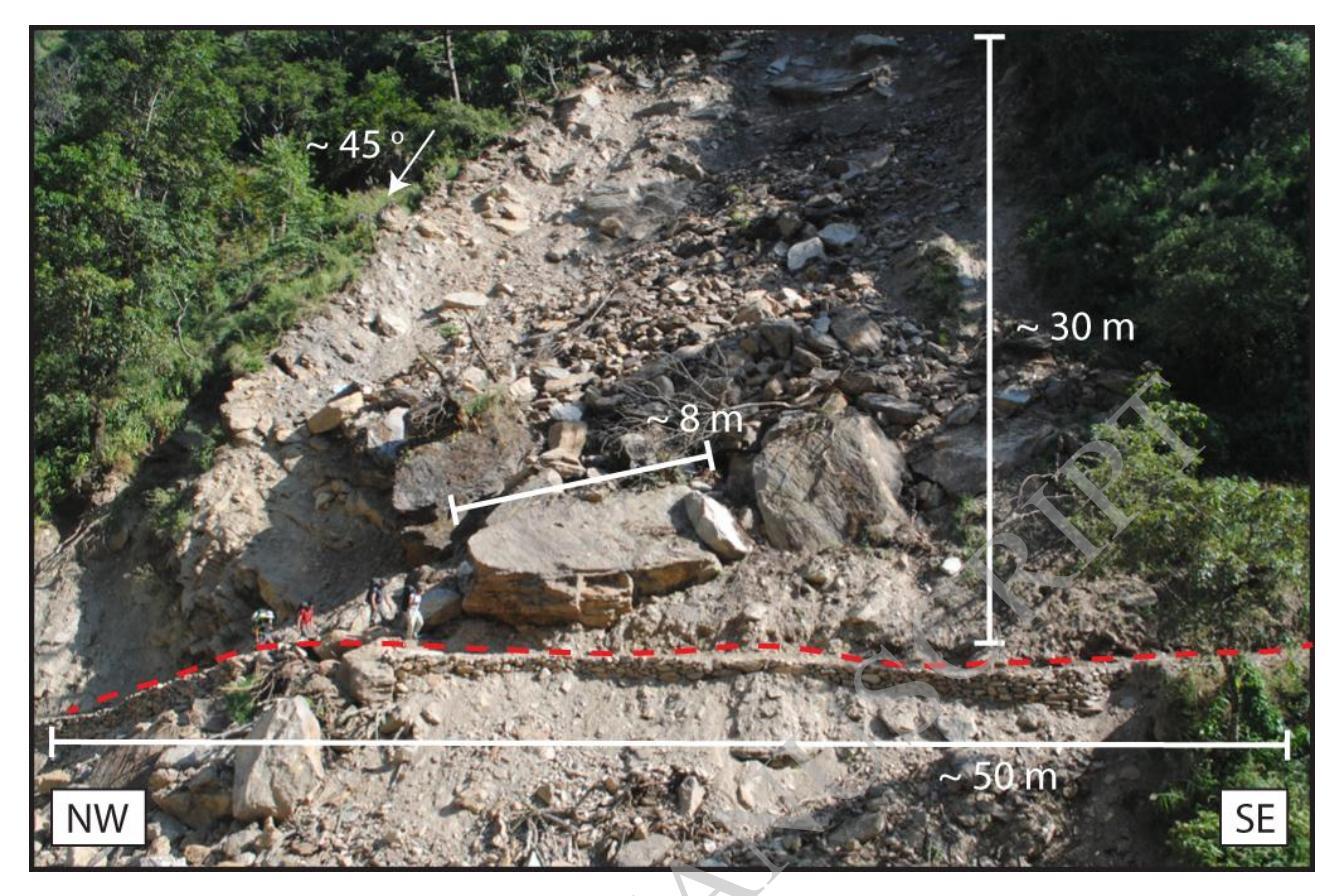
Fig. 8. Monsoon-triggered translational slide located 2 km east of Syraprubesi. A new trekking path (red-dashed line) has been constructed through the deposits, yet many large unstable boulders remain above the path.

As well as coseismic landslides, monsoon-triggered landslides were frequently observed across the valley, and care must be taken when distinguishing between these different triggering mechanisms. Fig. 8 shows a typical monsoon-triggered translational debris slide that has occurred on a forested, > 45° hillslope. This slide has a height of ~30 m, and completely destroyed an ~ 45 m wide section of the path below, which has since been re-built. The sides of the new path have been supported with small, < 0.5 m high walls of unconsolidated debris material. The debris material remaining above the new path is highly unstable, with several (> 10 m wide) blocks balancing within the deposits. This material will be highly susceptible to movement during subsequent monsoon-seasons, and as such remains at-risk of impacting the trekking path further.
