Mapping saline water intrusion into the coastal aquifer with geophysical and geochemical techniques: the University of Lagos campus case (Nigeria)

Elijah A Ayolabi¹, Adetayo F Folorunso^{1,2*}, Abiodun M Odukoya¹ and Adelere E Adeniran³

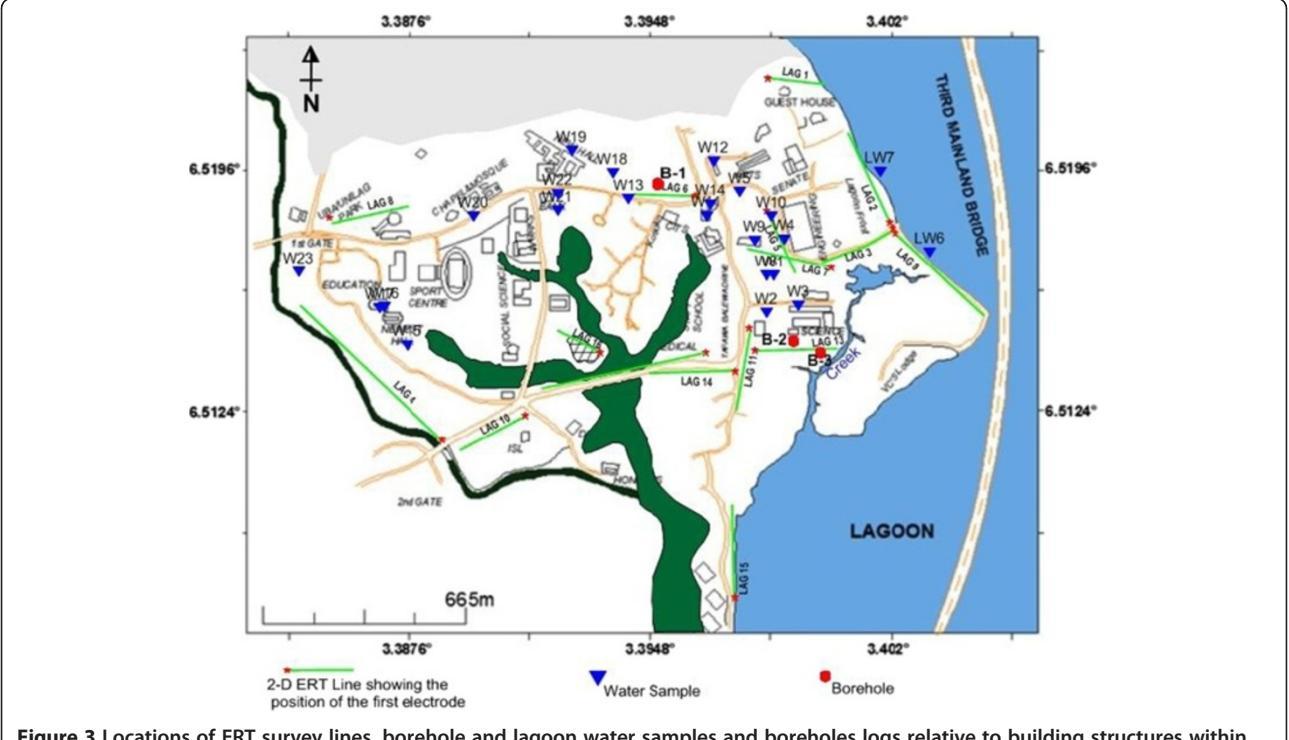
Figure 3 Locations of ERT survey lines, borehole and lagoon water samples and boreholes logs relative to building structures within the campus.

In all, fifteen (15) 2-D ERT profiles (Figure 3) were measured covering the whole coastal area. One of the latest softwares for the inversion of 2-D data, the Earth Imager, was used to invert the apparent resistivity profiles to obtain a 2-D image of the subsurface resistivity distributions. The ERT profiles were inverted using an iterative smoothness constrained least-squares inversion algorithm otherwise known as "OCCAM inversion" after deGroot-Hedlin and Constable (1990) and Loke and Barker (1996). These inversion routines involve a cellbased inversion technique; it subdivides the subsurface into a number of rectangular cells in which resitivities are varied to obtain the best fit with the observed data (Loke, 2004). The differences between the observed and calculated data are minimized to obtain an acceptable agreement (Loke and Barker, 1996). A measure of this difference is given by the root-mean-square error (RMS%). However, smoothness constrained models do not allow for large and unrealistic variations in the output models, as its name suggests. Notwithstanding this, a reasonable value of RMS (not shown) was maintained for all the profiles.

Water samples from twenty one boreholes and two lagoon water were collected at various locations within University of Lagos (Figure 3). Eight boreholes were not functioning at the time of this study. Several sensitive parameters of water such as total dissolved solids (TDS), electrical conductivity (EC), temperature and pH were determined in situ using digital meters (e.g. water treatment works (WTW)-conductivity meter model L/92 and WTW- pH meter model pH/91). The meter was calibrated with pH solutions 4 and 7. Water samples of approximately 125 mL were collected for multi-element analysis; pressure filtered through 0.2 mm Nuclepore membranes and 3 mL analytical grade HNO_3 was added to bring the water acid solution to approximate pH of 2.

Taking Traverses 1, 2 and 9 (Figure 3) for example, with increasing pumping of groundwater from boreholes 4, 5, 8 and 22 (Figure 2), the aquifers under these boreholes become more prone to invasion of salty water in a transgressive flow.

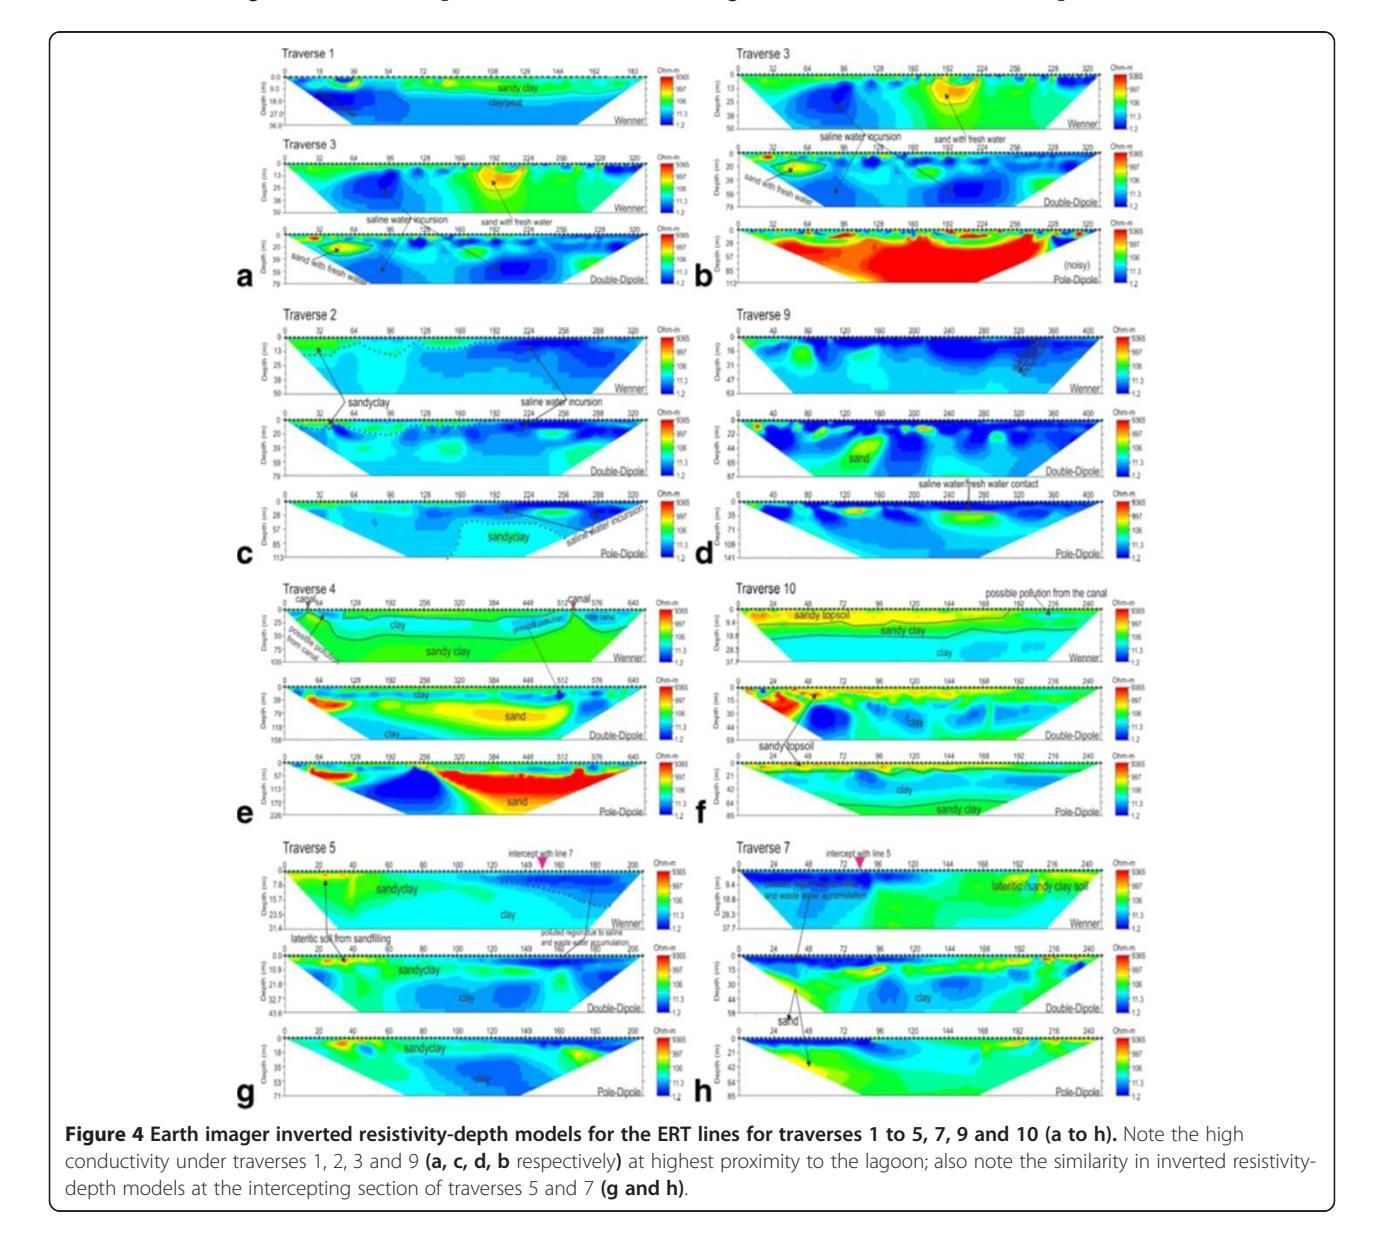
2-D ERT models for Traverses 5 (Figure 4g) and 7 (Figure 4h) were taken across each other and away from the lagoon, to further see the effect of the incursion inland. Low resistivity (below 10 Ω m) observed at the near surface from both traverses is a clear indication of change in lithology and fluid content (the site is waterlogged, not sand-fill and host brackish water evidently seen on the surface). This portion has been highly impacted by the accumulation of conductive waste water (brackish water) around the area and possibly saltwater from the lagoon may have polluted the groundwater within the first aquifer along the traverse as depicted by

very low resistivity value toward the second part of Traverse 5 which corresponds with the first part of Traverse 7 (Figure 4h – the intercept referred). The second geoelectric layer is sand with resistivity of 106–500 Ω m, which is possibly represents the aquifer unit.

The 2-D ERT sections along traverses 3 and 1 were taken perpendicular to the Lagoon to monitor the progressive seawater incursion to the neighbouring coastal aquifers. Resistivity distributions indicate salt water incursion from the lagoon extending to a depth of about 35 m (Traverse 1) and 45 m (Traverse 3) beneath the surface marked with very low resistivity value ranging from $0.3-10.0\Omega$ m. Ground surface under Traverse 1 from surface positions 60 m to 190 m was a sand-filled

2-D ERT sections for Traverses 2 and 9 were taken parallel to the lagoon probing a vertical depth of 50–113 m and 63–141 m respectively. The subsurface within this area is composed of predominantly low resistivity (0.11–5.0 Ω m) structure reflective of saline water incursion in to the aquifer. Figure 4c (Traverse 2) show that the entire traverse has been impacted by the lagoon water incursion to a depth of 40–85 m beneath the surface while Figure 4D (Traverse 9) clearly indicates Lagoon water invasion of the fresh water aquifer to a depth of 0–42 m; both at higher depths due to high proximity to the lagoon. This clearly shows that the first and the second aquifer have been polluted by the saltwater incursion from the lagoon.

Traverses 4 was run parallel to and Traverse 10 perpendicular to a major canal that demarcates southern and western sides of the campus from surrounding communities. 2-D ERT model along Traverse 4 (Figure 4e) shows possible brackish water pollution from the carnal (very low resistivity, 1–20 Ω m) beneath electrode positions 0-88 m and 424-640 m at a near surface depth of 0-25 m. At surface positions 424-640 m, the pollution falls within the first aquifer unit possibly prevented from further percolation by the underlying thin clayer (less than 50 Ω m). Similarly, low resistivity value of 10–20 Ω m (Traverse 10) was noticed within near surface depth of 0-9 m at a lateral distance of 195-225 m towards the Canal (Figure 4f) suggestive of the same possible brackish water invasion of this layer. The underlain sand/clayey sand is the aquifer unit and is prone to pollution as evident from polluted water invasion from the canal.

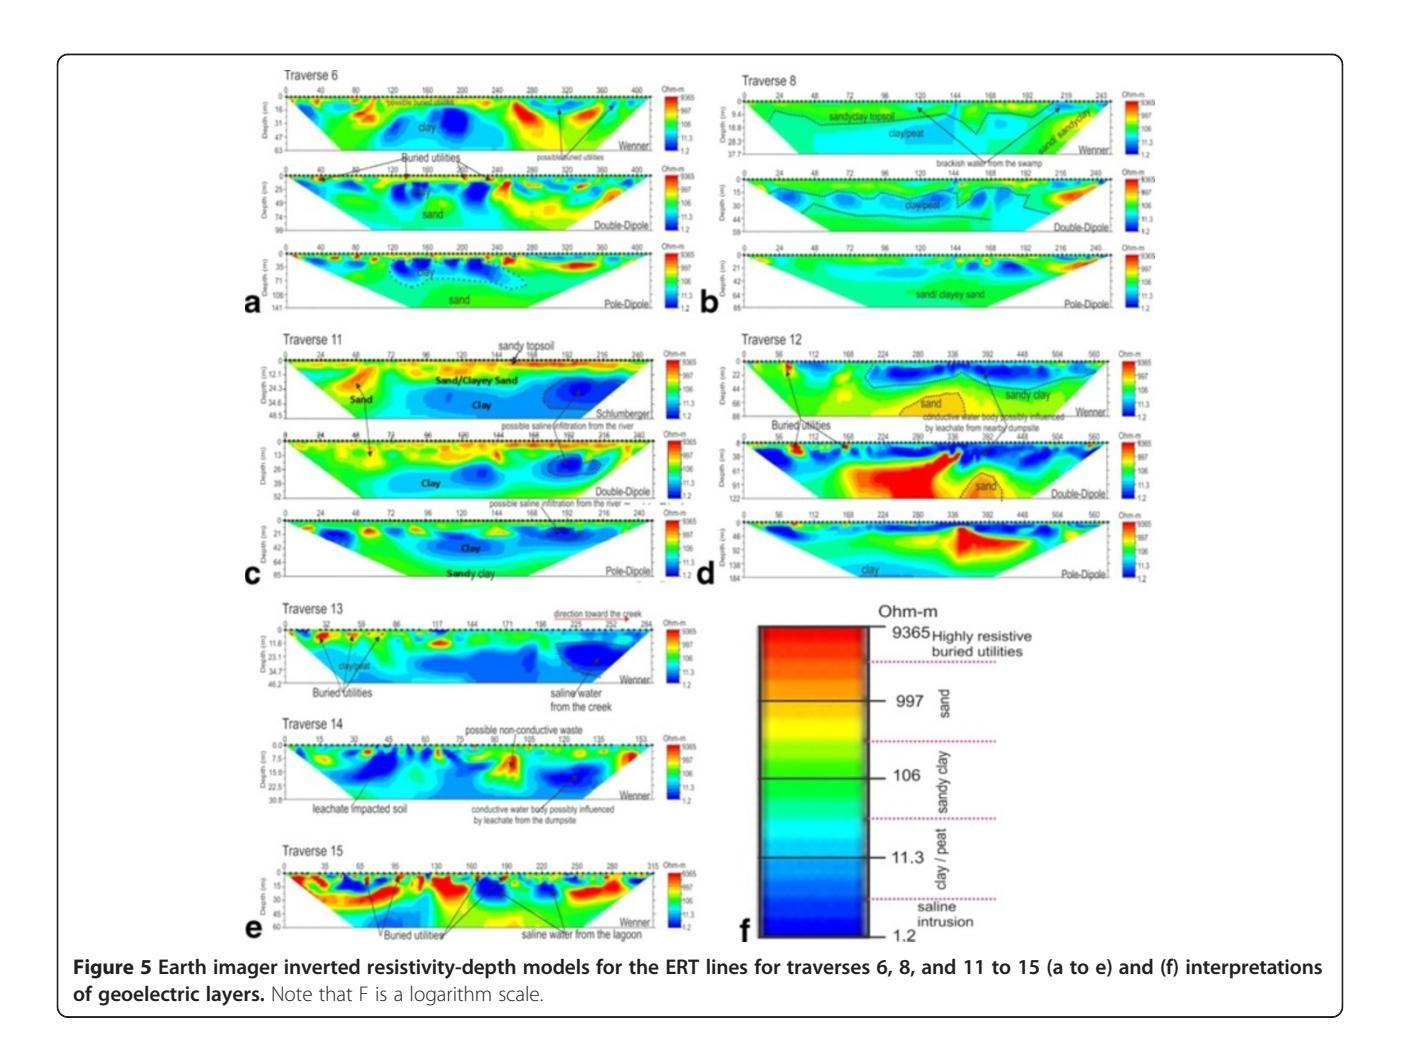
Depth range of 63-141 m was delineated from Traverse 6 (Figure 5a) established beside borehole B-1 (Figure 6a). Isolated near surface high resistivity within the sandy clay topsoil was reflective of buried utilities such as drainage and water, cables and canal. Because the traverse was located close to the water work station of the university, all pipes conducting water to the water station were buried in the topsoil around the traverse. Juxtaposing with borehole data the second sandy layer in the borehole was probably not mapped in the geoelectric layer because of the presence of saline water in the diminutive sandy layer which increases its conductivity and thus makes it impossible to be differentiated from underlying clayey layer. A long stretch of clay layer was mapped under this traverse, as observed from the log data. The 2-D ERT section (Figure 5b) along Traverse 8 depicts possible pollution from brackish water of the swamp.

Traverse 11 (Figure 5c) taken opposite Traverse 12, almost parallel but not across the stream dipping slightly towards the stream also reveals very low resistivity value $(3.5-30 \ \Omega m)$ towards the stream (third geoelectric layer) suggesting the possibility of infiltration of saline water from the stream at depth of about 18-70 m (surface positions of 170-250 m). This was mapped by both Schlumberger, double-dipole and pole-dipole methods. 2-D ERT model structure on Traverse 12 (Figure 5d) indicates low resistivity distributions towards the central portion of the traverse as a combination of water resistivity within the stream and its sediment as electrodes within these regions fell within the stream. This low resistivity structure is a reflection of the conductive nature of the stream (brackish water) and its sediment. The extension of this low resistivity structure outside the stream bank westward is suggestive of the possibility that the shallow aquifer in this area may have been polluted by the brackish water percolation through the porous topsoil. This stream could possibly serve as recharge unit for the aquifer.

Traverses 13 located close to the creek (Figure 5e), near the two Shell auger boreholes was marshy frequently flooded by the creek especially during raining season. Region close to the Lagoon exhibits very low resistivity structure reflective of saltwater intrusion from the creek as observed at surface distance of 210–284 m below 10 m depth. The affected layer was thought to be the first aquifer; its incursion by the lagoon water is an indication of progressive seawater intrusion to the inland aquifer within the campus. The Shell Auger borehole

Traverse 14 located on dumpsite within the campus shows leachate impacted soil from the decomposing refuse materials characterized with resistivity below 10 Ω m. Pollution from dumpsite leacheate was mapped in the 2-D ERT inverted resistivity structure (Figure 5e). Traverse 15 was run along the road to the High Rise (staff quarters) parallel to the lagoon. The 2-D ERT section (Figure 5e) is reflective of subsurface conductivity. An interesting features (Figure 5e) reflective of buried utilities such as drainage, canal, buried water pipes, etc., that empty their content into the lagoon were clearly marked along this traverse and exhibits isolated near surface high resistivity structures within the top soil. The second geoelectric layer has been impacted by saltwater from the lagoon to a depth of about 28 m, though largely masked by the buried utilities.

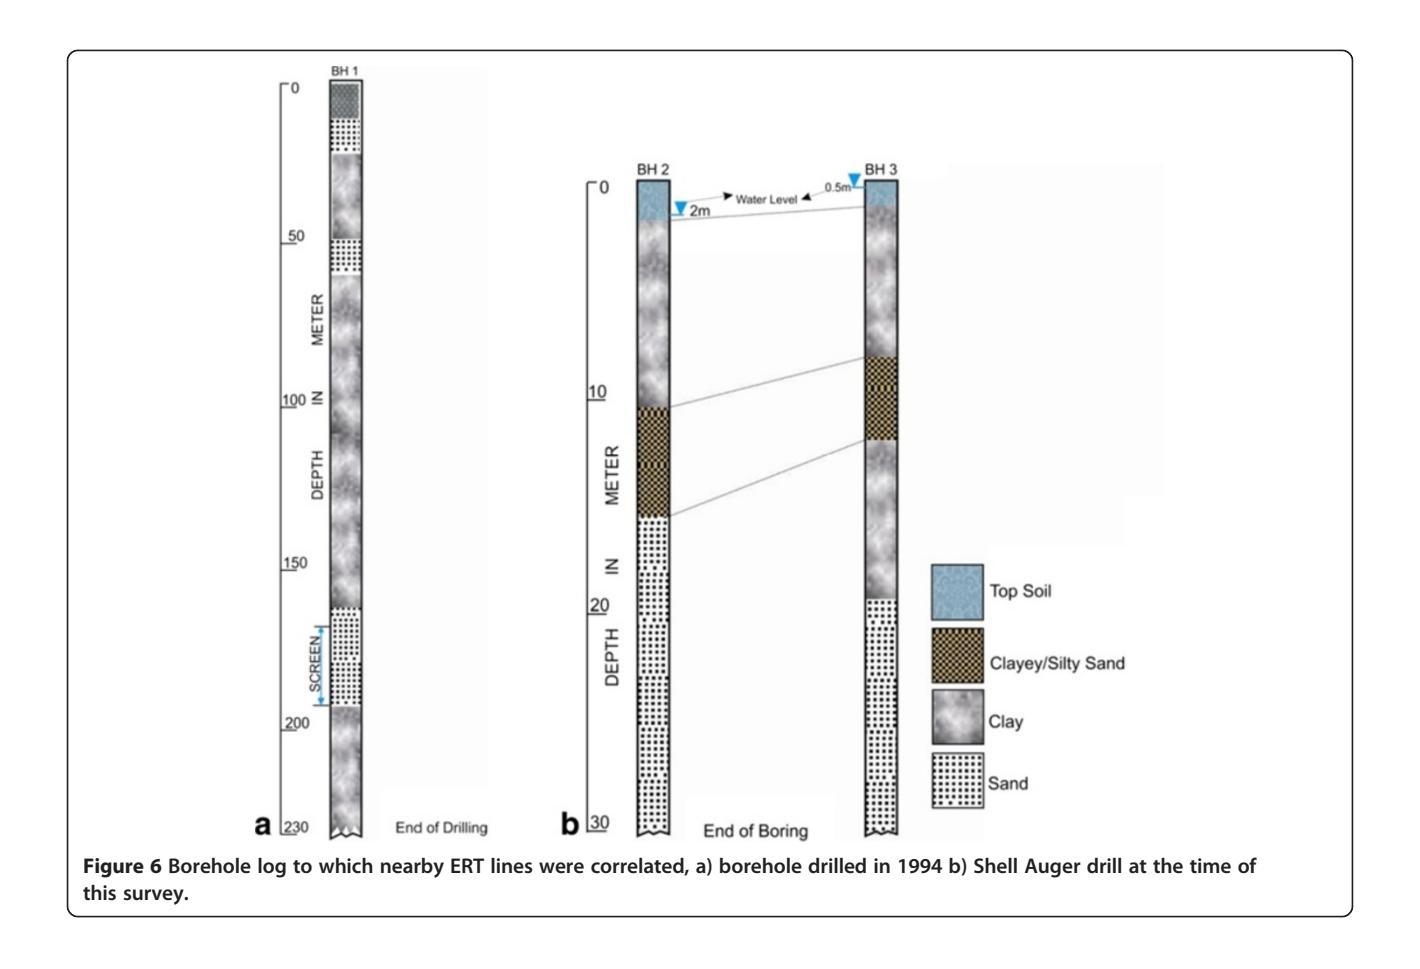
2-D ERT line 6 run across a borehole drilled and logged in 1994. Borehole log shows 10 m thick sandy clay top soil followed by 11 m thick reddish sand, which

is underlain by 28 m thick clay as shown in Figure 6a. A thin sandy layer of 11 m thick underlain the clay layer in alternation followed by a very thick layer of clay (100 m thick). Juxtaposing this with resistivity depth; there was no distinction between sandy clay topsoil and the underlying sand as both reflect resistivity variation interpreted as sand. The information that is not known is that between the time the borehole was drilled in 1994 and now if the present ground level is the same with what obtainable then. This would definitely affect the correlation of geoelectric layer obtained from our study and the geologic layer of the then subsurface. Nonetheless, the borehole would be used to correlate profiles around it (central part of the campus). Two other borehole sources used are Shell Auger boreholes (Figure 6b) drilled at the back of Faculty of Science (Traverse 13) a few days after the acquisition of 2-D ERT data.

(Figure 6b) corroborated the 2-D ERT result for this area.

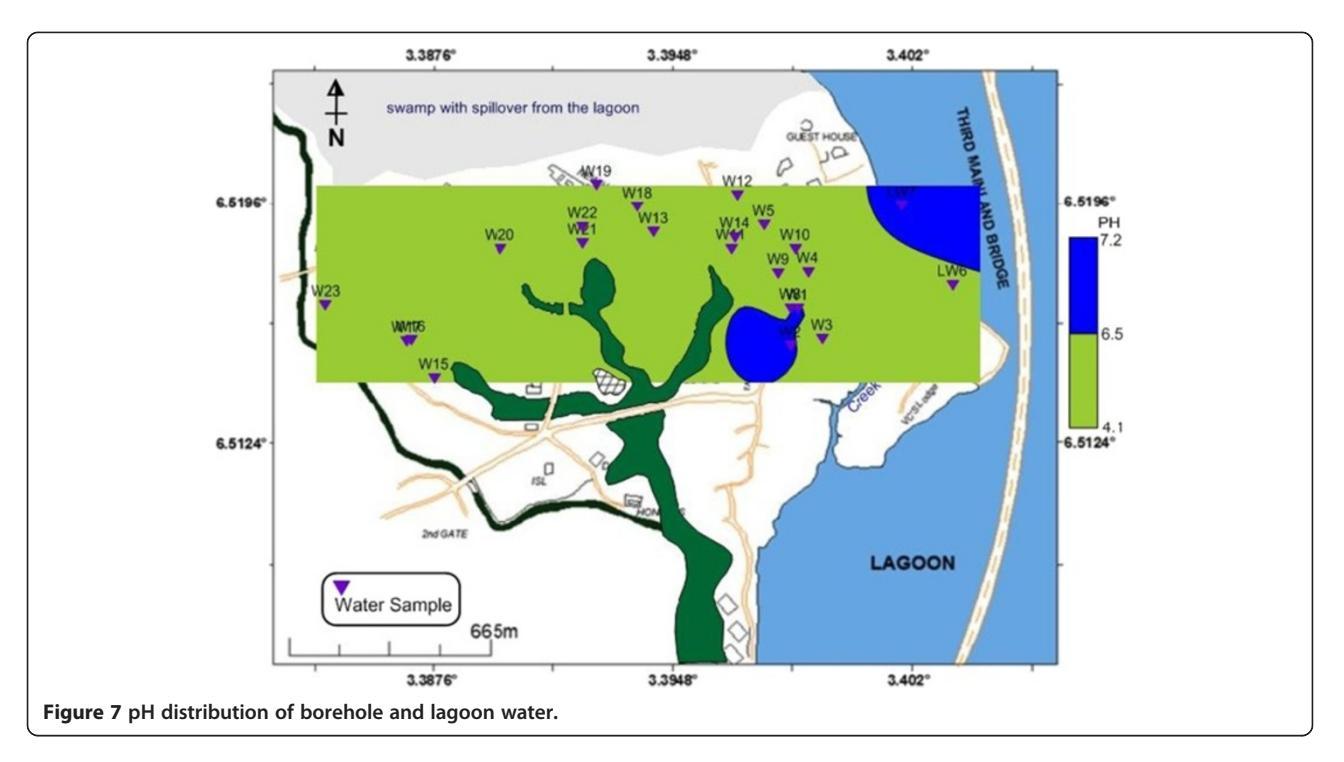
The observed pH values between 4.21 and 7.08 put the groundwater in the acidic domain. Figure 7 shows that over 70% (red colour) of the water samples are acidic which is out of USEPA (2008) and USEPA (2009)

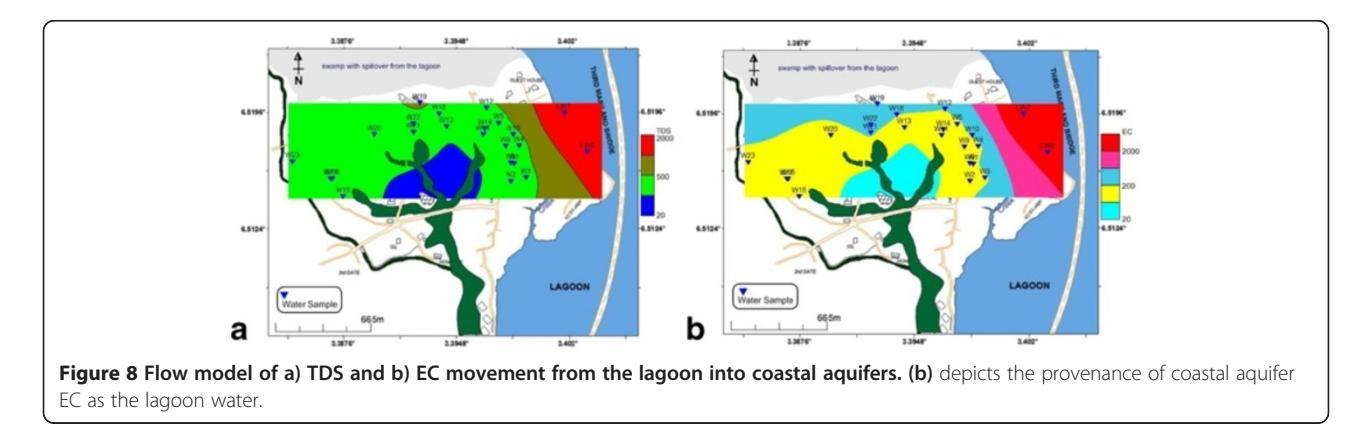
standards. TDS values below 1 g/L are associated with fresh groundwater (Postma et al. 2007; Larsen et al. 2008; Jessen et al. 2008; Winkel et al. 2011) and these values correspond to an electrical resistivity below 100 mS/m ($\rho_w > 10$ ohm-m) (Tran et al., 2012). Using a TDS below 1 g/L (1000 mg/L) to separate fresh groundwater from saline groundwater, the groundwater within University of Lagos could be classified as fresh water as depicted in Figure 8a.

Figure 8b plotted from the observed pH values depicts increasing electrical conductivity (EC) from mainland aquifers towards the lagoon, a situation that aptly suggests the influence of lagoon water salinity through gradual encroachment into the coastal aquifers as an evidence of the provenance of aquifer EC. The lagoon recharges the aquifers and since its water is saline, therefore the invaded aquifers become more conductive. Similar conductivity (resistivity) flow paths from the

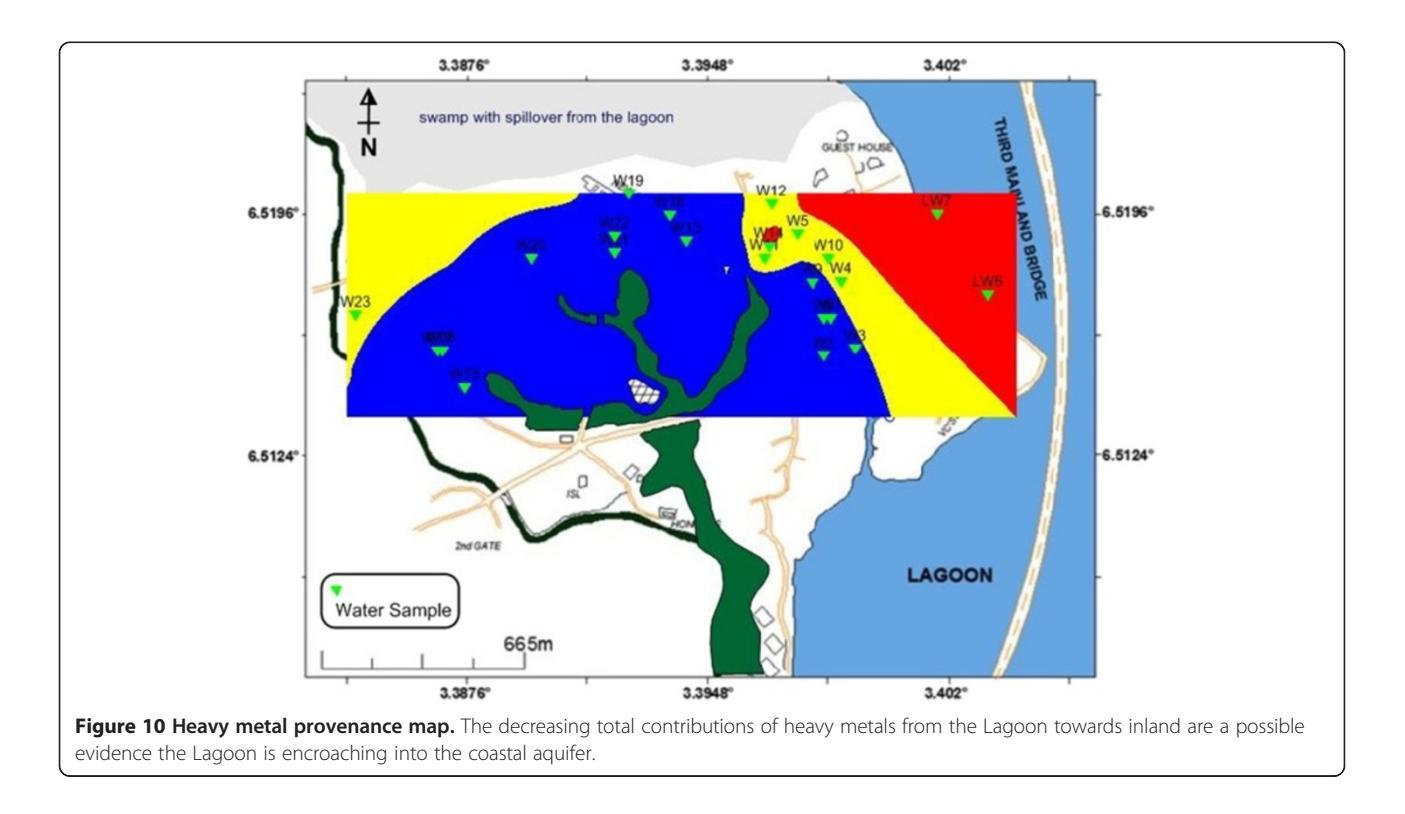
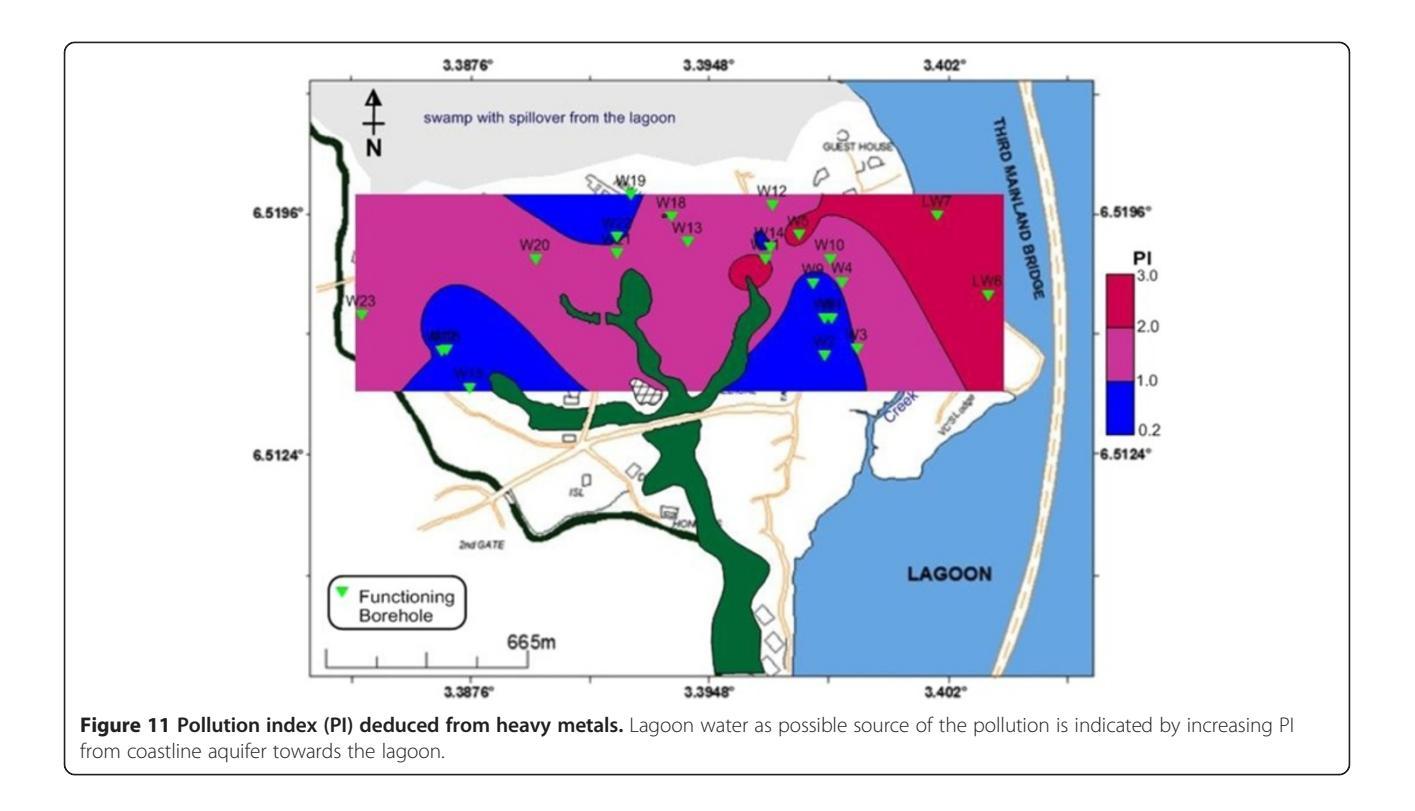
As the lagoon water transgresses and regresses (own to seasonal variations and specific gravity; liquid moving from region of high to lower concentrations), geochemical elements in the water also follow. This accounts for increasing pattern of the geochemical (and physical) elements from the mainland to the lagoon. Only Na macroelements exceeded the threshold values which apparently reflect in the electrical conductivity of the water. All the heavy metals are present in the lagoon water at very high concentrations and gradually infiltrate the nearby groundwater aquifers possibly during aquifer recharge or intrusion as depicted by increasing concentrations from the mainland

toward the lagoon (Figure 10). Continuous flow of these metals toward the mainland could become a threat and source of enrichment of the aquifers with heavy metals that may not be environmentally benign.

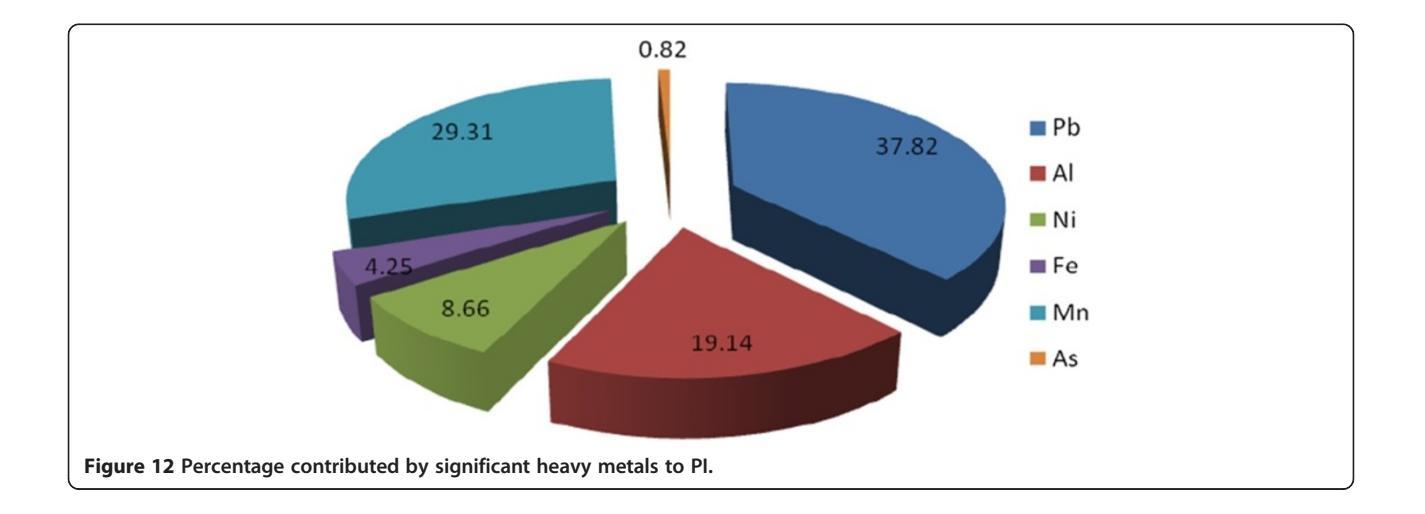
and 2.86. Most importantly, Figure 11 depicts the provenance of the PI as the lagoon with increasing contamination level from the coastal aquifers to the lagoon. Similar flow path has been earlier observed from EC, TDS, trace elements and the resistivity. Lead (Pb) contributed the highest percentage (37.8%) to the Pollution Index, followed closely by Mn, Al, Ni, Fe and As (Figure 12).
