Mitigation of efflorescence of wallboard by means of bio-mineralization

Bin Xue^{1,2} and Chunxiang Qian^{1,2*}

¹ School of Materials Science and Engineering, Southeast University, Nanjing, China, ² Research Institute of Green Construction Materials, Southeast University, Nanjing, China

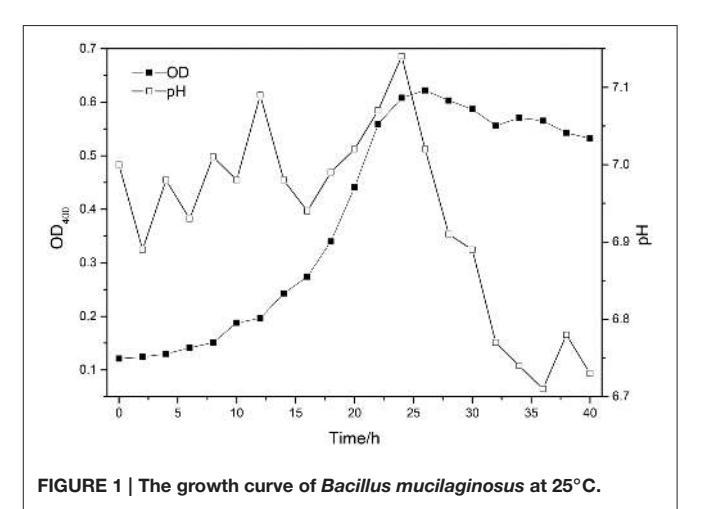
The growth curve of *B. mucilaginosus* was shown in **Figure 1**.

As indicated by the above test: the best time of culturing *B. mucilaginosus* should be 24–28 h. The growth of *B. mucilaginosus* was stable in this period and the total number of bacteria and metabolites reached maximum when the time of culturing *B. mucilaginosus* was 24–28 h.

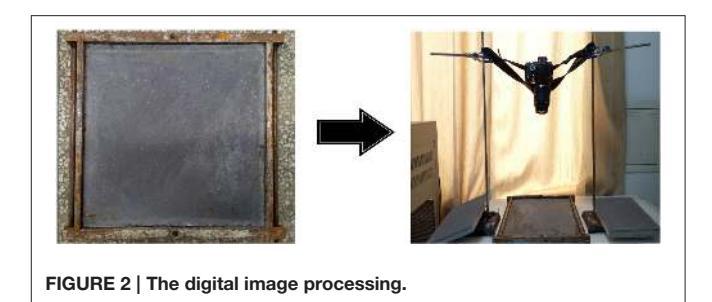
Prepared samples were placed in the laboratory at $20 \pm 3^{\circ}$ C for 1 day and then were covered with a layer of water. The thickness of water layer above the surface of wallboard was about 2–3 mm. The water layer disappeared about 2 days later at $20 \pm 3^{\circ}$ C. Repeat the above process for three times. This approach brought the internal soluble components into the surface of wallboard. So this process was to simulate rain erosion phenomenon and provoke efflorescence. Seven days later, all samples were taken photographs in the condition of same height and same light source by digital camera (Canon 5D Mark III) and the Imagej was used to analysis the surface efflorescence of wallboard. The digital image processing could be revealed by **Figure 2**.

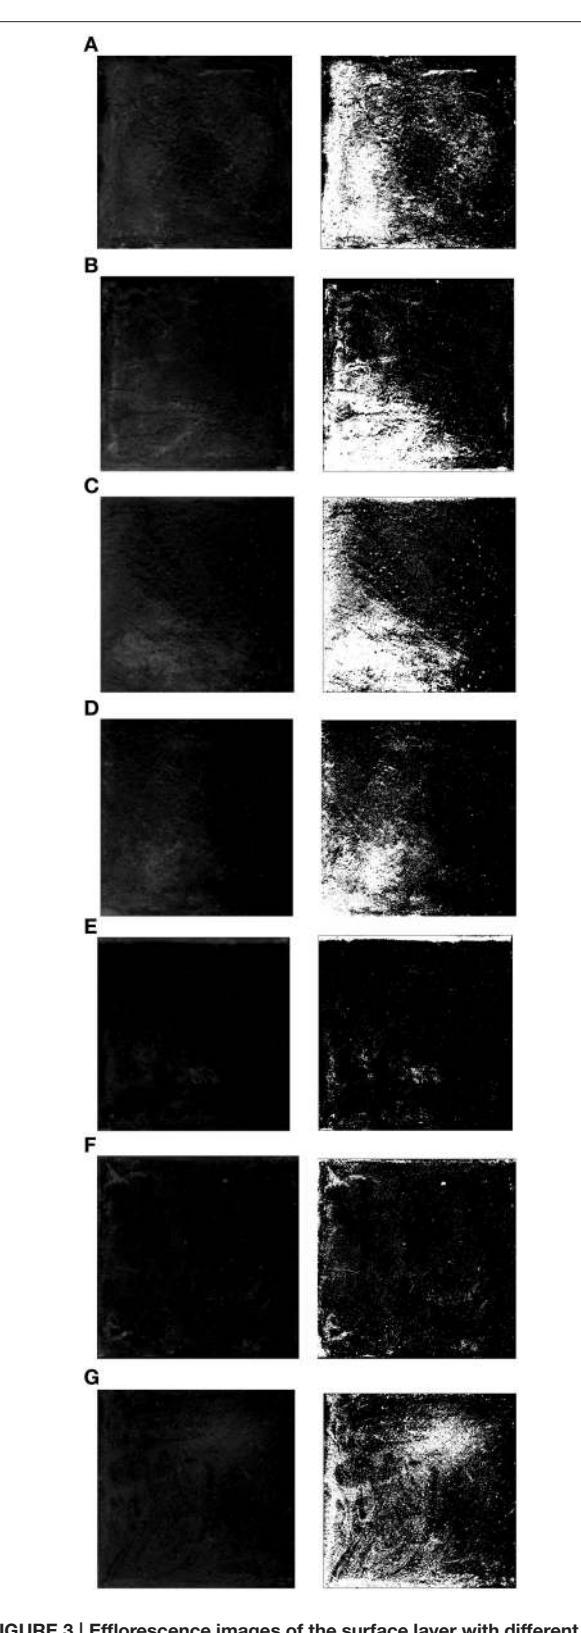
FIGURE 3 | Continued

Figure 3 showed the efflorescence images processed by means of ImageJ. The experimental results proofed the feasibility of reducing surface efflorescence by *B. mucilaginosus*. However, in

was 1%, and efflorescence area was $28 \pm 2\%$. (C) Bacteria content was 2%, and efflorescence area was $26 \pm 3\%$. (D) Bacteria content was 3%, and efflorescence area was $17 \pm 2\%$. (E) Bacteria content was 4%, and efflorescence area was $5 \pm 1\%$. (F) Bacteria content was 5%, and efflorescence area was $10 \pm 2\%$. (G) Bacteria content was 5%, and efflorescence area was $18 \pm 3\%$.

the other side, the effect was not always better as the content of B. mucilaginosus increased. By calculating with the Imagel, the efflorescence area was 32 ± 3 , 28 ± 2 , 26 ± 3 , 17 ± 2 , 5 \pm 1, 10 \pm 2, and 18 \pm 3% of the whole area of surface laver when the microbe content was 0, 1, 2, 3, 4, 5, and 6% of the mass of cementitious material respectively. In contrast to the efflorescence in the form of lump in Figures 3A-G, the Figures 3E,F both showed the mottled efflorescence on the surface of wallboard. The experimental results could be explained by the mechanism that B. mucilaginosus could capture atmospheric CO₂ by carbonic anhydrase. Then calcium carbonate was produced when CO₂ reacted with Ca(OH)₂ (engendered by cement hydration). The generation of calcium carbonate could improve the density of surface layer and reduce the porosity of wallboard. This process could not only reduce the content of Ca(OH)₂ but also prevented Ca(OH)₂ from effusing to the surface of wallboard. Efflorescence degree would be increased when microbe content was more than 4% of the mass of cementitious material.

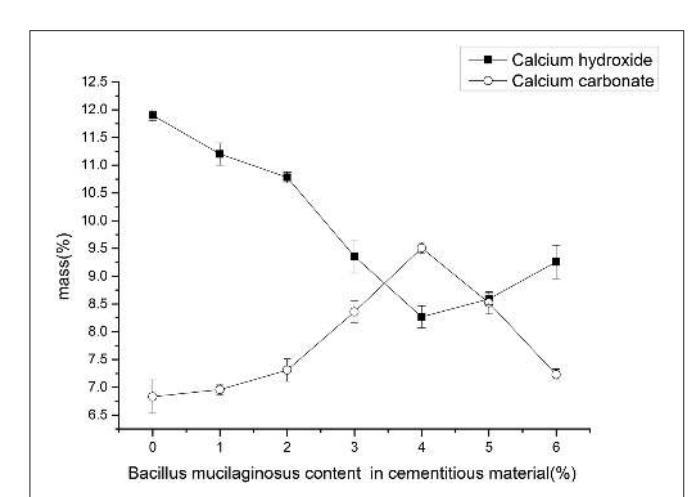
FIGURE 4 | The content changes of calcium carbonate and calcium hydroxide with the increase of *Bacillus mucilaginosus* content in cementitious material, and error bars represent one standard deviation.

Figure 4 showed the mass percentages of calcium hydroxide (portlandite) and calcium carbonate of the surface layer of wallboard. The mass percentage of calcium hydroxide (portlandite) was determined by the mass loss between 450 and 550°C, and, similarly, the mass percentage of calcium carbonate was determined by mass loss due to decarbonation between 700 and 900°C. The results showed that mass percentage of calcium hydroxide gradually reduced from 11.90 to 8.27% and calcium hydroxide increased from 6.83 to 9.51% with the increase of *B. mucilaginosus* content from 0 to 4%. However, the mass percentage of calcium carbonate decreased and the mass percentage of *B. mucilaginosus* exceed 4%. The experimental results were corresponding with the efflorescence images taken by camera and the mechanism could be explained same like 3.1.

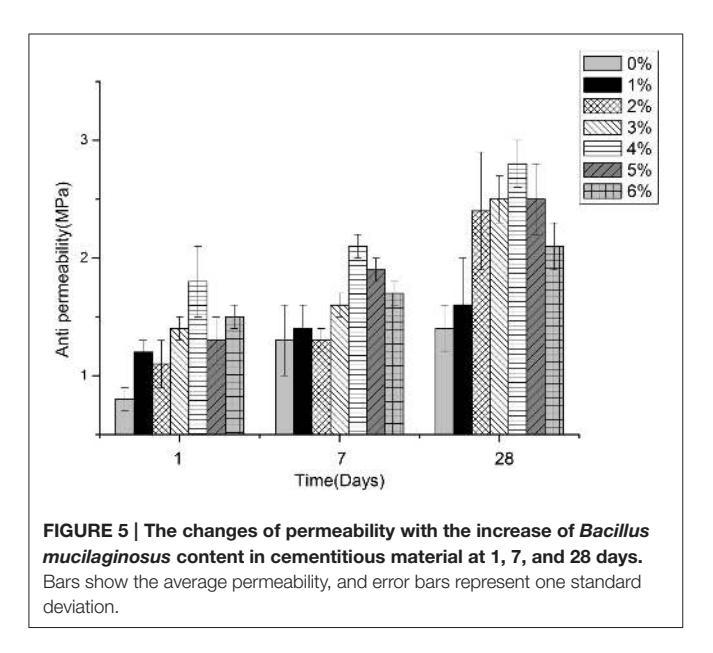
Figures 5–7 displayed the results of the permeability, compressive, and flexural strength of wallboard, respectively. The permeability, compressive and flexural strength of all the

specimens increased with time. At day 1, day 7, and day 28, the specimen always had the best permeability, compressive and flexural properties when the content of *B. mucilaginosus* was 4%. As the content of bacteria was from 0 to 4%, the increase of these properties could be seen. However, these properties decreased when the content exceeded 4%. These phenomena could be contributed to the reduction of porosity owing to microbial induced calcium carbonate formation on the surface layer. The mechanism could also be explained similarly to 3.1. Except that, it also illustrated that the *B. mucilaginosus* could live for a long time in the internal of mortar and the bacteria could absorb CO₂ from air constantly, which improved permeability, compressive and flexural strength of wallboard greatly at longer ages.

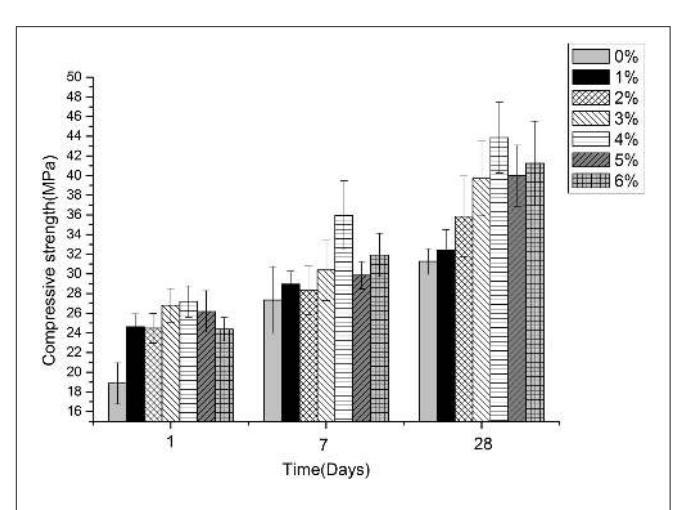
FIGURE 6 | The changes of compressive strength with the increase of *Bacillus mucilaginosus* content in cementitious material at 1, 7, and 28 days. Bars show the average compressive strength (based on triplicate mortar samples), and error bars represent one standard deviation.

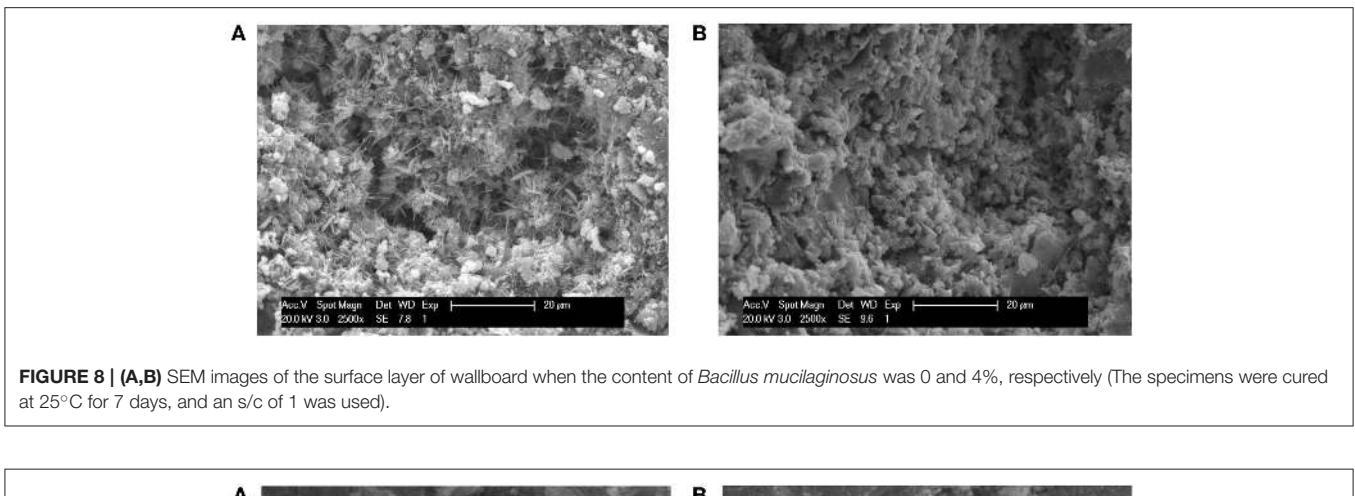
Figure 8 showed the SEM images of the hydration products and changes of the pore structure of the surface layer of wallboard when the content of *B. mucilaginosus* were 0 and 4%, respectively. In **Figure 8A**, there were many needle ettringite crystal, Ca(OH)₂, and some flocculent calcium silicate hydrate gel. The existence of large number of pores contributed to the loose structure of the wallboard. However, from **Figure 8B**, the pores between hydration products were filled with CaCO₃ induced by *B. mucilaginosus*, so the structure was more compact. **Figure 9** showed the SEM images of the interface transition zone of paste-aggregate of the surface layer when the content of *B. mucilaginosus* were 0 and 4% respectively. In **Figure 9A**, a gap

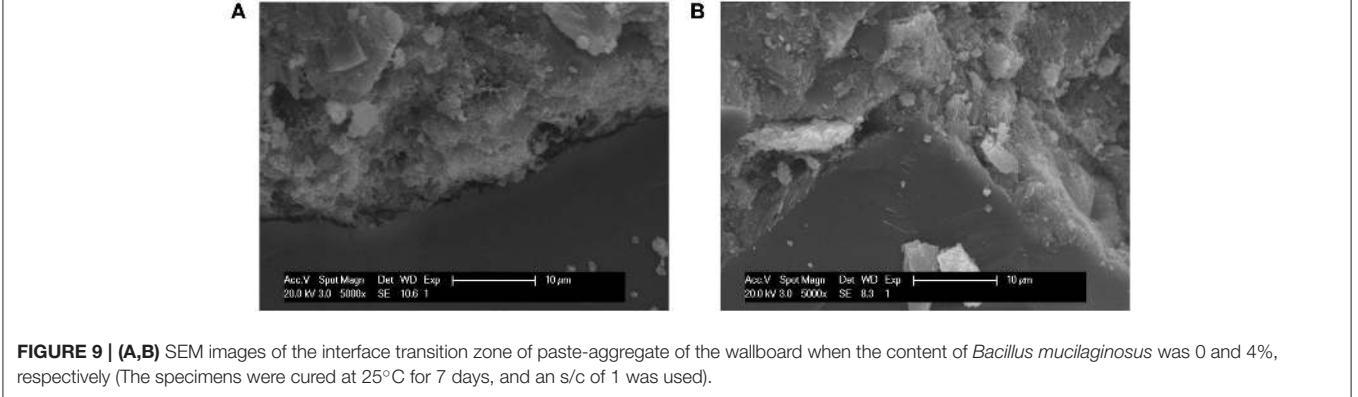
could be clearly seen between hydration products and aggregate. This phenomenon illustrated that the binding force between them was small and weak. In the later picture **Figure 9B**, the past and aggregate could combine closely and the structure was more compact. The transformation of the microscopic structure after adding *B. mucilaginosus* could explain the changes of permeability, compressive and flexural strength of wallboard. Three of these properties improved when the content of bacteria was lower than 4%.
