Recent Progress on HPFRCC in Japan Required Performance and Applications

Minoru Kunieda¹ and Keitetsu Rokugo²

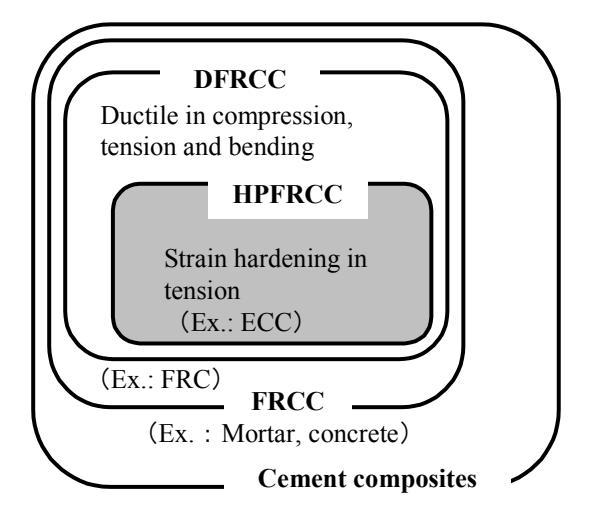
Fig. 3 Classification based on ductility of cement composites (JCI 2003b).

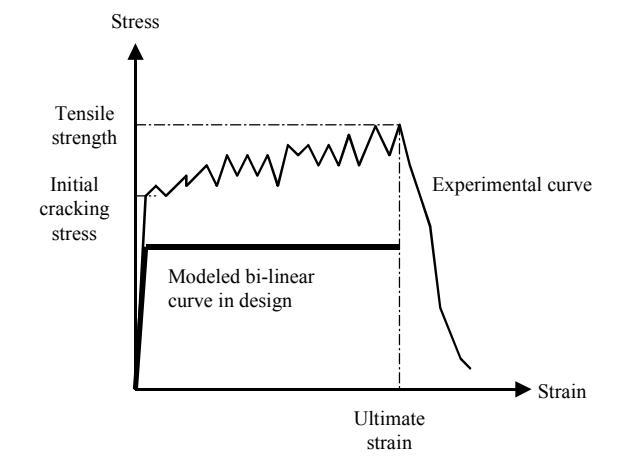
Fig. 4 Modeled stress-strain curves in design.

The modeled bi-linear stress strain relation shown in **Fig. 4** is proposed for the tensile stress strain relation of HPFRCC (JSCE 2005a). To determine the modeled stress strain relations, initial cracking strength and strain at tensile strength are proposed as specific values in the JSCE recommendation (draft), where initial cracking strength is divided by material factor 1.3. **Figure 5** shows the stress and strain distributions within the cross sections of HPFRCC members, compared with those of

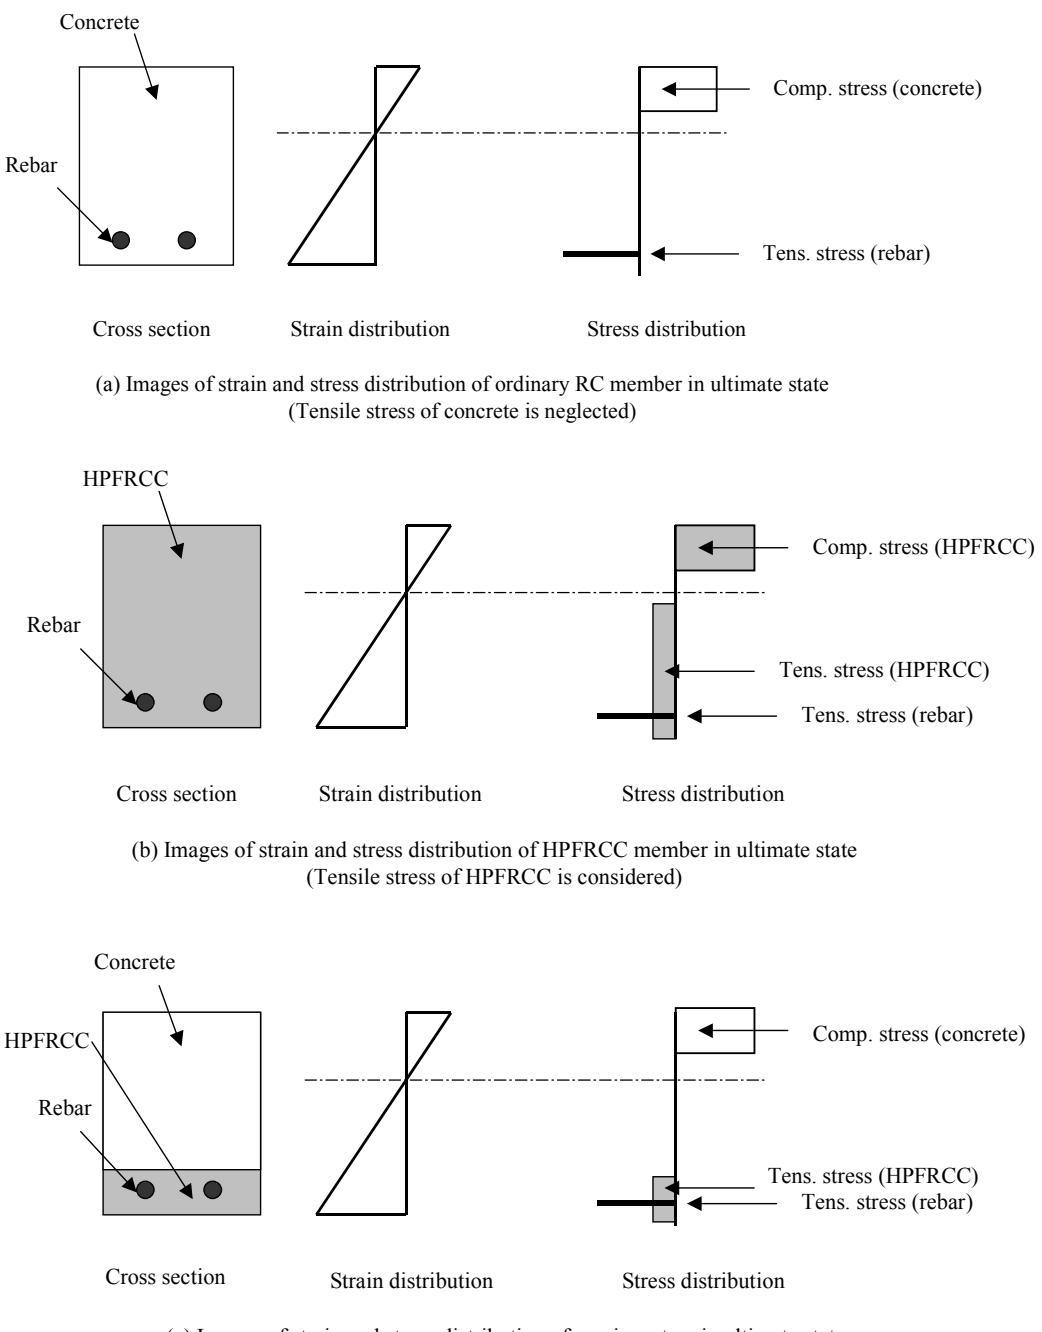
(c) Images of strain and stress distribution of repair system in ultimate state (Tensile stress of HPFRCC is considered)

Fig. 5 Calculation of bending moment of beams with or without HPFRCC.

RC. One is the members consists of HPFRCC, and the other is a composite member such as those used for overlay repair or patch repair systems. In calculations of load bearing capacity against bending moment, the tensile stress of HPFRCC at each strain level helps to provide higher load bearing capacity, assist reinforcement, or give higher fatigue resistance, for both serviceability and structural safety.

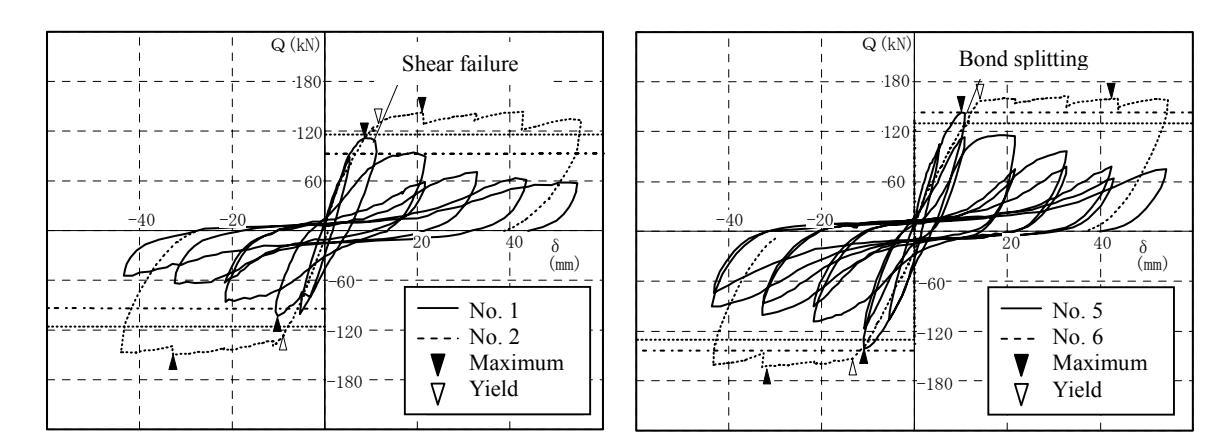
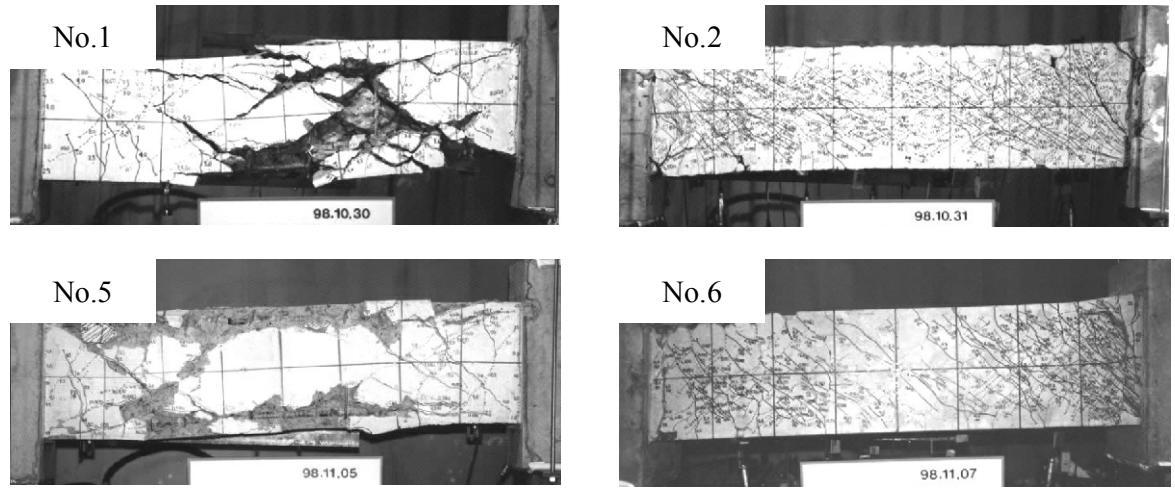
(a) Load-displacement curves

(b) Crack patterns (final)

Fig. 6 Shear failure behaviors of RC and HPFRCC (Fukuyama et al. 1999).

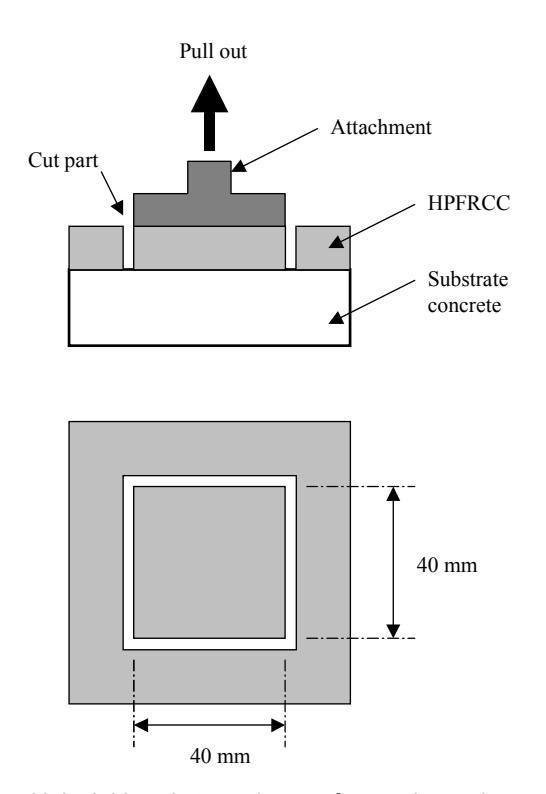
Fig. 7 Uniaxial bond strength tests for patch repair materials.

(Kanda *et al.* 2003). Evaluation of performance including shear bond behavior at the interface is quite difficult. In addition, required criteria for the performance have not been clarified. Therefore, for simplicity's sake, uniaxial bond tests were adopted as evaluation tests of patch repair materials in the JSCE specification (JSCE 2005b), as shown in **Fig. 7**.

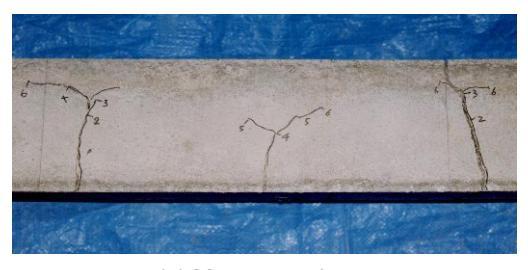
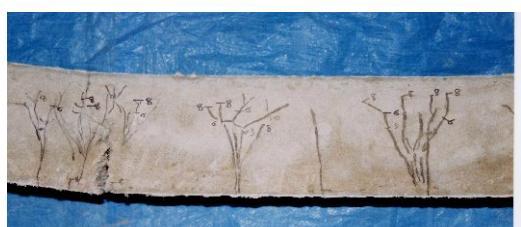
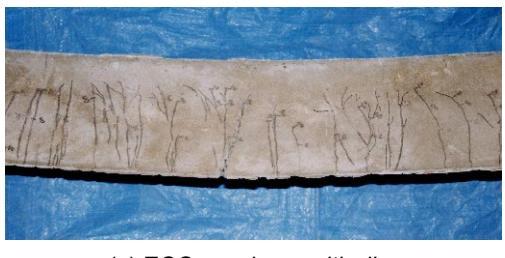
(a) Mortar specimen

(b) ECC specimen without ribs

(c) ECC specimen with ribs

Fig. 8 Cracking behavior of steel pipe covered with HPFRCC (Rokugo et al. 2002).

quired to obtain larger deformation of both materials uniformly. A typical example is shown in **Fig. 8**. This composite consists of HPFRCC and a steel pipe with and without bonding, each having ribs or no ribs, respectively (Rokugo *et al.* 2002). Good bonding between the HPFRCC and steel pipe results in narrow crack intervals within the members, and higher load bearing capacity. Another typical composite is reinforcement (rebar) covered with HPFRCC. Fischer (2002) investigated compatible deformation between HPFRCC and steel reinforcement. Here, compatible deformation gives lower interface shear stress and reduces splitting and/or spalling of cover concrete. Larger critical strain of the HPFRCC that equals yielding of reinforcement may achieve uniform multiple cracking among members.

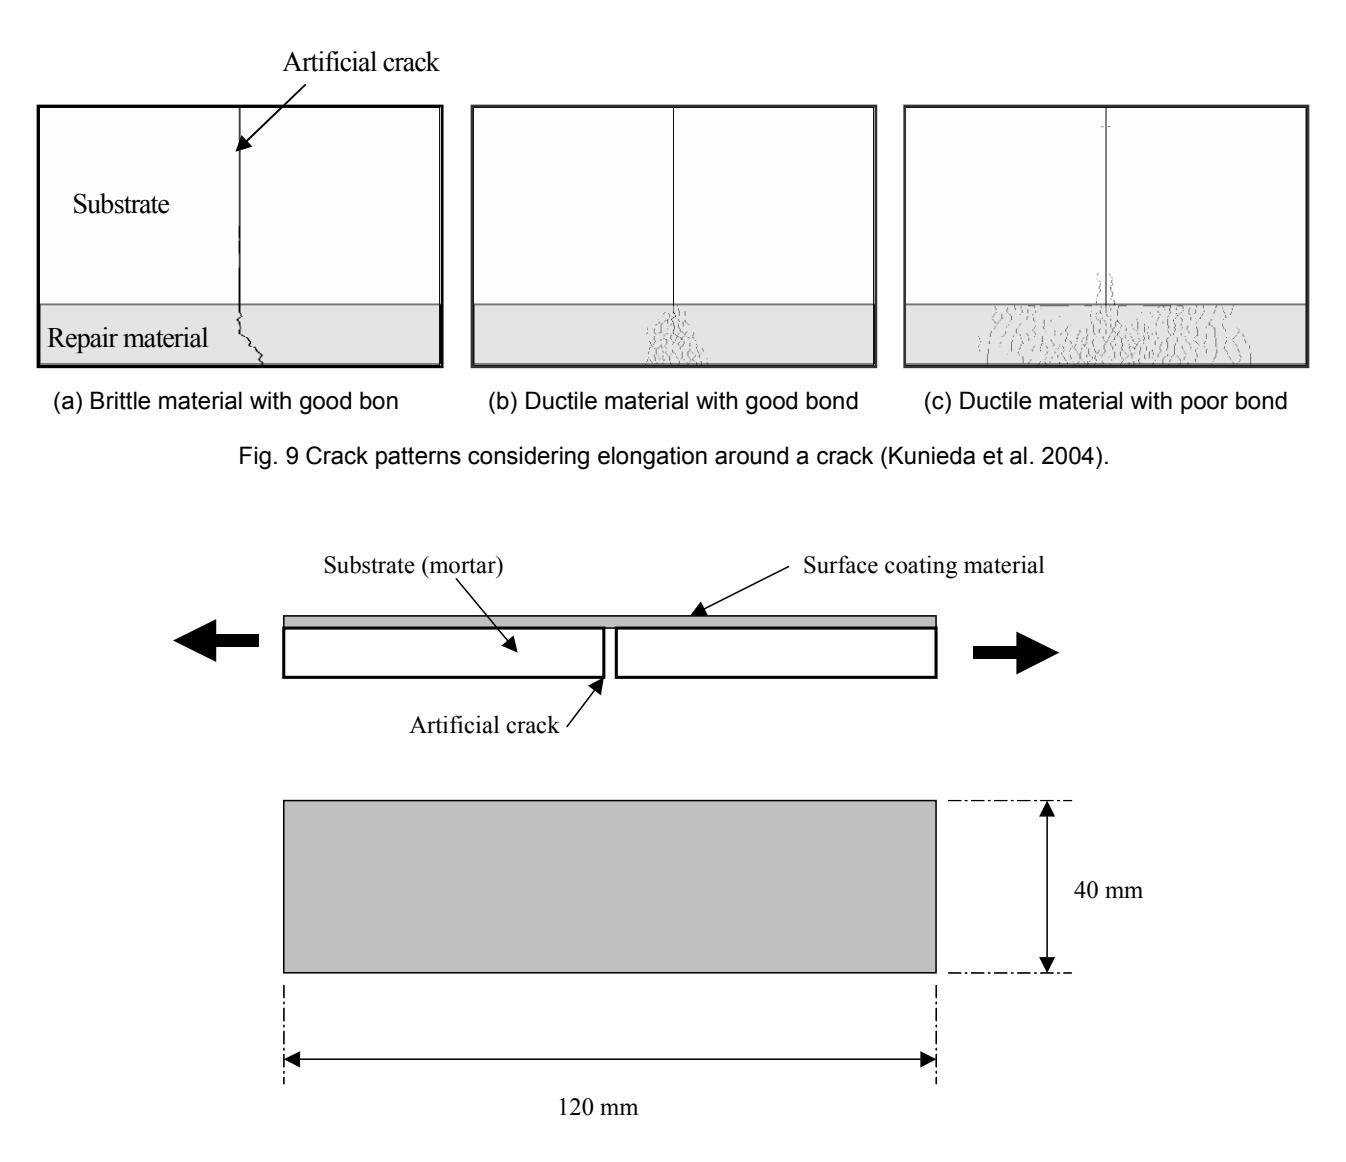
Fig. 10 Zero-span tensile tests for surface coating materials (JSCE K-532-1999).

For surface coating materials (paint type), the JSCE Standard (JSCE 2002) specifies zero-span tensile tests, as illustrated in **Fig. 10**. This type of test should be developed in the near future for HPFRCC.

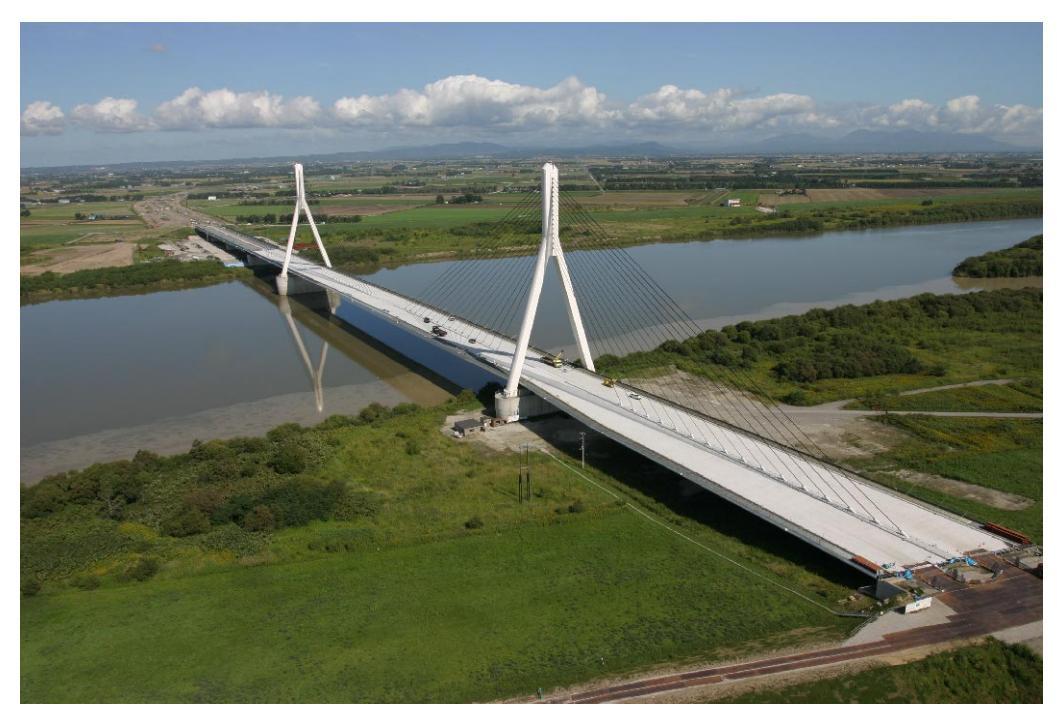
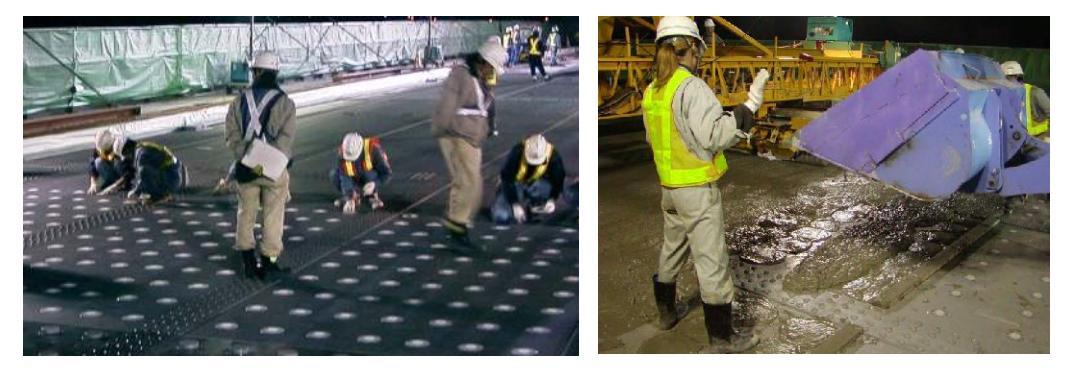
(a) Overview of bridge

(b) Adopted plate-type dowels

(c) Placement of HPFRCC

Fig. 11 Outline of Mihara Bridge (Mitamura et al. 2005).

Mihara Ohashi in Hokkaido with a bridge length of 972 m and central span of 340 m (Mitamura 2005). In 2004, half the depth of the asphalt overlay on the steel deck of this bridge was replaced with 40 mm thick HPFRCC to increase the load bearing capacity and stiffness of the decks while reducing the stress generated, thereby improving the fatigue resistance of the stiffener for the steel deck. This became necessary because the requirements for fatigue resistance in the standard specifications were revised while the bridge was under construction.

Plate-type dowels as shown in **Fig. 11(b)** were adopted to ensure the bond between the HPFRCC and the steel deck (Fukuda 2004). HPFRCC was mixed at ready-mixed concrete plants, hauled to the construction site by large agitating trucks, and subjected to secondary mixing at the construction site. Approximately 30 m³ of HPFRCC were placed each day, with the amount of mixed HPFRCC totaling approximately 800 m³. The placing process is shown in Fig. 11(c).

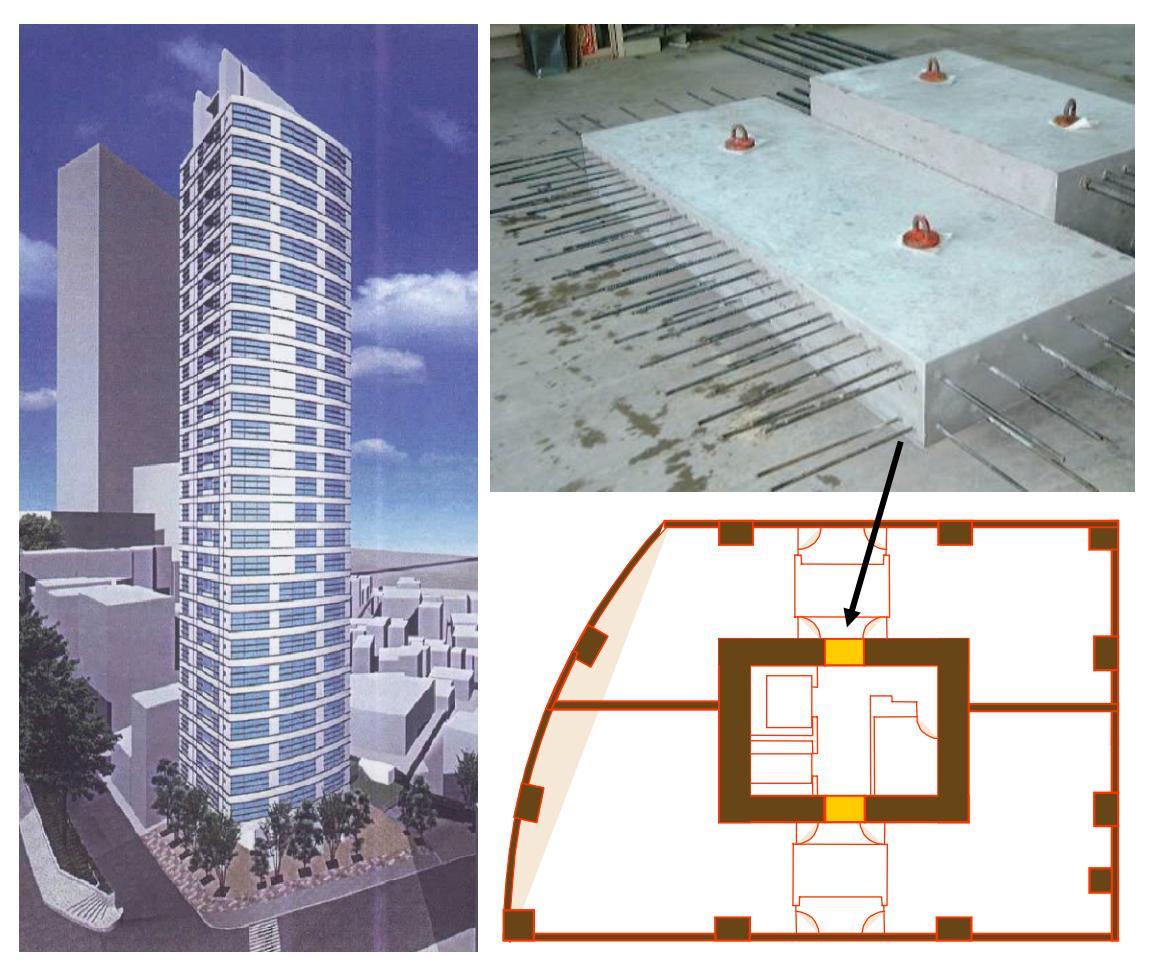
An HPFRCC member reinforced with steel bars is capable of absorbing a large amount of energy under alternate loading. As shown in **Fig. 12**, HPFRCC members were incorporated as dampers in reinforced concrete buildings in Tokyo and Yokohama in 2004 and 2005, respectively (Maruta *et al.* 2005). The HPFRCC members were connection elements with main (core) frames of high-rise buildings, and the elements involved both higher energy consumption and minimized repair work after earthquake. To design the elements considering structural response, shear tests using 1/2.5 scale specimens were conducted. The test results show that the elements have novel structural performance and narrow crack width (smaller than 0.3 mm) after cyclic loading.

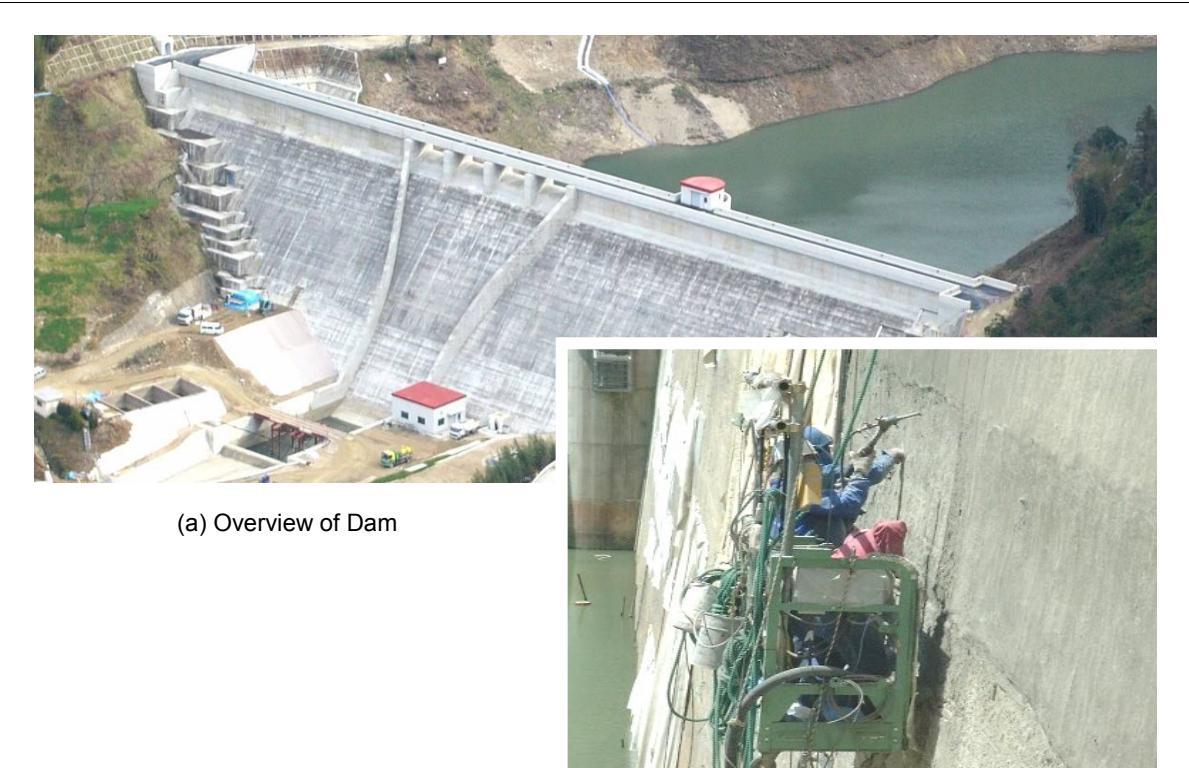
(b) Spraying

Fig. 13 Surface repair of concrete dam (Kojima et al. 2004).

The shielding performance of HPFRCC is excellent owing to its small crack widths, which minimize water permeation. The dam height of Mitaka Dam (Kojima 2004), a gravity concrete dam in Hiroshima Prefecture, was increased from approximately 33 m to 44 m by placing new concrete onto the existing dam body on the downstream side (**Fig. 13**). In 2003, 30 m³ of HPFRCC was sprayed on the upstream dam surface (area: 500 m²) with a thickness of 30 mm, to improve the shielding performance of the deteriorated existing concrete surface (**Fig. 13**). Anchors were driven at 1.5 m² intervals to ensure a strong bond between the substrate and HPFRCC.

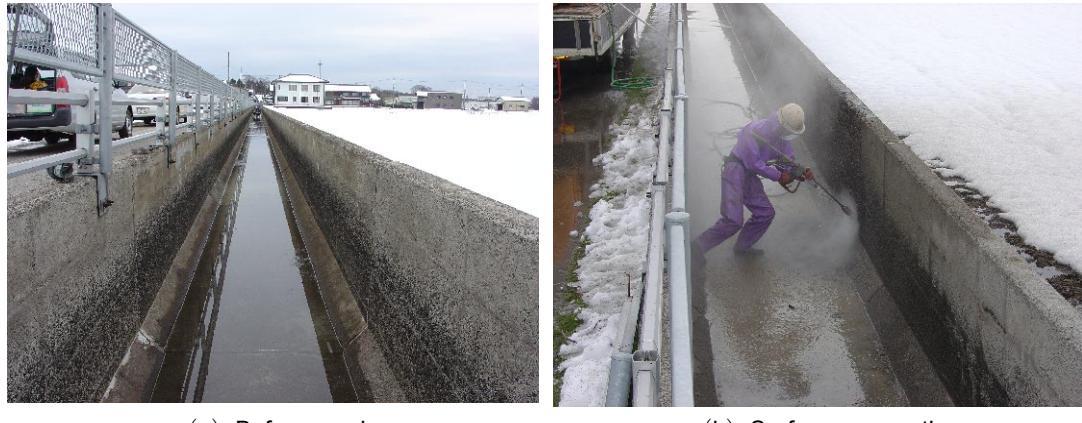
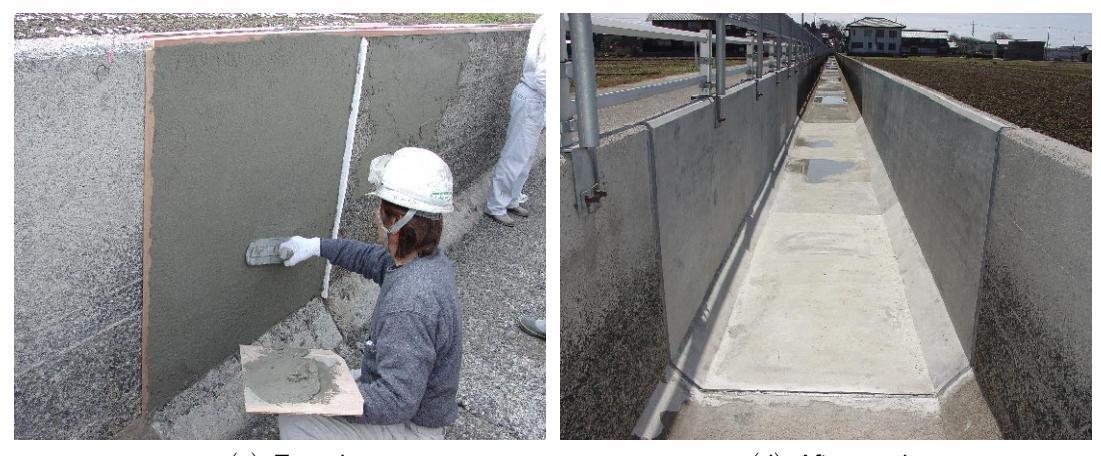
(a) Before repair

(b) Surface preparation

(c) Trowel(d) After repairFig. 14 Surface repair of concrete irrigation channel (trowel).

Many irrigation channels suffer deterioration due to abrasion, having been in service for several decades. The Central Main Channel (JSCE 2005a) (side wall height: 1.1 m, bottom slab width: 1.5 m) in Shiga Prefecture, shown in **Fig. 14**, was so deteriorated that coarse aggregate was exposed on the surfaces and the edges were

partially lost, with cracks approximately 1 mm wide and approximately 1m long. At Seridanno Channel in Toyama Pref. (side wall height: 1.1 m, masonry side wall height: approx. 2.4 m, bottom slab width: approx. 2.05 m), coarse aggregate was exposed on the surfaces and the bottom slabs were partially spalled off. Part of the filling mortar at the bottom of the masonry sidewall was also lost.

A water jet was used for substrate treatment to remove deteriorated mortar. Each masonry joint in the sidewalls of the Seridanno Channel was filled with mortar. HPFRCC was troweled and sprayed at the Central Main Channel and Seridanno Channel, respectively, in 2005. (thicknesses of 6 and 10 mm for sidewalls and bottom slabs, respectively.) Spraying resulted in a work speed two to three times higher than that of troweling.

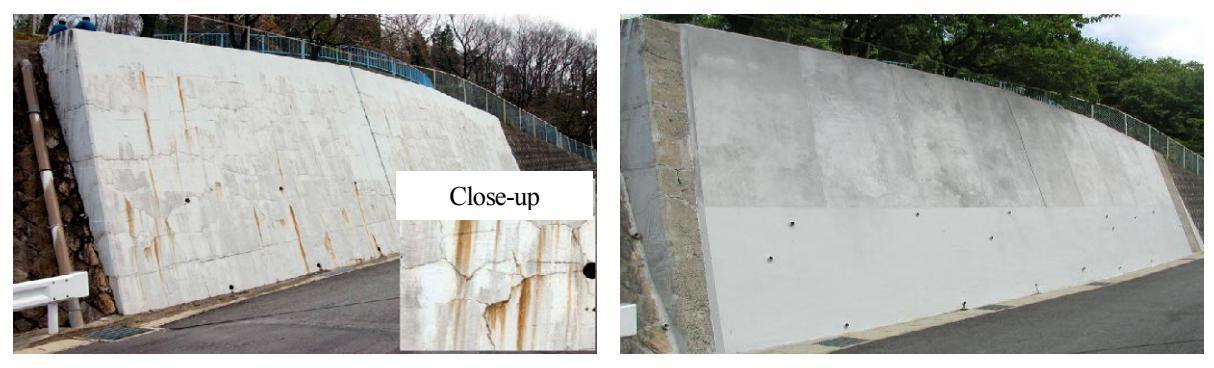
(a) Before repair

(b) After repair

Fig. 15 Surface repair of concrete retaining wall (Rokugo et al. 2005).

Because of its small cracking widths, HPFRCC is suitable for application on the surface of cracked concrete structures in terms of aesthetics. A gravity concrete retaining wall in Gifu Prefecture measuring approximately 18 m in width and 5 m in height was constructed in the 1970s. As cracks due to alkali-aggregate reaction developed in the wall, these cracks were injected with epoxy resin and the wall surface was coated with an organic material in 1994. When the surface repair material also cracked, the wall was subjected to surface repair using sprayed HPFRCC and other materials (Rokugo et al. 2005) in 2003, as shown in Fig. 15 and Table 3. The wall was divided into nine repaired sections and one no-repaired one. These were combinations of three repair materials (two HPFRCCs and one repair mortar), three reinforcement levels (welded wire mesh, expanded metal, and no reinforcement), and two crack treatment levels (with and without sealing to increase the bondless areas). The wall surface was chipped off using a water jet. Acrylic resin coating was applied to the repaired surface in the area from the bottom of the wall to a height of 2 m. The residual expansion of concrete cores drilled from the wall was low, ranging from 0.005 to 0.011. A shotcreting

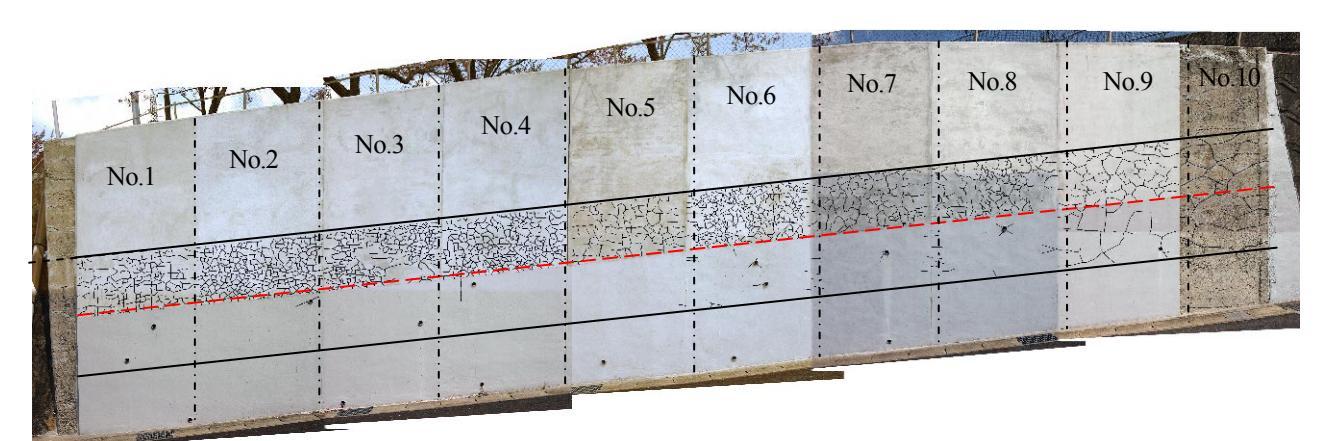
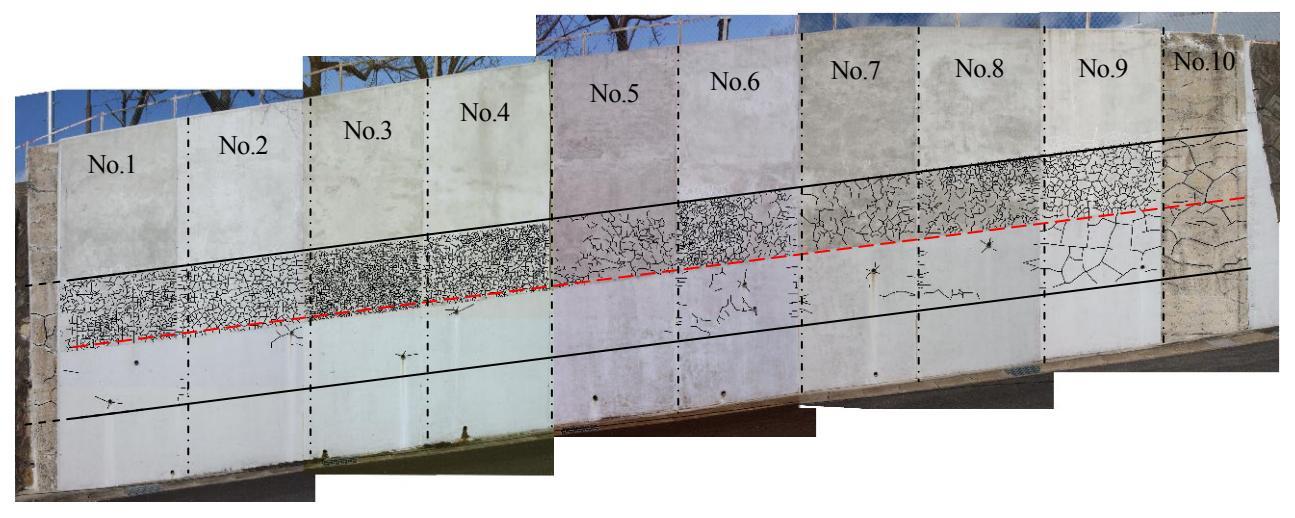
(a) 12 months

(b) 24 months

*Each numbers indicate a block number with different materials and reinforcements.

Fig. 16 Crack patterns at 12 and 24 months observation (Rokugo et al. 2005).

No cracking was observed until seven months after repair by HPFRCC. The crack widths then developed to not more than 0.05 and 0.12 mm at 10 and 24 months after repair, respectively. **Figure 16** shows the state of cracking 12 and 24 months after repair. Meshes of fine cracks were similarly observed. Cracking was harder to observe 24 months after repair compared to 12 months after, being obscured by dirt accumulated on the surface. On the other hand, cracking was visually observed on repair with normal repair mortar (Block 9) just one month after repair, with crack widths developing to 0.03, 0.2, and 0.3 mm at 3, 10, and 24 months after repair, respectively.

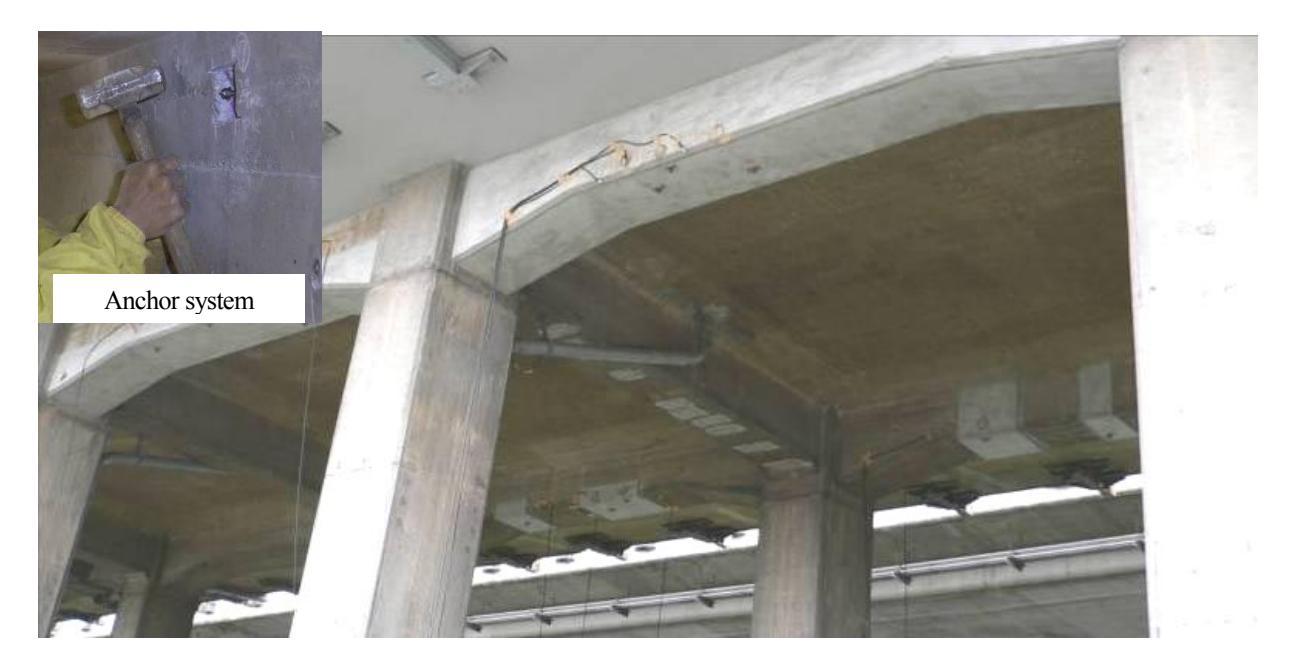
Fig. 17 Surface repair of railway viaduct.

(opening and closing action) under the loads of railway traffic. Sprayed HPFRCC was applied to a thickness of 10 mm to viaduct girders having bending cracks for surface protection in 2005 (**Fig. 17**) (Suda and Rokugo 2005, Inaguma *et al.* 2005). Anchors were used to ensure bonding between the substrate concrete and HPFRCC.
