14th-16th-CENTURY DANUBE FLOODS AND LONG-TERM WATER-LEVEL CHANGES IN ARCHAEOLOGICAL AND SEDIMENTARY EVIDENCE IN THE WESTERN AND CENTRAL CARPATHIAN BASIN: AN OVERVIEW WITH DOCUMENTARY COMPARISON

Andrea Kiss^{1,2*}, József Laszlovszky³

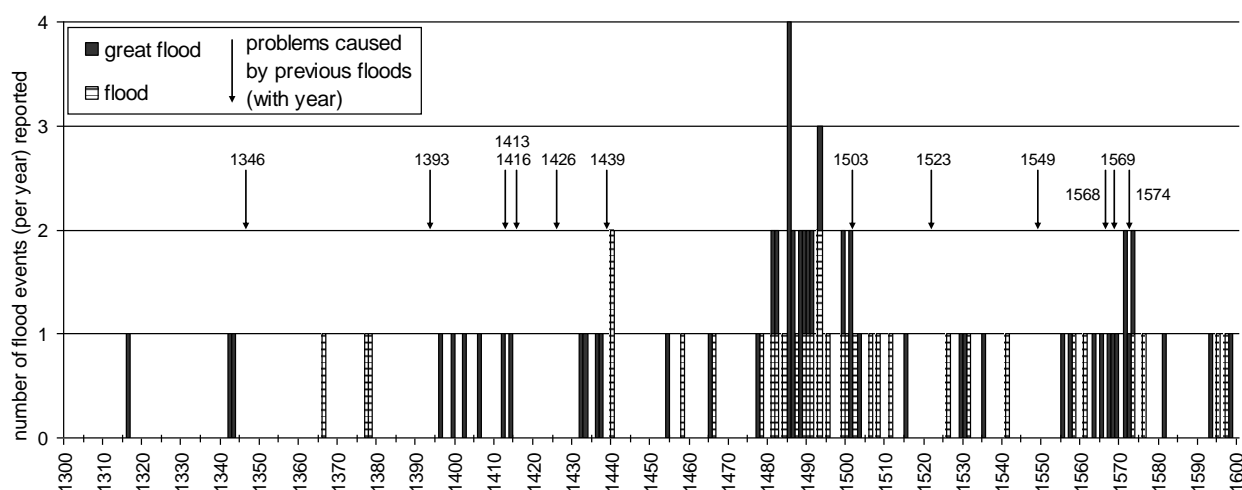
Fig. 1 14th-16th-century Danube floods in the Carpathian Basin, based on presently available documentary evidence (Sources: Kiss, 2012a, 2012b; Kiss and Laszlovsky, 2013)

Documentary evidence is mainly related to individual flood events or the relatively short-term consequences of preceding great flood events and therefore mainly provides high-frequency information. Archaeological and sedimentary evidence is mainly connected to the consequences of great or catastrophic flood events, flood-rich periods and long-term hydrological changes. Since dating of these events, periods and processes, with using natural scientific and archaeological methods, are usually possible on a multi-annual, multi-decadal level, archaeological and sedimentary data on floods are good indicators of medium- and low-frequency changes in flood behaviour. Nevertheless, documentary evidence can provide an important help in the possible more exact dating of flood events or flood peaks whose impacts could be observed in archaeological (and sedimentary) evidence (for presently available data, see: Fig. 1).

As a possible parallel, described in an official letter in 1549, short before the Danube at Bratislava also partly changed its bed, and floods were actively damaging the town walls (see Kiss, 1908; for more details see: Kiss, 2012b). Concerning this case, Ortway (1912) suggested that – similarly to the cases described by Fieber and his colleagues at Orth – an avulsion of the Danube channel occurred at Bratislava, and made the town walls (which were anyway in bad condition) more prone to destructive flood events. It is quite probable that this later event had connections to the great 1548 flood in Vienna mentioned above. Moreover, a number of flood events were also reported in contemporary documentation concerning the 1550s, and the great floods occurred practically in each year around the turn of the 1560s and 1570s (see Fig. 1).

The archaeological data on late 15th–early 16th-century floods is in good agreement with the information detected in documentary evidence: one of the most important (and certainly best documented) medieval flood peaks took place exactly around the decades of the 1480s, 1490s and 1500s (see Fig. 1).
