Article

A New Fault Location Approach for Acoustic Emission Techniques in Wind Turbines

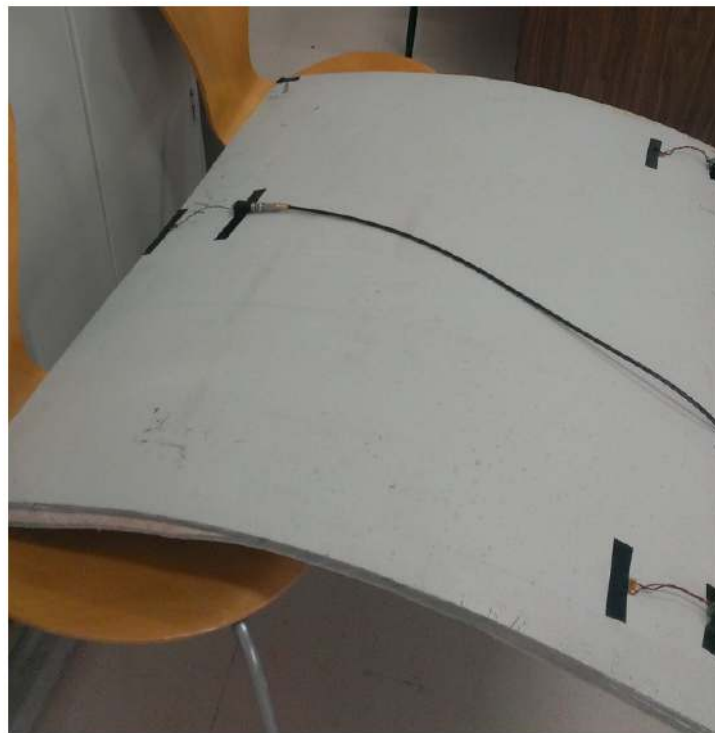
The experiments are done in a section of the wind turbine blade. The fragment, shown in Figure 1, is made of glass fiber-reinforced polymer (GFRP), with dimensions of 100×79.5 cm. The section is composed of a honeycomb central layer embedded between two fiberglass layers made of polyester resin. This type of material has good structural properties, resistance to fatigue and other advantages. The attenuation of the acoustic emission in the blade is high, and it depends on the material, wave frequency and travelling distance between the failure source and the sensor location [23].

Figure 1. Wind turbine section with sensors for acoustic emission location.

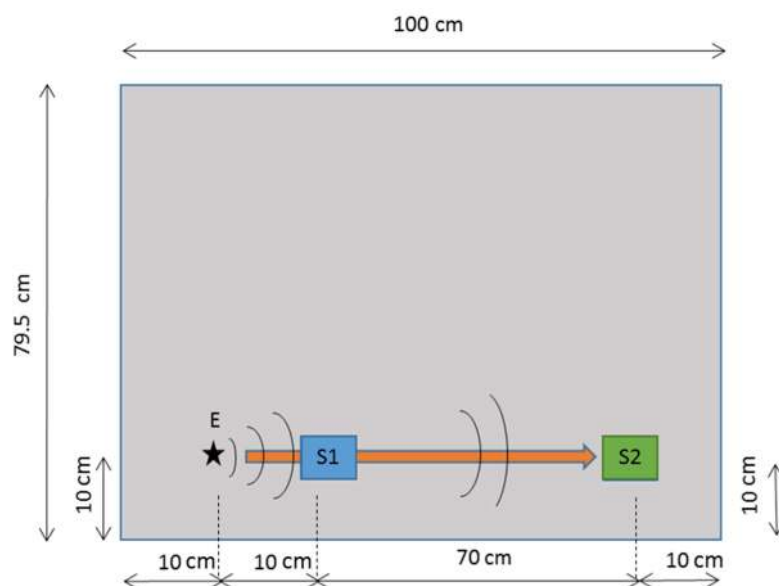
The propagation velocity of the acoustic emission (see Figure 2) has been experimentally calculated by breaking a pencil lead and measuring the delays in the excitement of the sensors S1 and S2 (Figure 3).

Figure 2. Measuring the experimental propagation velocity in the composite material.

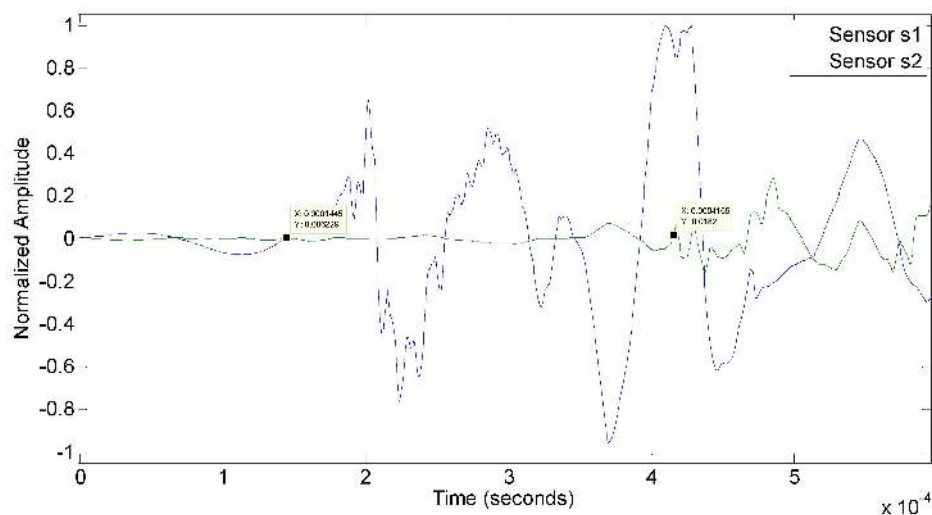
Figure 3. Peak detection of the acoustical emission collected by Sensor 1 (blue) and Sensor 2 (green) to obtain the experimental propagation velocity in the composite material.

The delay between Signals 1 and 2 is 271 μs (542 samples), and the propagation velocity for the composite material is 2583 m/s.

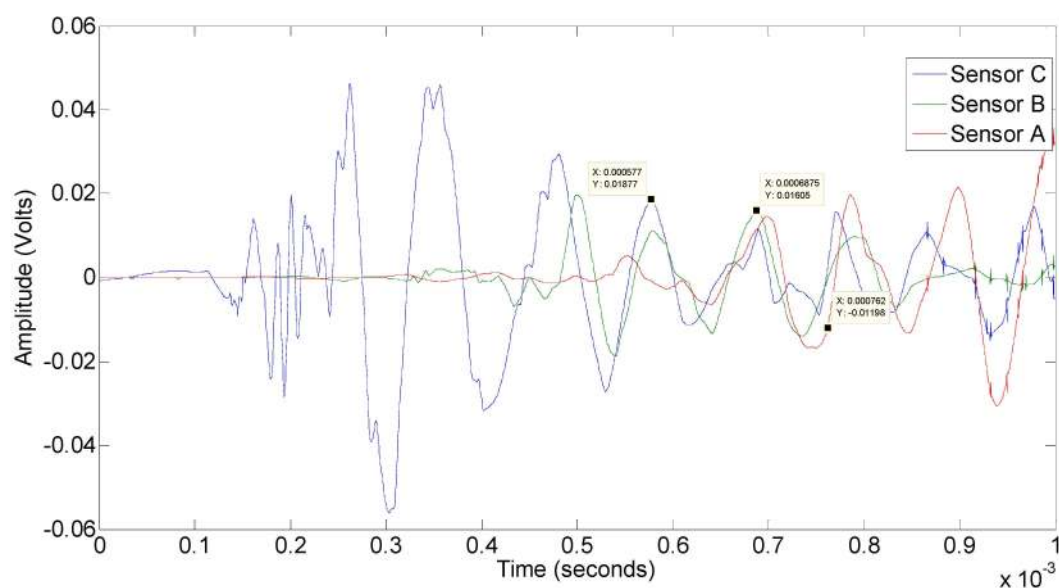
The signal processing consists of a pass band filter that eliminates low and high frequencies and carries out a comparison of the peaks of the wave front in the same frequency range of Signals A, B and C, generated by the above-mentioned MFC sensors, A, B and C (Figure 4).

Figure 4. Pre-processing of the signal. Wave front collected by Sensors C (blue), B (green) and A (red).

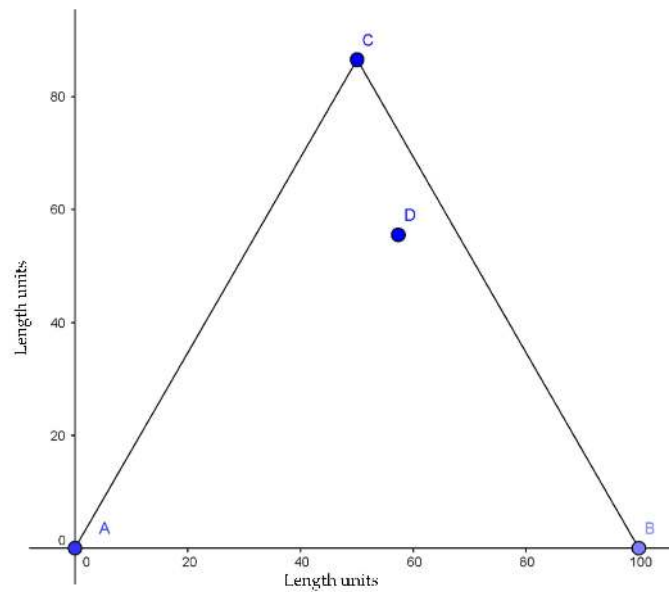
The MFC Sensors A, B and C are placed as an equilateral triangle (see Figure 5). D is the location of the emission source by the breaking, D (D is known in this experiment).

Figure 5. Location of Vertices A, B and C and the, defect D.

The seven nonlinear equations to solve this problem are given by Equations (3) to (9), considering the scheme shown in Figure 4, where the MFC sensors are located at Points A, B and C, and the defect is at Point D. The coordinates and radius are:

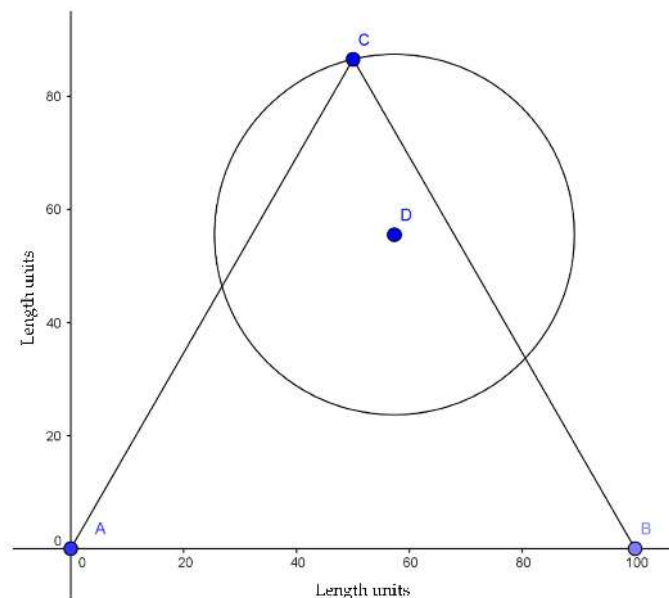
The nearest Sensor C is the first to be excited due to the wave front coming from the acoustic emission (Figure 6).

Figure 6. Wave front of the acoustic emission collected by the nearest Sensor C.

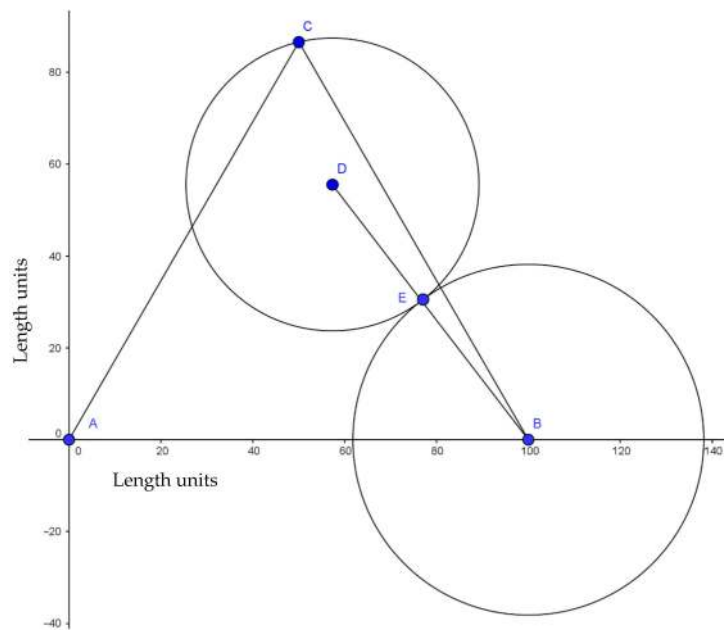
The delay between the excitation of the first Sensor C and the second closest Sensor B to the defect, D, is given by the distance from E to B (Figure 7). The delay time and the speed of the wave propagation on the blade is calculated by Equation (1):

$$D_{EB} = v \times t_{CB} \tag{1}$$

where D_{EB} is the distance between E and B, v is the propagation velocity of the wave (obtained experimentally) and t_{CB} is the time delay between the excitation of Sensors C and B.

Figure 7. Location of Point E, set by the delay between the excitation time in Sensors C and B.

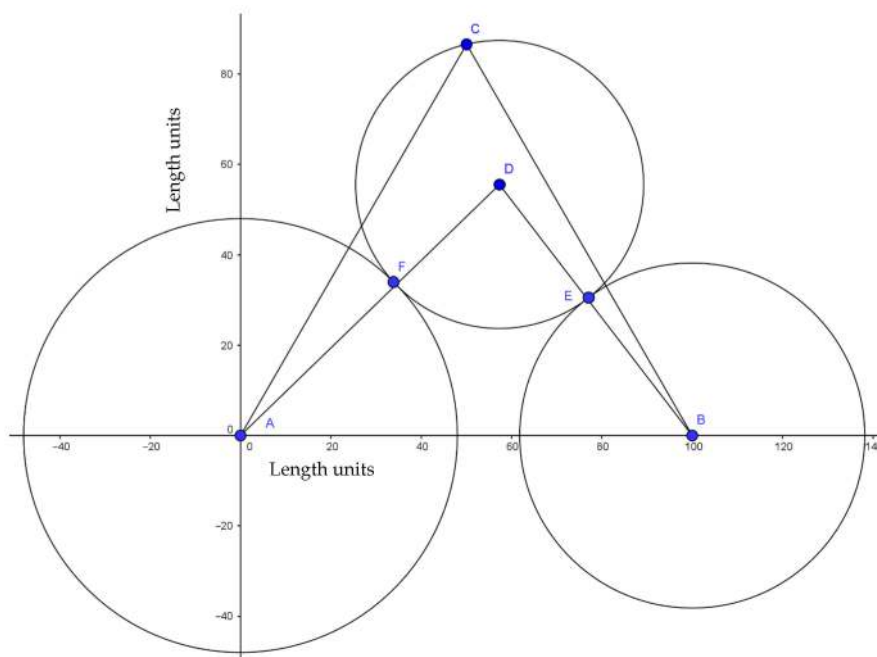
where t_{CA} is the time delay between the excitation of Sensor C and Sensor A. Figure 8 shows the scheme of the triangulation approach, the delay being represented by a circle.

Figure 8. Scheme of the acoustic emission delays for locating the source.

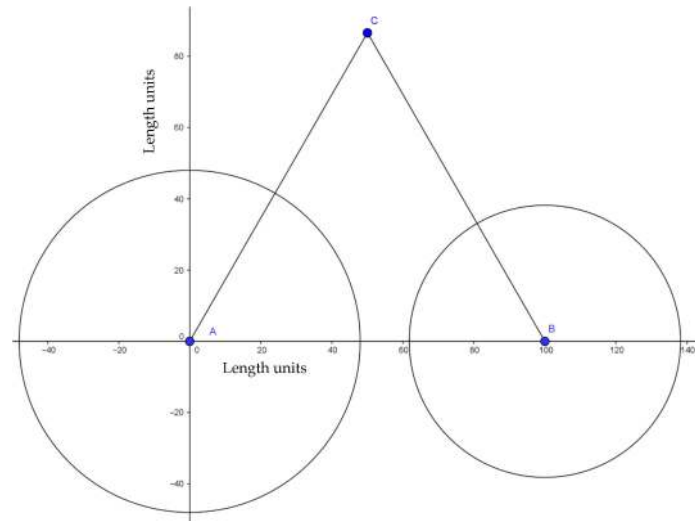
In a real case study, Point D is unknown regarding the time and location, and the delays between the different sensors can be calculated. This condition is shown in Figure 9, where the circumferences represent the delays of the signal that comes to each sensor with respect to the first sensor (C).

Figure 9. Initial conditions to locate the source of the acoustic emission.

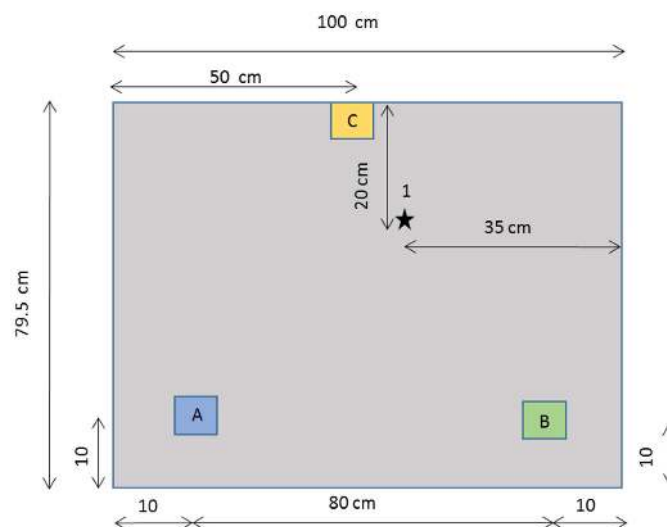
Figure 10. First experiment. Case Study 1.

The breaking of the lead is made in the following coordinates from Sensor A at Point 1 (star); see Figure 10. Sensor A is the coordinate origin.

- Coordinate x: 0.55.
- Coordinate y: 0.495.

The location of the source employing the algorithm is: Point 1: (x: 0.5533, y: 0.4920). The error in the location is: coordinate x: 3.3 mm; coordinate y: 30 mm.

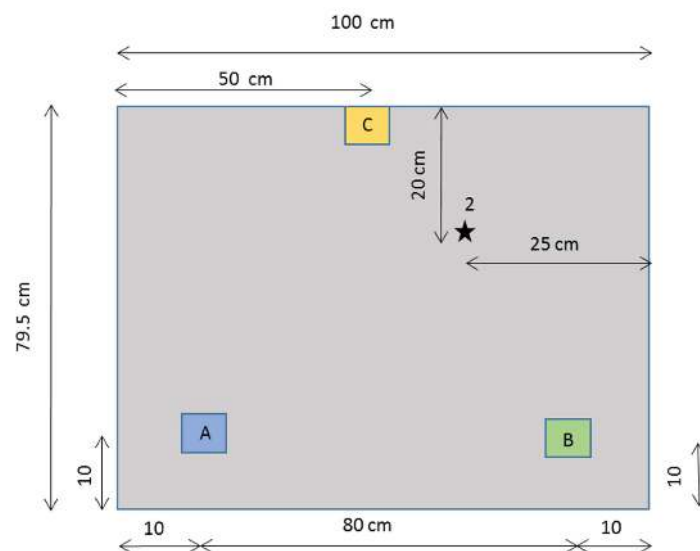
In this case, the emission source was generated at Point 2 (star), shown in Figure 11:

- Coordinate x: 0.65.
- Coordinate y: 0.495.

**Figure 11.** Scheme for Case Study 2.

The location of the source employing the algorithm is: Point 2: (x: 0.6502, y: 0.4950). The errors in the location are: coordinate x: 0.2 mm; coordinate y: 0.00 mm.

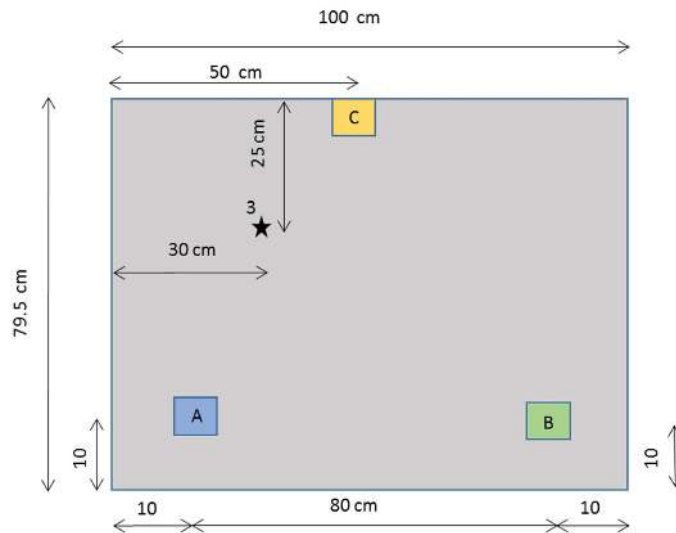
In this case, the emission source was generated at Point 3 (star); see Figure 12:

- Coordinate x: 0.20.
- Coordinate y: 0.445.

Figure 12. Scheme for Case Study 3.

The location of the source employing the algorithm is: Point 3 (x: 0.1914, y: 0.4434). The errors in the location are: coordinate x: 8.6 mm; coordinate y: 1.6 mm.

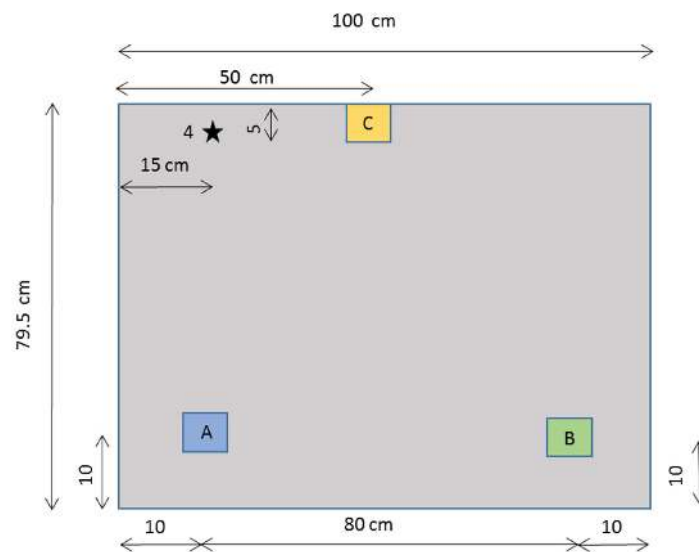
In this case, the emission source was generated at Point 4 (star), and it is shown in Figure 13:

- Coordinate x: 0.05.
- Coordinate y: 0.645.

Figure 13. Scheme for Case Study 4.

The location of the source employing the algorithm is: Point 4: (x: 0.050, y: 0.6495). The errors in the location are: coordinate x: 0 mm; coordinate y: 4.5 mm.

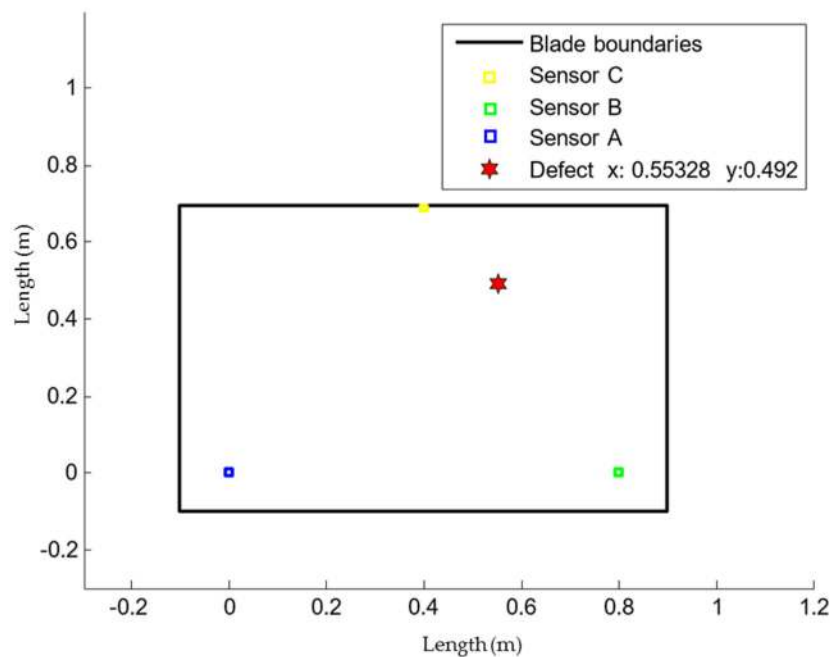
Finally, the algorithm shows the position of the acoustic emission point with the real dimensions of the blade. Figure 14 shows the location of the acoustic emission for the first case study.

Figure 14. Scheme of the location of the acoustic emission for the first case study.
