# A Review of Common Problems in Design and Installation of Water Spray Cooling and Low Expansion Foam System to Protect Storage Tanks Containing Hydrocarbons Against Fires

**A Technical Report**

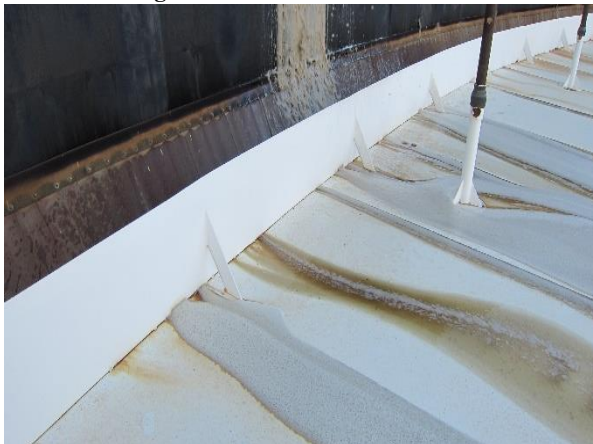
1. Drainage Slots: nonstandard drainage slots at the bottom of the foam dam drain more foam solution than enters the rim seal area. The area of the drainage slots is specified in NFPA 11 as being  $278 \text{ mm}^2$  for every square meter of the dammed area. Drain slot height is restricted to 9.5mm [15]. In many tanks, the slot area is much more and causes excessive foam drainage from dammed area. This in turn causes no foam to reach the areas of foam dam not directly above the discharge device.

**Fig. 2:** Excessive Foam Drainage from under the Foam Dam Due to Non-standard Slot Size

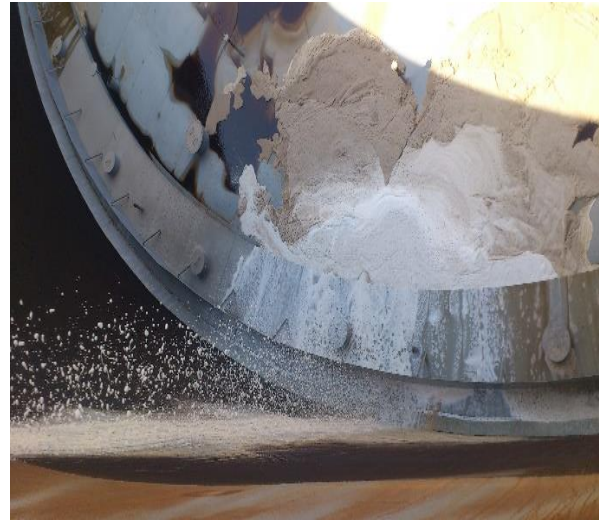
**Fig.3:** Excessive Foam Drainage from Foam Dam Causes Localized Foam Application

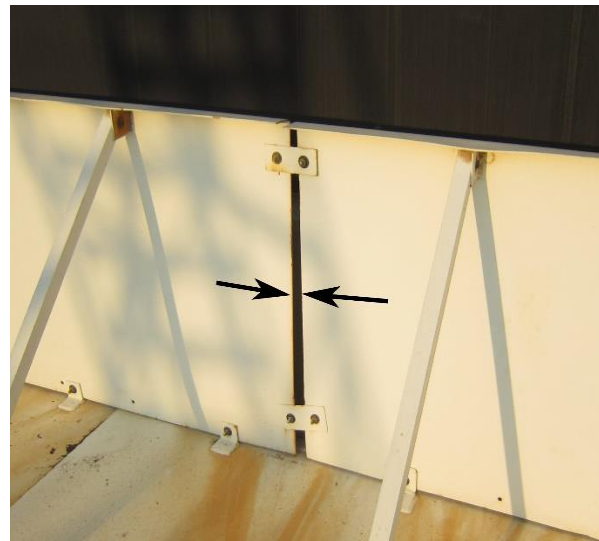
2.-Foam Dam Fastening Method: Fastening of dam plates to roof is very important. If fastening is not carried out properly more drainage area will be available and no foam build up occurs. To solve this problem foam dam plates shall be fastened to roof plates. So as to make a leak proof joint [15]. For foam dams fastened by nuts and bolts the gap between plates of foam dam or foam dam plates and roof plates is another place for excessive foam drainage. Welding is the most reliable method of fastening foam dam plates and use of nuts and bolts is highly prohibited due to inadequacy in sealing the foam dam.

**Fig. 4:** Foam Dam Fastening Using Nuts and Bolts

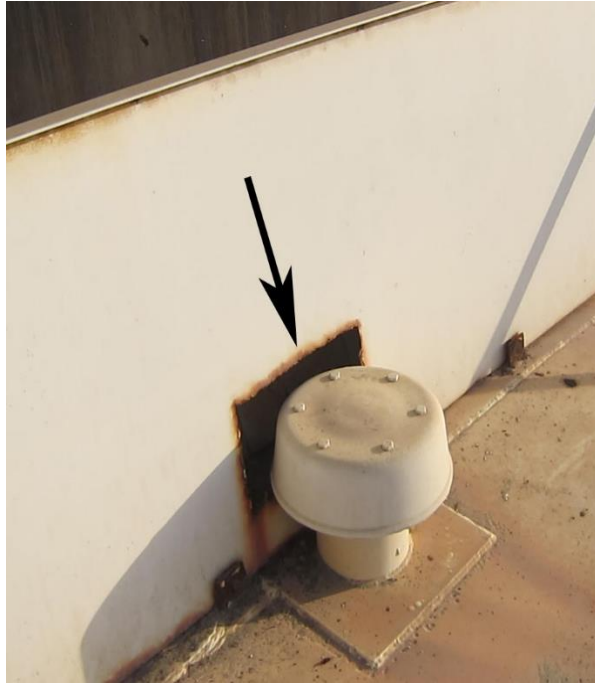
3- Detrimental Modifications to Foam Dam: in some tanks the vent or other tank components are located near the foam dam and the dam is cut or modified in a way that affects foam build up in the rim seal area (Fig. 5). To solve this problem with the foam dam is run around the component just the way such method is applied for guide and anti-rotation poles (Fig. 6 and Fig. 7). In a few cases, the foam dam height is reduced in some places by cutting the dam plate. This must be avoided due to foam loss over the dam and inadequate foam coverage over the secondary seal (Fig. 8).

Fig. 5: Detrimental Foam Dam Modifications

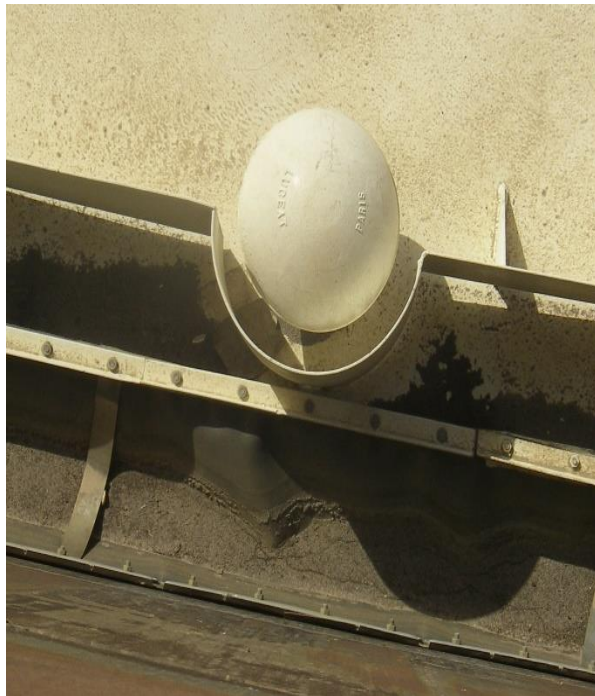
Fig. 6: Tank Components Excluded from Dammed Area

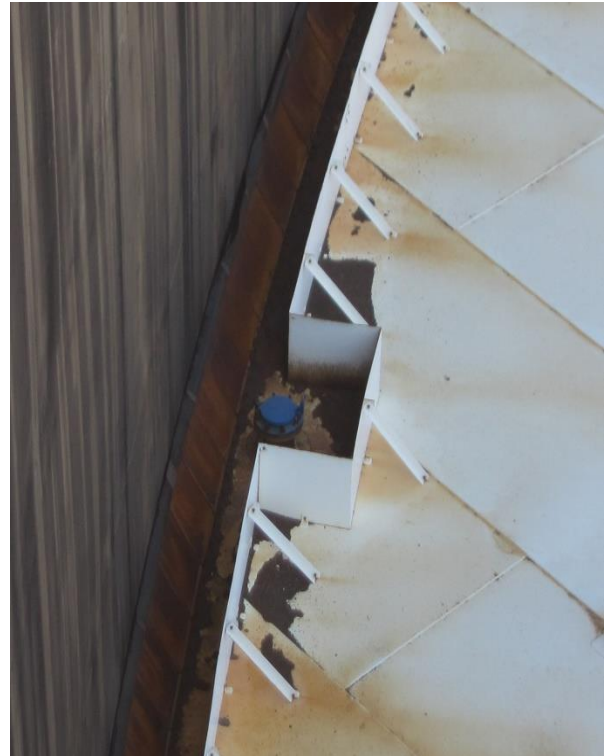
Fig. 7: Tank Components Included in Dammed Area

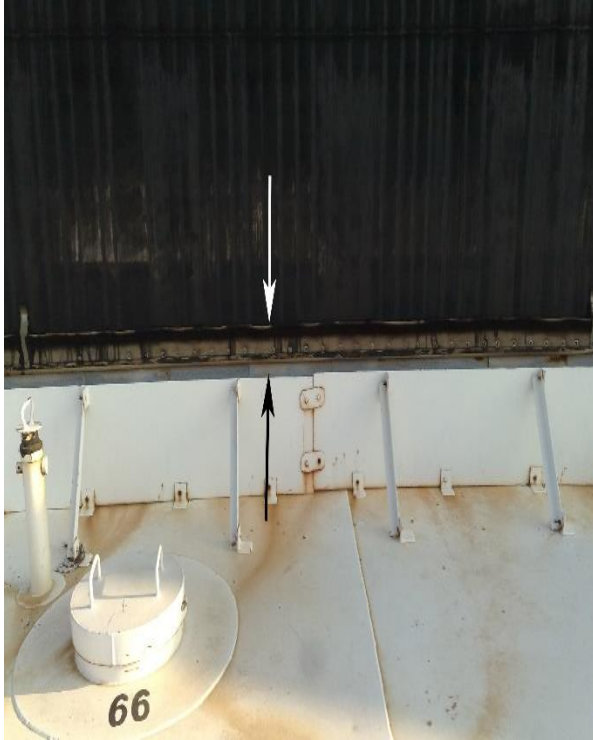
4- Non-standard Foam Dam Dimensions: NFPA 11 standard specifies that foam dam shall be a minimum of 305mm high and its height shall be a minimum of 51mm higher than any metal secondary seal [15]. In many tanks foam dam height does not satisfy the

standard specifications and dam height in the rim seal area is not enough to ensure the necessary foam height and extinguish the fire (Fig. 9). The width of foam dam is also restricted to a maximum of 0.6 m from a tank shell which is not observed in some tanks (Fig. 10) [15].

**Fig. 9:** Inappropriate Foam Dam Height

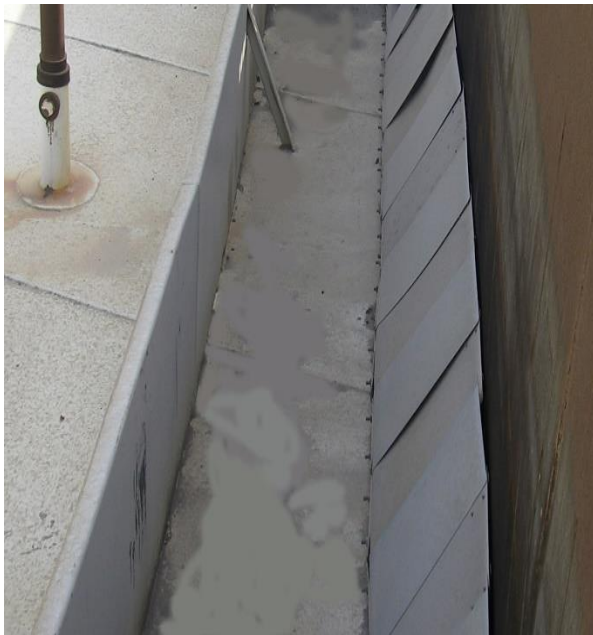
**Fig. 10:** Inappropriate Foam Dam Width

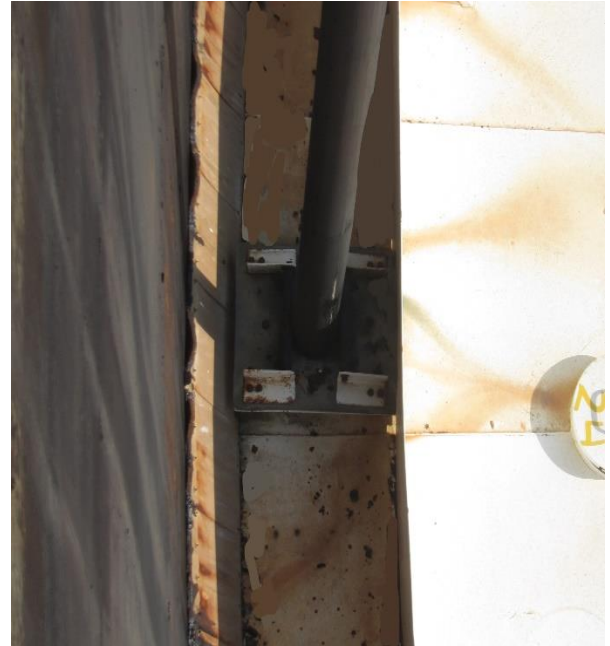
5-Foam Blockage inside Dammed Area: foam dam design around guide and anti-rotation poles and other tank components located in or near rim seal area is important because of the need for flow of foam within rim seal area between two adjacent discharge devices. In some tanks, the foam dam is so designed

that the flow of foam is blocked by tank components (Fig. 11). To solve this problem foam dam plates are so shaped as to keep the same distance from tank components as from the tank shell (Fig. 12). This causes the foam to flow easily past them and reach farther areas.

**Fig. 11:** Foam Blockage by Guide Pole Due to Poor Design of Foam Dam

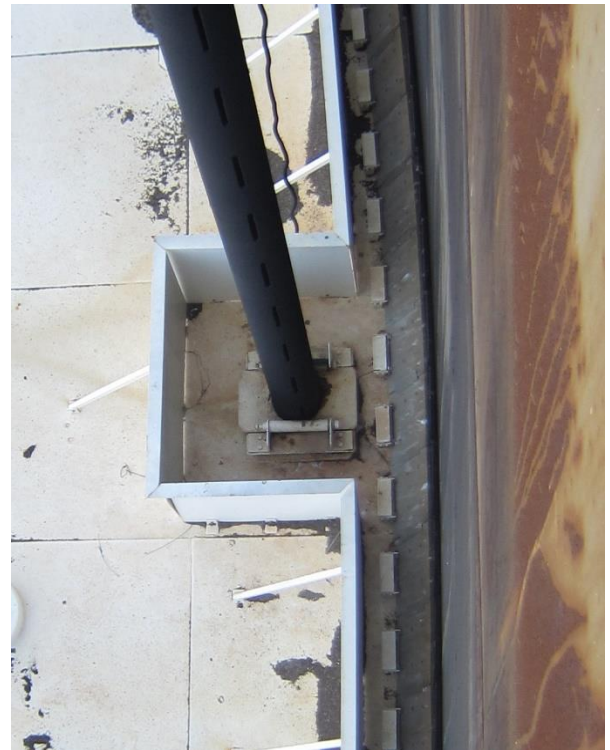
**Fig. 12:** Good Design of Foam Dam around Guide Pole

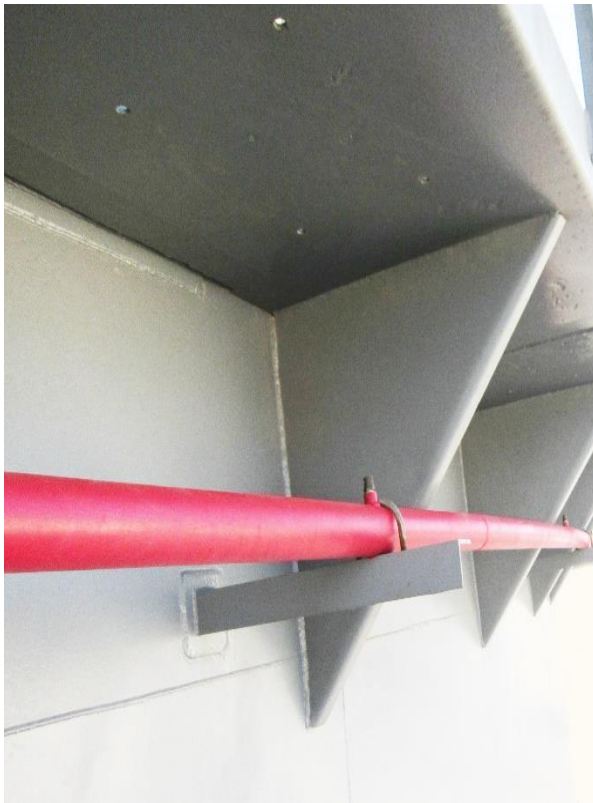
1-Water Curtain Blockage by Support Members: use of triangular support members under the top walkway of the tank hinders the water curtain ejecting from spray nozzles (Fig. 13) [16]. Dry areas in the form of strips form where the curtain is blocked and the strip continues down to the below stiffening ring or to the bottom of the tank if no wind girders exist below. To solve this problem, it is best to use slender members to support the top walkway (Fig. 14). For previously installed members the triangular support plate can be cut and an angle member should be added to provide support for the outer edge of the walk way (hatched area of Fig. 15 is needed to be cut). Triangular support plates for lower wind girders rarely pose a problem but the same remedy can be applied as well just in case.

**Fig. 13:** Water Curtain Blockage by Triangular Support Members

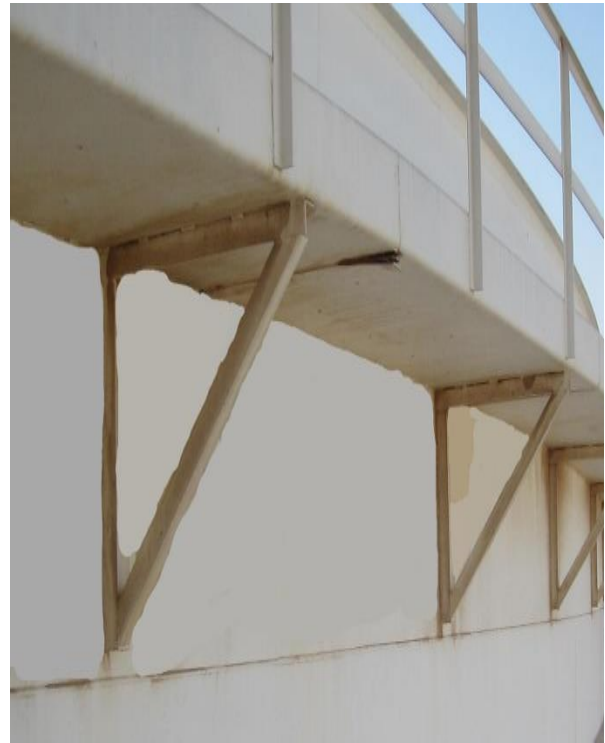
**Fig. 14:** Slender Support Member for Walkway

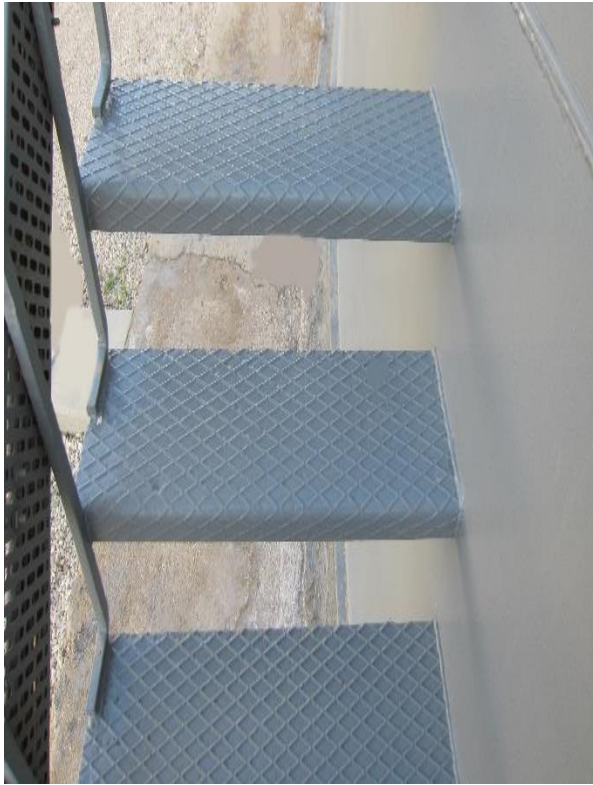
2-Water Film Blockage by Stairway: stairways which are attached to the shell disrupt the water film and the shell area below the stairway is left dry (Fig. 16, Fig. 17). One way to solve this problem is to completely separate the staircase separated from the tank and construct it as a self-standing structure next to the tank (Fig. 18). The other way is to insert a space between the tank and the spiral stairway and support

Fig. 16: Spiral Stairway with Steps Attached to Tank Shell

Fig. 17: Spiral Stairway with Steps Attached to Tank Shell

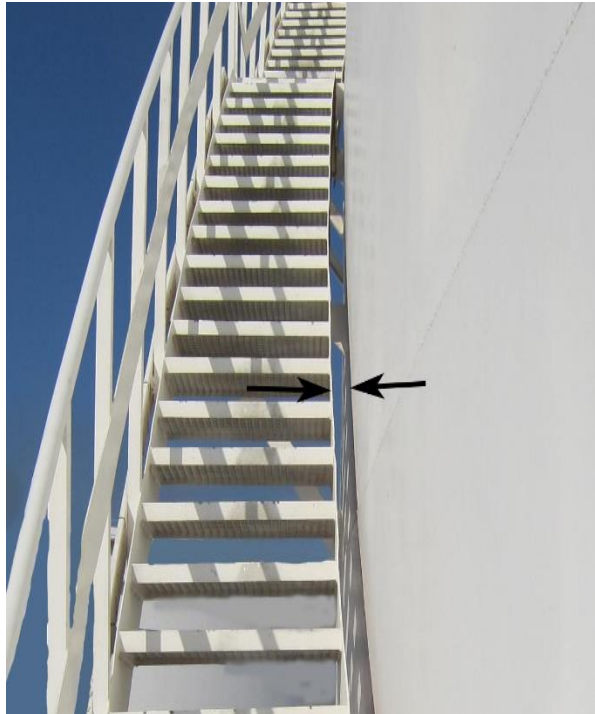
Fig. 19: Spiral Stairway Separated from the Tank Shell

**Fig. 20:** Spiral Stairway Separated from Tank Shell

the whole stairway by means of a few brackets on the shell (Fig. 19, Fig. 20). This allows the flow of water down the shell and past the stairway so no dry area forms under it.

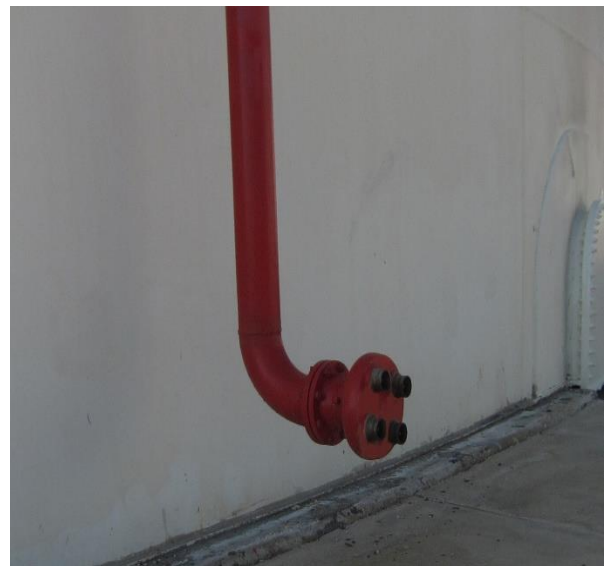
2. Location of Fire Department Connection: in some tanks the riser pipe is terminated at tank bottom which requires entering the diked area of a tank (Fig. 21). To solve this problem, the piping is required to be extended to the dike wall so that running the system is possible without entering the diked area. In some tanks the fire department connections are not installed meaning the whole system is not operable (Fig. 22).

**Fig. 21:** Piping Terminated at Tank Bottom

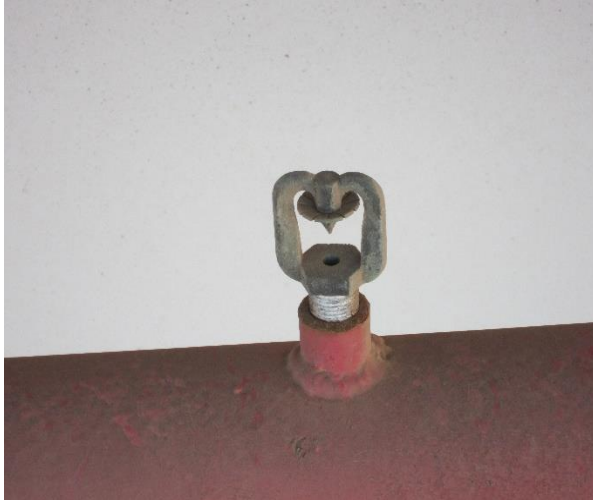
3. Inappropriate Nozzle Selection: the selection of nozzles affects the efficiency, the level of protection of the cooling system offers and also the amount of water wastage [16,19]. The type of nozzle usually used for cooling a vertical surface is flat fan nozzle. For some tanks medium velocity nozzle [20] with cone shaped spray pattern is used which wastes considerable amount of water (Fig. 23). Wastage of

**Fig. 23:** Inappropriate Spray Nozzle - Full Cone Medium Velocity Nozzle

water minimizes if the nozzle is installed horizontally so that the cone is normal to the tank surface. For some nozzles, the discharge angle of water spray is 180 or more. Such nozzles are used as water curtain and are not appropriate for cooling vertical surfaces because of high wastage. Although NFPA 15 standard requires manufacturers to mark flow and pressure characteristics on spray nozzle body, some spray nozzles used in cooling systems bear no marking [15]. It is found in some cases that the flow rate of spray nozzles is not according to mark for nozzles. In a few cases, the right type of nozzle is not selected and the flow characteristics of nozzles installed on the cooling system are not according to hydraulic design of the system.

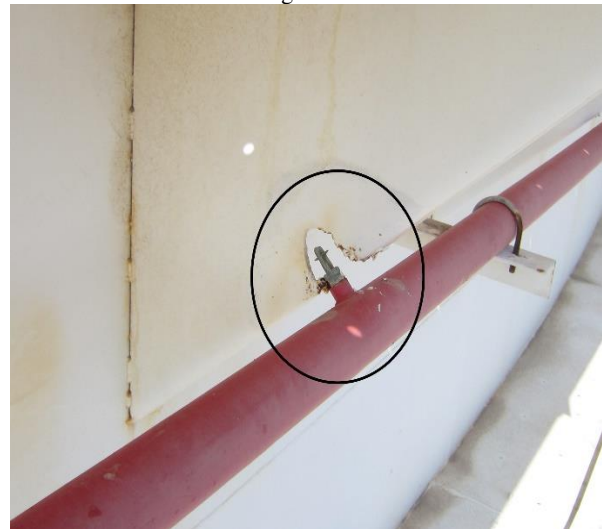
4-Inappropriate Water Ring Main Position: the location of the ring main relative to tank protrudances and the deflection of spray nozzles from vertical is vital to achieve full coverage and avoid dry areas. In some tanks the ring main is installed far below the wind girder so the part of the tank shell above the ring main and below the wind girder remains dry (Fig. 24 and Fig. 25). Installation of ring mains close to tank components results in plugging of outlets or cutting of wind girder support to allow for nozzle installation (Fig. 26 and Fig. 27). Spray pattern for such nozzles is also distorted and partly blocked. In a few cases, the water ring main is not installed for cooling the area of the shell between two wind girders (Fig. 28). In some designs, the nozzle is located in 6 o'clock position of the ring main pipe. This aggravates the problem of incomplete wetting of the shell area above the ring main and below the wind girder and is not recommended. It is worth mentioning that this design ensures better drainage and hence limited water accumulation occurs in the piping (Fig. 29).

**Fig. 26:** Cutting Wind Girder Support to Allow Installation of Spray Nozzle

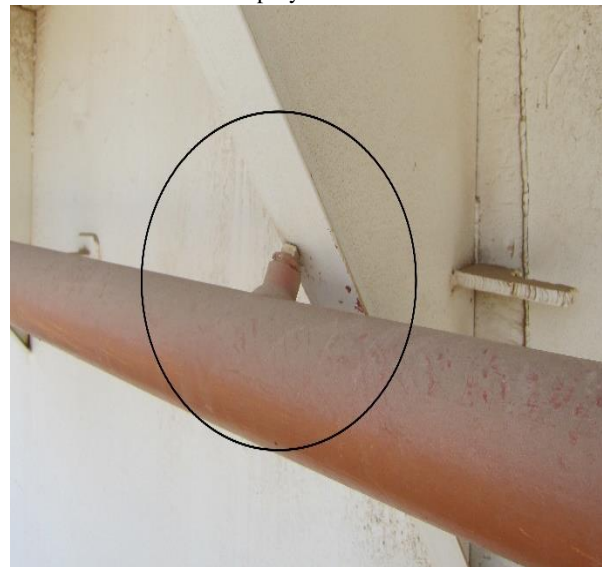
**Fig. 27:** Blockage of Outlets by Tank Appurtenances

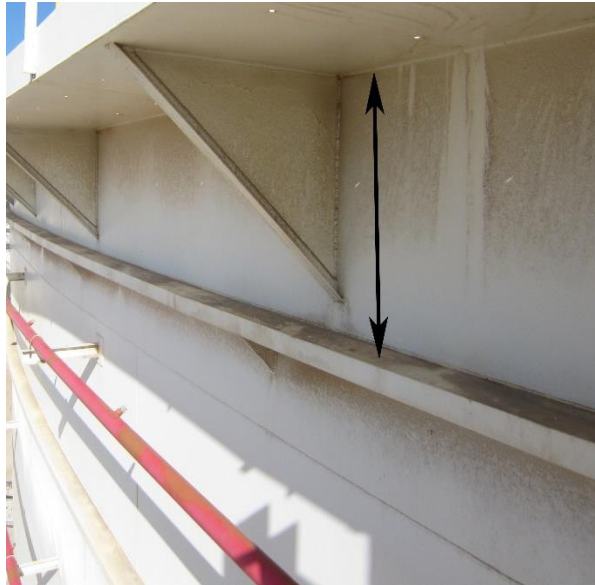
**Fig. 28:** Providing No Cooling Ring above Wind girder

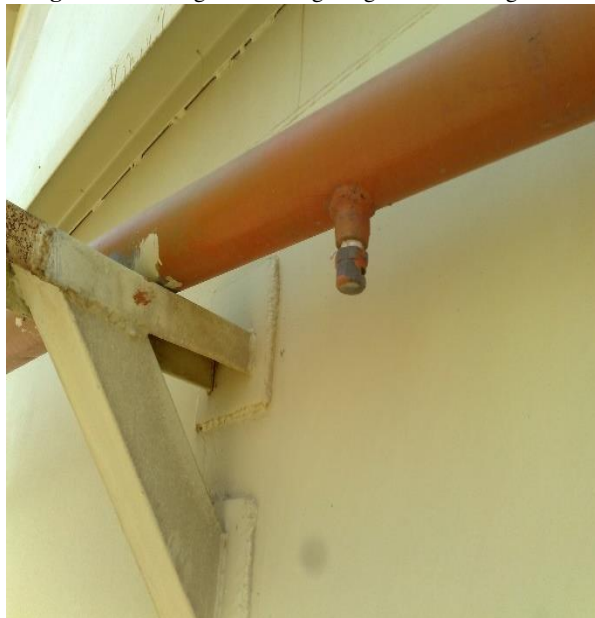
**Fig. 29:** Water Spray Nozzles Installed in 6 O'clock Position of Ring Main

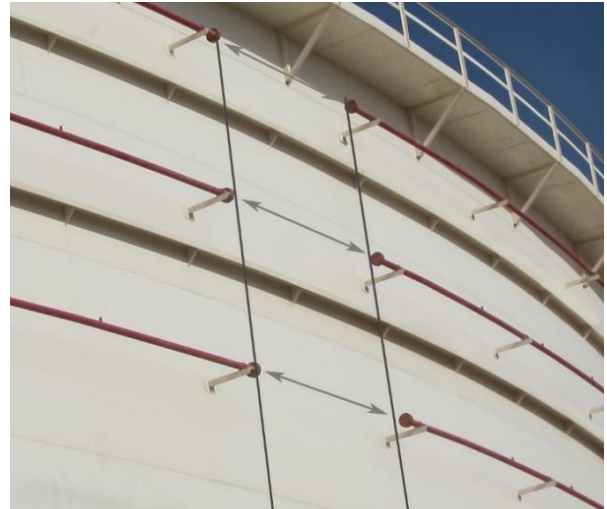
5-Incomplete Nozzle Water Curtain Overlap: in order to avoid dry areas water curtain of nozzles is required to overlap. For some cooling systems which use two half rings to cover the circumference of a tank, the water curtains of terminal nozzles on the half rings do not overlap mostly because of great distance between the ends of the two rings or inappropriate nozzle position there and a dry strip forms as a result (Fig. 30). In some case the spray nozzles are not installed at regular intervals or the distance between outlets is greater than the recommended separation of nozzles by the manufacturer (Fig. 31).

**Fig. 30:** Dry Strip Due to Inadequate Nozzle Separation Distance

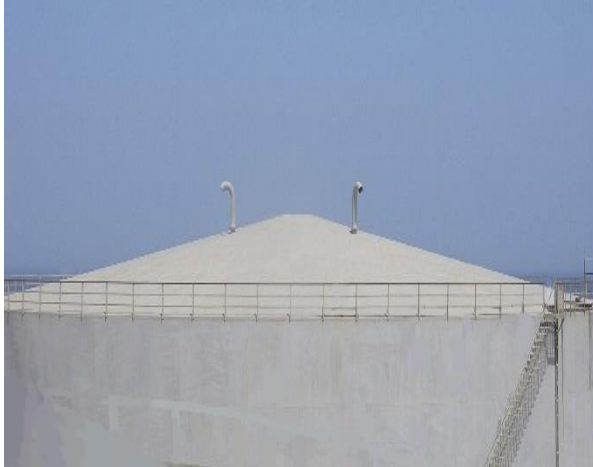
6-Cooling System of Fixed Roof Tanks: cooling of the roof of fixed roof tanks is important because of the higher incident radiation level [21]. In some fixed roof tanks cooling of the roof is neglected (Fig. 32). Total exposure protection for fixed roof tanks includes spraying the shell and roof by water (Fig. 33). The piping for the cooling of the roof and shell of some fixed roof tanks are not separated (Fig. 34). As the roof of fixed roof tank is attached to the shell by frangible weld and because the roof and shell cooling system piping is not separated, the mentioned cooling system is rendered useless upon an internal explosion in the tank. So the cooling systems for the roof and shell are required to be fed from two valved separate lines (Fig. 35).

**Fig. 32:** Fixed Roof Tank with No Roof Protection

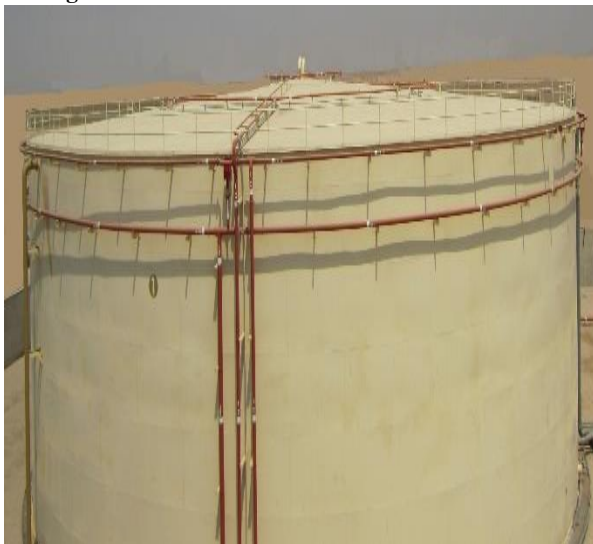
**Fig 33:** Cooling System for Shell and Roof of a Fixed Roof Tank

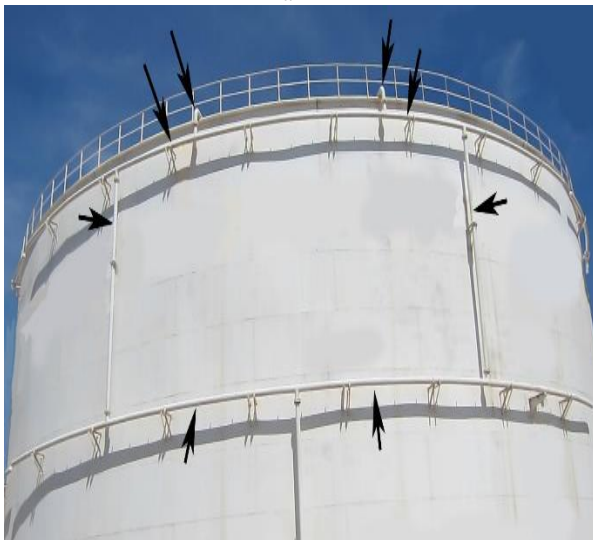
**Fig 34:** Connected Roof and Shell Water Spray Cooling System

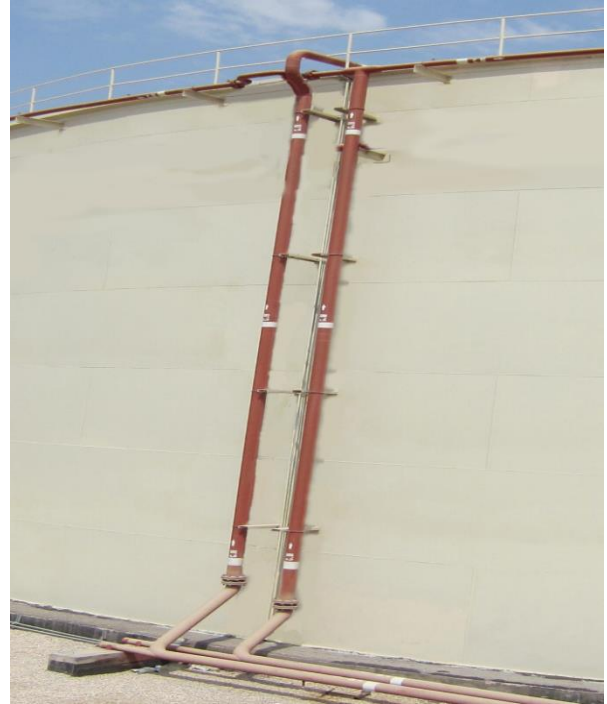
**Fig. 35:** Separated Roof and Shell Water Spray Cooling System

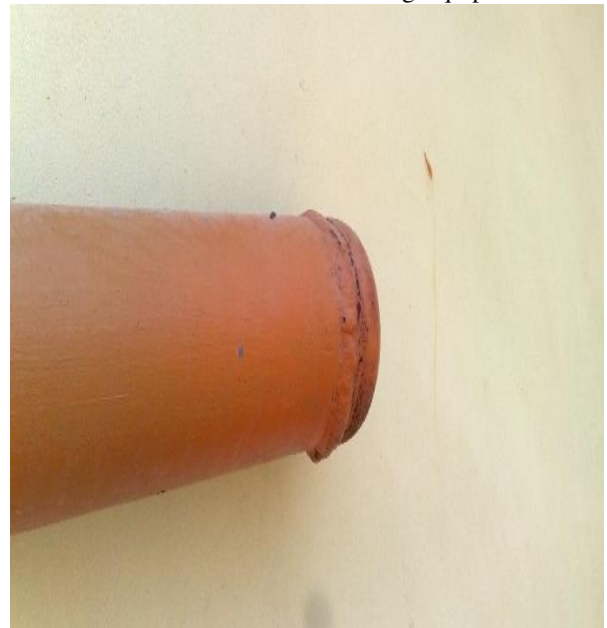
7-No Provision for Flushing: in some cooling systems the end of ring main is capped and permanently closed so flushing the piping is not possible (Fig. 36). Use of a flanged end which is blinded (Fig. 37) is one way to solve the problem but the better way is to use a valve with an equal bore at the end of the ring main (Fig. 37). If the valve is positioned so as to be accessible from the emergency ladder or stairway of the tank, flushing the system is carried out without the need for lifting equipment.

**Fig. 36:** Ring Main with End Cap

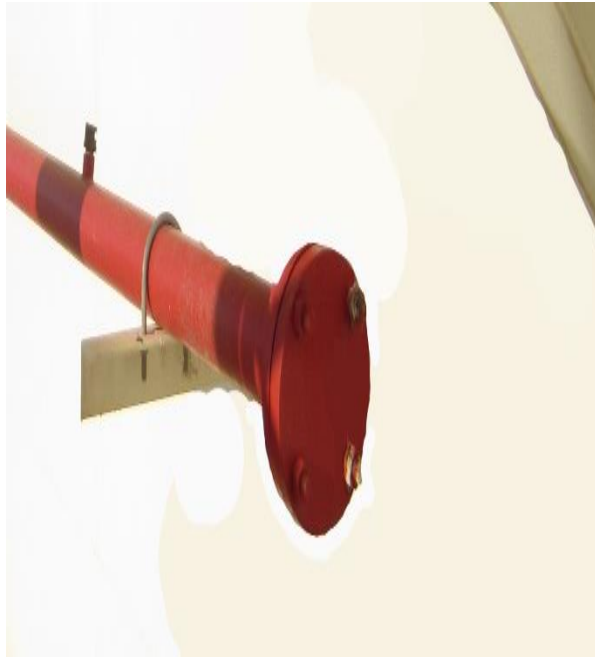
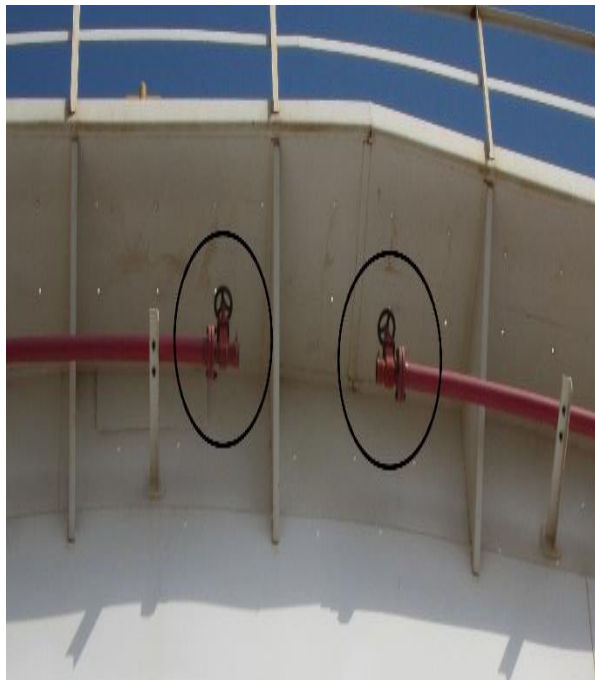
**Fig. 37:** Ring Main with Flanged End

**Fig. 38:** Ring Main with a Valve at the End

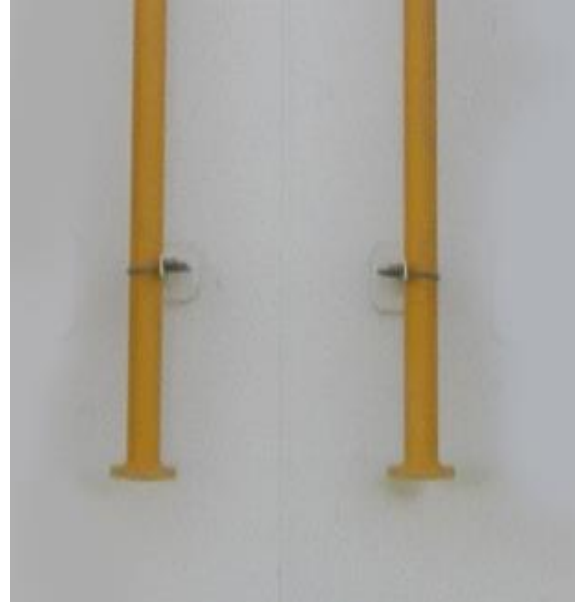
2. Location of Fire Department Connection: the foam system feeder pipe is terminated at tank bottom which requires entering the diked area in order to operate the system (Fig. 41-a). The piping is required to be extended so that feeding the system is done without anyone entering the diked area (Fig. 41-b) [15]. In some cases the fire department connections are not installed (Fig. 42).

Fig. 42: Foam System with No Fire Department Connections

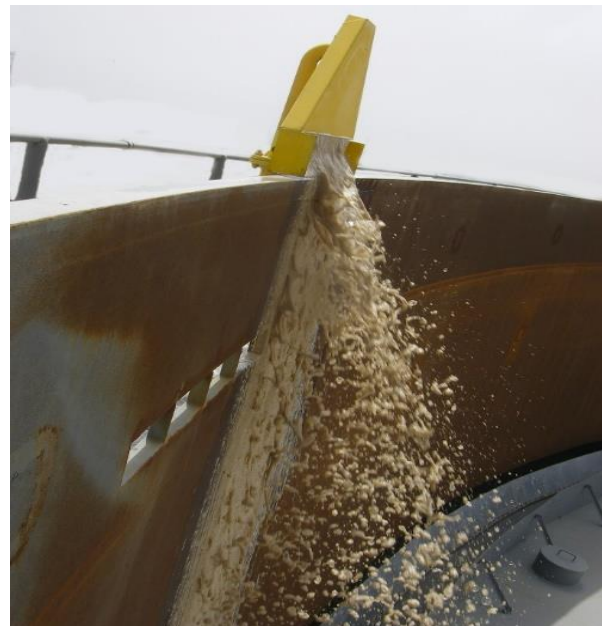
3-Foam Discharge Devices Design: the foam pourer design is of high importance. In some cases, the generated foam by a foam pourer manufactured by one of domestic companies is thrown away from the device so most of foam ends outside the foam dam and is wasted (Fig. 43).

Fig. 43: Throwing of Foam Stream by Foam Pourer

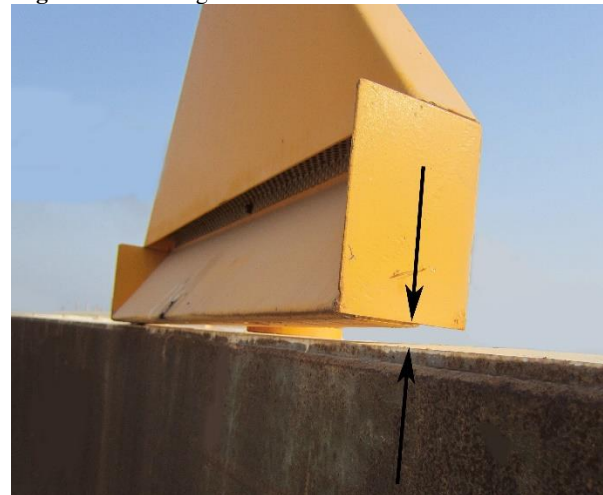
In some tanks the foam pourer is not fixed at the top angle of the tank so the generated foam does not adhere to the inner wall of the tank and some is wasted (Fig. 46). The likelihood of generated foam to be affected by wind or the device to break down under wind induced vibrations is higher.

**Fig. 46:** Foam Pourer Not Fixed to Top Angle

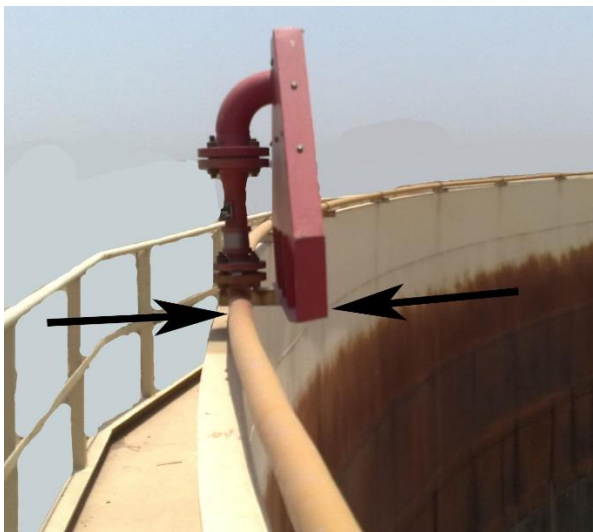
In some tanks the ring main is installed on the top angle and foam pourers are located just inside the tank (Fig. 49). This is the extreme case of the problem discussed in the previous paragraph. The foam produced does not run down the inner wall and falls freely. The wastage in this case is very high and foam stream is adversely affected by winds.

**Fig. 49:** Foam Pouwer Sticking inside the Tank

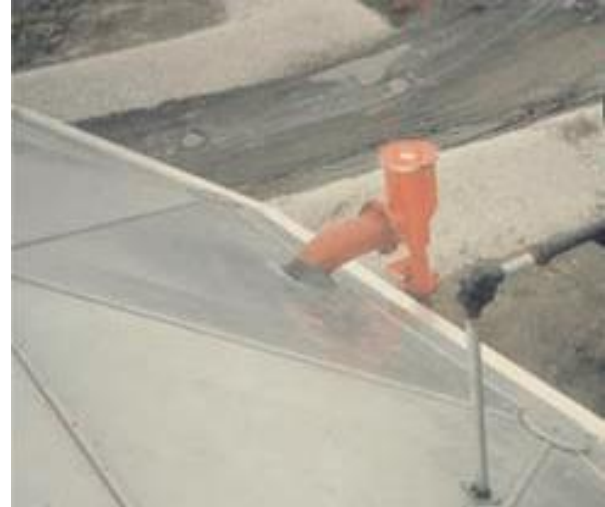
In some cases, the foam chamber is attached to the roof of a fixed roof tank (Fig. 50 and Fig. 51). Since the roof of fixed roof tanks is designed to separate from the shell the whole foam system is rendered inoperable in case of an explosion [22].

**Fig 50:** Installation of Foam Pouwer on the Roof of Fixed Roof Tanks

**Fig. 51:** Foam Chamber Installation for Fixed Roof Tanks

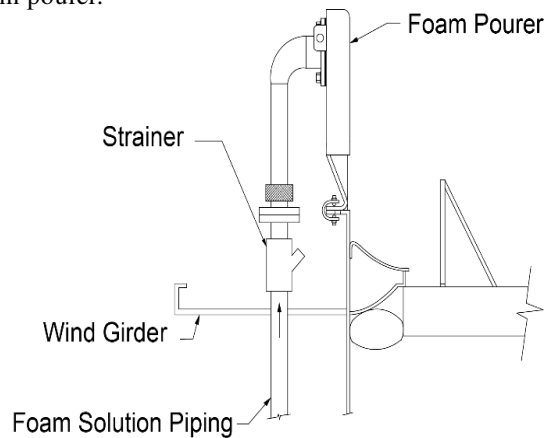
5-Use of Strainers: strainers are commonly not used upstream of foam pouwers but it's necessary since strainers prevent clogging the foam pouwer venturi or orifice plate and the maintenance of strainers is much simpler than foam pouwer. It is recommended to use a strainer upstream of each foam pouwer.

**Fig. 52:** Strainer Upstream of Foam Pouwer

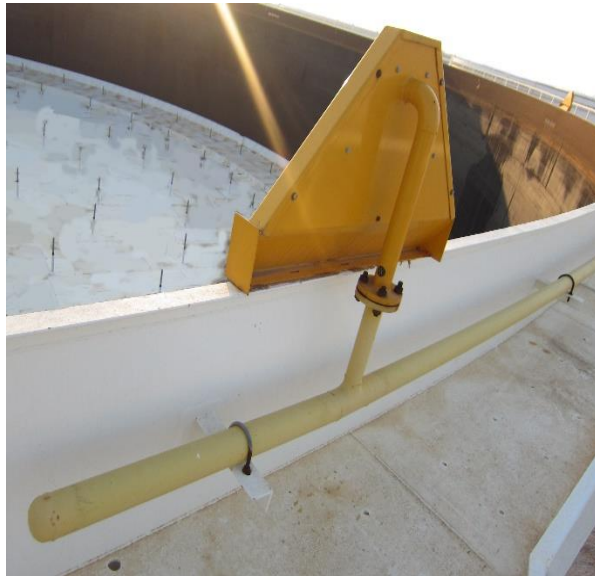
6-Ring Main Position: foam ring main for some tanks is placed above the walkway (Fig. 53 and Fig. 54-a). This type of installation limits the vital space available around top periphery of the tank and also the pipe support for the ring main acts as an obstruction and frequently causes tripping and injury to foot. The better design is to install the main ring below the walk way ( Fig. 54-b).

Fig. 53: Foam Solution Ring Main Above Walkway

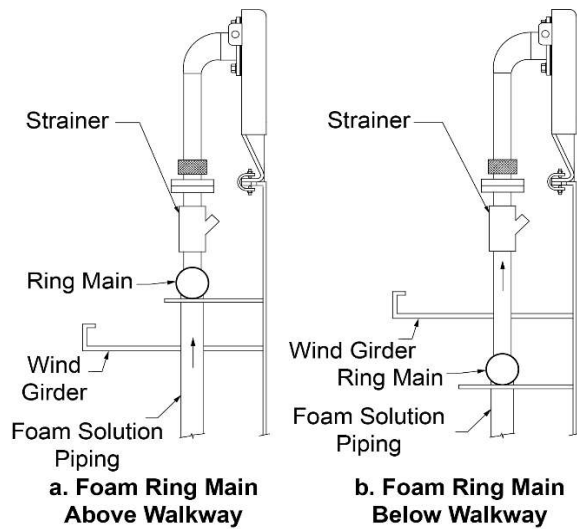
Fig. 54: Foam Ring Main Position

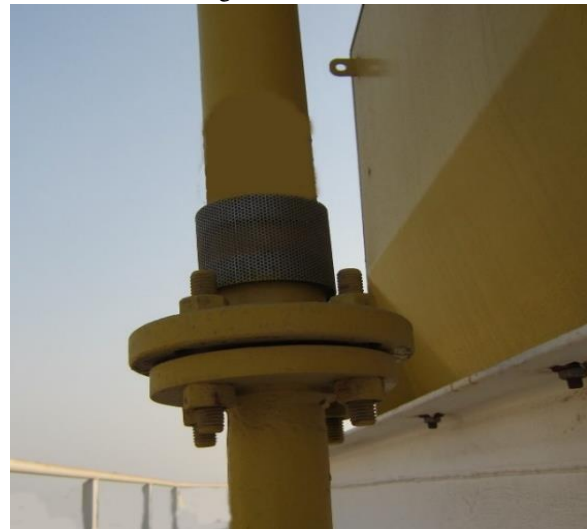
7- Unequal Flange Sizes: in some systems the branch pipes feeding the foam pourers from the ring main terminates in a flange with a different size from the foam pourer inlet flange (Fig. 55). This problem is usually solved by flange bolt hole modifications. To solve this problem, it is required to change the flange

Fig. 55: Incompatible Ring Main Branch Pipe and Foam Pourer Flange Sizes

and pipe size of the branch to conform to inlet flange of the foam discharge device.

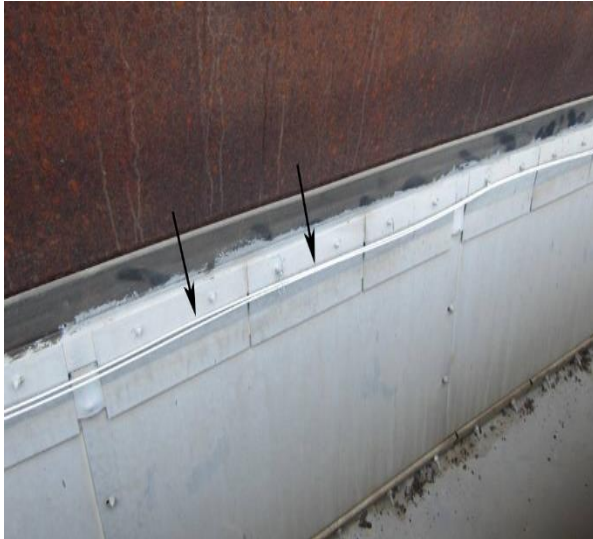
9-Linear Heat Detector Placement: in automatic foam systems a sensing element called linear heat detector is used to actuate the system. It is necessary to install linear heat detectors as close as possible to the source of fire [22]. In some cases, they are attached to foam damplate which causes a long delay in fire detection due to greater distance to the source of fire. The best place to install the detector is on the weather shield of floating roof tanks (Fig. 57).

In some automatic system design one strand of linear heat detector is placed which increases the chance of

**Fig. 57:** Linear Heat Detector

false alarm and system actuation. To make the system more reliable it is recommended to use two linear heat detectors (Fig. 57) and define the logic based on pre-alarm and alarm states.

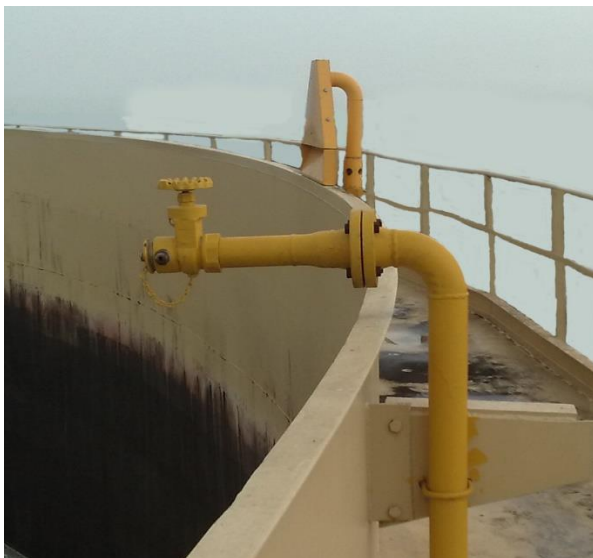
10-Foam Handline: a handline is a hose stream mainly used for small roof fires and supplements the primary protection [15]. The connection is valved and shall be provided at the top rim of the tank (Fig. 58). This connection provides for fighting small fires on the roof and rim seal area. This connection is not considered for various tanks.

**Fig 58:** Foam Handline

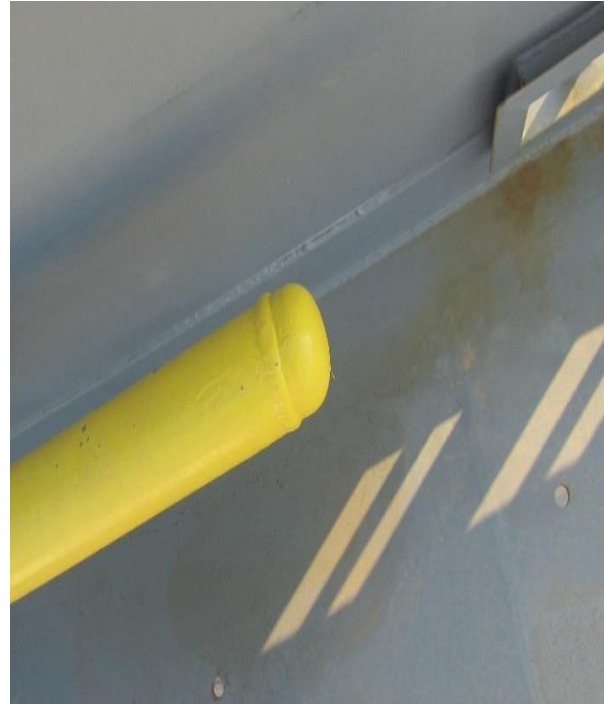
11-Provision for Flushing: in some systems the end of the foam ring main pipe is permanently closed and flushing of piping is not possible (Fig. 59) [15]. Due to high risk of clogging it is necessary to flush the system periodically so use of flanged end connections is recommended (Fig. 60).

**Fig. 59:** Foam Ring Main with End Cap

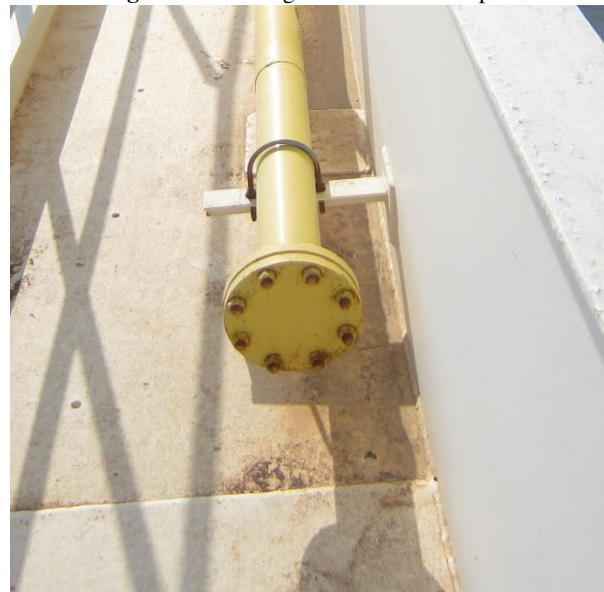
**Fig. 60:** Foam Ring Main with Flanged End
