CIVIL & ENVIRONMENTAL ENGINEERING | RESEARCH ARTICLE

A review on automated pavement distress detection methods

Tom B.J. Coenen¹ and Amir Golroo^{2*}

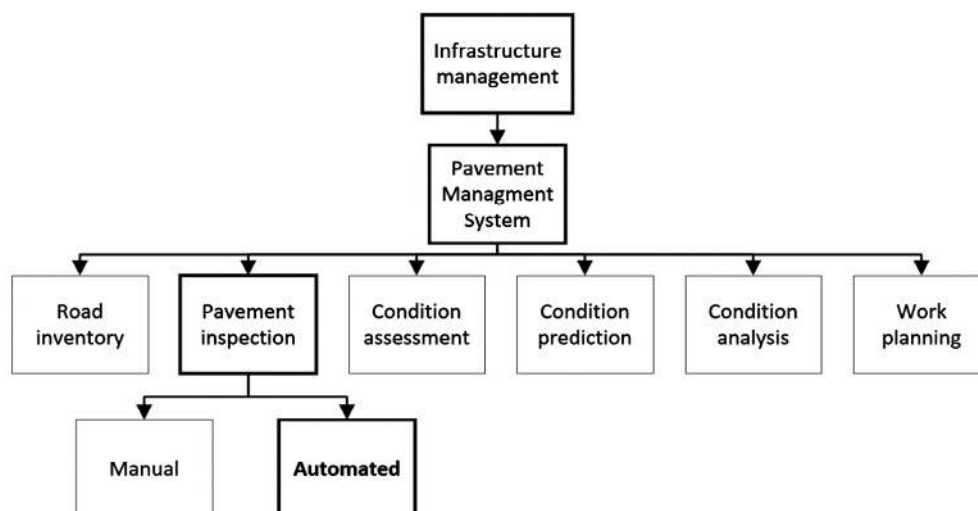
Figure 1. Automated pavement inspection.

Koch, Georgieva, Kasireddy, Akinci, and Fieguth (2015) conducted extensive studies on automated condition assessment, but aimed at the data processing part rather than data collection equipment. Mathavan, Kamal, and Rahman (2015), on the contrary, aimed their research at the collection techniques, but confined themselves to three-dimensional (3-D) techniques. This paper is therefore aimed at the entire pallet of detection instruments in relation to the distresses and road condition and goes mainly together with “pavement inspection”. However, these instruments may also play a role in the “road inventory” and “condition assessment”. The orientation of this research within IM is shown in Figure 1.

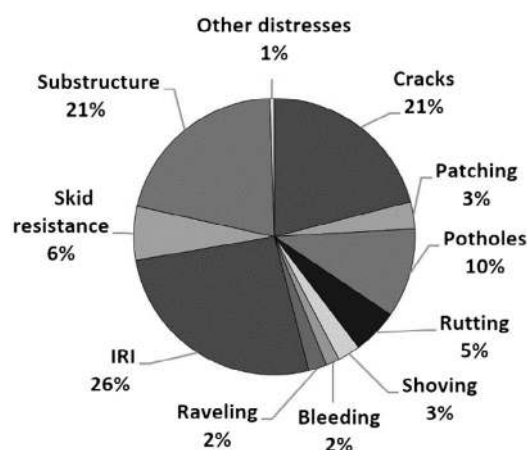
Figure 5. Division of literature in relation to distresses.

that can be clearly understood from this figure is the peak points in the graph. Especially for pothole detection and measurement of the pavement roughness, different methods can be found. This is the result of the fact that those distresses have different visual characteristics, such as colour, depth and microtexture. Striking is that the seemingly big gaps in for example crack detection methods as shown in Table 2 form in reality no gap at all, as they are the second most researched topic and the top researched distress if only the LTP distresses as Figure 5 shows are considered.
