A study of defects on EUV mask using blank inspection, patterned mask inspection, and wafer inspection

# A study of defects on EUV masks using blank inspection, patterned mask inspection, and wafer inspection

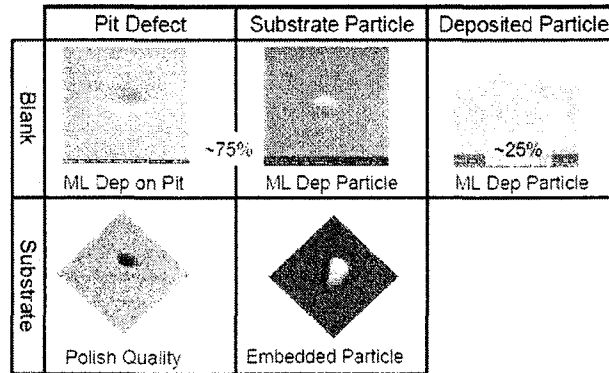
Figure 1. Types of defects on an EUV blank

Three types of defects can be found on the blank level of an EUV mask: surface pits, which originate from the substrate pits that decorate during multilayer deposition; bumps or covered particles, which originate from embedded substrate particles or mechanical walk particles; and covered or partially covered defects added by the multilayer deposition process. Figure 1 shows defect types on the substrate and blank. Pit defects are the most dominant, accounting for on average 75% of the defects observed. Embedded particles on the substrate can be cleaned by an advanced cleaning process. The remaining 25% of the defects are due to particles deposited during the deposition process [3]. Figure 2 shows the EUV mask fabrication flow and the required metrology and inspection tools. A blank inspection tool, patterned mask inspection tool, and defect inspection using an actinic wavelength (EUV AIMS) are needed to qualify the mask. However, a blank inspection tool with sufficient sensitivity and an EUV AIMS are not currently available. Furthermore, it appears that this tool will not be available even for pilot line or early HVM operations. Consequently, the final EUV mask must be qualified by wafer inspection. It is therefore important to compare the sensitivity of each inspection tool to determine whether a wafer inspection tool can fully characterize potentially printable defects on EUV masks.

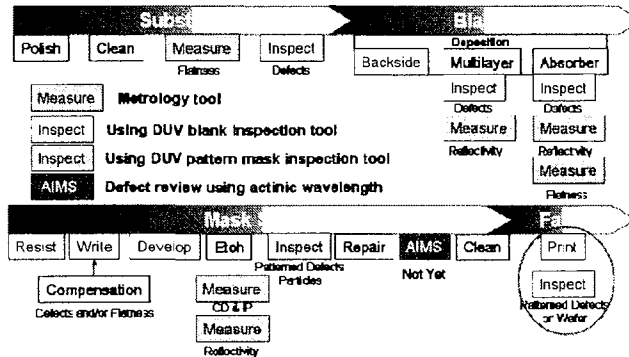
Figure 2. EUV mask fabrication flow for pilot line application or early HVM

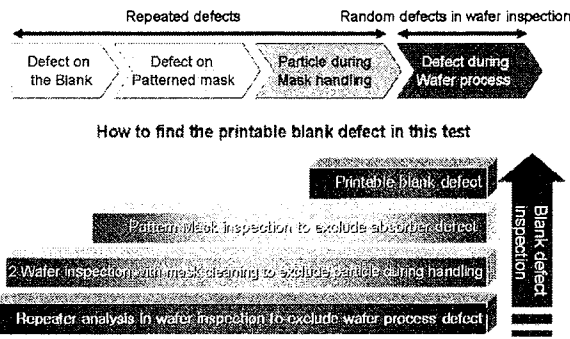
Figure 4. Procedure to identify defects from wafer inspection

inspection. The experimental plan is explained in the Figure 4. After mask fabrication, patterned mask inspection was done to qualify defects on the patterned absorber. After that the mask was shipped from Asia to the USA without using a dual pod. Particles may be added to the mask during mask handling and shipping. These particles cannot be detected by a patterned mask inspection tool. However they will be detected as repeater defects on the wafer inspection tool. At CNSE in Albany, NY, the mask was exposed with the EUV ADT. Then the wafer was inspected with CNSE's KLA 28XX wafer inspection tool to classify printable pattern defects, blank defects, and particles. The mask was then sent back to Asia for cleaning to remove particles from the first ADT exposure. The cleaning removed all the particles, but other particles were added in different locations. One more ADT exposure and wafer inspection was done to exclude the particles on the EUV mask. When the coordinates of the wafer inspection overlap in first and second wafer inspection, they can be considered printable blank or pattern defects. However, when a coordinate does not overlap, it can be classified as a particle, as all particles are removed or added at different locations after mask cleaning. Figure 4 summarizes how to classify defects on the blank and patterned absorber, particles, and process defects. Figure 4 explains the classification procedure, which is outlined in more detail as follows:

- After repeater analysis, any random process defect can be excluded from the results of wafer inspection. Repeated defects include blank defects, pattern defects, and particles.
- Two wafer inspections were conducted. After the first wafer inspection, the mask was shipped back to the mask shop and cleaned to remove the particle from the original site. Overlapping coordinates indicate blank defects and pattern defects. The others are particles added during mask shipping and handling.
- Patterned defects are excluded from the results of the repeater analysis using the information from patterned mask inspection. Finally, a printable blank defect can be obtained without the information from the blank inspection.

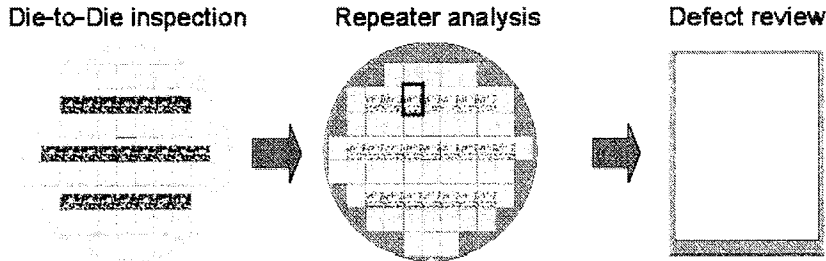
Figure 6. The procedure for wafer inspection and repeater analysis

The wafers were printed using CNSE's EUV ADT with a NA of 0.25 and sigma of 0.5. SERV40, 80nm thick, was used for this test. The 26 die are arranged on the wafer at best dose and focus, which is shown in Figure 6. CNSE's KLA 28XX was used for die-to-die wafer inspection using a developed resist pattern. After repeater analysis, one die was chosen for review to classify the defects.

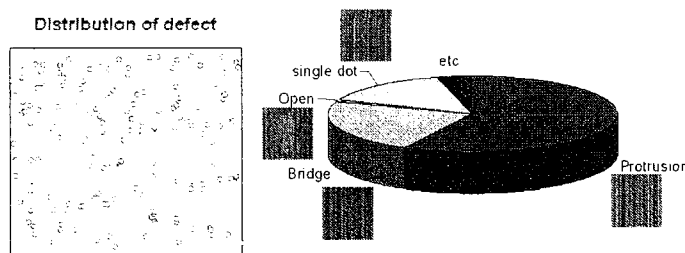
Figure 7. The result of patterned mask inspection

After patterning the absorber, the mask was inspected using a DUV patterned mask inspection tool with a wavelength of 257nm. The tool can inspect part of the inherent blank defects on the substrate and patterned defects generated during patterning of the absorber. Defects were classified as protrusion, bridge, open, single dot, etc. Figure 7 shows the distribution and Pareto chart classifying each defect. Protrusion and bridge types have the highest percentage. The printable/inspectable defects, printable/uninspectable defects, and unprintable defects are classified based on the inspection and defect review.

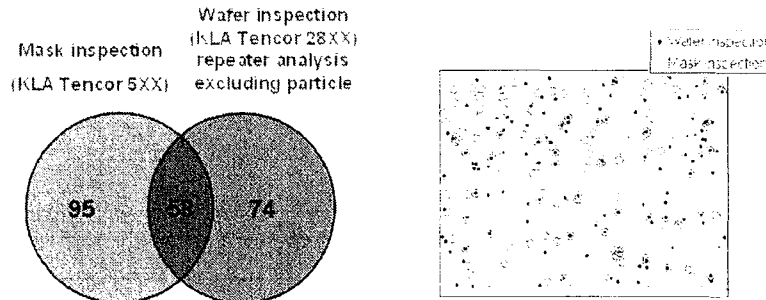
(a) Comparison of mask inspection and wafer inspection (b) Coordinates of defects

Figure 9. Comparison of patterned mask inspection and wafer inspection

Ninety-five defects, which were detected by only the patterned mask inspection tool, were reviewed by wafer review scanning electron microscopy (SEM) to determine whether they are unprintable on the wafer or undetectable by the wafer inspection tool. Twenty-five defects were printable on the wafer, but not detected by the wafer inspection tool. The other 70 defects were unprintable on the wafer, which is why they could not be detected by the wafer inspection tool. Figure 10 shows the kinds of defects that are more detectable by the wafer inspection tool. Small defects such as protrusions are difficult to detect with the wafer inspection tool, but they can be detected with the patterned mask inspection tool. Large defects or bridge defects are easily detected by both inspection tools. From these results, the patterned mask inspection tool is more sensitive than the wafer inspection tool. We therefore need to find ways to improve the sensitivity of wafer inspection. SEMATECH is focusing on improving sensitivity using the two methods described below. Figure 11 shows some SEM images of the defects from this study.

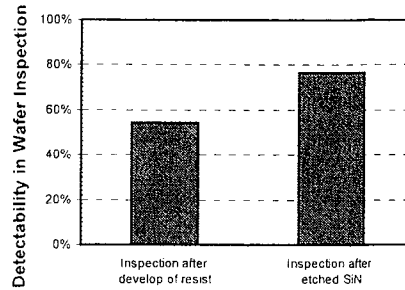
Figure 12. Improved wafer inspection sensitivity using a different wafer stack.

Phase defects on mask blanks have a strong focus-dependent printability on the wafer. The printability of pits and bumps is opposite from through focus. Figure 11 shows some AIT review images of blank defects on the mask [4]. Each defect has a different printability at through focus [5]. This means that through-focus wafer inspection can improve the detectability of the wafer inspection tool. Wafer inspection of the exposed sample from through focus can improve the sensitivity toward blank defects. Defect printability depends on size, profile, and location. Furthermore, different wafer stack will induce different sensitivity. Wafer inspection is less sensitive toward developed resist images than SiN wafer stacks because of the improved contrast in the pattern of the SiN stack on the wafer in the wavelength of the inspection source. An improved wafer inspection sensitivity of about 20% has been demonstrated using an underlayer stack (SiN) rather than developed resist (see Figure 12).

The identification of defects on EUV mask blanks is a key technology for EUV lithography when used in mass production. SEMATECH, in collaboration with industry, is evaluating defect printability on EUV masks using ADT, AIT, and wafer inspection tools. In this paper, the printability of defects and identification of their source from mask fabrication to handling were studied using wafer inspection. Blank defects, patterned defects, and particles were classified using repeater analysis on the wafer inspection. Blank defects should be quantified in the mask shop or blank company; particle defects should be quantified and controlled in the wafer fab. However, printable blank defect density excluding particle adders and patterned defects is indirectly quantified during wafer inspection, resulting in  $0.63/\text{cm}^2$  for this particular EUV mask. Mask inspection is more sensitive than wafer inspection. Small defects on the mask may be unprintable or undetectable by wafer inspection only. Therefore, the sensitivity of wafer inspection must be improved using through-focus analysis and a different wafer stack. SEMATECH continues to focus on improving the sensitivity of wafer inspection. So far, improved sensitivity of about 20% has been demonstrated using an underlayer stack (SiN).
