MISCELLANEOUS PAPER SL-86-14

# ABRASION-EROSION EVALUATION OF CONCRETE MIXTURES FOR STILLING BASIN REPAIRS, KINZUA DAM, PENNSYLVANIA

Structures Laboratory

Prepared for: US Army Engineer District, Pittsburgh  
Pittsburgh, Pennsylvania 15222-4186

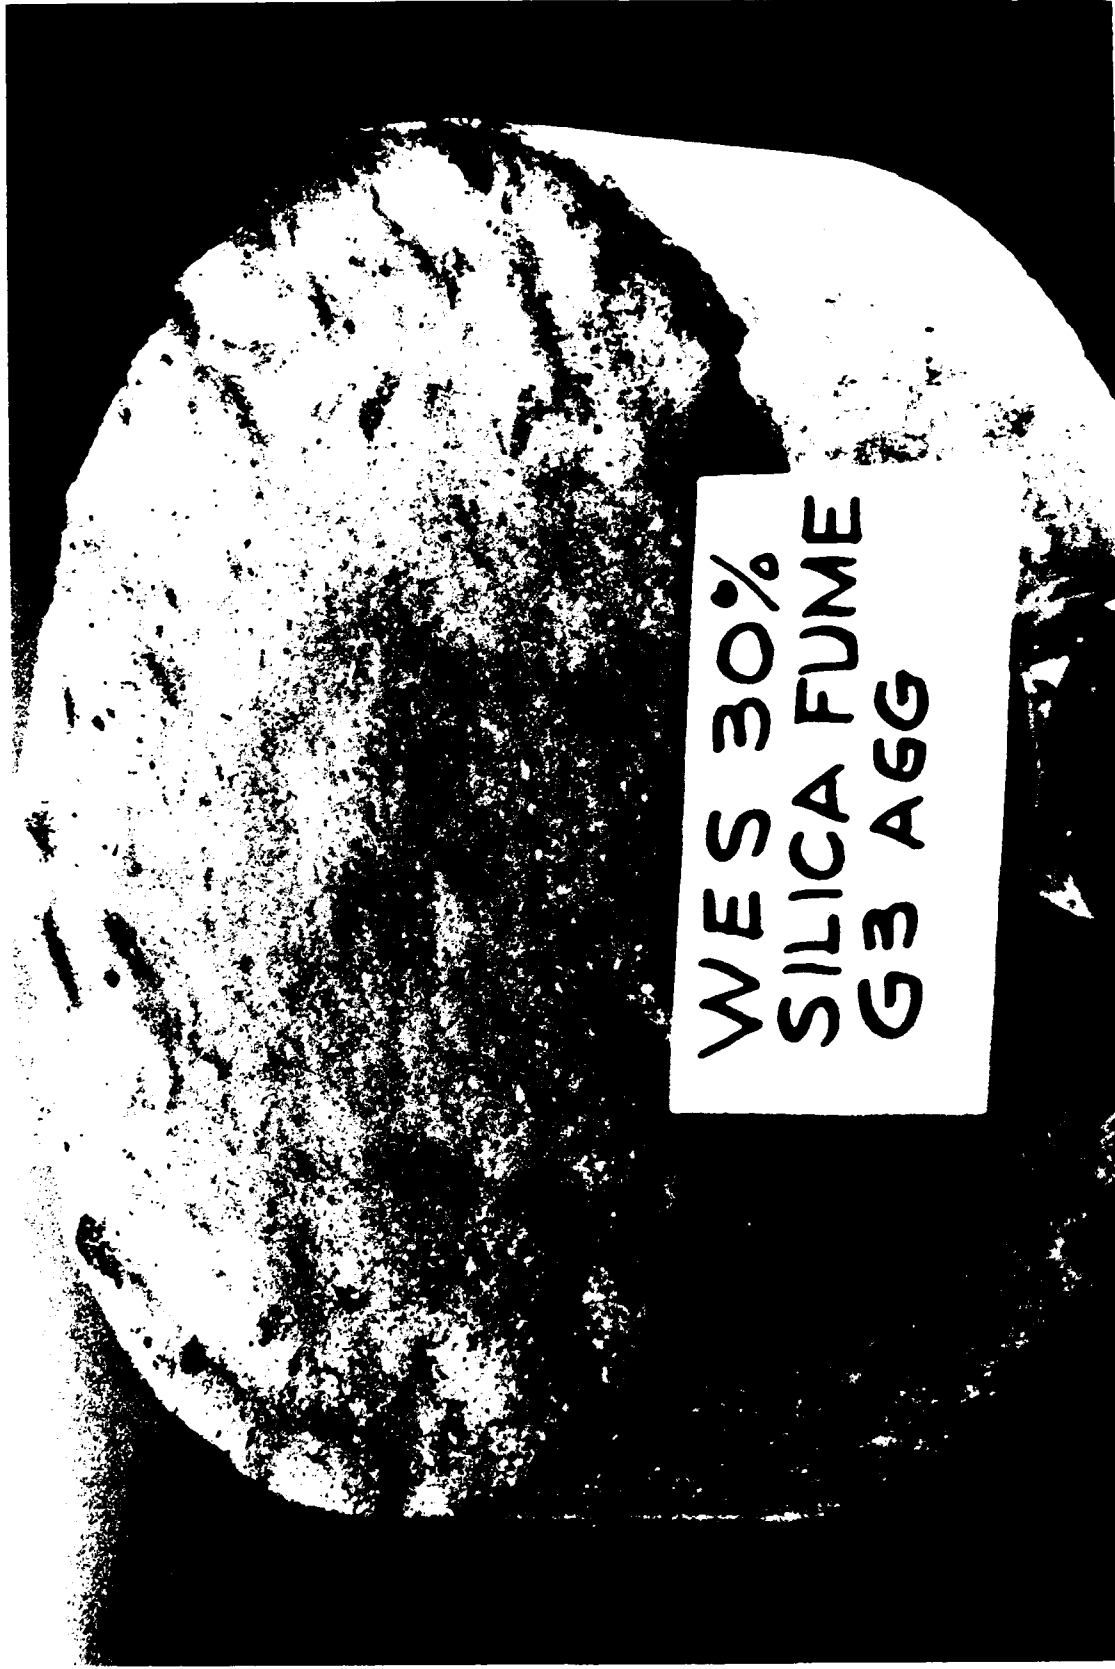
Figure 2. Abrasion-erosion specimen at conclusion of testing, Mixture G3 (30 per cent silica fume)

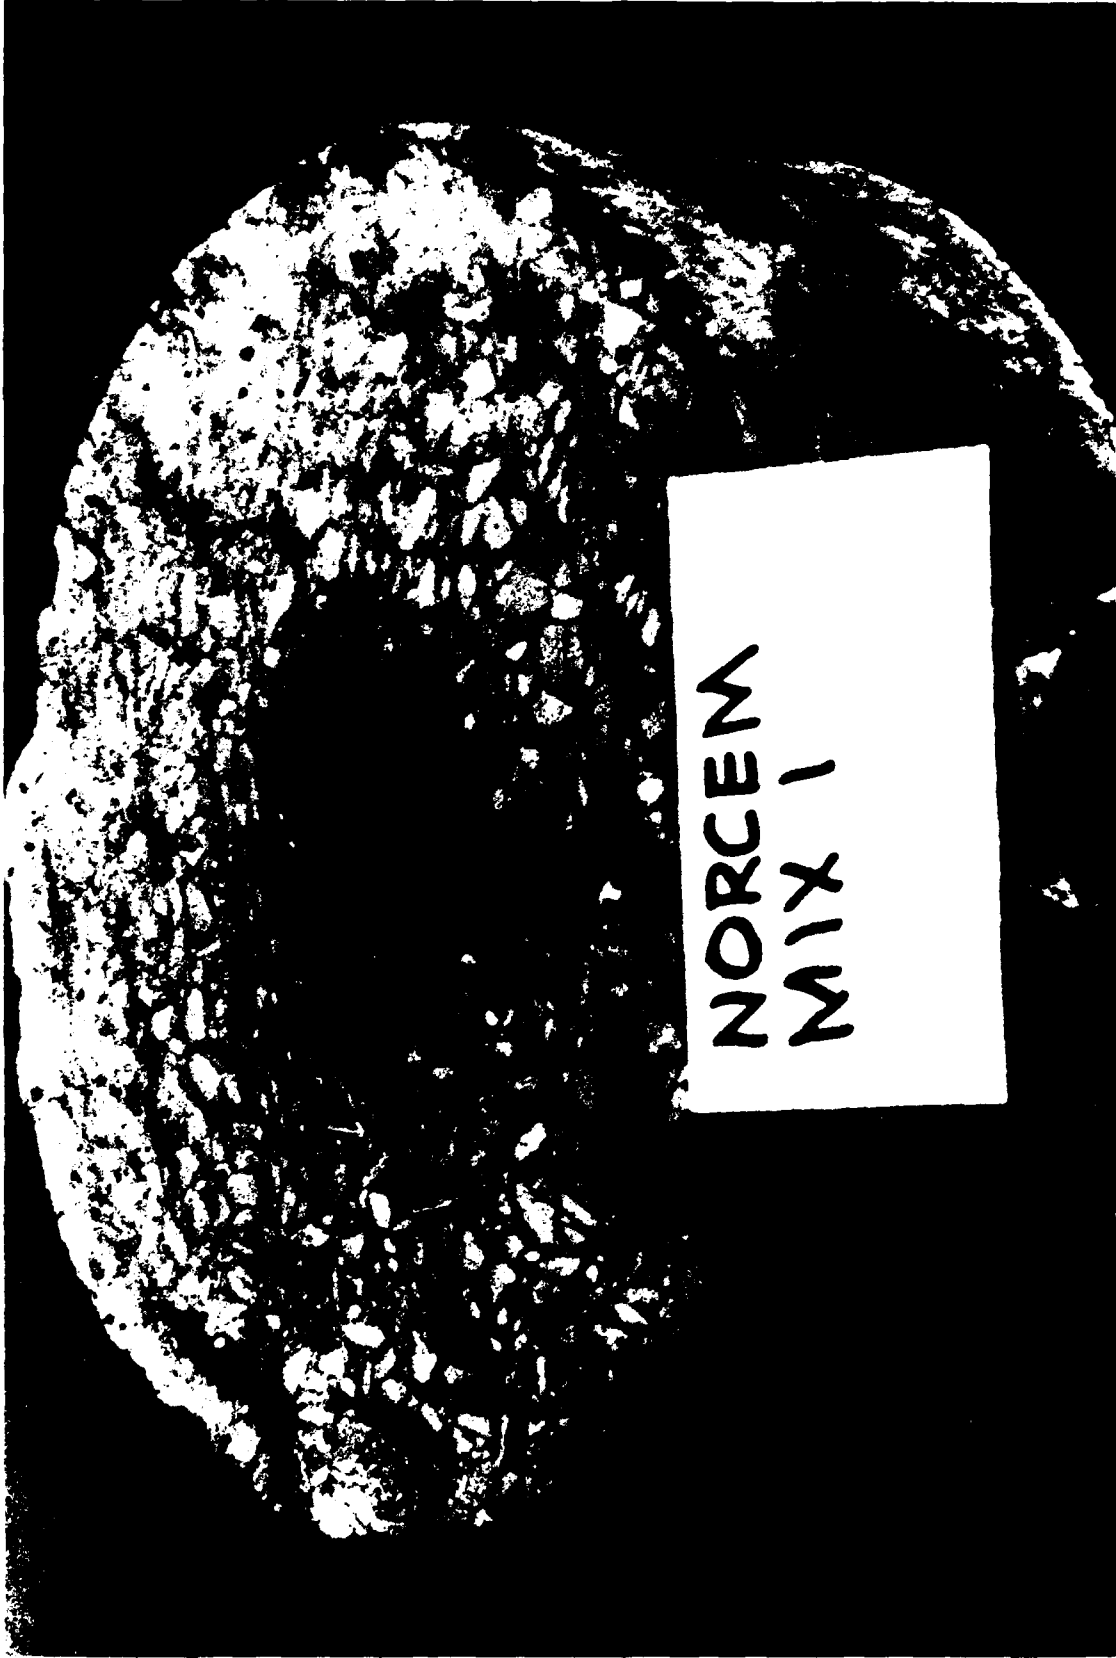
Figure 5. Abrasion-erosion specimen at conclusion of testing, Mixture Norcem 1 from Neville Island trial placements

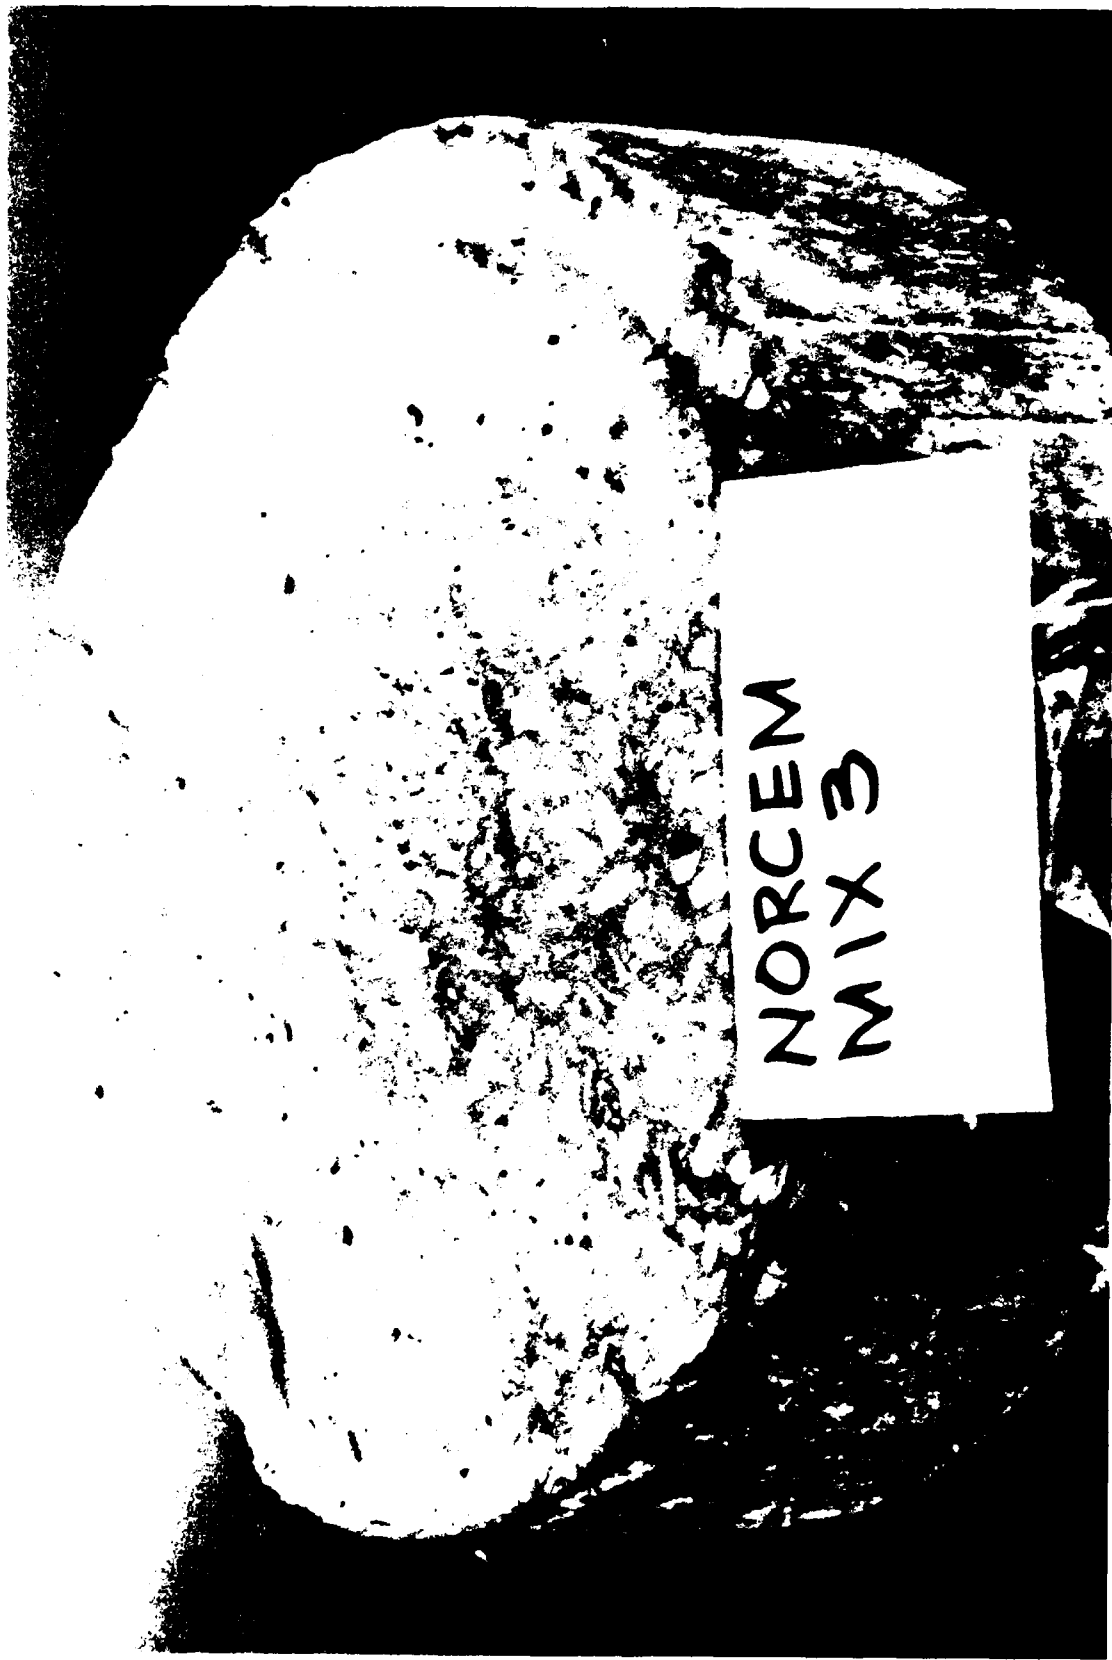
Figure 6. Abrasion-erosion specimen at conclusion of testing, Mixture Norcem 3 from Neville Island trial placements

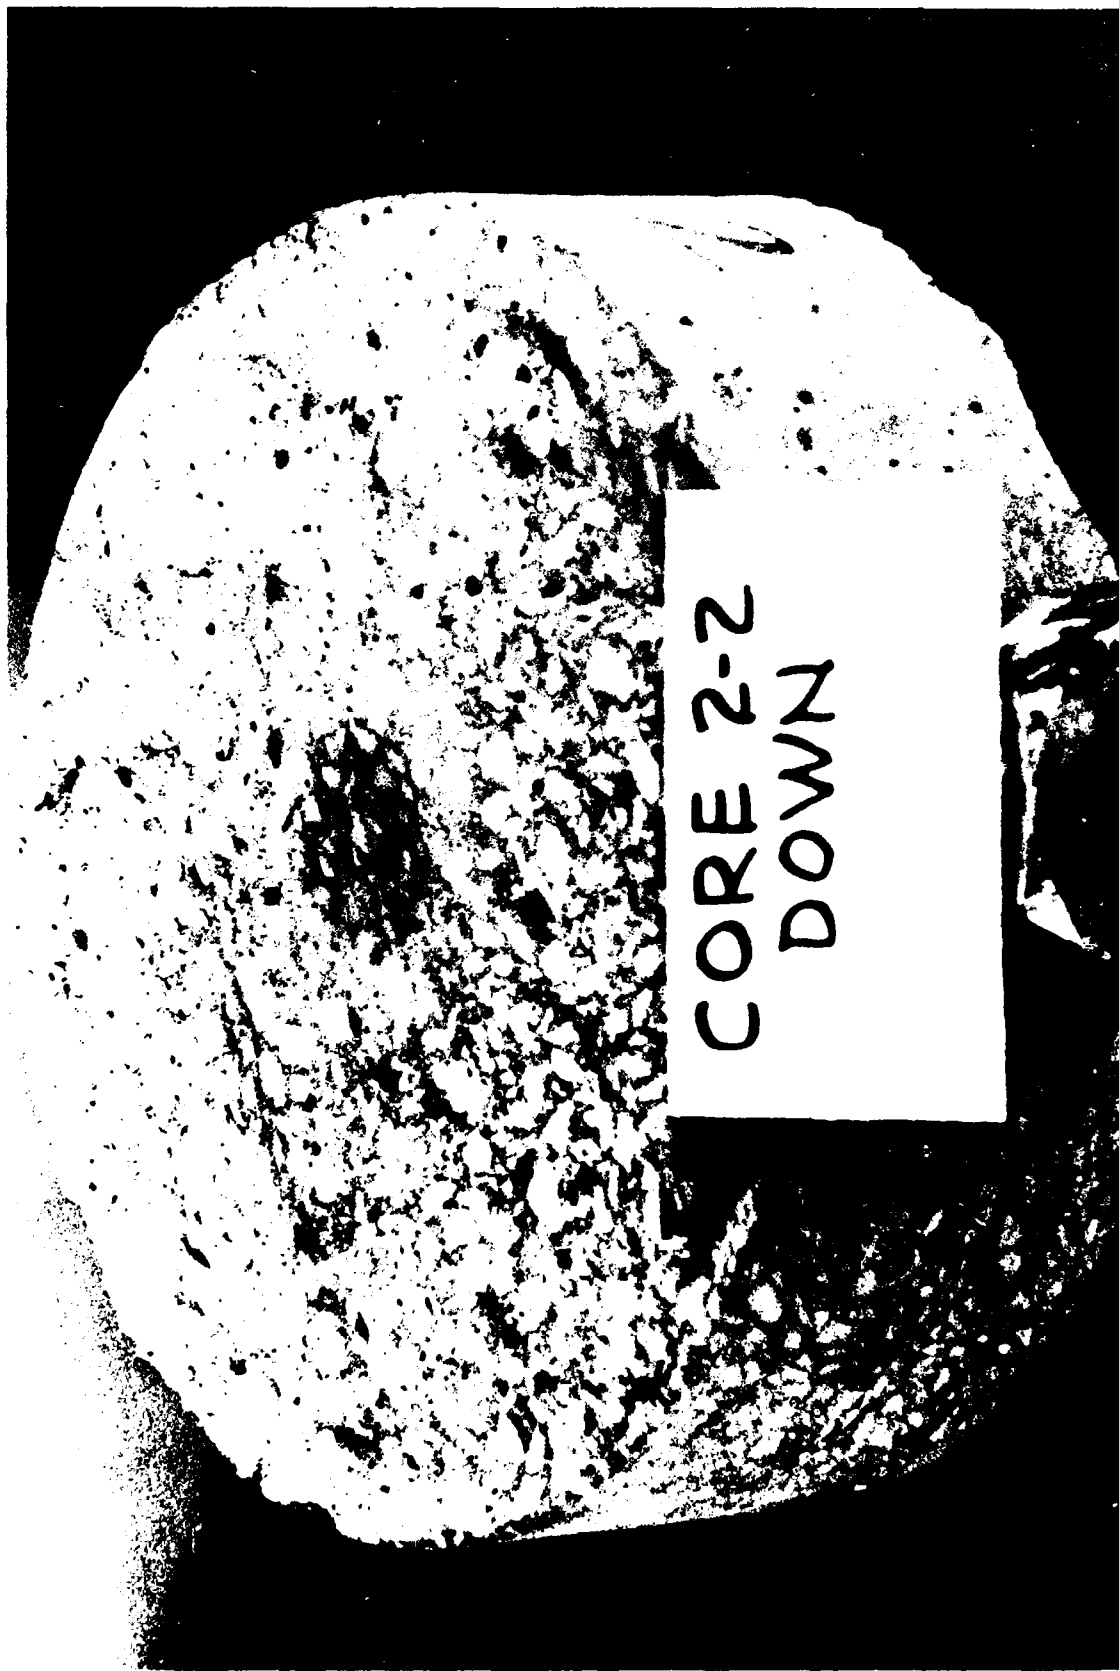
Figure 16. Abrasion-erosion specimen at conclusion of testing, core ORP No. 2-2 from Neville Island trial placements, lower surface tested

- d. The plastic shrinkage cracks in the two Norcem specimens tested did not have a significant effect on the abrasion resistance. The higher abrasion loss seen when these samples were inverted and tested suggests that the finishing process produced a very dense concrete near the surface, while the concrete below the surface was not as dense. This thought is in keeping with the low amount of vibration seen during the Norcem placements.
