Active sinking at the bottom of the Rincón de Parangueo Maar (Guanajuato, México) and its probable relation with subsidence faults at Salamanca and Celaya

Abstract

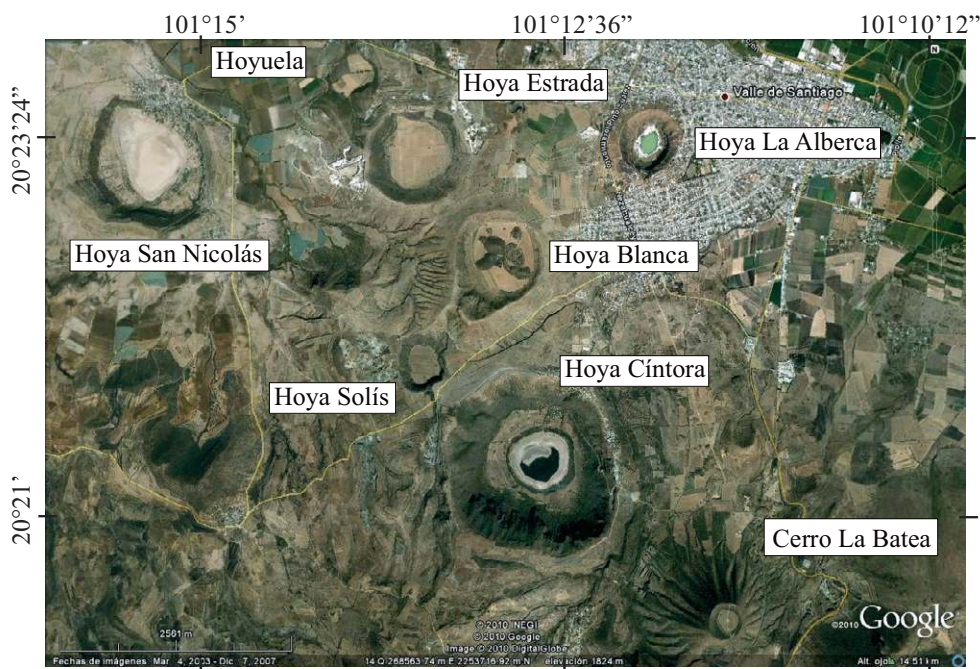
Figure 5. Volcanoes near Valle de Santiago, Guanajuato. San Nicolás, Alberca, and Cíntora are good examples of maars (*sensu stricto*) as older rocks are exposed on the craters walls. Hoya Estrada is an example of a tuff-ring. Inside the crater of Hoya Blanca exist the remnants of several cinder/scoria cones; these volcanoes grew inside the maar when the system ran out of water. Note the marked contrast in the morphologies of Cerro La Batea (a cinder cone plastered with surge deposits from neighboring maars) and the maar-type volcanoes

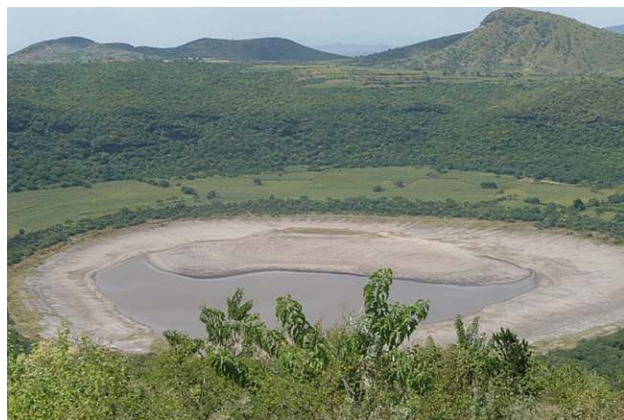
Figure 9. Panoramic view of the bottom of Hoya Cíntora as seen from 20° 21.065'N, 101° 12.359'W (see figures 4 and 5) for location. Note that the bottom of the crater is a gently curved, concave upward, surface with no evidences of subsidence. Poorly developed microbialites were found near the former shore, which is marked by the vegetation line.

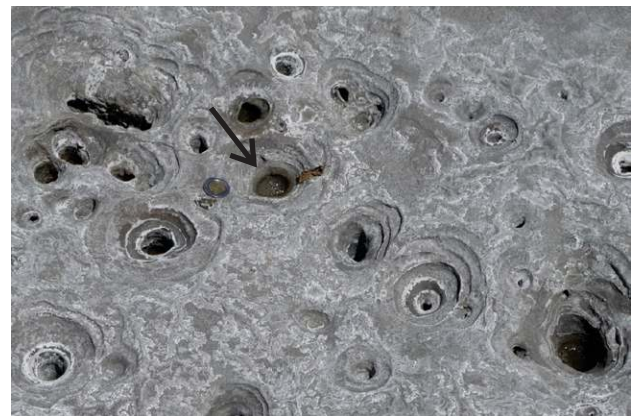
Figure 17. Thick crust of evaporite formed during the dry season of 2009 shows small craters formed by gas bubbles (arrow). The craters suggest that gas was continuously expelled through conduits that acted during time periods of days or weeks. Note coin near the arrow as a scale.
