Research Article

AE propagation velocity calculation for stiffness estimation in Pier Luigi Nervi's concrete structures**

2 The slanted pillars of hall B: the monitoring site

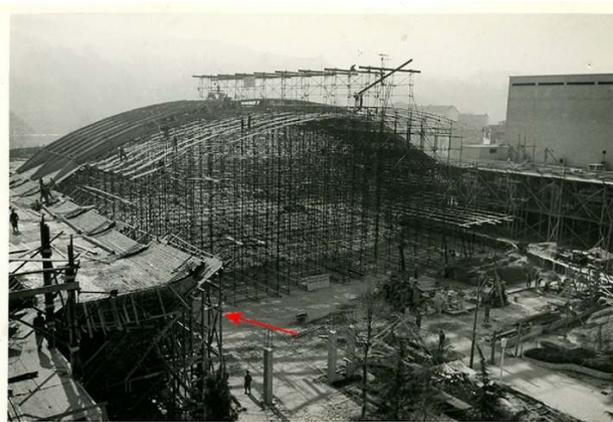
Figure 2: (a) A picture showing the initial stage of the construction site of hall B, which started from the apse. It is also possible to notice the prefabricated elements in ferrocement built simultaneously. (b) Advancement of the construction site, in which the red arrow indicates a pillar that has not been cast yet, while the ones closer to the apse are in a more advanced stage (photos by Riccardo Moncalvo)

The construction site started from so-called “apse”, the round element with the ribbed half dome (Figure 2a). At the same time, workers started to build the prefabricated ferrocement elements of the undulated vault (Figure 2a).

ingly. In Figure 2b, a red arrow indicates a pillar that has not been cast, while the ones closer to the apse are in a more advanced stage. In fact, the scaffolding of the first section of the vault was built from the apse, and it was moved sequentially in the direction of the main façade. The scaffolding was moved only when the undulated elements

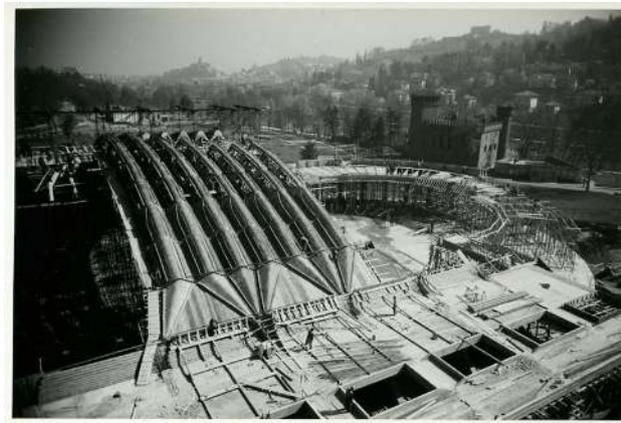
Figure 3: (a) Advancement of the construction site with the elevation of the first portion of the undulated vault (photos by Riccardo Moncalvo). (b) Detail of the reinforcing of the pillars and the connections with the slabs at the various levels and the fanned elements [18]

of a set of arches were set (Figure 3a). In the last stages, it was poured the concrete for the connections of the fanned elements and the pillars; subsequently, also elements of the undulated vault were completed with the casting of the ribs. Figure 3b reports the detail of the reinforcing of the pillars and the connections with the slabs at various levels and the fanned elements.

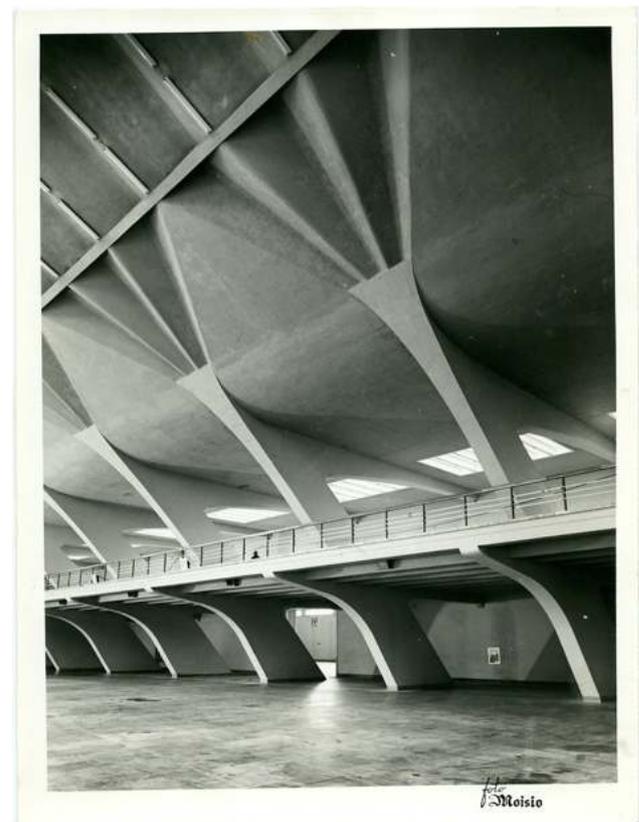
Figure 4: (a) Scheme of the various casting stages of pillars. (b) Detail of the interiors just after the completion of the hall (photo of Aldo Moisio)

The supporting structures of the vault were instead built in four different stages, in which the concrete was poured sequentially in different months. Figure 4a shows a section of an inclined pillar reporting a scheme of the various casting stages, while Figure 4b shows a picture of the interiors just after the completion of the hall.
