An Experimental Work on Multi-Roller Burnishing Process on Difficult to Cut Material – Titanium Alloy

S.Thamizhmanii* and S.Hassan
Faculty of Mechanical and Manufacturing Engineering,
Universiti Tun Hussein Onn Malaysia

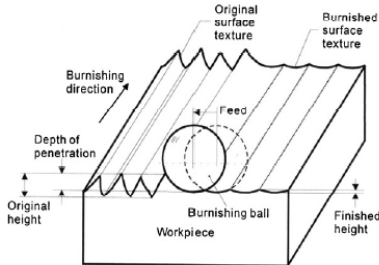
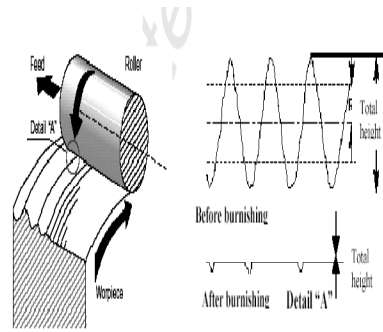
Fig.1. Schematic diagram of burnishing process – (a) ball and (b) – roller [11-12]

The Fig.1 (a) and (b) show typical ball and roller burnishing process respectively. The Fig. 2 shows multi roller burnishing tool used for this experiments. The Figs. 3 to 6 show the feed rate against surface roughness for depth of penetration of 0.20, 0.25, 0.30 and 0.35 mm for various spindle rotation 700, 1050, 1400 and 1750. Hassan and Maqableh [8] have identified that reduction in the surface roughness and the increase in hardness with increase in the initial hardness of the burnished work material. The plastic deformation of asperities depends on the normal force, and mechanical properties of the work piece materials, as well as geometric characteristics of the original asperities. The initial surface roughness before burnishing was 0.41 μm . At feed rate of 100 with DOP 0.20 mm having the spindle speed of 700, the surface roughness obtained was 0.25 μm with sudden reduction of

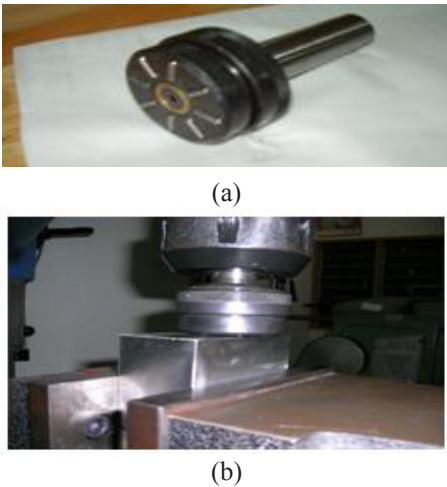
Fig.2. Multi-roller burnishing tool and vertical roller burnishing process

A multi roller burnishing tool are hardened rollers fitted in a housing and are rotates freely in a horizontal axis. The rollers project by 1 mm from housing surface. The tool used have 8 rollers and as shown in the Fig.2 (a). The process of vertical roller burnishing is shown in the Fig. 2-(b). The work material used was Titanium alloy Ti-6Al-4V. Ti- 6Al-4V material was cut from stock of material and machined to 45 x 45 x 120 mm. The surface of the work material was skin ground to have smooth surface before burnishing. The surface roughness was measured by using Mitutoyo SJ 400 tester. The micro hardness was measured by digital micro hardness tester make –HWMMT–X3 manufactured by M/s TT unlimited INC, of Japan. The plastic deformation was measured by Scanning Electron Microscope (SEM) Joel 6380 LA. A Pinnacle vertical milling machine was used for burnishing process. Before the experiment was conducted the initial surface roughness and hardness were recorded. The initial surface roughness measured was 0.41 microns and hardness 270 HV. The operating parameters are the spindle speeds of 700, 1050, 1400 and 1750 RPM, 100, 200, 300 and 400 mm/ min as the feed rate and depth of penetration (DOP) of 0.20, 0.25, 0.30 and 0.35 mm.

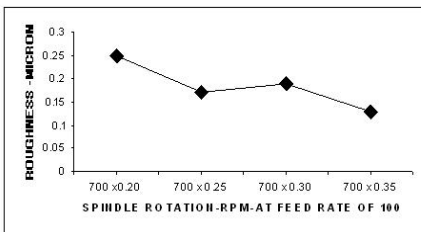
Fig.3. Feed rate Vs Roughness at 700 RPM

approximately 40 % from the initial roughness value. As the depth of penetration was increased to 0.25, 0.30 and 0.35 mm for the same operating parameters, the surface roughness values are 0.17, 0.19, and 0.13 microns respectively. The reductions in percentages are 58 %, 53 % and 68 % for 0.25, 0.30 and 0.35 DOP respectively. As the DOP was increased, the deformation of material taken place and peaks and valleys were reduced. This is shown in the Fig. 3. At feed rate of 200 at spindle rotation of 1050 with DOP of 0.20, 0.25, 0.30 and 0.35 mm, the roughness values are 0.15, 0.18, 0.15 and 0.14 microns respectively. This is shown in the Fig.4. The percentage difference between 100 and 200 feed rate was 40 %, 0.10 %, 21 % and 7. Figs. 5 and 6 show the roughness values at feed rate of 300 and 400 mm/min for spindle rotation of 1400 and 1750 rpm. The roughness values are 0.12, 0.13, 0.14 and 0.13 microns for feed rate 300 and for the feed rate of 400 mm/min, values are 0.12, 0.24, 0.18 and 0.18 microns. As the feed rate was increased to 400 mm/min, there was deterioration surface roughness and the deformation was ineffective. i.e. the peaks and valleys again formed. The higher the depth of penetration by the roller, the peaks and valleys reduced and better surface finish is obtained. It was not advisable to further deepen the penetration which may lead to micro-cracks on the surface which may not be seen by the naked eye. It was clear that depth of 0.20 mm is the better option to get good surface finish even though, 0.25, 0.30 and 0.35 mm DOP produced almost same effect. Consequently an indication that surface roughness started to increase. The ideal operating parameters are spindle rotation of 1400 rpm; feed rate of 300 mm/min and depth of penetration 0.20 mm.

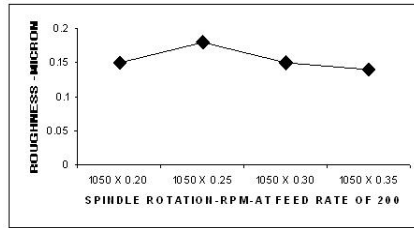
Fig.4. Feed rate Vs Roughness at 1050 RPM

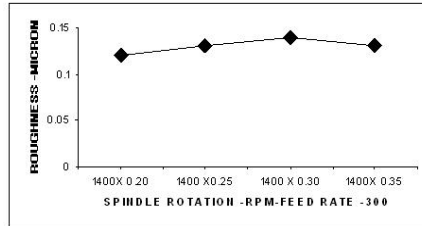
Fig.5. Feed rate Vs Roughness at 1400 RPM

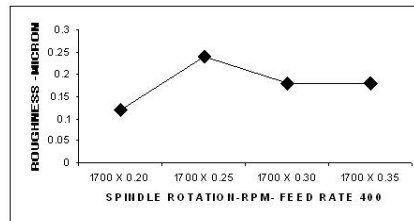
Fig.6. Feed rate Vs Roughness AT 1700 RPM

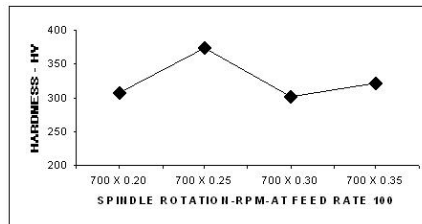
Fig.7. Feed rate Vs Hardness – 700 RPM

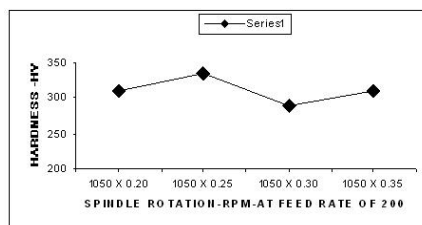
Fig.8. Feed rate Vs Hardness-1050 RPM

Hassan [9] studied burnishing force or number of tool passes to certain limits increases the wear resistance of brass components under different rotating disc velocities or applied contact forces of the wear testing device. When a metal is continuously moving over a surface, plastic deformation takes place. This produces work hardening effect and produce harder surface than other surfaces. The surface hardness is directly proportional to applied force, i.e. an increase in compressive force increases surface hardness. This is due to the increase in depth of penetration, increases in metal flow that leads to an increase in the amount of deformation and voids present in the metal. When the burnishing process continued for a longer period of time, hardness of the disturbed layer of the surface increased significantly. The heat produced at the deformation zone and friction zones overheat the tool and work material [10]. The surface hardness is based on the initial surface hardness of the work materials to be burnished [11–12]. Figs. 7 to 10 show the surface hardness against depth of penetration. When a metal is continuously moving over a surface, a plastic deformation takes place. This produces work hardening effect and this surface is harder than other surface. The hardness of distributed layer increased significantly. At feed rate of 100 with DOP of 0.20, 0.25, 0.30 and 0.35 mm, the surface hardness increased 308, 375 302 and 323. Between the initial hardness and this test, the hardness values increased by 12%, 28%, 10% and 16% for DOP of 0.20, 0.25, 0.30 and 0.35 mm respectively. When the depth of penetration was 0.25 the hardness value was 375 for feed rate of 100 at 700 spindle rotation. This is shown in the Fig.8.

This was due to initial surface hardness before burnishing. At 400 feed rate, the hardness values are 330, 355, 290 and 310 which is far below from the hardness as shown in figure 8. Any further increase in the DOP will only produce flaking effect on the surface with out any increase in hardness. This is shown in the Fig.9. From Fig. 10, it is understood that high surface hardness value was possible by 1400 spindle rotation with feed rate of 300 , m/min at DOP of 0.25 mm. Fig.11 shows the SEM view on deformation taken at spindle rotation of 1400 for feed rate of 300 with 0.2 DOP.

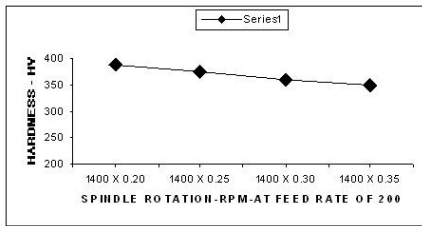
Fig.9.Feed rate Vs Hardness -1400 RPM

This is similar to number of passes. It was clear that there was decrease in the surface hardness at spindle rotation of 1050 with feed rate of 200 mm/min with the same DOP as that of 100 mm/min. At feed rate of 300 with spindle rotation of 1400 rpm, the hardness values were increased to 388, 375, 360 and 350 HV.

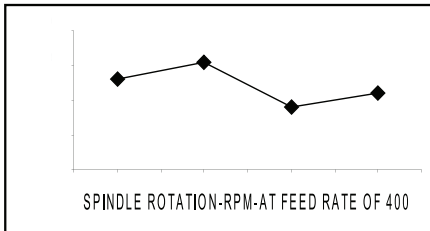
Fig.10.Feed rate Vs Hardness -1750 RPM

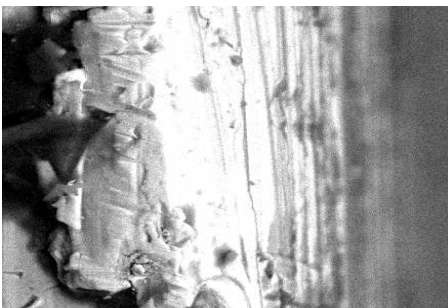
Fig.11.Deformation of material
