# Analyses of the Long-Term Performance and Tribological Behavior of an Axial Piston Pump Using Diamondlike-Carbon-Coated Piston Shoes and Biodegradable Oil

*This work reports on the performance enhancement of a real-scale hydraulic system consisting of diamondlike-carbon (DLC)-coated components in combination with biodegradable oil in long-term experiments under conditions simulating those in an actual application. The performance of a hydraulic axial piston pump with DLC-coated piston shoes was evaluated in a newly designed, dedicated hydraulic test system using fully formulated biodegradable, synthetic ester oil. For comparison, an equal but separated hydraulic system with a conventional commercial pump and stainless-steel shoe surfaces was tested. The tests were run at 85% of the maximum pump load and an oil temperature of around 80°C for a period of 2000 h, which corresponds to more than 1 yr of continuous 8 h/day operation in an application. A major abrupt oxidation-induced degradation of the oil did not occur in either system; however, the oil from the system comprising the DLC-coated shoes showed noticeably and consistently better results. The wear of the DLC-coated shoes,

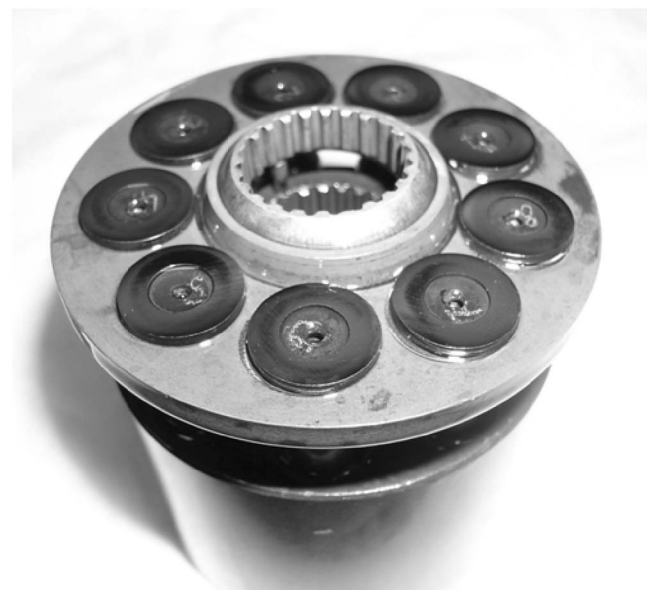
**Fig. 3 Assembly of the pistons with DLC-coated shoes, inserted into the pump cylinder block**

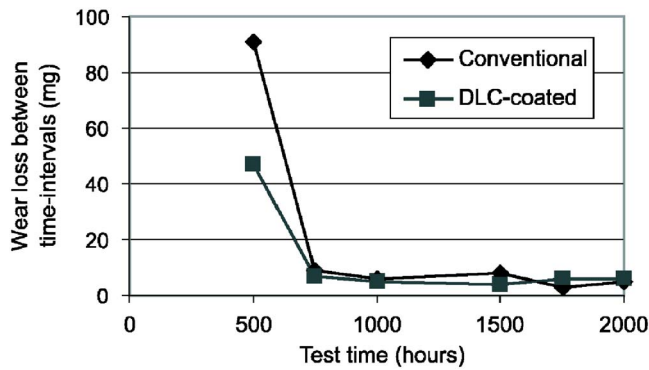
**Fig. 5** Wear loss of the set of conventional and DLC-coated shoes

Figure 5 shows the total wear of a whole set of nine conventional and DLC-coated piston shoes within the pump. It is clear that the wear was the highest during the initial 500 h. It is also clear that the wear in the conventional steel system was much higher than that in the DLC-coated system, i.e., by as much as two times. The wear between all the analyzed periods after the 500 h evaluation was about ten times lower than the wear measured in

the initial period of 500 h. It appears that running-in phenomena are responsible for most of the wear. From the results, it is clear that the running in was particularly beneficial and less severe for the DLC-coated system than for the conventional system. After the initial period, the rate of wear was much lower and steady, and no distinctive increase was measured through the end of the test, after 2000 h. This was true for both the tested systems.

The lower amount of wear in the DLC-coated system (Fig. 5) also suggests lower "pollution" of the oil due to released wear debris. Moreover, since the wear particles in the oil also increase the rate of oil oxidation, this could suggest improved oxidation performance of the oil, too. In accordance with this suggestion, we have indeed observed that, consistently, the oil oxidation related data, i.e., TAN and viscosity, were always better for oils using the DLC-coated shoes than those for the conventional ones (see Figs. 10 and 11).

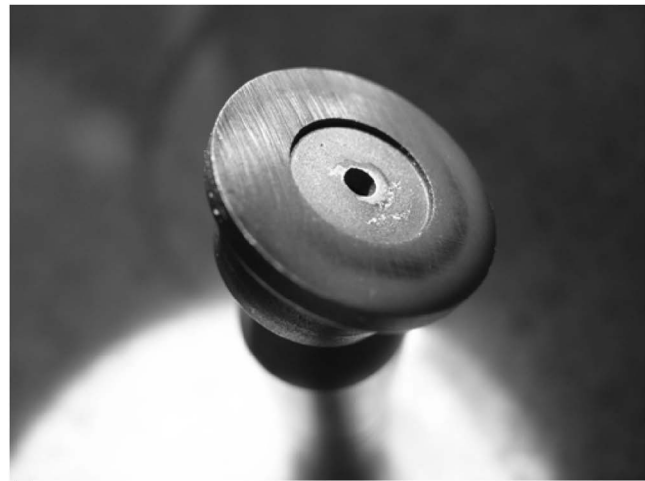
**Fig. 6** A photograph of the piston-shoe front surfaces after 500 h on (a) DLC-coated piston shoe and (b) steel piston shoe

The appearance of the contacting surfaces of the piston shoes is mainly in agreement with the wear data; however, there are some clear, qualitative differences between the conventional and the DLC-coated shoes. After 500 h, almost no changes can be observed with the DLC shoes (Fig. 6(a)). Grinding scratches from the preparation of the samples/piston shoes are still visible and the coating covered the whole surface, i.e., no spalling or major signs of wear were observed. However, there is a distinctive circular region observable on the shoe's surface, most probably representing an area of more intense contact against the swash plate. In contrast, many scratches in various directions could be seen on the steel shoes, indicating abrasive damage (Fig. 6(b)). Several larger scratches are also observed, which agrees with the higher and more severe wear during the running in and also a higher measured wear loss (Fig. 5). Namely, the loose wear debris that were generated during the running-in period were trapped in the pump and at least occasionally in the contact, which causes these abrasive marks. Moreover, if these debris were to deform in the contact and become work hardened, they could become even more abrasive and cause a lot of damage during operation.

spalling or detachment. On the contrary, only minor polishing-type wear with smoothening of the surfaces occurred under selected conditions over the whole period of the test (Figs. 6(a), 7(a), and 8(a)). Most of the wear occurred during running in, while during the later stages, the wear was much lower. On the other hand, the conventional system experienced about two times more wear loss than the coated system during the initial 500 h (Fig. 5). Obviously, the running-in period was significantly improved by the use of DLC-coated shoes. Moreover, the wear debris that were generated in the conventional steel system during running in most probably got trapped in the pump and occasionally at the contact. If this occurs, the debris also become work hardened and therefore even more abrasive. This subsequently caused abrasive wear scratches on the front shoe surfaces (Figs. 6(b), 7(b), and 8(b)), as well as erosive wear of the inner ring edges (see particularly Fig. 7(b)). The abrasive scratches were visible for all the test intervals, and they accumulated during the test, as can be seen by their increase in number during the period of the test. In contrast, no scratches or any other signs of wear, except smoothening, were found on the DLC-coated shoe surfaces, clearly indicating significantly improved wear behavior and performance of the coated system. With prolonging the testing time (over 2000 h), these defects would probably become even more pronounced due to the stress intensities and the amount of damage, leading eventually to leakage from the system. The severe erosion marks on the shoe edges that were observed after just 750 h (Fig. 7(b)) certainly support such a possible scenario.

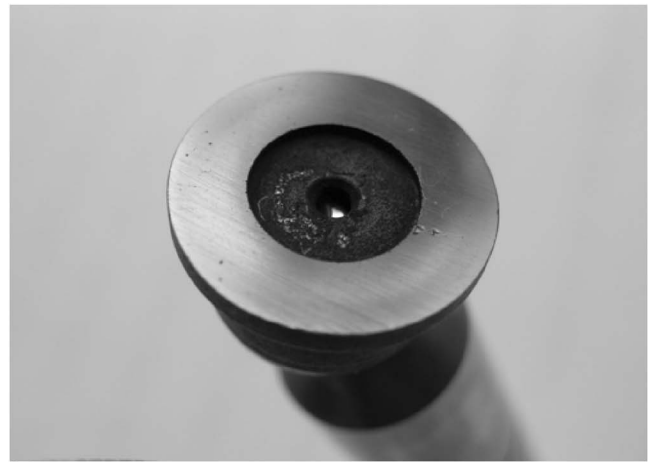
**Fig. 8** A photograph of the piston-shoe front surfaces after 2000 h on (a) DLC-coated piston shoe and (b) steel piston shoe

slightly worn and smoothed, which suggests a mild wear regime during the test for these surfaces. No wear through or spallation of the coatings was observed. A few DLC-coated shoes, however, showed small pits in the surface (Fig. 8(a)). These features are typical, even for the unworn surfaces, and it did not affect the performance of the pump. After 2000 h, the coating and the whole system still performed very well.

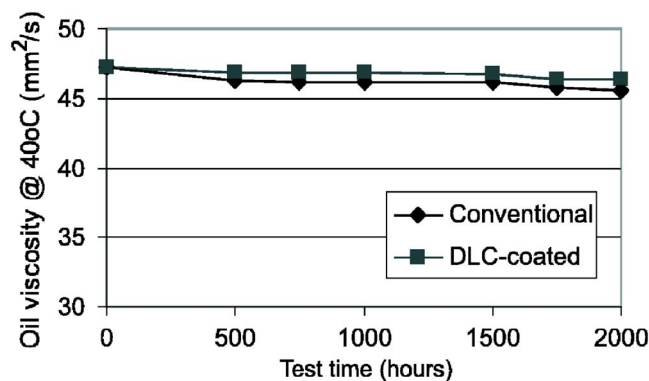
Fig. 10 Kinematic viscosity of the oil in the systems with conventional and DLC-coated piston-shoe surfaces during the 2000 h test

The viscosity of the oil, which indicates oxidation when it increases, was relatively stable during the experiment. The change of about 1–2 mm<sup>2</sup>/s that was found during the experiments can be considered small (Fig. 10). The difference was even smaller for the oil from the system with the DLC-coated shoes. A slightly more significant change was observed in the initial 500 h for the conventional steel system. In this initial stage, the decrease in the viscosity of biodegradable oils is expected and typical and does not necessarily indicate the oxidation of the oil. Namely, since the quantity of fatty acids is the most sensitive to these changes and in very plentiful in ester oils, it is expected that some of these molecules would rearrange and degrade initially and thus the viscosity would drop slightly, as was in fact observed. Moreover, based on the measurements, it appears that severe oxidation of the oil did not start during the whole of the 2000 h test. An increase of more than 5% would be expected under such conditions. In reality, however, the viscosity of the oil in our experiments was observed to decrease. The reason for this slight decrease during the later stages is not clear, but it is very possible that it is due to the measurement uncertainty over the period of 2000 h. Nevertheless, it is interesting to note that the oil from the system with DLC-coated surfaces consistently exhibited a smaller change in viscosity than the oil from the conventional system.
