Application of 8D Methodology for Minimizing the Defects in Manufacturing Process: A Case Study

Keywords: 8D Methodology, Problem Solving Techniques, Quality Control Tools, Rejection Analysis.

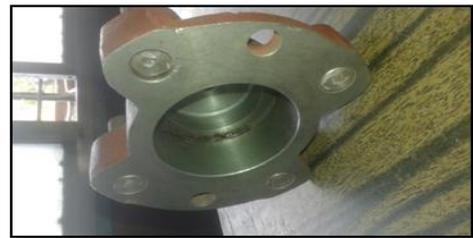
Figure 1: Coupling disc

For the case study purpose, the coupling disc component was selected because the issue was live and occurred many times. There was maximum customer complaints about this part and there was demand of 8D for this part from the customer.

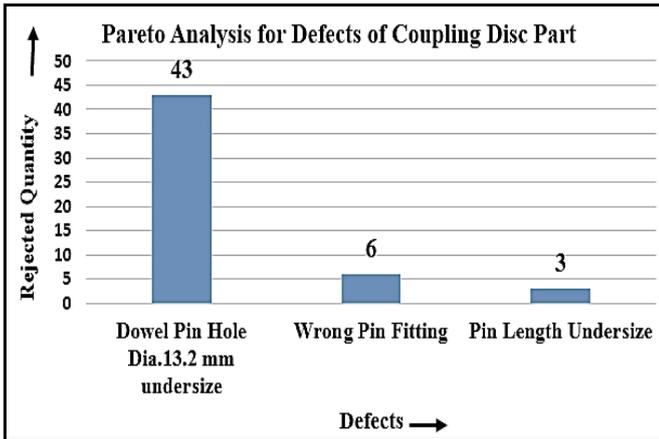
Figure 2: Pareto analysis for defects of coupling disc part

For preliminary analysis, past three months rejection data for coupling disc was collected. To identify the major defect, Pareto analysis has been carried out. The ultimate aim of this step was to focus on the major issue. The table shows the rejection data (defect-wise) of coupling disc.

Type of Defect	No. of Part Rejected
1 Dowel pin hole dia.13.2 undersize	43
2 Wrong pin fitting	6
3 Pin length undersize	3
Total Rejected Parts	52

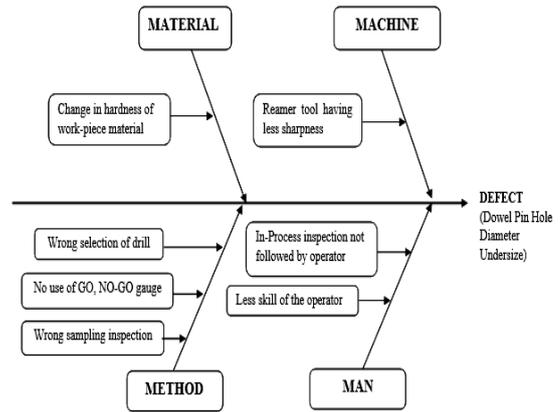
Figure 3: Fish bone diagram for the root causes of defect

To identify the root causes of occurrence of defect and to get deeper understanding of probable causes for the occurrence of problem brainstorming technique and why-why analysis is used. The following causes were identified for the occurrence of problem

- In-process inspection was not followed by operator at defined frequency
- 13mm drill used instead of 13.2mm drill
- No use of GO, NO-GO gauge for checking hole
- Wrong sampling inspection(1 part checked in 1 lot)
- Less skill of the operator (Not maintaining proper drilling speed and wrong selection of tool)
- Rimmer tool having less sharpness
- Change in hardness of work-piece material

- Use proper 13.2mm drill tool instead of 13mm drill tool for performing drilling operation.
- Use proper Go, No-Go gauge for checking hole size during the dispatch.
- Revise sampling inspection method (Instead of one sample, check 5 samples per lot)
- Maintain the tool history card
