ARL/AERO-PROP-R-163

AERO PROPULSION REPORT 163

**APPLICATIONS OF VIBRATION ANALYSIS TO THE
CONDITION MONITORING OF ROLLING
ELEMENT BEARINGS**

JANUARY 1984

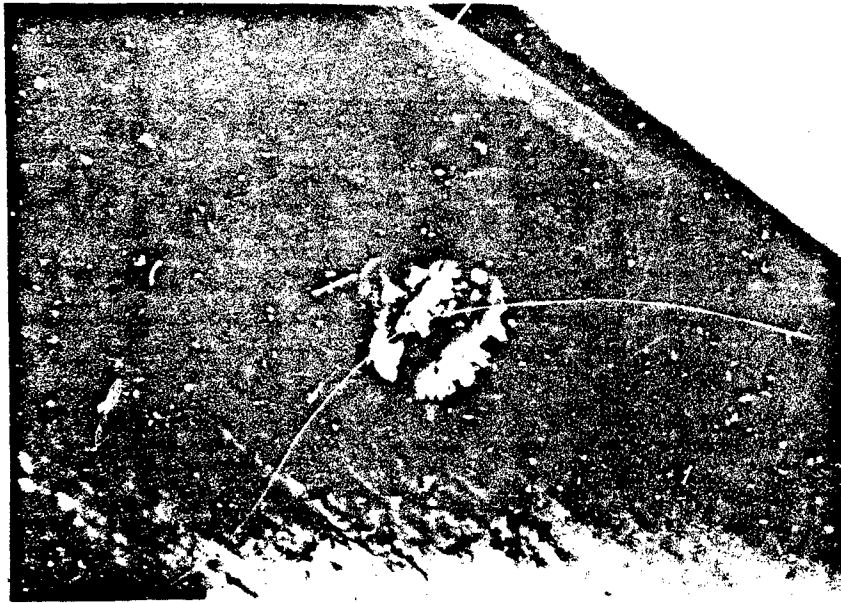
FIG 6.1 DAMAGE TO BEARING AFTER 65 HOURS RUNTIME

(a) Inner race spall size: .75 mm x .5 mm

(b) Outer race spall size: 2.5 x 2.0 mm
