Research Article

Case Study: In Situ Experimental Investigation on Overburden Consolidation Grouting for Columnar Jointed Basalt Dam Foundation

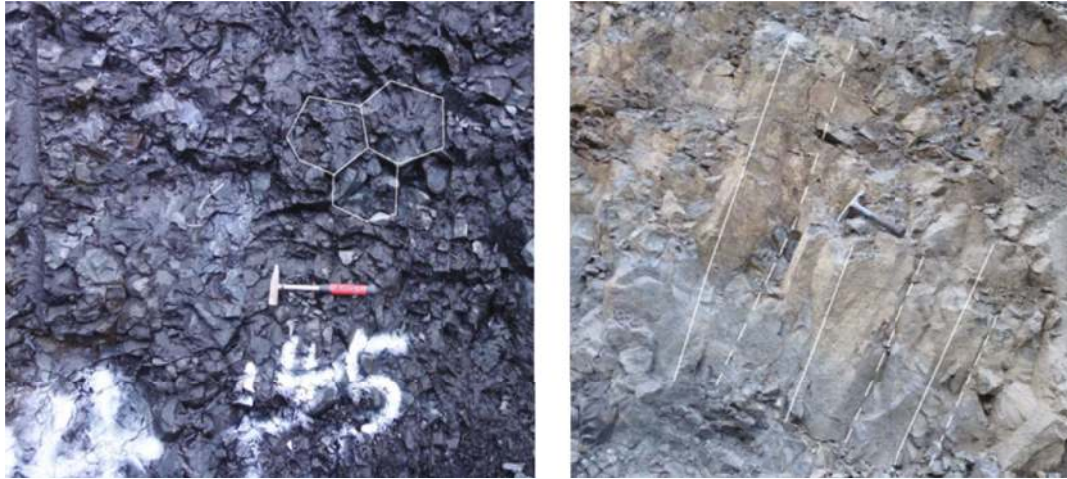
FIGURE 1: Small-scale columnar jointed basalt and weakly weathered columnar jointed basalt [15].

grouting in dam area. Typical type I basalt columnar joints are shown in Figure 1.

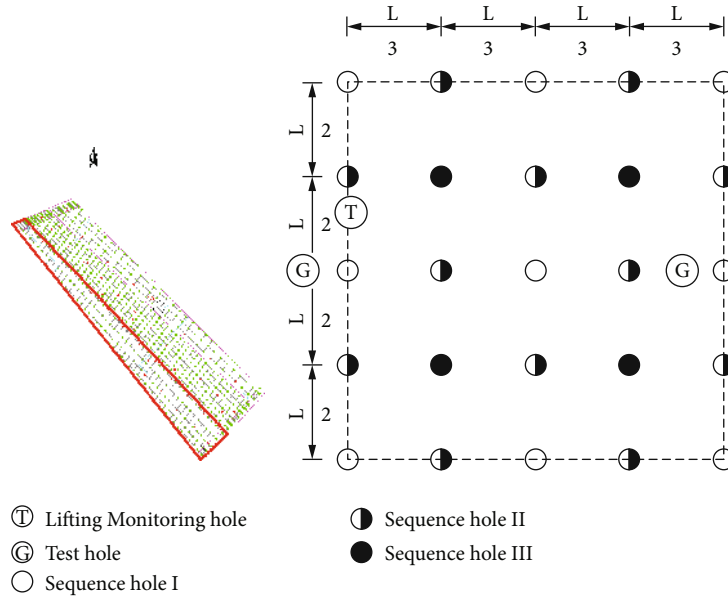
FIGURE 8: Schematic diagram of the grouting hole layout.

4.5. Grouting Hole Arrangement. The spacing of the consolidation grouting holes is 3.0 m × 3.0 m and 2.0 m × 2.0 m. The borehole is perpendicular to the foundation plane and penetrates 25 m below the foundation plane. The layout diagram of the consolidation grouting holes in the overburden is shown in Figure 8. The lifting dynamic monitoring hole, test hole, sequence hole I, sequence hole II, and sequence hole III are included. The test hole aperture is $\Phi 76$ mm; lifting dynamic deformation observation hole aperture, $\Phi 91$ mm. Because consolidation grouting holes need anchor bar piles, the consolidation grouting hole diameter is $\Phi 110$ mm. The tube grouting is injected through a steel pipe, with a head diameter of $\Phi 38$ mm, auxiliary diameter of $\Phi 25$ mm, and tube wall thickness of 1.5 mm. A QZJ-100B-J drilling rig was used to drill the grouting hole. All grouting holes are rinsed with a water pressure of 1 MPa to clear out the cracks. The flushing method utilizes open flushing, which flushes a large amount of water from the bottom of the hole to the area around the hole, and rotation flushing. The condition for the end of drilling flushing is that the residue thickness at the bottom of the hole is not greater than 20 cm after flushing and the flushing ends when the water inside the hole is clean.

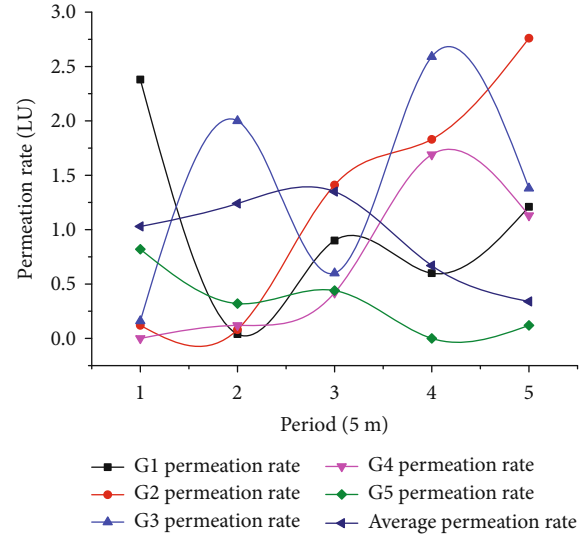
FIGURE 10: Permeability of test hole G1-G5.

By comparing the test data of the test hole before grouting and quality inspection of the Lugeon value after grouting, the variation parameters of the permeability of the dam foundation rock layer are obtained, and the grouting effect is evaluated. Lugeon tests were carried out on 17 test holes before grouting. The water pressure in 89 sections was greater than 4.5 LU in 69 sections, and the permeation rate over 3 LU accounted for 68.5% of all the test holes. A Lugeon test and inspection were carried out 7 d after the end of grouting. During this process, 10 test holes, with a hole depth of 25 m (excluding the 5 m protective layer) and 5 m section, were randomly drilled to conduct the Lugeon test, and a total of 50 sections of pressurized water were considered. After grouting, the Lugeon test results were collected and are shown in Figures 10 and 11. All 50 sections have Lugeon values less than 3 LU, the average permeability of the G1-G5 test hole is less than 1.5 LU, and the average permeability of the G5-G6 test hole is less than 1.2 LU. After grouting, the permeation rate of the pressurized water test section at all the inspection holes should not be greater than 3 LU. The permeability is obviously reduced, and the antiseepage effect is greatly improved. Effect analysis shows that the weight of the 5 m thick overburden can stop the fracturing and lifting of the base surface caused by high-pressure fluid. The grouting pressure is very important for the formation stability. A low-pressure grout cannot fill rock fractures effectively, and only a high-pressure grout can fill small cracks. The weight of a 5 m thick slurry seal overburden can provide an effective force to meet the required grouting pressure to limit formation disturbance. Cracks are effectively filled under high pressure, which leads to a decrease in permeability and a significant improvement in the antiseepage and consolidation effects.

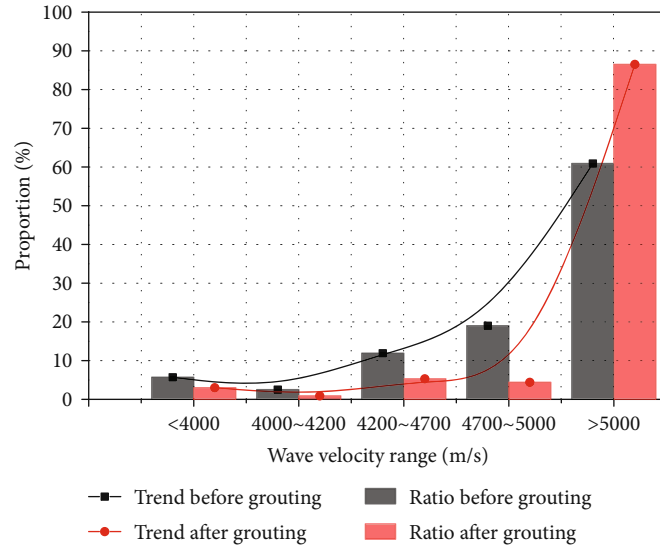
FIGURE 12: Velocity distribution before and after grouting for the #25 dam section.

≥ 4700 m/s accounted for 94.8% and that <4200 m/s accounted for 1.4%. According to the acoustic inspection standard of the dam foundation rock mass stipulated in the design document, more than 90% of the columnar basalt should have a velocity greater than 4500 m/s, and less than 5% should have a velocity less than 4200 m/s after grouting to meet the inspection standard of a rock mass. Figure 12 shows that for an initial velocity greater than 5000 m/s, the wave velocity ratio of grouting increased by 25.6%; for an initial velocity less than 5000 m/s, the wave velocity of the filling ratio dropped by approximately 50%; and for an initial velocity less than 5000 m/s, the wave velocity decreased after grouting. Due to the filling of the fractures, fissures, and fault zones, the wave velocity increased, showing that the effect of grouting is obvious.

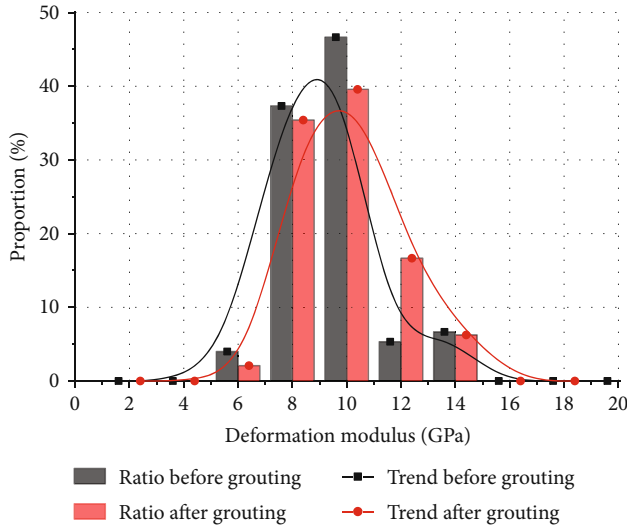
FIGURE 13: Distribution of deformation modulus after grouting.

deformation modulus after grouting is 8.71 GPa; the average deformation modulus after grouting is 1.7% higher. As shown in Figure 13, the ratio of the deformation modulus increased by 11.4% to 12 GPa after grouting, and the ratios of 8 and 10 GPa decreased by 1.9% and 7.1% compared to that of 6 GPa, respectively. The improvement in the rock deformation modulus of the dam foundation indicates that the resistance stress value of the rock mass increases and the strain decreases, which indirectly indicates that the physical properties of the rock are improved and that the mechanical properties are enhanced. However, the deformation modulus of the stratum after grouting increased to 12 GPa. The analysis shows that the rock integrity is relatively good because the deformation modulus data before grouting concentrate in the range of 8–10 GPa, so the increase in the modulus after grouting is relatively small.

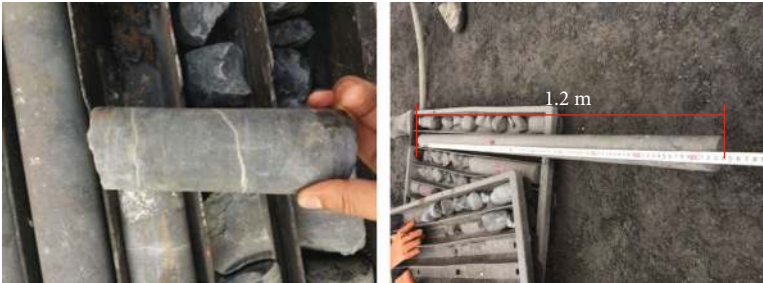
FIGURE 15: Test hole core sampling.

shown in Figure 15. Figure 15 shows that the rock cracks are effectively filled by the consolidated slurry and the grouting materials are tightly bonded to the surrounding rocks, with an obvious phenomenon of complete consolidation. There is no collapse observed during drilling, and intact core samples are collected, up to 1.2 m long, as shown in Figure 15.

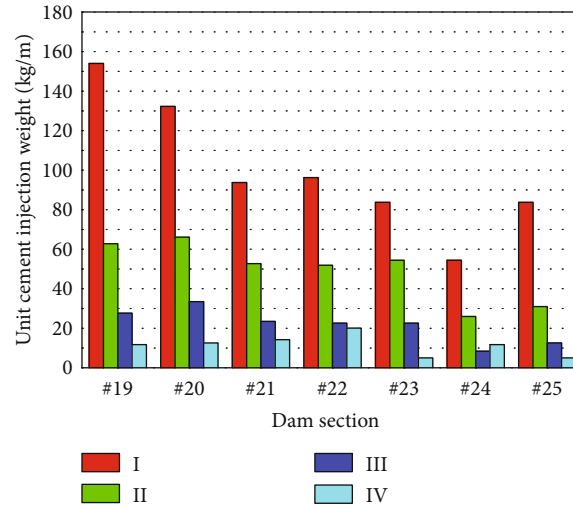
FIGURE 19: #19~#25 dam section consolidation grouting of hole: unit cement injection weight.

6.2. Cement Injection Quantity and Water Permeability. The right bank dam foundation elevation, 590 m below the overburden consolidation grouting, is used to determine the injection quantity. Sequence hole I grouting is 25915 m; sequence hole II grouting is 50690 m; sequence hole III grouting is 25045 m; sequence hole IV (encryption) filling grouting hole is 49690 m. The average permeability of grouting holes in each sequence of the dam foundation and the unit cement injection amount are shown in Figures 19 and 20.
