Characterization of Multicrystalline Silicon Modules with System Bias Voltage Applied in Damp Heat

*Presented at the 25th European Photovoltaic Solar Energy
Conference and Exhibition
Valencia, Spain
September 6 – 10, 2010*

Conference Paper
NREL/CP-5200-49344
July 2011

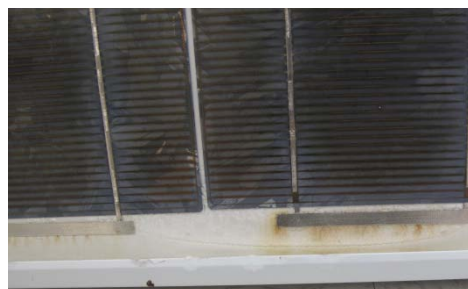
Fig. 2. Region of a module (model 1) after 2000 h in damp heat with + 600 V applied to the active layer with respect to the grounded module frame. There is evidence of grid-finger corrosion and metal-ion transport from the bussing, especially in regions of de-adhesion in the model package seen on the bottom right of the image.

In modules with the cells in the DH(+) configuration, corrosion of the silver grid fingers was apparent (Fig. 2). In aqueous solutions with bias applied to the cell, the reaction $\text{Ag} \rightarrow \text{Ag}^+ + \text{e}^-$ exists, whereby the Ag dissolution is proportional to the voltage applied [13]. The oxidation of the silver is a factor leading to increased series resistance of the module [11]. Leakage current has been reported to be greater with positive bias applied to the cell because of the comparative ease of ionization of the Ag anode, which provides the source of ionic migration leading to a leakage current through the wet encapsulant medium [2]. We however observed higher current flow with positive bias to the active layer in model 1 only (Fig. 1). In most cases, the ionic motion was apparently limited in a place weakly influenced by the direction of the bias.

Two replicas of module model 1 were subjected to various temperatures (Fig. 3) and relative humidities (Fig. 4) in the positive bias configuration. At a constant RH of 30%, the activation energy of these modules for current flow was 0.86 eV, which corresponds closely to the activation energy of current flow through glass (0.9 eV) [3]. This suggests current flow through the module face as the rate-limiting path for leakage, even at modest RH. Resistivity of the polymeric materials used in PV modules is orders of magnitude higher than soda-lime glass [15]. If the interfaces were to degrade in humidity or because of ultraviolet light, the current flow can revert through the interfaces. This was observed in model 1 placed at 85°C/85% RH with +600 V applied to the active layer with respect to the grounded module frame for 2000 h (Fig. 2). Current flow in this model was significantly elevated, as can be seen in Fig. 1.

current saturates at higher humidity levels, but in parallel to the work of BP Solar, which found that the interfacial adhesion rate drops precipitously at 85% RH compared to 60% RH [5]. Considering that we observe interfacial ion migration in this model design in 85°C/85% RH (Fig. 2), there is remarkable consistency between the high leakage current, reduced interface strength, and visible ionic motion in model 1. In the framework of the results of del Cueto [3], we may consider that with weakened interfaces for reasons such as higher humidities than seen in outdoor tests, the leakage current can revert from through-glass to the encapsulant/glass interface.

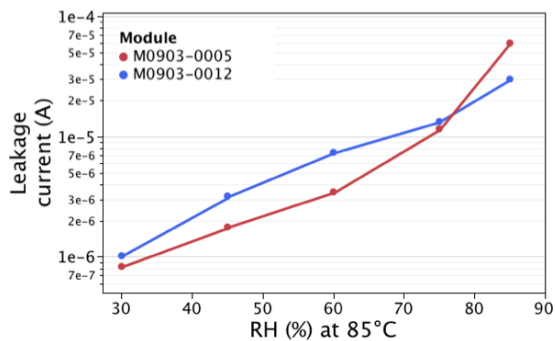
Fig. 4. Median leakage current as a function of RH at 85°C for two replicas of model 1. In the range of 60%–85% relative humidity, leakage current increases significantly. The voltage applied to the active layer was +600 V.

This module design was also placed at 85°C with humidity stepped up to 85%. In the 65% to 70% range, there appears to be additional current flow mechanisms leading to a much higher current leakage. This is in contrast to the work of JPL, which found that leakage

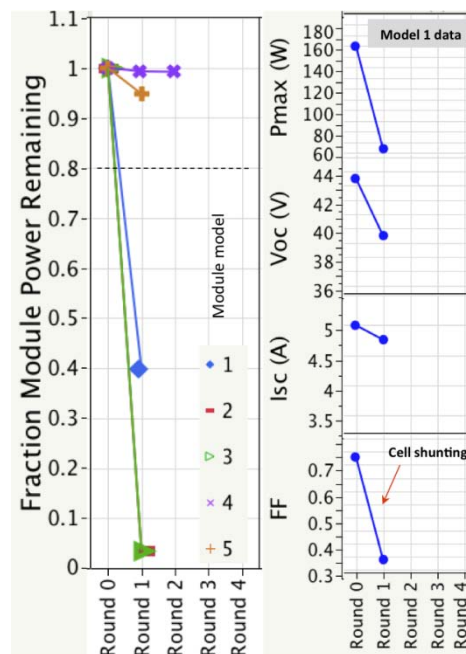
Fig. 6. Performance of five commercial modules in 85°C/85% RH, -600 V applied to the active layer for 1000 h rounds (left), and the detailed module test results for model 1 (right).

Fig. 7. Complete removal of the silicon nitride cell coating seen after 1000 h in 85°C/ 85% RH with -600 V applied to the active layer. Silicon nitride remains, however, in the center of the cell where water concentration is expected to be lower.

environment results in electrolytically assisted stripping of silicon nitride from the cell in a faster, more localized way than in the DH (+) configuration (Fig. 7).

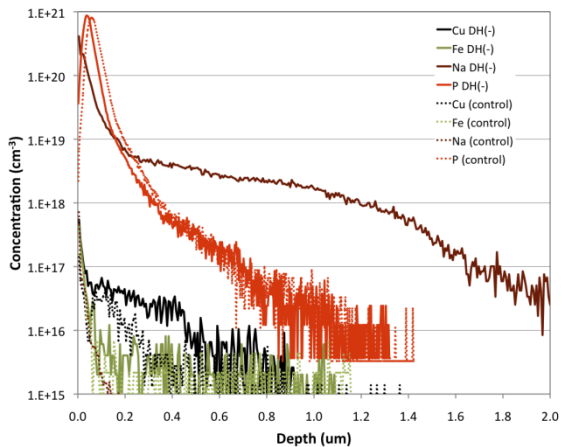
Fig. 8. SIMS analysis of a cell in a module that has undergone 1000 h of 85°C/85% RH with -600 V applied to the active layer. Significant Na accumulation and up to an order of magnitude higher Cu concentration is seen near the surface. Fe concentration was not significantly changed.

Although migration of Na ions under bias has been studied in thin-film modules, the effects have not been well established in c-Si modules. SIMS analysis was carried out, comparing the silicon surface of a module exposed for 1000 h in 85°C/85% RH to a control that had never been encapsulated. The stressed sample was removed from an area of a module that exhibited delamination for ease of removal from the encapsulant. Although sample preparation was enabled because of the delamination, shunting in these regions tended to be lower according to thermal imaging; therefore, concentration of species causing shunting may be higher elsewhere. Also, one should note that the textured multicrystalline surface leads to inaccuracies in the depth resolution. With these provisos, it can be seen that a very high Na concentration exists in the vicinity of the surface of the stressed sample (Fig. 8). Cu, a species known to shunt junctions very effectively [18], can be seen in concentrations that are as much as one order of magnitude higher in the stressed sample compared to the control. The concentration of Fe was not found to be elevated in the stressed sample compared to the control, evidence that elevated Fe concentration is not a cause of the observed shunting degradation in the DH (-) configuration.

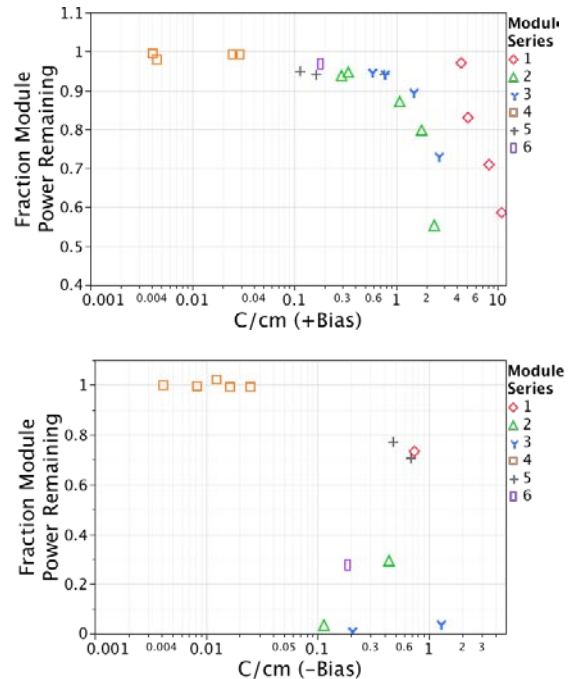
Fig. 9. Fraction of module power remaining vs. accumulated charge transfer for commercially available crystalline-Si modules with +600 V bias to active layer (top) and -600 V bias to active layer (bottom).

JPL attempted to make correlations between coulombs leaked per unit length of edge of the module frame (ground electrode) and the power degradation [19]. They suggested that precipitous (>50%) degradation occurred between 1 and 10 coulombs per centimeter (C/cm) of charge transfer. These results were obtained for stress conditions in the range of 70°–80°C, RH between 0% and 100%, and voltage bias between 30 and 500 V; however, the polarity of the bias was not specified. We examined this relationship for the six commercial module designs. The results shown in Fig. 9 (top) for +600 V bias applied to the active layer trend consistently with JPL results. Further, there is a noticeable and reasonably reproducible degradation of about 5% with charge transfer in the 0.1–1.0 C/cm range for the various models tested. After examining the degradation with negative bias to the active layer in Fig. 9 (bottom), one can see that the power is significantly degraded with less than 1.0 C/cm charge transfer—always more than 20% and usually more than 70% degraded. These results, however, offer little resolution in the 0.01 to 0.1 C/cm range. Bracketing the degradation over a decade, the failure occurs somewhere in the range of 0.02 to 0.2 C/cm.

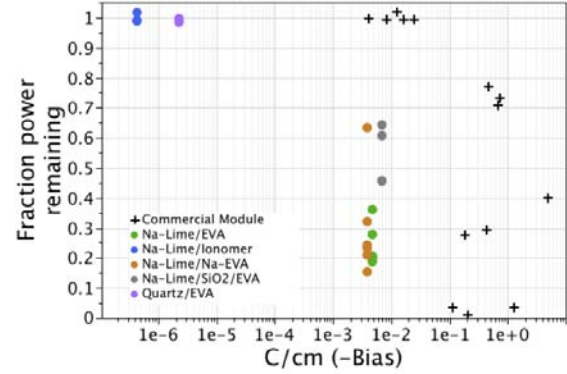
Fig. 11. Loss in power (as estimated by Suns-Voc technique) for five mini module constructions, superimposed over those results of commercial modules.

The mini module data are applied in Fig. 11 to further understand the relationship between power degradation and coulombs per centimeter of module edge when there is a negative bias on the active layer. It is confirmed that less than 1x10⁻⁵ C/cm has no measurable effect on performance. Marked degradation occurs in the 0.001–0.01 C/cm range. We could not, however, resolve the effect of the SiO₂ film on glass with regard to reducing current flow, despite its ability to slow the voltage-bias degradation.

the cell more efficiently, the mini module degradation rate is much faster than that found in the damp-heat chamber-loaded commercial modules on a C/cm basis (Fig. 11). We therefore chose to exclude the mini module data in our estimate of 0.02–0.2 C/cm as the threshold for degradation of real modules in the DH(-) configuration that we extracted from the commercial full-size module data in Fig. 9 (bottom). It must, however, be considered that some differences in this threshold may be expected depending on current paths and nature of the materials used.
