Combination of terrestrial laser scanning and UAV photogrammetry for 3D modelling and degradation assessment of heritage building based on a lighting analysis: case study—St. Adalbert Church in Gdansk, Poland

Abstract

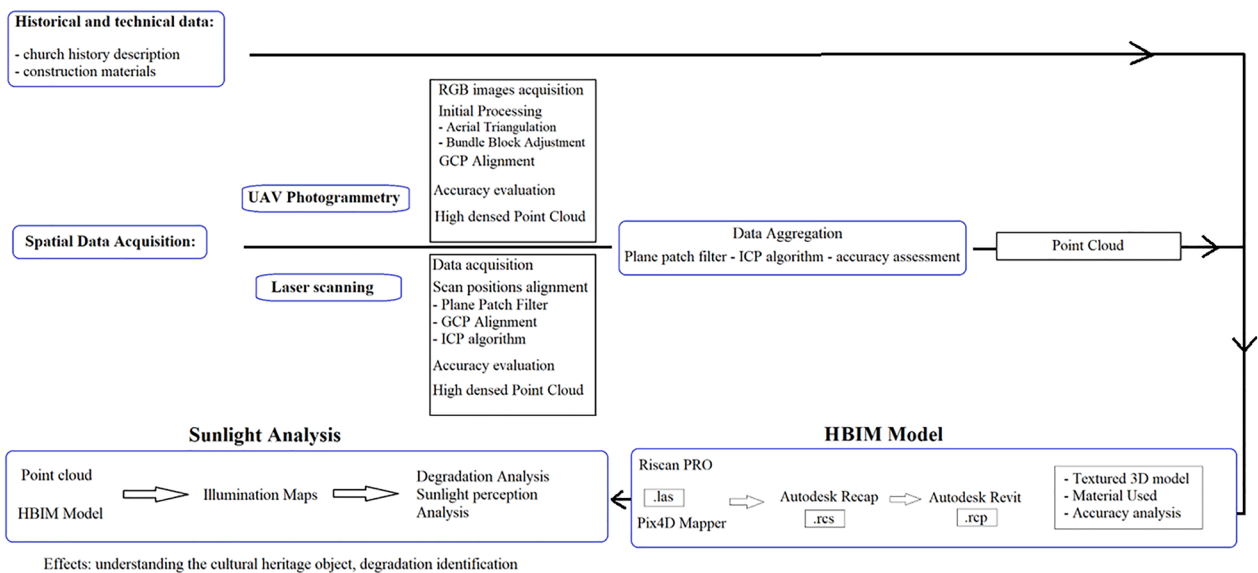
Fig. 2 The research workflow

- (1) Acquiring all details of the historical information of the church.
- (2) Acquiring spectral and geometric information from a laser scanner and UAV photogrammetry.
- (3) Building an individual HBIM of the church based on the obtained data.
- (4) Proposing a sunlight analysis in terms of possible degradation and light perception by humans.

The research method presented in this study is based on multitechnology measurements of a temple (St. Adalbert Church in Gdansk, Poland). An UAV and a TLS were used for data acquisition. This approach gave us the opportunity to fully evaluate the measurement results. Moreover, using orthoimages allowed us to expand sunlight analyses to the immediate vicinity of the church. Figure 2 shows the workflow of this research. The workflow consists of the following:

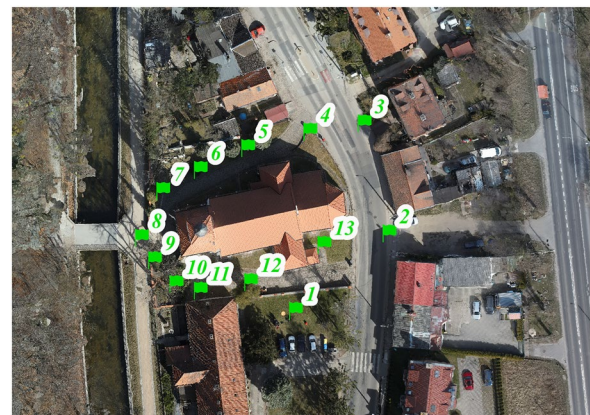
Fig. 4 Scan positions location

In order to present the possibilities of using the laser scanner more broadly, we have presented the location of the scanner positions during the measurements in Fig. 4. According to the Fig. 4, scan positions around the church are numbered from 1 to 13. Additional scan positions from 14 to 20 were located inside the church. Denser distribution of scanner positions around the tower was

because the scanner was located in close proximity to the church. This was for two reasons: first, to combine the scans recorded outside and inside the church, we needed to have as many common elements as possible to minimize an alignment error. Second, we used the beam reflection intensity for our analyses. Due to the fact that its value also depends on the angle, the type of material, its colour and humidity, we didn't want the angle of a laser beam to be perpendicular to the church (which has the effect of too high intensity value saturation) or too large (where the laser beam won't be able to return to the scanner).

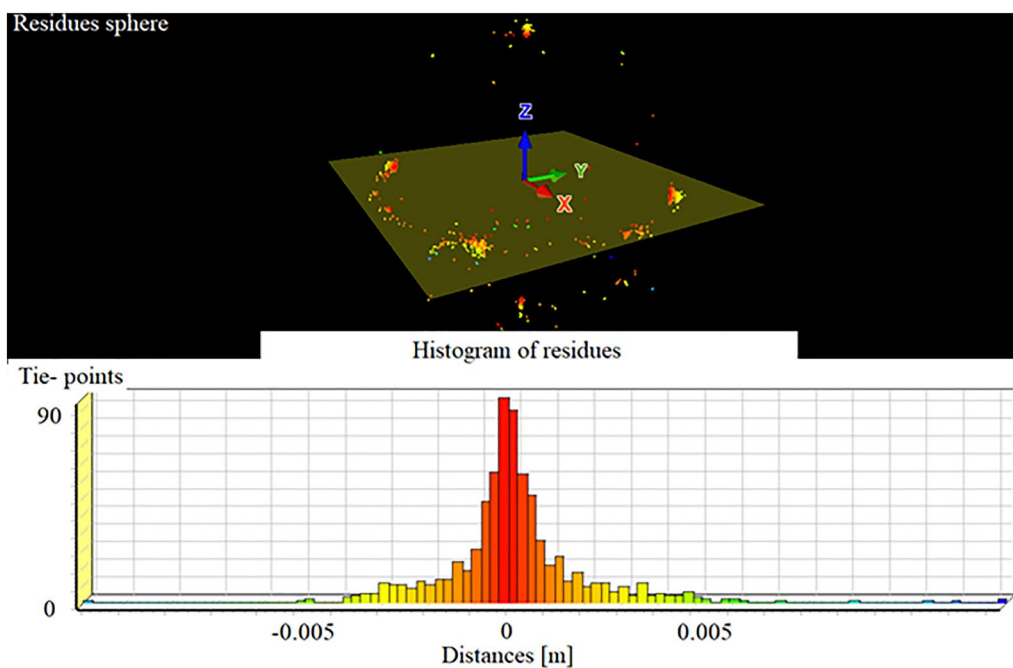
Fig. 5 TLS Alignment results as a histogram of residues between tie-points

individual scanner positions to each other) as accurately as possible. Moreover, as in the case of UAV oblique photogrammetry, manual and automatic filtered tie-points were used to align the data to the same coordinate system (ETRS89/Poland CS2000 zone 6 (EPSG: 2177) and the EGM2008Geoid model). In this way, we obtained two photogrammetric models in relatively close proximity. The registration process was performed in RiSCAN PRO[®] software. This process was based on corresponding tie-points (created automatically or indicated manually). To minimize alignment errors, RiSCAN PRO[®] has a plugin function called "Multi-Station Adjustment" (MSA). The main functionality of MSA is to improve the registration of scan positions. For that purpose, the external position of each scan position was modified to calculate the best overall fit for them. The alignment results are shown in Fig. 5 as a histogram of the residues of the tie-points and an error sphere.

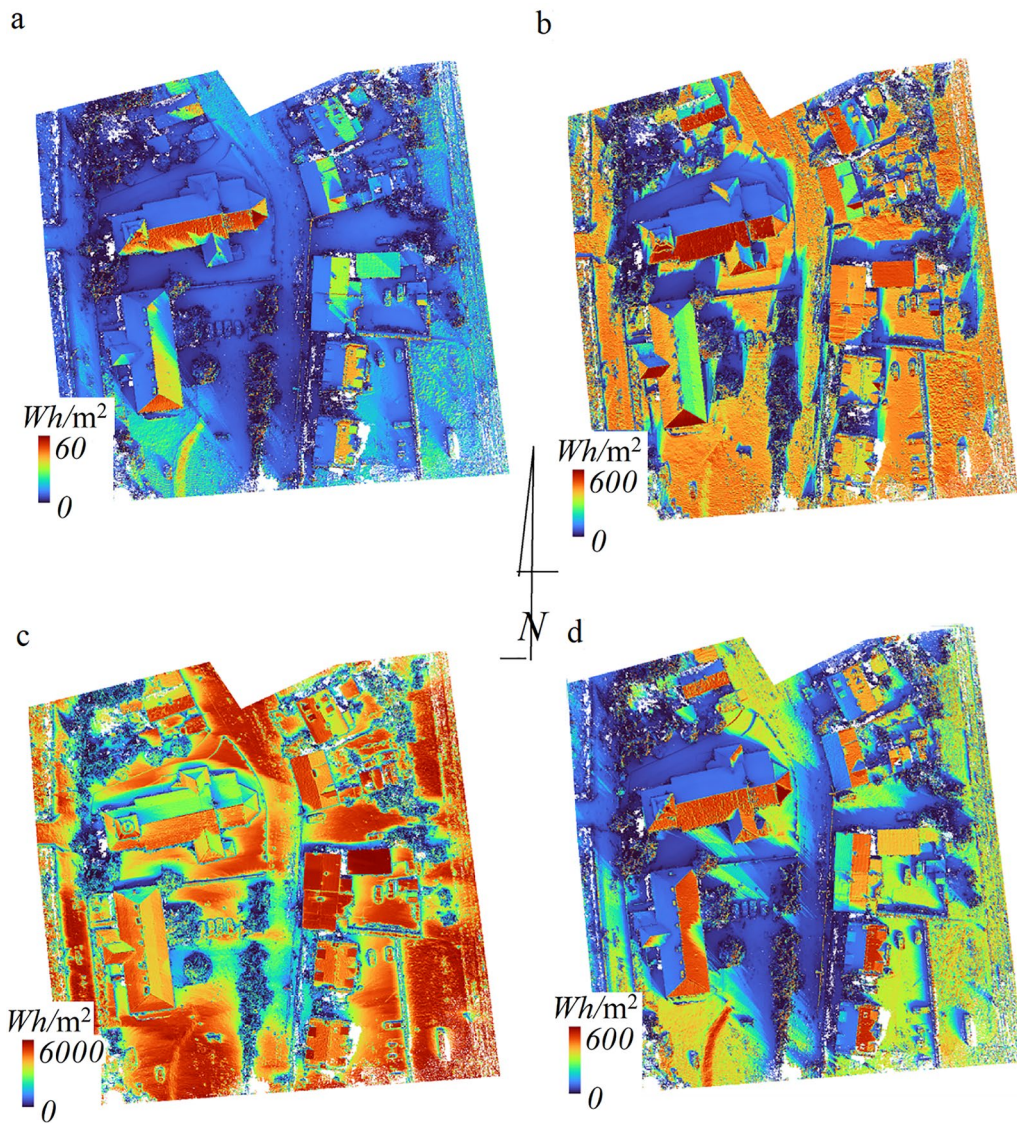
Fig. 8 Insolation results in ArcMap® software **a** 21st December; **b** 20th March **c** 21st June **d** 23rd September

In the case of lighting analysis, the object was illuminated during the spring and fall equinoxes, then during the summer solstice and the winter solstice. The results are shown in Fig. 8.

As seen in Fig. 8, the northern façade remains without access to sunlight in all four cases. During the summer, when the sun rises above the horizon, it reaches much closer to the wall but does not fall directly onto it. On this day, it can be concluded that the northern façade receives the greatest amount of light dispersed in the atmosphere. The opposite of the abovementioned situation is the winter solstice. During this period, sunlight does not reach the northern lobe of the roof. Furthermore, the southern facade is poorly illuminated during this period, as the ray angle is small, and thus, the shadow generated by the surrounding objects is large. The images that show the insolation during the equinox are identical. As seen in Fig. 7,

the illumination of the church is strongly influenced not only by its orientation but also by the heights and positions of neighbouring objects such as buildings and trees. Figure 8 shows that the lighting is affected by objects to the east and south of the object under study. As representative examples, we performed a spectral and geometrical analysis of the places with the smallest coefficients in each of the periods. Thus, we emphasize comparative analysis and propose an idea for how to analyse possible degradations of cultural objects with little documentation but rich histories.
