# Common failures of ship propulsion shafts

Goran Vizentin, Goran Vukelić, Mateo Srok

## ABSTRACT

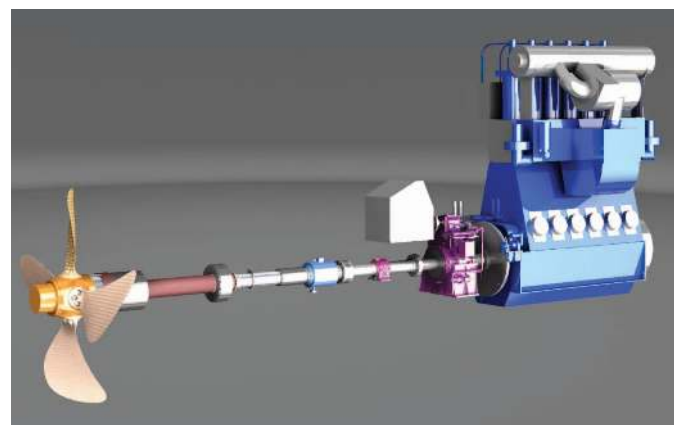
**Figure 1** Typical Ship Propulsion System Elements Rendering

The propulsion system has a pivotal role on board ships. A typical marine propulsion system is comprised of the following main parts: main engine, driving device, marine shaft and propeller as shown in Figure 1. As far as fatigue is concerned, the main engine is a complex unit for itself. It represents a vibrations source (impulse operation) for the entire ship and the propulsion system as well. Here, the propulsion shaft will be discussed more in detail.

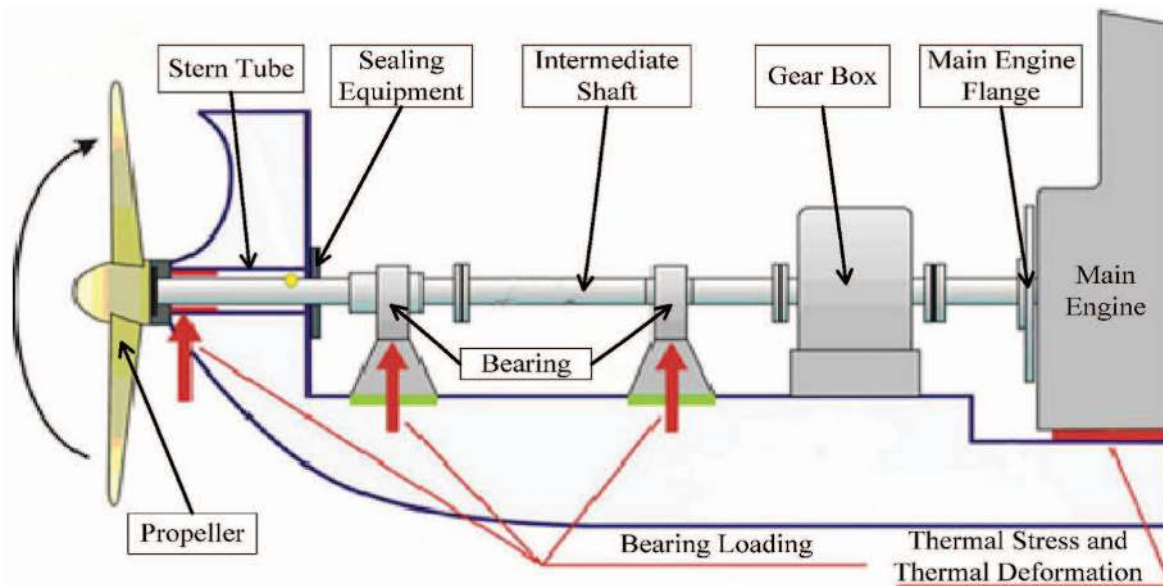
Figure 2 Propulsion System Elements and Loads Schematics [1]

The propulsion shaft is subjected to various types of loading during operation, namely torque moment, bending moment, axial thrust force and transversal loads (gravitational and centrifugal forces). The operating environment of the propulsion system is characterized by significant changes in temperatures and humidity, aggressive atmosphere (salt and/or oil mist), long lasting interrupted operating time (several months) and variations in load amplitudes. The risk of failures of the propulsion system additionally increases with the severity of sea and weather conditions as they have a direct effect on the dynamics of the load variation. All of the above has a direct influence on fatigue behaviour and life time of the propulsion shaft.

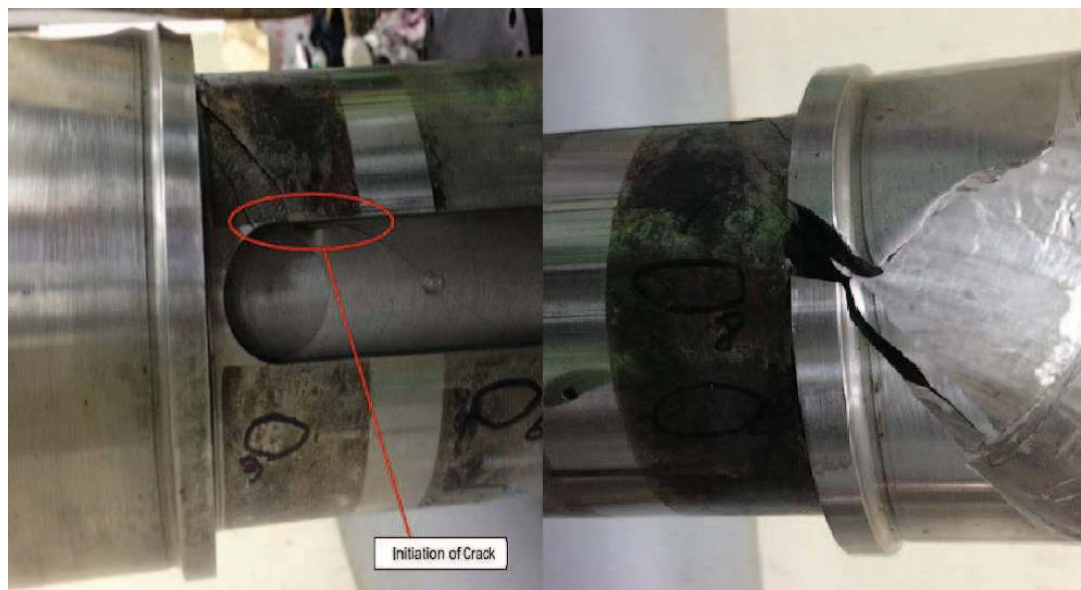
Figure 3 The Characteristic Torsional Failure Crack Shape [8]

The geometry of the ends of keyways represents a stress concentration factor in the cases of torque transmission through shaft keys for dynamic vibrational loads. Faulty machining of shaft key elements (key groove, keyway and key) geometry, inadequate run out radii or material imperfection can be root causes of torsional fatigue failure in shaft keys. The characteristic torsional failure indicator is the crack pattern that initiates at the end of the keyway and propagates in a  $45^\circ$  rotational direction in a helical shape, shown in Figure 3.

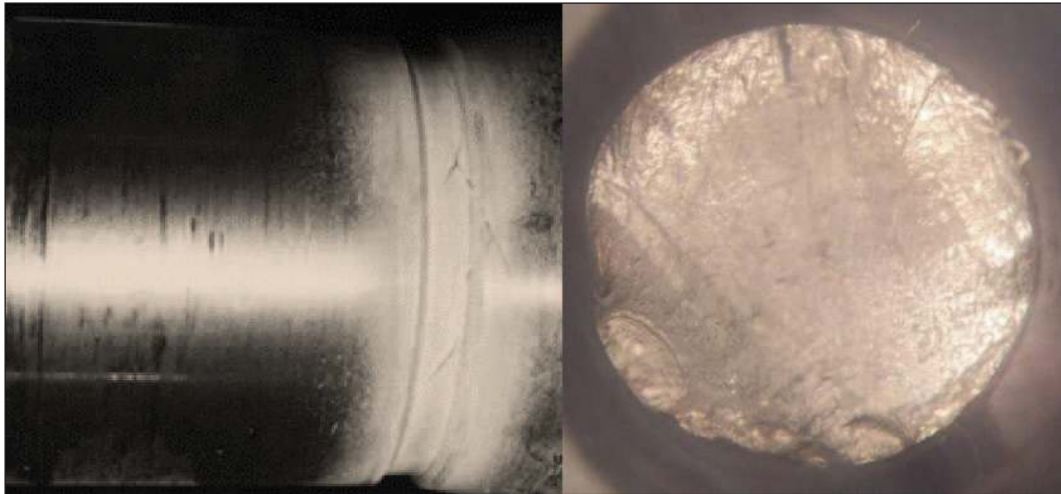
Figure 4 Shaft Fillet Failure Crack Shape [10]

studies of fractures initiated at this elements [10], [11] show fatigue due to cyclic torsional-bending load, with a crack that originates in multiple points on fillet shoulders on the shaft, gradually reducing the load bearing area of the shaft as it grows, and finally resulting in a sudden failure during overload as shown in Figure 4. The analysis for this case study has been comprised of chemical composition analysis, micro-structural characterization, fractography, hardness measurements, and finite element simulation.

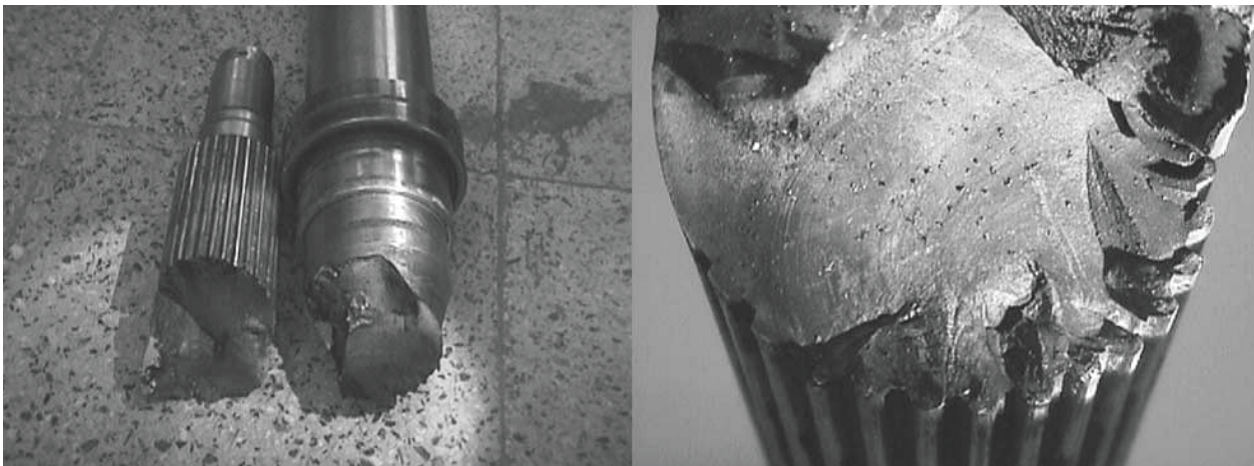
Figure 5 The Characteristic Torsion Failure Crack Propagation Shape (45° angle) [10]

The alternatives to shaft key joints are spline joints which are press fitted to other shaft elements. The analysis of spline joint failure [12] has shown that the press fitting of the joining elements can cause surface deformation which in turn causes surface cracks formation. Cracks usually start on the spline teeth at the shaft junction zone, Figure 5. Torsion fatigue caused by fluctu-

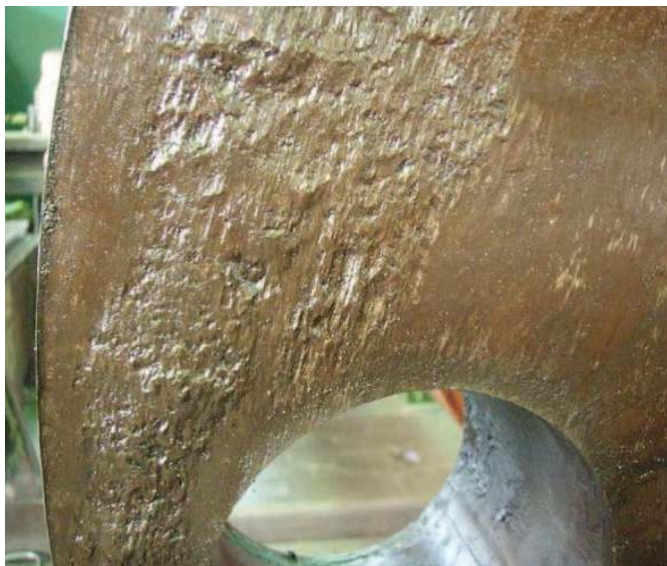
Figure 6 Fatigue Indicative Fretting on Surfaces [13]

Bolted connections are used in collar coupling of shaft elements and in propeller blades connections. Changes of the shaft rotation direction result in torque moment overloading and direction change as well as thrust force direction change. The resulting effect is a dynamic load on collar coupling bolts in a longer operating time [13] which can result in fatigue failure. The fretting that occurs on adjacent connecting surfaces in these cases creates micro notches that develop into fatigue cracks with the direction

of failure growth in planes angled from  $35^\circ$  to  $60^\circ$  which is not characteristic of pure torsion fatigue failures. The analysis has shown that the coupling bolts are subjected to an increasing bending moment which contributes to fatigue crack growth. The experimental research and numerical calculation done in this case study proved the hypothesis of variable bending stress in the coupling as the failure cause.

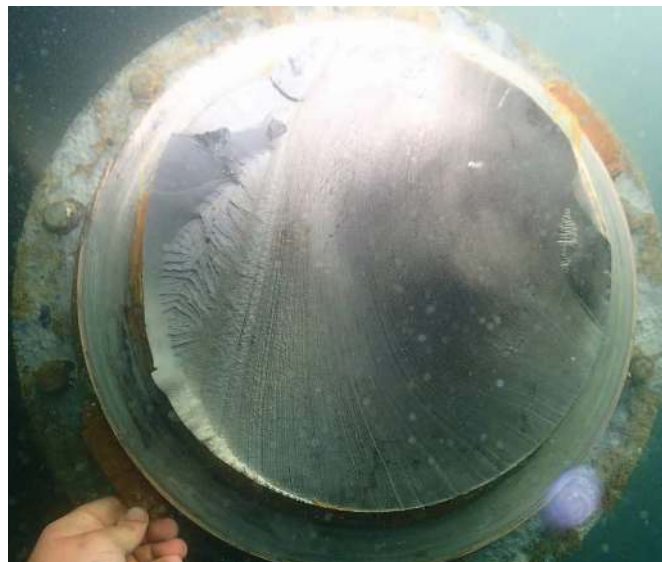
Figure 7 Uniaxial Fatigue Failure Crack Shape [15]

Abnormal performance of the propeller by way of one non-performing malformed blade can generate a uniaxial force which fluctuates once per rotation in a consistent transverse direction across the shaft. The fluctuating force generates a couple which can cause fatigue failure of the propeller hub [15]. Uniaxial type of failure is characterized by a fatigue fracture with a single origination point that progresses across the shaft from the side where the force is being applied and results in the final overload failure occurring on the opposite side from the fluctuating force.
