COMPARISON OF TOUGHENED COMPOSITE LAMINATES USING
NASA STANDARD DAMAGE TOLERANCE TESTS

ACEE COMPOSITE STRUCTURES TECHNOLOGY CONFERENCE

August 13-15, 1984

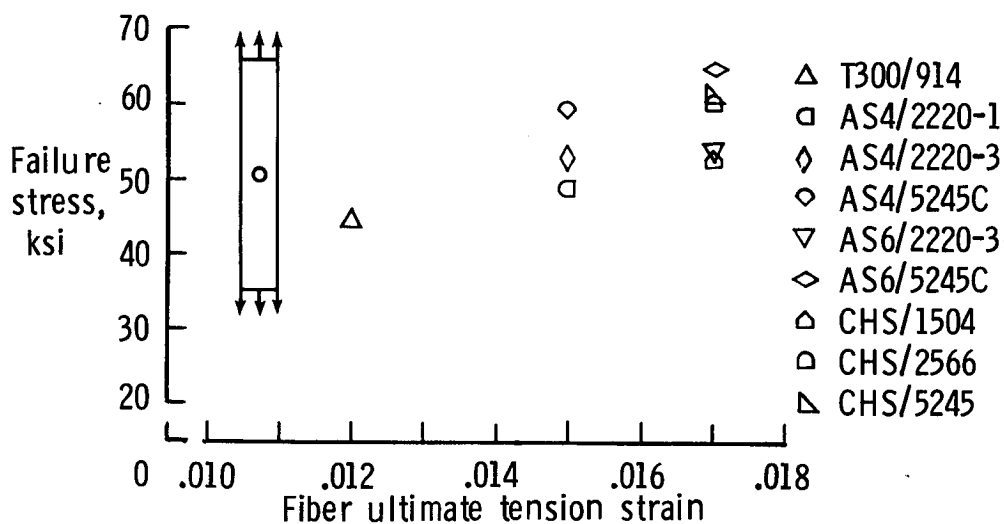
Figure 10

Tension failure stresses of specimens having a 0.25-inch diameter hole are shown in figure 10. The tests were performed according to standard test method ST-3 described in reference 1. Laminate failure stress is shown as a function of the representative ultimate tensile strain of the graphite fiber used in each material. Although failure stress generally increases with higher fiber ultimate strain, there is as much as twenty percent variation in the failure stresses of different materials systems containing the same fiber, depending on which resin system is used. Material containing the 5245C resin matrix system exhibited the highest strength with both intermediate and high strain fibers.

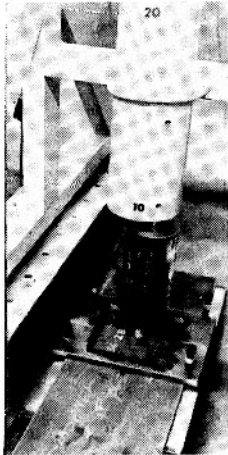
Figure 13

The technique used to impose impact damage on specimens tested by NASA involves propelling a small mass (0.5-in. diameter aluminum sphere) at approximately 443 ft/sec to achieve the 20 ft-lb impact condition. This damage test was conducted in the same fixture used to conduct the residual strength test. In both test methods, the specimen was removed from the fixture following the impact test to measure the damage size using ultrasonic equipment. The two test methods imposed identical impact energies; however, results presented in the following figures will show that the two tests are not necessarily equivalent. Photographs of the two test set-ups are presented in figure 13.

- 1/2-inch hemispherical steel tip
- 10 pound
- 11 ft/sec

- 1/2-inch aluminum ball
- 0.0065-pound
- 443 ft/sec

The ST-1 test method for damaging a laminate is specified in reference 1 to be conducted in the following manner. The impactor shall weigh 10 pounds, be less than 10 in. in length, and have a 0.5-in. diameter hemispherical steel tip which strikes the specimen normal to its plane. The 7-in. by 12.5-in. specimen is mounted in an impact test fixture in which a picture frame with a 5-in. by 5-in. window is clamped over the specimen. The 10 pound weight is dropped from a height of 2 feet to provide the 20 ft-lb test condition. The specimen is then trimmed to a 5-in. by 10-in. size and placed in a compression fixture which imposes approximately fixed end boundary conditions on the loaded ends and simple support conditions on the lateral edges. With minor variations, this method is the test technique used by industry to damage specimens.

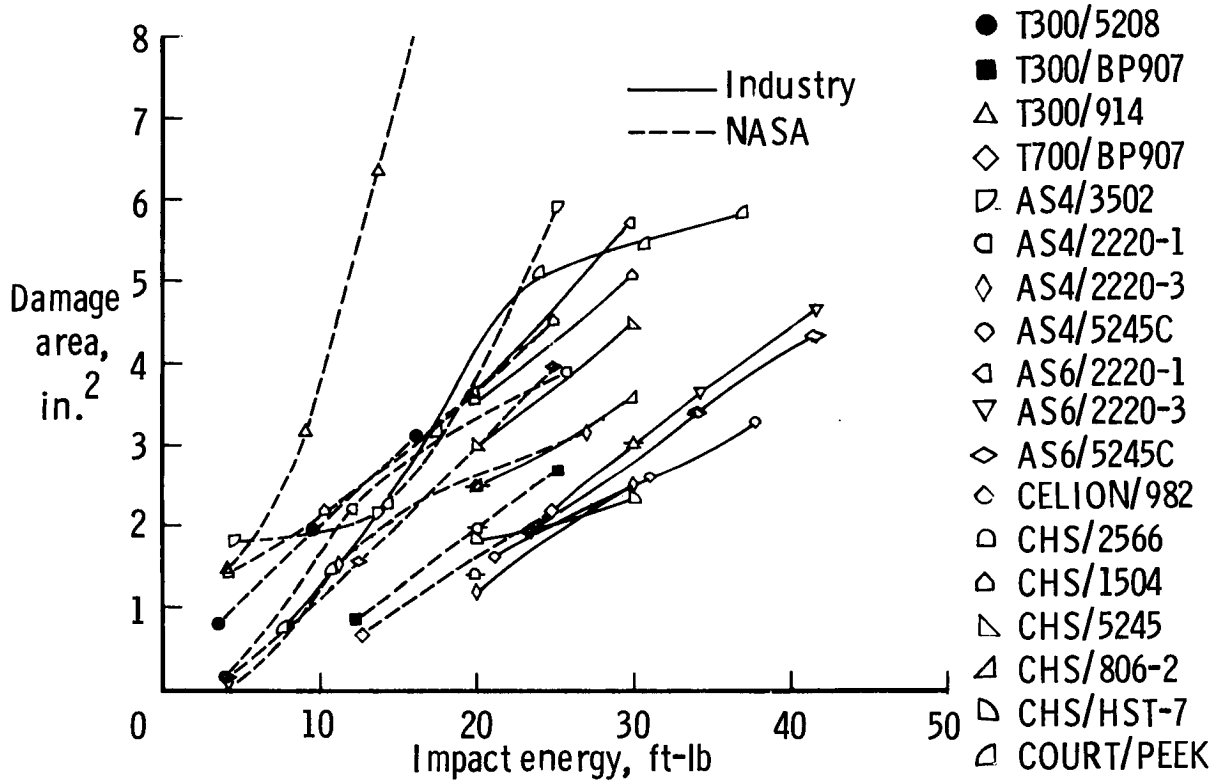
Figure 14

In addition to the 20 ft-lb standard test impact condition, data were obtained for a range of impact energies. The damage size plotted as a function of impact energy is presented in figure 14 for the standard, approximately 0.25-in thick, quasi-isotropic laminate. The damage area was determined using ultrasonic C-scan equipment. The data indicate the damage size depends on the properties of both the resin and fiber with some materials showing considerably less damage for a specific impact energy than others. Industry data are indicated by solid lines and NASA data by dashed lines. For materials systems tested by both industry and NASA, results show considerably greater damage for the NASA low-mass/high-velocity impact test than for the industry dropped-weight test method. For the materials systems studied using the NASA test technique, none of the toughened epoxy systems has resistance to impact damage as high as the laminate with the baseline BP907 resin. The data for the Courtaulds/PEEK material taken from reference 5 is for a 0.2-inch thick 0-degree dominated orthotropic laminate. The Courtaulds/PEEK material shows large damage for energies up to 20 ft-lb; however, the slope of the curve is reduced for higher energies.

C-SCAN MEASURED DAMAGE AREA FOLLOWING IMPACT

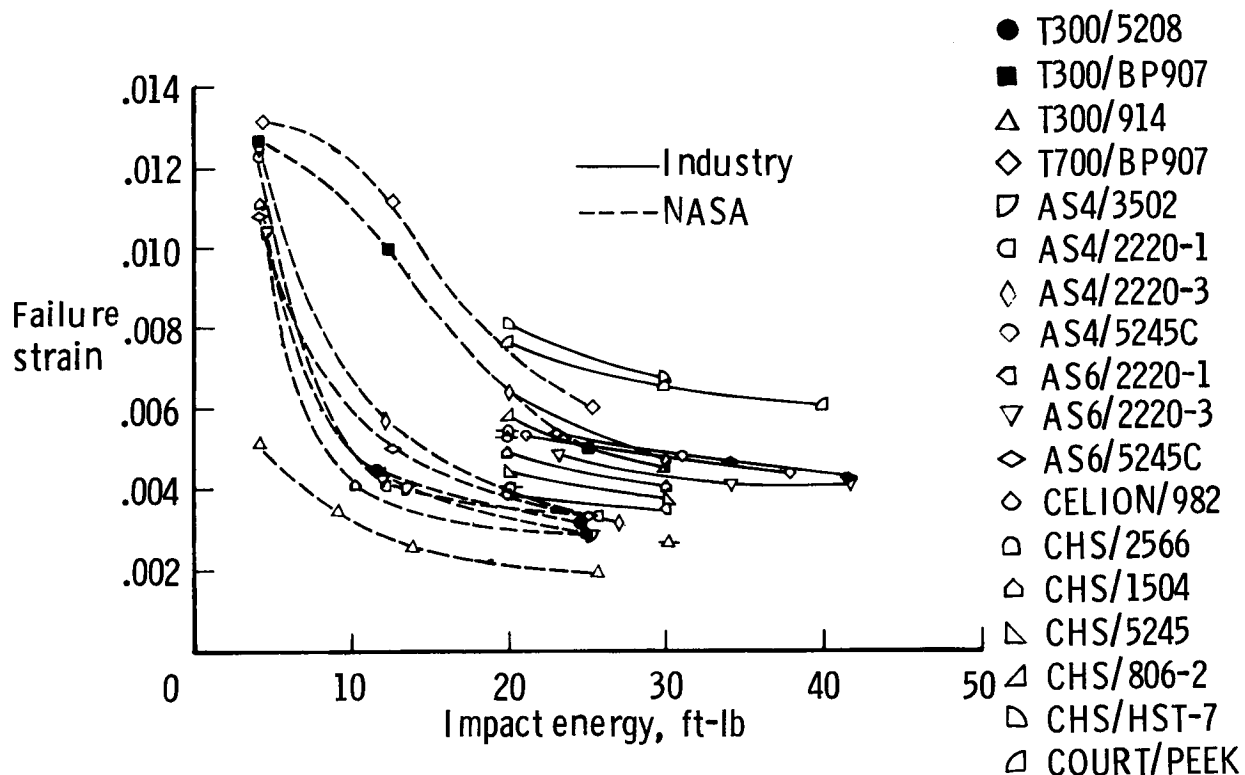
Figure 15

The failure strain for specimens loaded in compression following impact damage at selected impact energies is presented in figure 15. Industry data are represented by solid lines and NASA data by dashed lines. In general, the NASA low-mass/high-velocity impact condition caused a greater reduction in failure strain than did the industry dropped-weight test. None of the materials tested by NASA has a higher failure strain at 25 ft-lb impact energy than the baseline T300/5208 material and all are substantially lower than the baseline T300/BP907 material. Laminates constructed using BP907 resin and the higher strain T700 fiber recorded a higher failure strain than did BP907 laminates with T300 fiber. For the materials tested by industry, Courtaids/PEEK and CHS/HST-7 had the highest failure strains.

The stress at failure following impact damage for most of the data presented in figure 15 is presented in figure 16. Failure stress is a useful parameter for making materials comparisons for quasi-isotropic laminates because it predicts the relative load carrying capability and introduces the effect of variations in resin content and thickness. High resin content, for example, is the reason CHS/HST-7 shows less advantage on the basis of stress than strain. The T300/914 specimens were constructed using prepreg material with approximately twice the thickness of the other materials systems. The effect that ply thickness has on the compression strength of damaged laminates is not established. On the basis of failure stress, some improvement in performance can be credited to higher strain fibers. As was the case for the failure strain comparison, the NASA low-mass/high-velocity impact caused greater reductions in the failure stress than did the industry dropped-weight test.

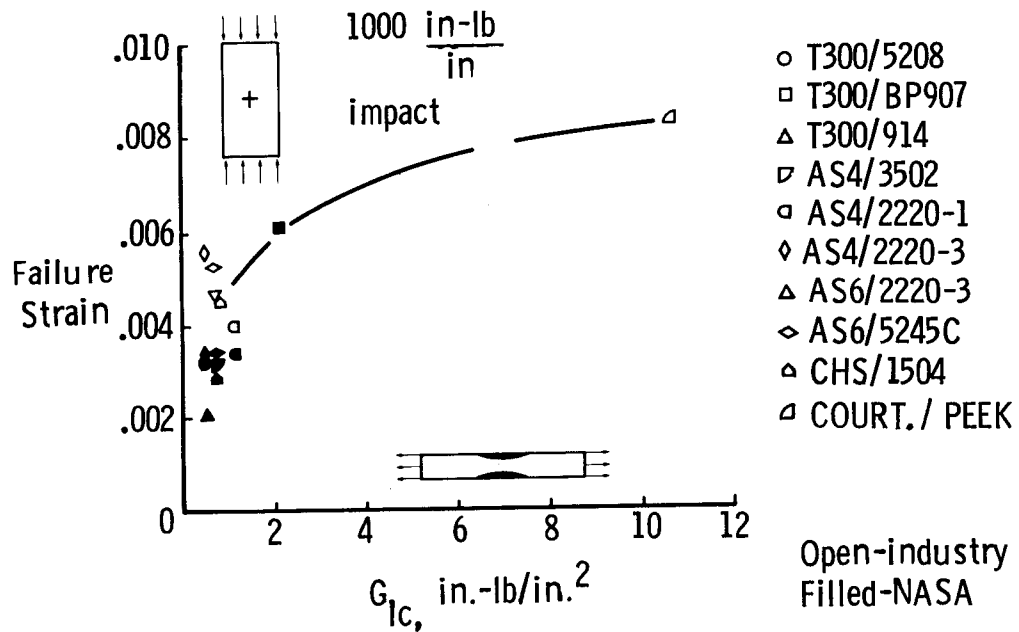
Figure 19 shows a plot of compression failure strain for laminates subjected to impacts of 1000 in.-lb/in. versus the mode I interlaminar fracture toughness G_{Ic} . The solid symbols represent tests using the low-mass/high-velocity aluminum projectile as the impactor, whereas the open symbols represent tests using the high-mass/low-velocity dropped weight. Most of the baseline and ACEE materials have G_{Ic} values less than 1 in.-lb/in.² Data for T300/BP907 and Courtaulds/PEEK (ref. 5) suggest that if G_{Ic} is increased, a corresponding increase in compression failure strain after impact will be observed. More data are needed to further substantiate this observation and to define better the correlation curve suggested in figure 19.
