Correlation of manufacturing defects and impact behaviors of kenaf fiber reinforced hybrid fiberglass/Kevlar polyester composite

Abstract: In this study, the impact properties of kenaf fibre reinforced hybrid fiberglass/Kevlar polymeric composite was investigated. In this study, a new fiber arrangement based on kenaf bast fiber as reinforcement to the hybrid fiberglass/Kevlar fiber and polyester as matrix used to fabricate the hybrid polymeric composite. Five different types of samples with different of kenaf fiber content based on volume fraction (0, 15, 45, 60 and 75%) to hybrid fiberglass/Kevlar polymer composites were manufactured. 0% of kenaf fiber has been used as control sample. The results showed that hybridization has improved the impact properties. These results were further supported through SEM micrograph of the manufacturing defects of the polymer composite. Based on literature work, manufacturing defects that occurs in composite system reduced the mechanical properties of the material. Therefore, in this research the correlation of impact behaviors and manufacturing defects of kenaf fiber reinforced hybrid fiberglass/Kevlar polymeric composite has been successfully d

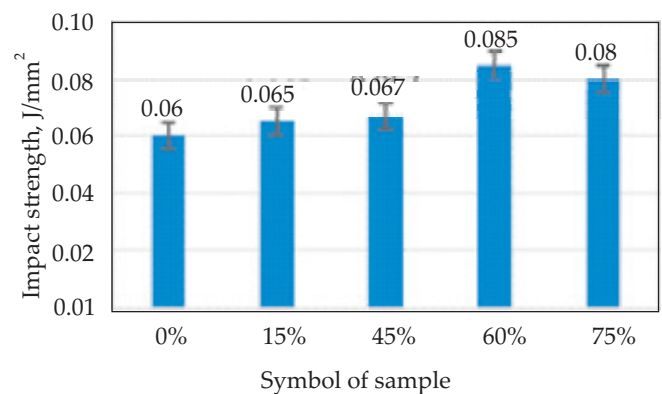
Fig. 2. Impact strength of kenaf fiber reinforced hybrid fiberglass/Kevlar polymeric composite with respect to kenaf fiber content

Indirectly, as depicted in Fig. 2 and tabulated in Table 1, we can conclude that the Charpy low velocity impact toughness seems to have the same impact energy and impact strength behaviors. It is clearly seen that the composite material with 60% kenaf fibers content has the greatest impact toughness value of 0.085 J/mm². As the research study has been reported, both fiber content and properties of the polymer are accountable for deciding the impact toughness [13, 14]. This implies that both effects of interlaminar delamination and interfacial adhesion between fiber and matrix highly decide impact properties [15].
