Damage Evaluation in Woven Glass Reinforced Polyamide 6.6/6 Composites Using Ultrasound Phase-Shift Analysis and X-ray Tomography — [Source link](#)

Published on: 05 Feb 2018 - Journal of Nondestructive Evaluation (Springer US)

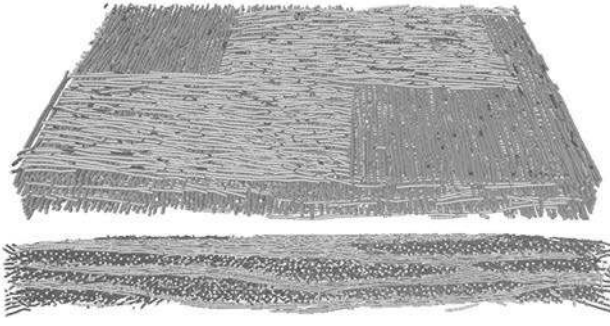
Fig. 1 Overall 3D mesostructure of the studied composite consisting of 2/2 twill weave fabric reinforced polyamide 6.6/6 matrix

The composite material considered for this study is referenced as VizilonTM SB63G1-T1.5-S3 and is manufactured by DuPont. The studied composite is produced by a thermo-compression molding process and it consists of a 2/2 twill weave glass fabric reinforced co-polyamide 6.6/6, with three plies, of 1.53 mm thick in total. The overall 3D woven fabric of the studied composite material is shown in Fig. 1. The

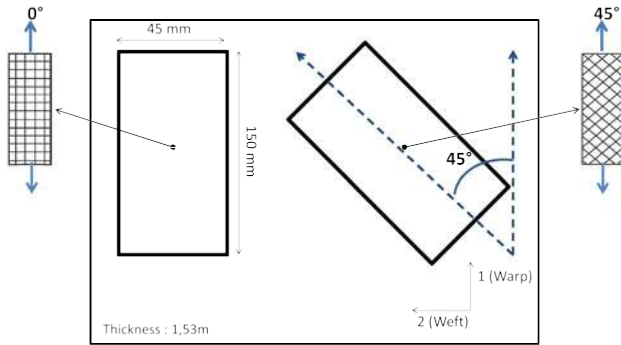
Fig. 2 Position of the samples oriented at 0° and 45° with respect to the warp direction assumed as the mold flow direction of the composite plate

weight fiber content is 63% corresponding to a fiber volume fraction of 43%. Ten samples are cut in rectangular plate of 45 mm length and 150 mm width. Four samples are cut at 45° with respect to the warp direction (mold flow direction) and six other ones are cut along the warp direction. The orientations of these two sets of samples are indicated in Fig.

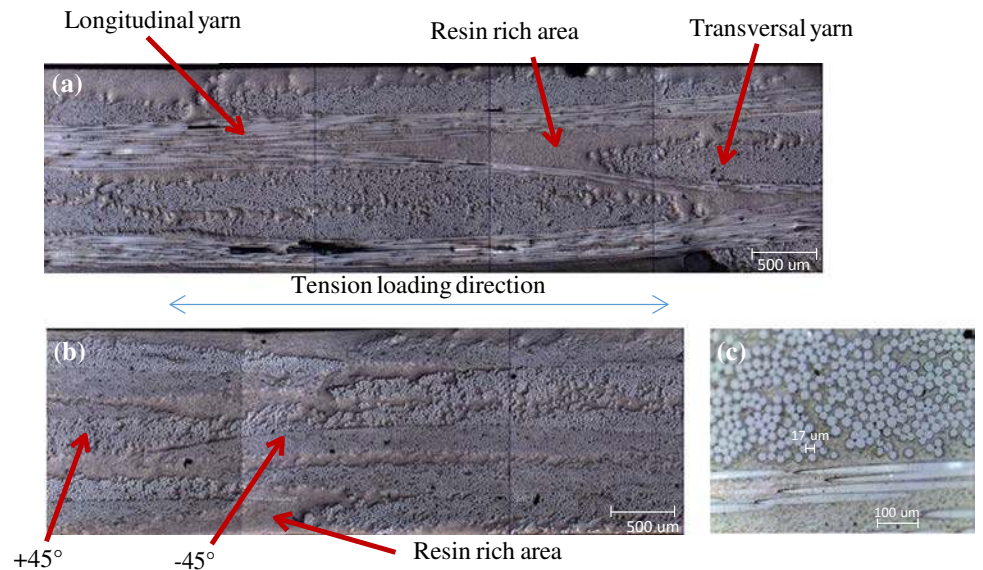
Fig. 3 Cross-sectional observation with optical microscope of the 2/2 twill weave fabric reinforced polyamide composite microstructure for samples oriented at 0° and 45°. **a** 0° sample, **b** 45° sample and **c** Zoom-in on a sample's yarns in the 0° orientation

2. The two different microstructures can be observed in the Fig. 3. All the samples are stored in a humidity chamber in order to have the same initial conditions in terms of relative humidity. The latter is set at a level of 50% for all tested composite material. Initial tensile tests are performed on the material until failure for both 0° and 45° sample configurations. The experimental stress/strain curves are normalized with respect of the tensile ultimate strength of the 0° sample configuration.

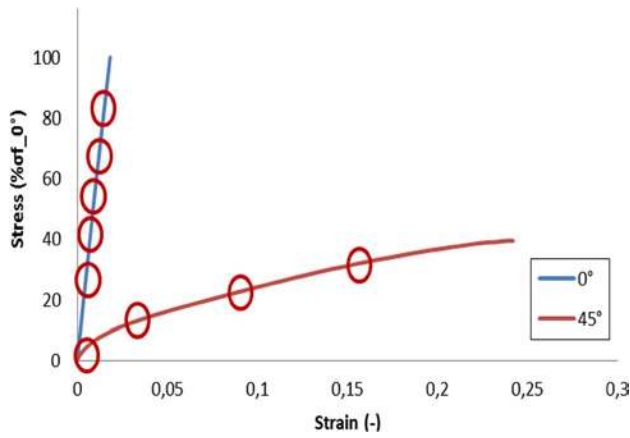
Fig. 4 Typical stress/strain responses of the 2/2 twill weave fabric reinforced polyamide composite under tension at 0° and 45° . The red circles show schematically where the tensile tests have been interrupted for both tested configurations

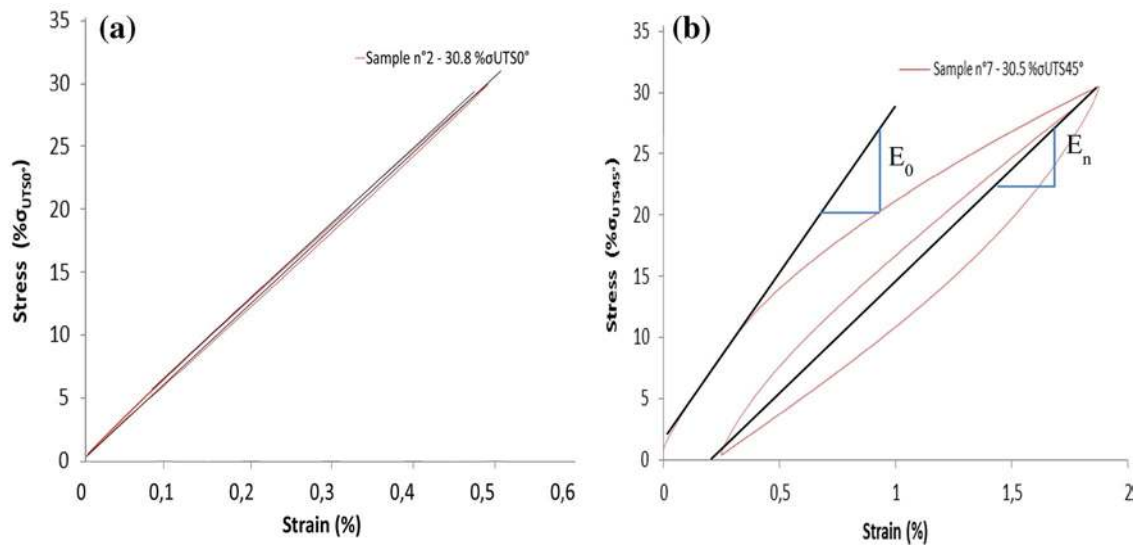
Fig. 5 Schematic representation of the elastic moduli estimation of the of E_0 and E_n for respectively **a** 0° and **b** 45° configuration samples

culated after the unloading according to a common damage measurement procedure [17]. A representation of the elastic moduli calculation is depicted in Fig. 5a, b for the two tested sample configurations.

As shown in Fig. 5, a noticeable difference is observed between the overall stress-strain responses of the two configuration samples, namely 0° and 45° . In fact, for the samples tested at 0° , the behavior in tension is mostly linear and brittle since it is governed by the fiber breakage whereas the behav-

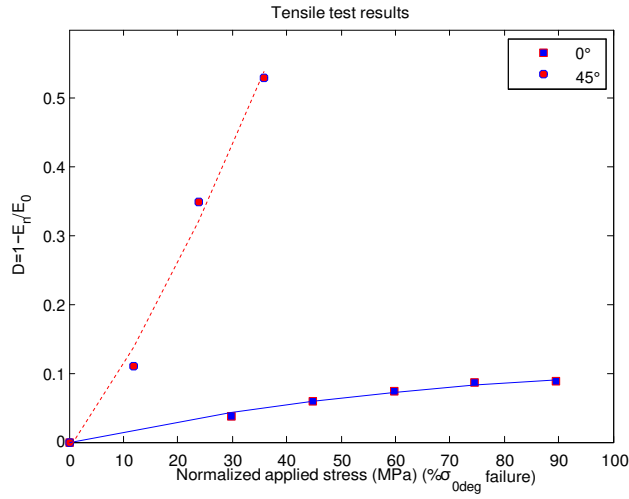
Fig. 6 Evolution of the the damage for 0° and 45° sample's configurations. The damage is estimated from the Young's modulus reduction for different applied stress levels

This is particularly clear for the evolution of the damage estimated on the elastic modulus reduction when the applied stress increases, as illustrated in Fig. 6. For the samples oriented at 45° from the warp direction, the damage D reaches a value of 0.53 close to the final failure. However, for the 0° case, it only goes up to 0.1. The values of damage for every tested sample are summarized in Table 1. This damage estimation is employed as a first reference to validate the proposed ultrasonic damage indicators detailed in further sections. Indeed, as discussed, Fig. 6 indicates a higher amount of damage induce by the loading for the 45° configuration, which could imply different damage mechanisms with different associated typical scales. In fact, to investigate the sensitivity of the ultrasonic techniques, it is necessary to consider different scales of induced damage. Hence, the typical scale of those mechanisms for the two sample configuration requires further study.

The evolution of the void volume fraction as a function of the applied stress level (Fig. 12c) exhibited a similar increase as the evolution of the macroscopic damage estimated from the Young's modulus reduction plotted in Fig. 6. Accordingly, these two quantitative estimations of the damage state, namely void volume content and Young's modulus reduction will be two actual measurements of the damage that validate the proposed new damage indicators.

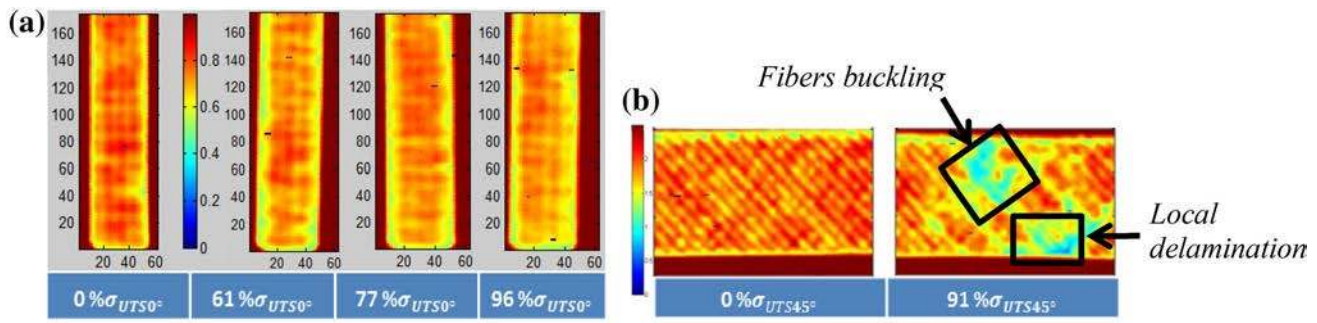
Fig. 7 Preliminary C-scan results on 2/2 twill weave fabric reinforced polyamide composite previously loaded in tension with different amplitude. **a** Samples in 0° configuration; **b** Samples in 45° configuration. For the latter, besides the large damage zones, one can easily distinguish the 45° orientation of the yarns

7a related to the samples tested at 0° from the warp direction, the attenuation of the ultrasound amplitude's signal remains low and a very slight difference, if any, was noticed when increasing the applied stress level from 0 to 92.6% σ_{UTS0} .

For the sample in 45°, the Fig. 7b shows the evolution of amplitude attenuation (C-scan images) between the unloaded state and the ultimate state level prior failure (92.6% σ_{UTS45}). Two damage zones were actually observed macroscopically and the related high attenuations in the signals were associated to the fibers buckling and the local delamination. In addition, the low signal attenuations observed at the border of the samples were clearly induced by a well-known border effect and were not caused by the mechanically induced damage.

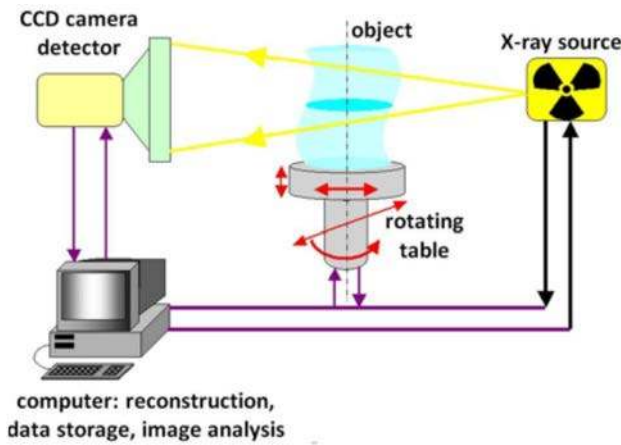
Fig. 8 Principle of the X-ray micro computed tomography techniques [22]

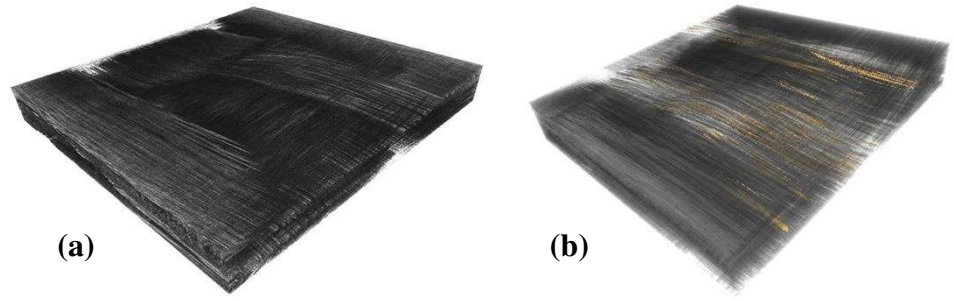
Fig. 9 **a** As received mesostructure of the 2/2 twill weave fabric composite obtained by 3D reconstruction prior to mechanical loading. **b** Initial voids and process-induced defects are represented by light color and their content is estimated using Avizo software segmentation (about 0.6% volume)

The matrix and the fibers of the composite are characterized by distinctive values of X-ray absorption. Hence, they can be easily separated on a grey level map. Air cannot significantly absorb X-ray. Consequently, the voids cannot be easily observed inside the composite samples, however during the image 3D-reconstruction, the voids appear as completely black volumes. A median filtering was first applied to the raw results to reduce the amount of noise in the images. A despeckle filter was then applied to remove the main part of the remaining interference noise. The different reconstructions were then segmented in three classes (void, matrix and fibers) using a grayscale thresholding. The Avizo software segmentation enables an accurate estimation of the volume fraction of each of the three phases. Figure 9 illustrates an

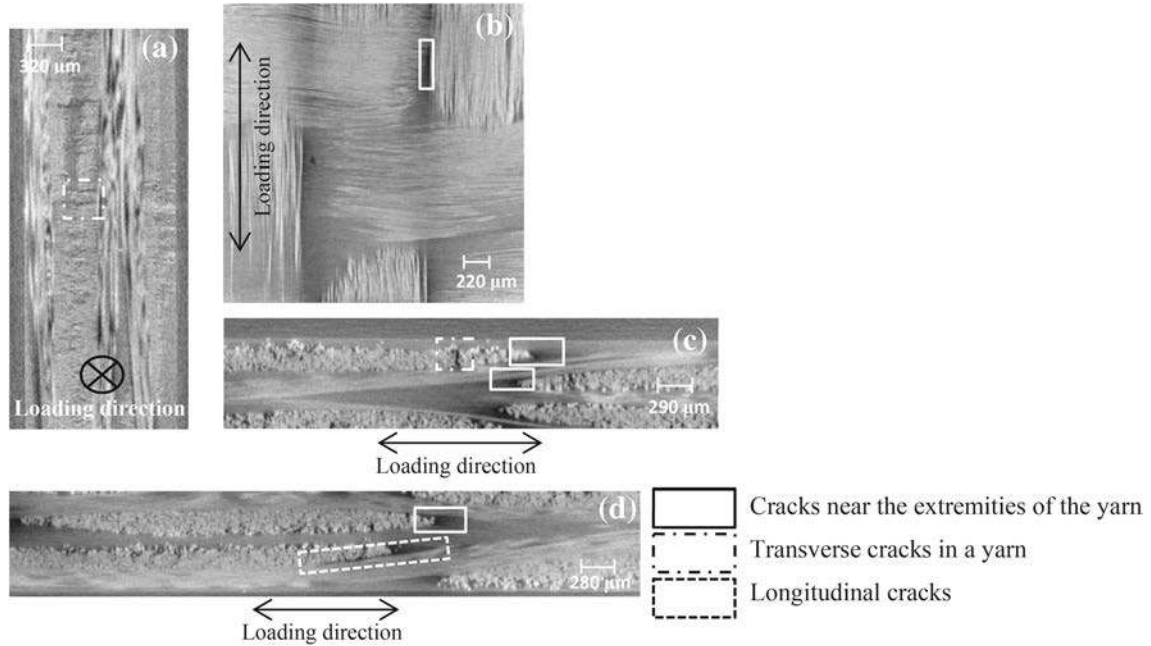
Fig. 10 Three main damage mechanisms identified for 0° sample configuration under tension loading. These main mechanisms consist in cracks near the extremities of the yarns, transverse cracks in yarns and longitudinal cracks

Some examples of damage mechanisms observed for samples in the 0° configuration are illustrated in Fig. 10. For tensile tests along the warp fiber axis, the main damage mechanisms observed were the formation of cracks near the end of the yarns (Fig. 10b, c, d), and transverse cracks inside the yarns (Fig. 10a, c), for example). Some longitudinal cracks that follow the transverse yarns very locally in the last step of damage were also observed (Fig. 10d). As the loading level increased, the number and the size of defects (cracks and voids) increased too (Tables 3, 4).

of 50 μm for the highest damaged samples. These longitudinal cracks can then propagate along the warp yarns as shown in Fig. 10d.

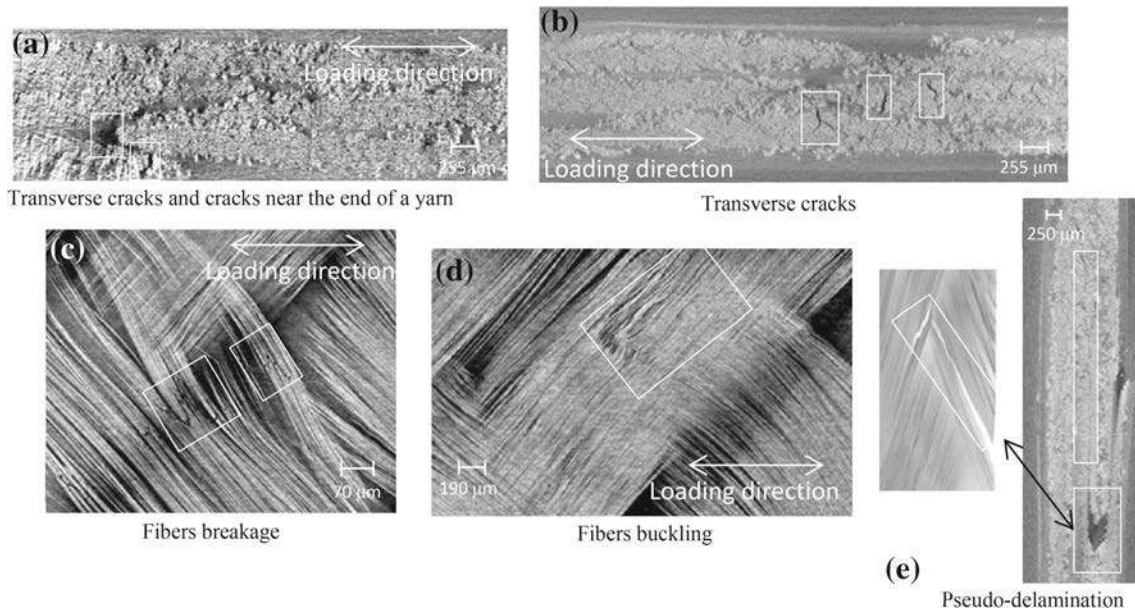
Fig. 11 The different damage mechanisms that appear when a sample in the 45° configuration is submitted to tension. These mechanisms consist in transverse cracks, cracks at the extremities of the yarns, fiber breakage, fiber buckling and yarns pseudo-delamination due to the propagation of the longitudinal cracks

For samples in the 45° configuration, all the observed mechanisms are shown in Fig. 11. Firstly, cracks at the extremities of yarns (visible in Fig. 11a) as well as cracks along the yarns were observed in Fig. 11a, b. On the 91.6% σ_{UTS45° loaded sample many local fiber breakages were also observed, some of them were already visible in Fig. 11c for the sample tested at 61.1% σ_{UTS45° . Those defects were observed around the central region of the sample, along the loading direction, especially near the edges. In Fig. 11d, some micro buckling

of fibers was noted, more notably in the sample loaded at the highest stress level. This is due to the reorientation of fibers during the loading test. Indeed, as the load increases the angle between the fibers tends to decrease but when the tension is interrupted, the fibers cannot return to their original position because of the section reduction caused by the Poisson effect. This effect of the fibers' reorientation during off-axis loading was also observed by Vieille and Taleb [23] among others. Pseudo-delamination also appeared locally after roughly $60.1\% \sigma_{UTS45^\circ}$ of loading in some specimen, as visible in Fig. 11e. It was propagated inside a yarn and followed the fiber orientation until it reached the location where the weft and warp yarns were intertwined together. When the stress level continued to increase, the crack turned and started propagating along the direction of the other yarn.

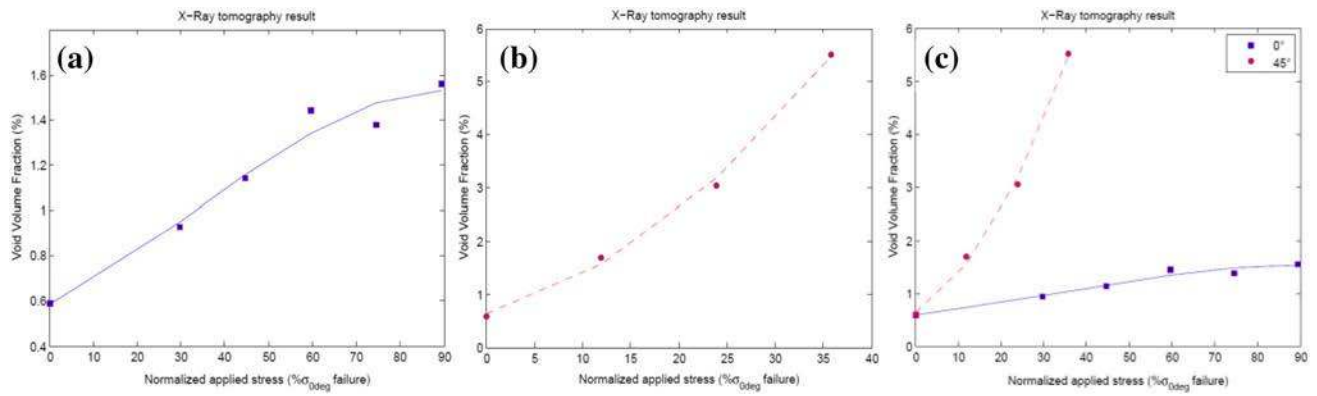
Fig. 12 Evolution of void volume fraction for **a** 0° and **b** 45° configuration of sample with increasing loading. In **c** data of both configurations are plotted for comparison purpose

The evolution of the void volume fraction is plotted for both orientations in Fig. 12. The experimental data 0° and 45° configurations are plotted as function of the stress to failure of the 0° sample (respectively Fig. 12a, b). The Fig. 12c allows an easy comparison of the two results.

The void volume fraction clearly increased with the tension loading level for both considered orientations. However, a higher growth of damage in the set of samples oriented at 45° from warp direction was observed. In fact, for the samples oriented at 0° and loaded at $92.6\% \sigma_{UTS0^\circ}$, a void volume fraction of 1.56% was measured as it can be seen on the mCT-3D reconstruction in Fig. 13. On the other hand, as shown in Fig. 14, for the sample tested at 45° for a stress level of $91.6\% \sigma_{UTS45^\circ}$, the estimated volume void content was about 5.51% . These results are in agreement with the difference in terms of the behavior between the two sample's orientations discussed in Sect. 2. Indeed, the overall response of the 45° samples was more ductile compared to the behavior of a sample tested at 0° , which exhibited a linear elastic brittle behavior.

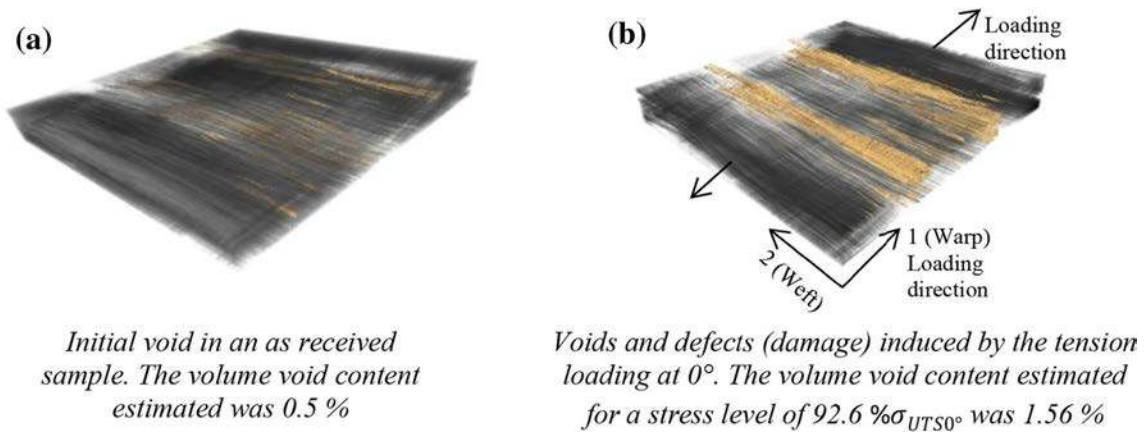
Fig. 13 mCT-3D reconstructions of composite samples in the 0° configuration respectively **a** before and **b** after tensile loading at a stress level of 92.6% σ_{UTS0°

Qualitatively, Fig. 13b shows a clear preferred orientation of the damage accumulation, which is perpendicular to the

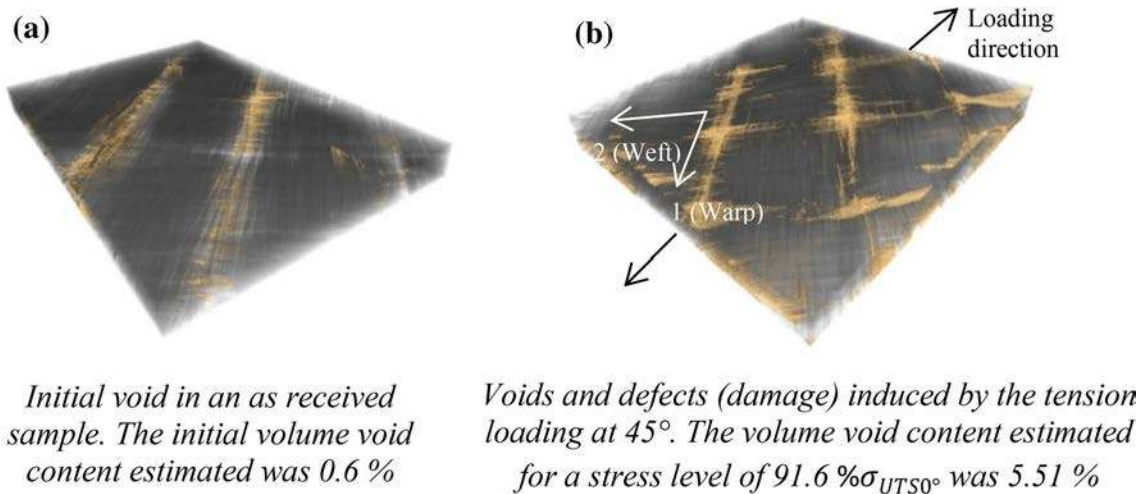
Fig. 14 mCT-3D reconstructions of composite samples in the 45° configuration respectively **a** before and **b** after tensile loading at a stress level of 91.6% σ_{UTS0°

tension loading direction for the samples oriented along the warp direction (0°). In the case of the 45° samples, the cracks grow along the two yarns direction as visible in the Fig. 14b.

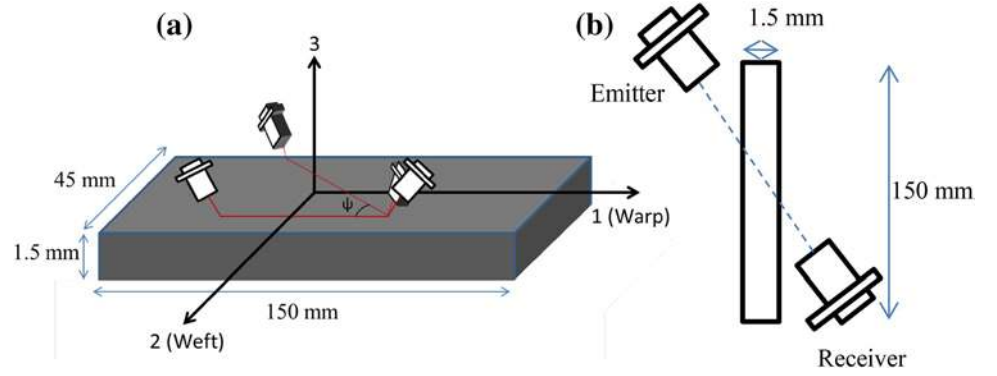
Fig. 15 Schematic representation of the two planes of interest: **a** the plane 1–2 or azimuth plane and **b** the plane 1–3

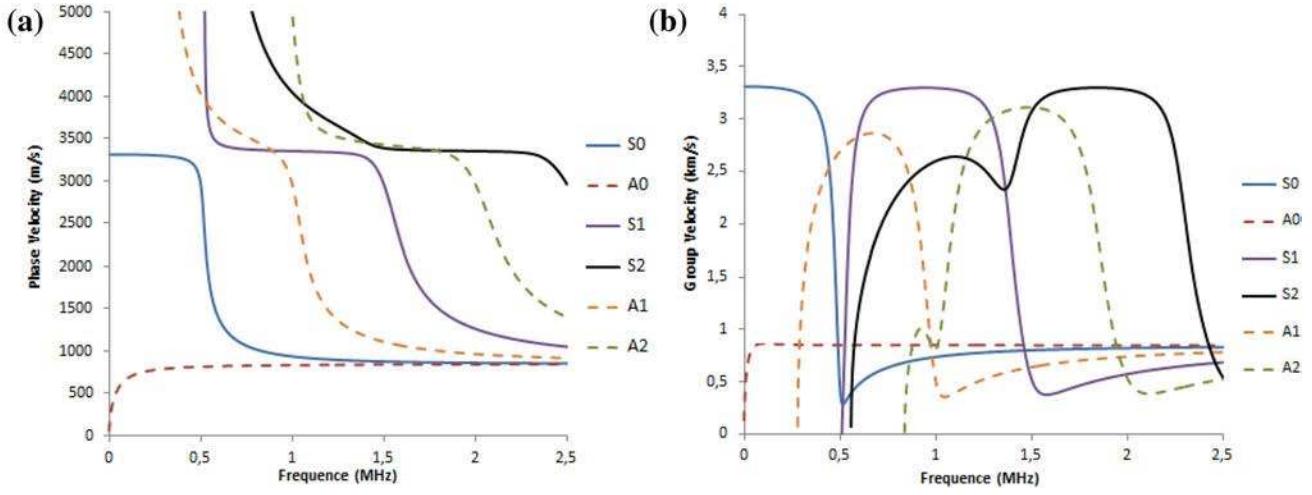
Fig. 16 Dispersion curves computed with the *Disperse software* for guided wave propagation in a 1.53mm thick studied composite along the fibers direction. **a** Phase velocities, **b** group velocities

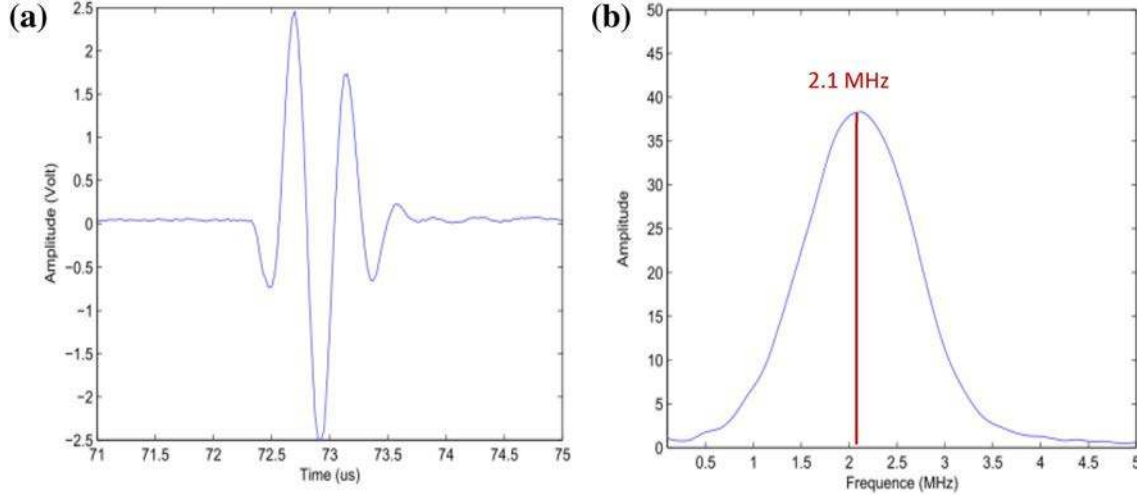
Fig. 17 **a** Emitted pulse signal and spectrum **b** for a 2.25 MHz center frequency transducer. The experimentally measured center frequency is about 2.1 MHz

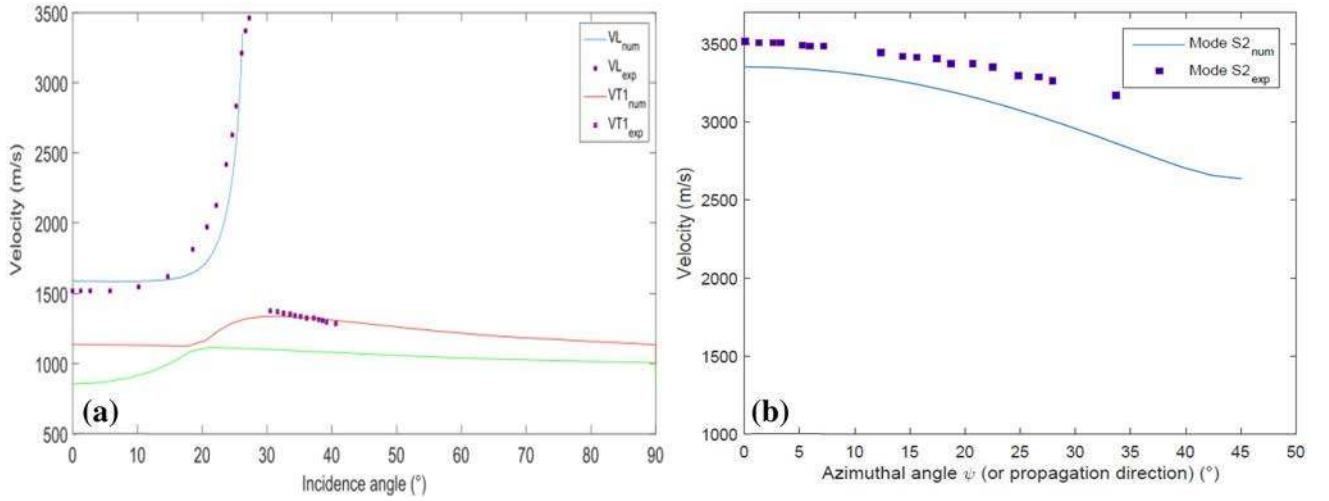
Fig. 18 Comparison of numerically and experimentally determined propagation wave velocities. The experimental values are represented by points whereas numerical values are represented in continuous line. **a** Plane 1–3; **b** Plane 1–2 or azimuth plane

Before running the optimization procedure for obtaining the stiffness constants, a computation of the expected velocity as a function of the incidence angle was performed. The quasi longitudinal, the quasi transversal 1 and the quasi transversal 2 modes propagated in the 1-3 principle plane were calculated for a refraction angle ranging from 0 to 90°. This computation was based on the stiffness matrix obtained by periodic

homogenization (Table 5). The computed velocities were compared to those obtained experimentally for the undamaged sample. The same calculation was made for Lamb wave propagation in the 1-2 planes, more particularly for the S2 mode. The comparison of experimental and analytical velocities of wave propagation is illustrated in Fig. 18. It confirms that the mode experimentally measured corresponds to the actual wave mode that was assumed to propagate in the composite material.

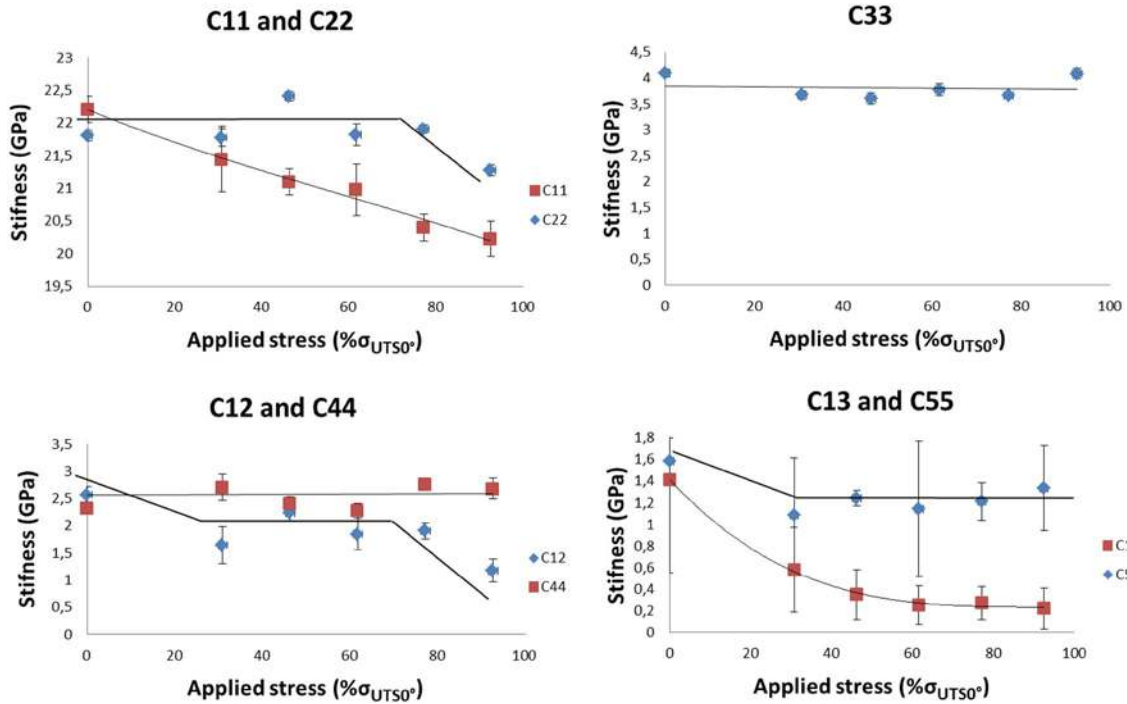
Fig. 19 Evolution of seven of the stiffness constants, function of the tensile stress, with the increase of the loading for the 0° configuration of sample with their respective confidence interval

One can then conclude that the components depending on the loading direction (direction 1), namely C_{11} and C_{13} were more affected by the damage. The component C_{12} was also impacted by the damage but at a lower extent.

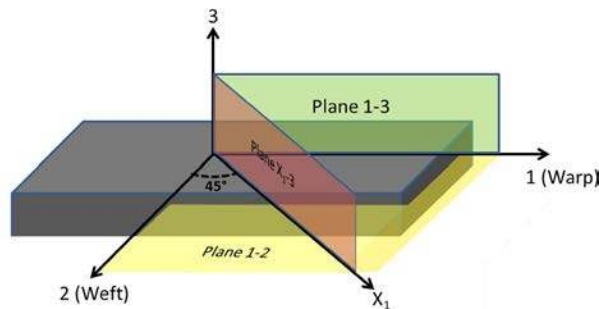
Fig. 20 Schematic representation of the different propagation planes of ultrasonic waves. For samples in the 0° configurations, the planes 1-3 and 1-2 were used. For the samples in the 45° configuration, the plane X-3 and 1-2 (or azimuth plane) were used

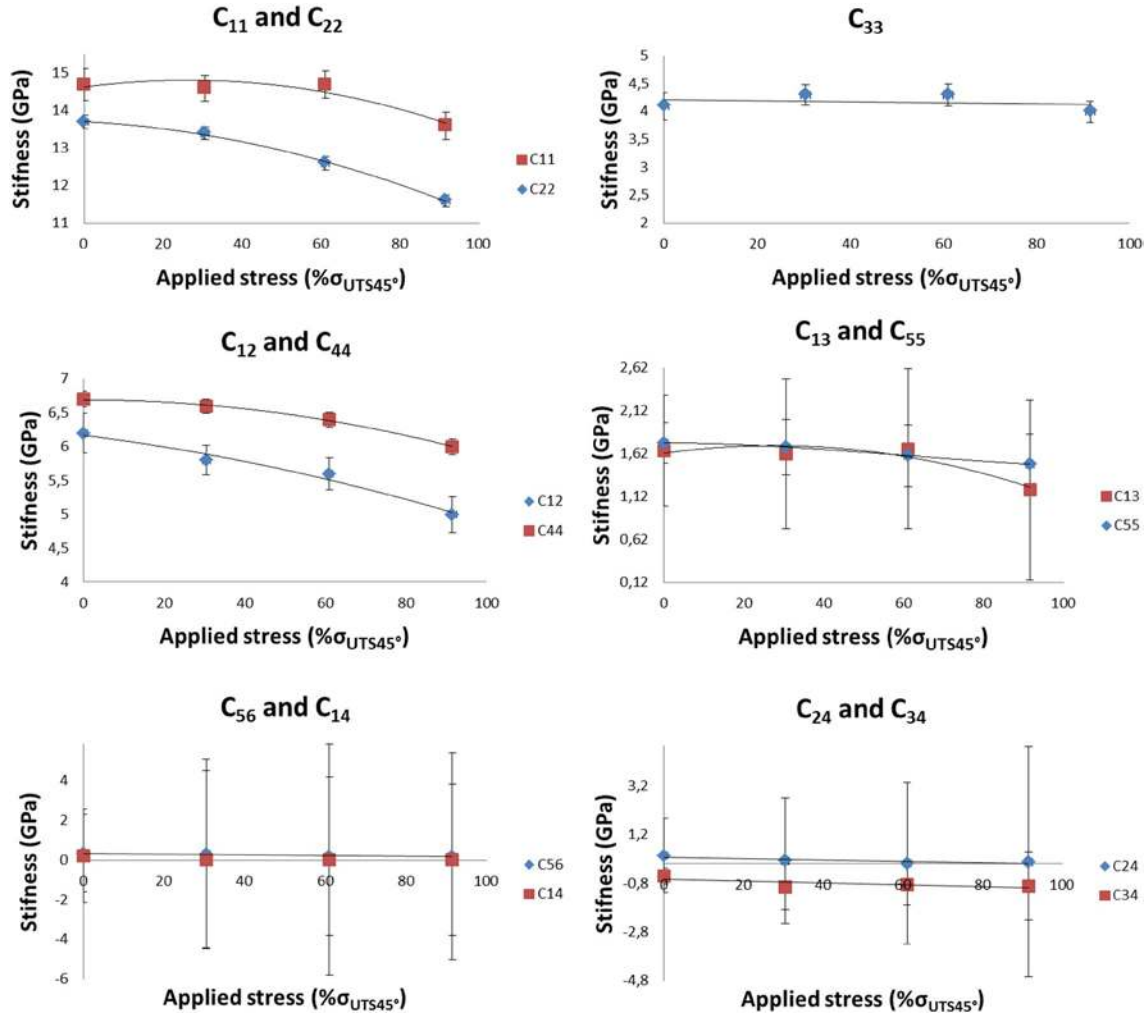
Fig. 21 Evolution of seven of the stiffness constants with the increase of the applied stress level for different 45 ° configuration of sample with their respective confidence interval

The evolution of the stiffness components is plotted in Fig. 21 with their respective confidence interval. During the first steps of the loading, the components that are a function of the loading direction (especially C_{11} and C_{13}) did not change at

all, but they dropped drastically after 61.1% σ_{UTS45° . The shear components C_{44} and C_{12} were of course impacted from the beginning of the test. The components C_{33} and C_{55} did not really change during the tensile tests. This led to a very different damage behavior compared to the other sample configurations. Some minor changes were observed for the C_{56} , C_{14} , C_{24} and C_{34} components. However, the confidence interval was very large when compared to the other stiffness components. This is explained by the lack of measurement in two additional planes as mentioned earlier. The major impact from the loading on the shearing components was clearly detected with the present method. Furthermore, this was in agreement with the damage mechanisms observed in the previous section. Indeed, it is worth recalling that the fiber buckling was caused by the reorientation of the fibers which was induced by important local shearing in the meso-structure.

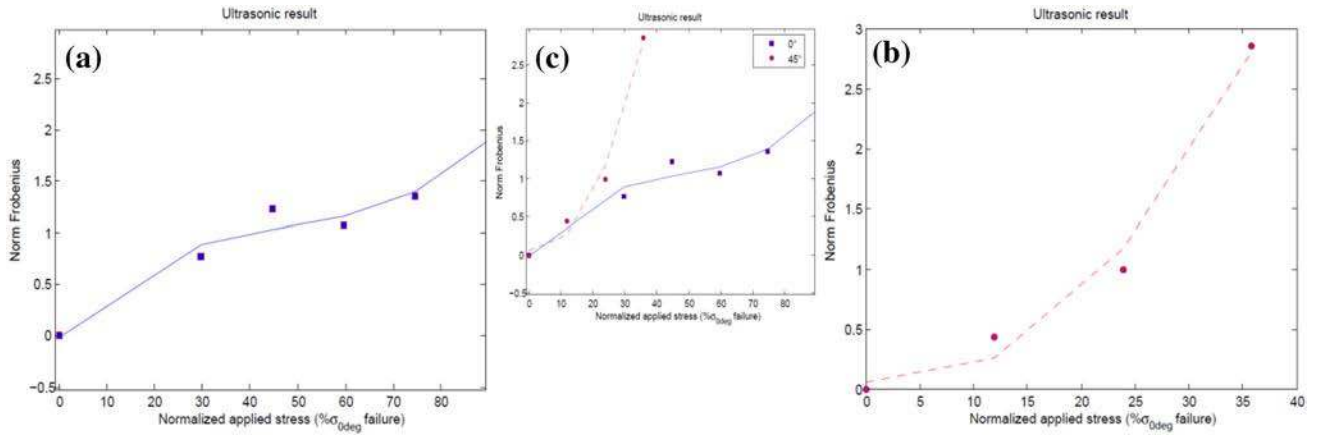
Fig. 22 Evolution of the Frobenius norm of the stiffness matrix for the two configurations of samples **a** 0° and **b** 45° function. In **c** data of both configurations are plotted for comparison purpose

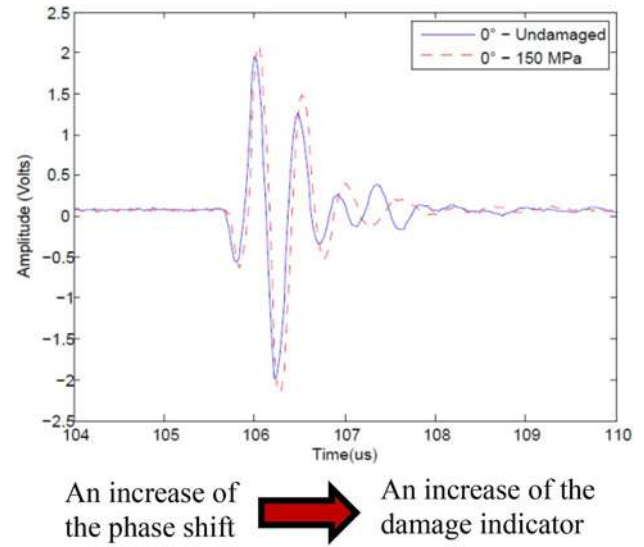
Fig. 23 Response of ultrasonic signals that propagates through the 1-3 plane, at 0° of incidence, of a 0° undamaged sample and loaded at a stress level of 150 MPa

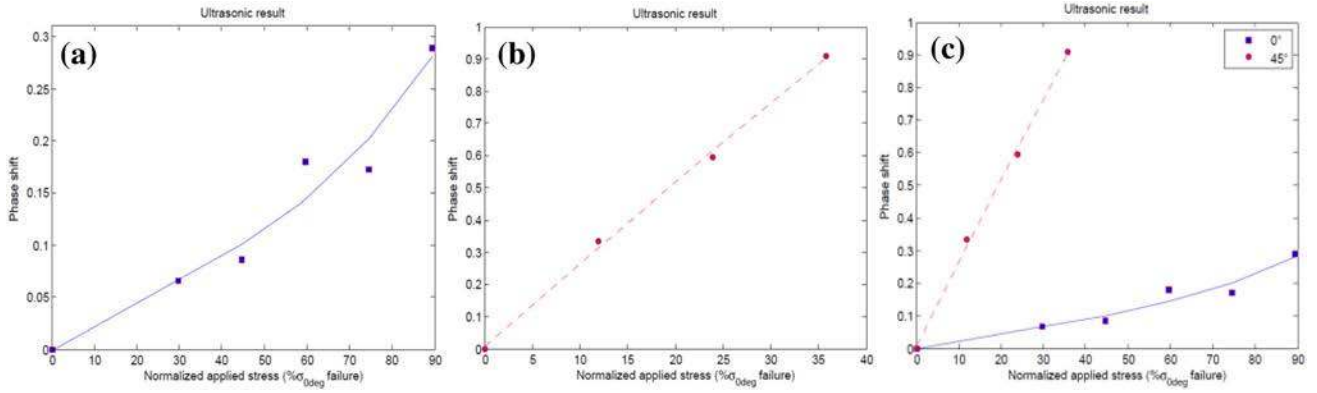
Fig. 24 Absolute phase angles evolution with increasing tensile stress to the sample for **a** 0° and **b** 45° configuration of sample. In **c** data of both configurations are plotted for comparison purpose

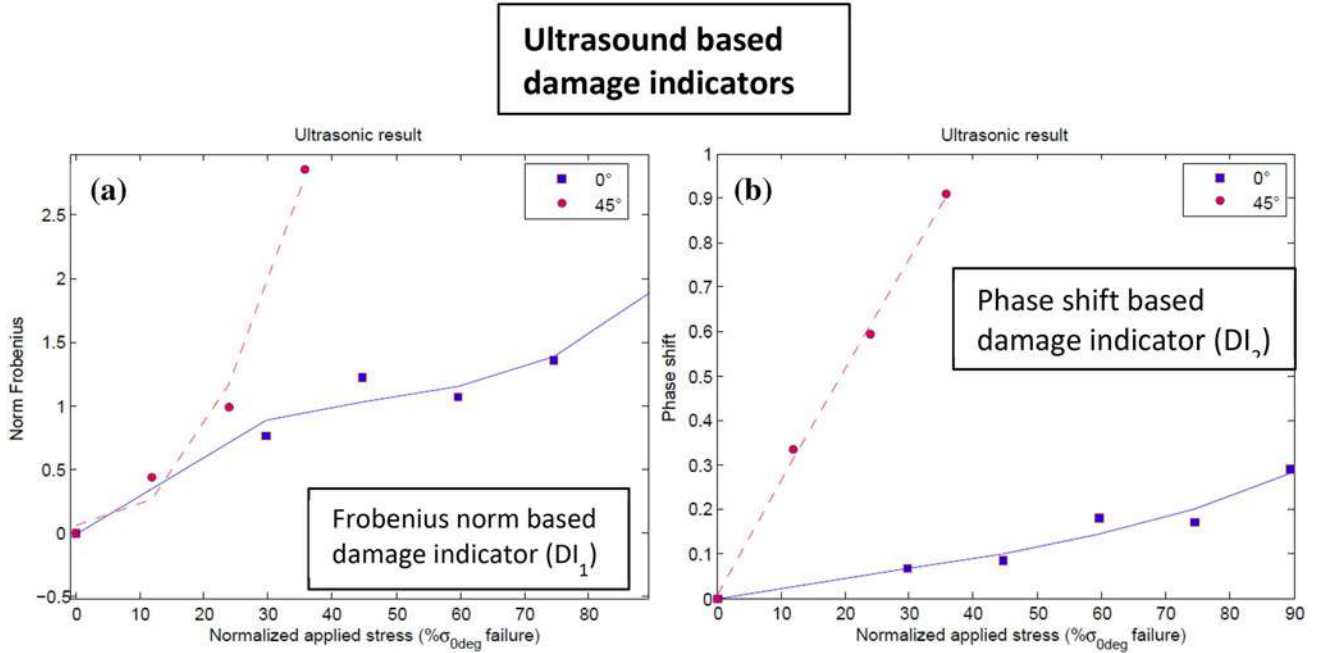
Fig. 25 Proposed ultrasonic damage indicators. **a** Evolution of Frobenius Norm and **b** Phase shift indicator. Those indicators are plotted for the sets of samples oriented at 0° and 45° from the warp direction and function of the normalized applied stress level

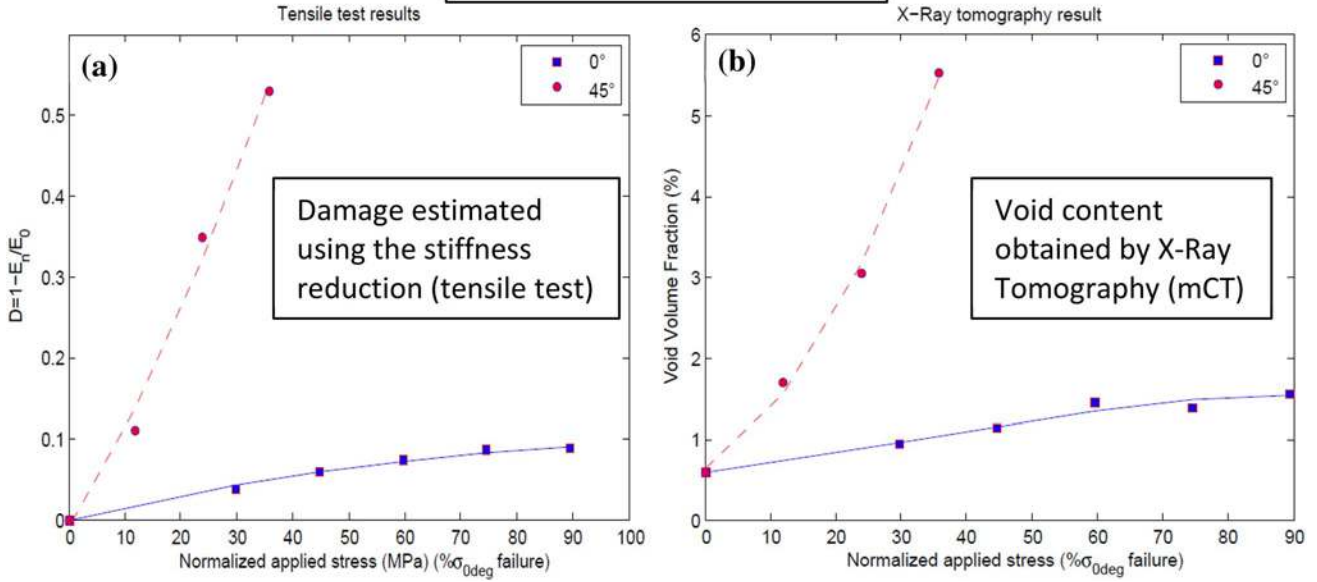
Fig. 26 Damage indicators used as validation tools. **a** Damage estimated on the elastic modulus reduction and **b** Void volume fraction. Those indicators are plotted for the sets of samples oriented at 0° and 45° from the warp direction and function of the normalized applied stress level
