# Delayed ruptures of the extensor tendon secondary to the use of volar locking compression plates for distal radial fractures

From Selly Oak  
Hospital,  
Birmingham,  
England

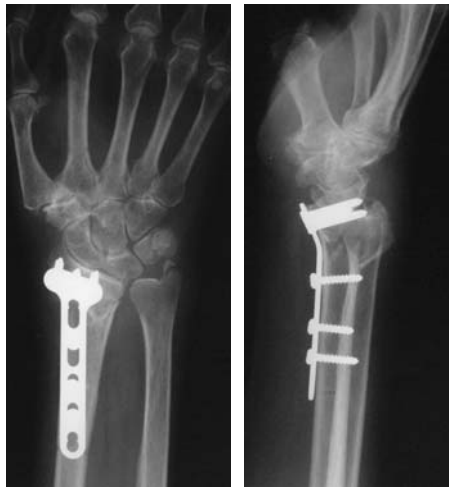
Fig. 1a

Case 1. a) Anteroposterior and b) lateral radiographs showing the volar locking plate in position, and healing of the fracture.

The first of these patients was a 64-year-old woman who sustained a displaced intra-articular fracture of the distal radius after a fall. Two days later she underwent open reduction and internal fixation with a 3.5 mm T-shaped AO locking compression plate (AO) applied to the volar aspect. Four weeks after surgery her wrist was not painful; she had dorsiflexion of 40°, palmar flexion of 40° and full supination and pronation. However, she reported that she was unable to extend her thumb. Radiography showed that the fracture was healing in a satisfactory position (Fig. 1). She underwent exploration of the extensor compartment which revealed a rupture of the extensor pollicis longus tendon with no evidence of protrusion of screws. However, an empty drill hole made at the time of initial surgery was found at the base of the third dorsal compartment. The tendon injury was treated by an extensor indicis proprius to extensor pollicis longus tendon transfer with a satisfactory result.

We had an incidence of 8.6% after fixation using a volar locking plate for both dorsally and volarly angulated fractures of the distal radius. There were no other complications. In case 1, damage from drilling at the time of surgery was probably the cause of rupture of the tendon. The post-operative radiographs and subsequent surgical exploration revealed no evidence of protrusion of screws, which was probably the cause of the rupture in the second and third cases. It is possible that rupture could have occurred for reasons other than iatrogenic damage or attrition on protruding screws. However, the incidence of rupture of the extensor pollicis longus tendon after fractures of the distal radius treated conservatively is low (0.07% to 0.88%).<sup>17,18</sup> A study by Hove<sup>19</sup> showed that in a period of five years, 0.3% of cases had rupture of the extensor pollicis longus tendon after such a fracture. It is suggested that ruptures of the extensor pollicis longus can occur after minimally-displaced fractures because the attachment of extensor retinaculum to Lister's tubercle remains intact and together with formation of callus, leads to narrowing of the third compartment.<sup>20</sup> This can cause reduction in the blood supply to the tendon, degenerative necrosis and eventual rupture.<sup>14</sup> We recommend careful drilling and placement of the distal radial screws so that they sit flush on the dorsal cortex to prevent such complications. Another option is the use of a smooth pin although this may affect the ability to hold the reduction. Leaving the screws a little short is not desirable because engagement of the dorsal cortex allows compression of dorsal intra-articular fragments, preventing gapping or intra-articular steps.
