Design of bridges against large tectonic deformation

Abstract: The engineering community has devoted much effort to understanding the response of soil-structure systems to seismic ground motions, but little attention to the effects of an outcropping fault offset. The 1999 earthquakes of Turkey and Taiwan, offering a variety of case histories of structural damage due to faulting, have (re)fueled the interest on the subject. This paper presents a methodology for design of bridges against tectonic deformation. The problem is decoupled in two analysis steps: the first (at the *local* level) deals with the response of a single pier and its foundation to fault rupture propagating through the soil, and the superstructure is modeled in a simplified manner; and the second (at the *global* level) investigates detailed models of the superstructure subjected to the support (differential) displacements of Step 1. A parametric study investigates typical models of viaduct and overpass bridges, founded on piles or caissons. *Fixed-head* piled foundations are shown to be rather vulnerable to faulting-induced deformation. End-bearing piles in particular are unable to survive bedrock offsets exceedi

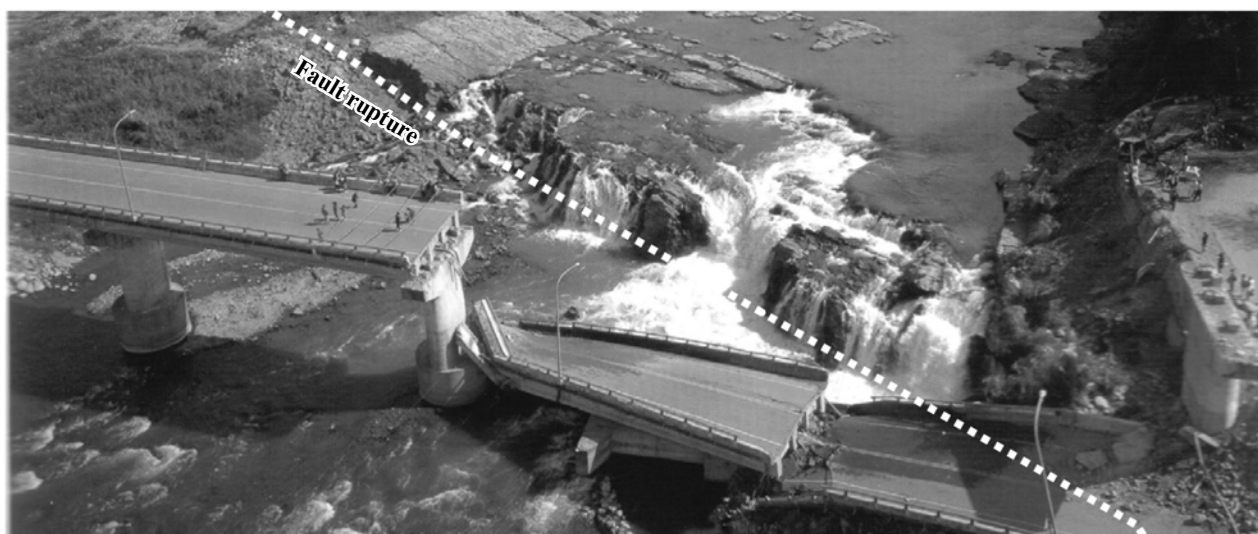
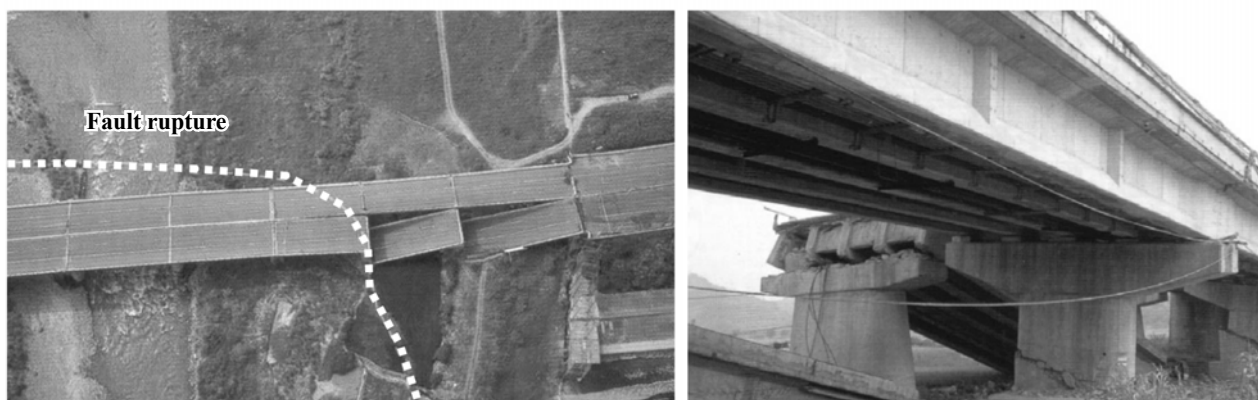
(a) Collapse of two spans of the Bei-Fung Bridge

(b) Collapse of two spans and pier shear failure of the Wu-Shi Bridge

Fig. 1 Examples of bridge failures due to tectonic dislocation in the 1999 Chi-Chi (Taiwan) earthquake. Both bridges were subjected to upthrust of the order of 5 m due to surface rupturing of the Chelungpu thrust fault. (photos adapted from Hwang, 2000)

Nevertheless, several bridges were damaged due to surface faulting in the 1999 Chi-Chi earthquake (Kawashima, 2001; Pamuk *et al.*, 2005). Two such examples are illustrated in Fig. 1. The first (Fig. 1(a)) shows a prestressed concrete bridge, the Bei-Fung Viaduct in Fung-Yan City (photos adapted from Hwang, 2000). The Chelungpu thrust fault crossed its south abutment with an upthrust of about 7 m. The result: collapse of two spans of the bridge due to differential displacement between the piers. The second example is the 17-span prestressed concrete Wu-Shi Bridge, subjected to about 2 m of upthrust at a 40° angle to its longitudinal axis. As shown in Fig. 1(b), two decks collapsed and most of its piers were severely damaged (mostly shear failures). Interestingly, one of its caisson foundations survived the direct “hit” by the outcropping fault, sustaining shear failure (Kawashima, 2001). The
