Development and Application of a Relative Displacement Sensor for Structural Health Monitoring of Composite Bridges

Abstract: One of the typical bridge construction types on Australia highways is composite bridge consisting of cast-in-situ reinforced concrete (RC) slab supported by steel or precast RC girders. The slab and girders are connected by distributed steel shear links. The shear links are under constant cyclic loadings during bridge operations therefore may experience fatigue damage besides possible corrosion damage and overstressing owing to increased traffic volume and weight. This paper proposes a relative displacement sensor developed to directly measure the relative slip between slab and girder in composite bridges to detect the health condition of shear connections. The structure, design principle, features and calibration of the developed relative displacement sensor are presented. The design of the sensor ensures that there are no voltage outputs for the tension, compression, bending and torsion effects, but only measures the relative displacement between the two connecting pads of the sensor. The accuracy of the developed sensor in measuring the relative displace

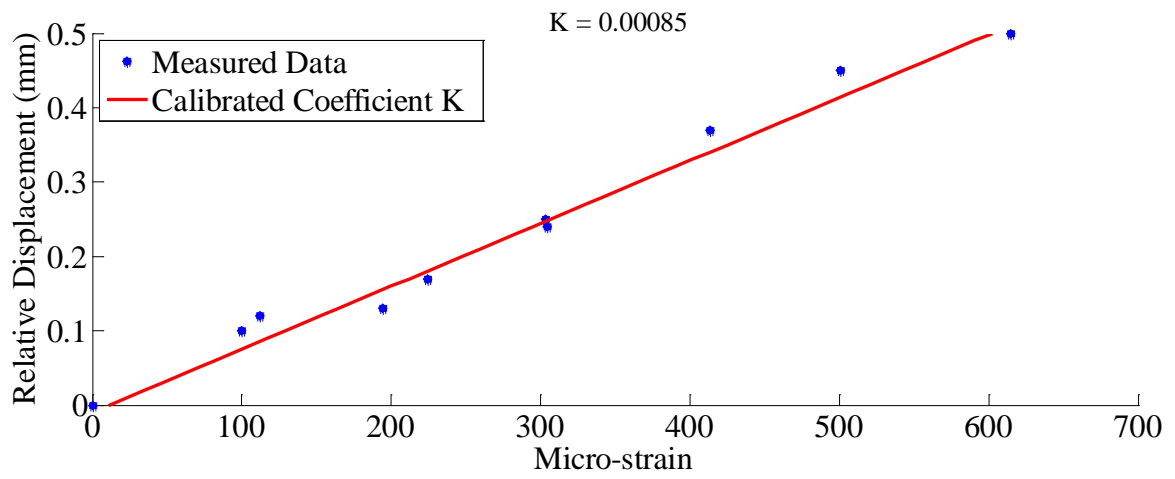
Figure 5 - Sensor calibration between strain and displacement

micrometer. The least-squares method is used to best fit these data with a straight line and calculate the coefficient K . Figure 5 shows the introduced relative displacement on the sensor vs output micro-strain from the Wheatstone bridge. The slope, that is the coefficient K , can be used to convert measured strain from the sensor as relative displacement when installed on a structure. Most points are fitted well with a clear linear relationship as shown in Figure 5. The relative error is calculated as 7.4%. The error in the calibration is probably due to the measurement inaccuracy in the micrometer with the resolution of 0.1mm and in strain measurement system besides the noise effect in measured signals. Unfortunately we do not have a more sensitive equipment to give a better relative displacement measurement. Nevertheless a linear behavior can be observed to demonstrate the relationship between strain and displacement. Moreover, it should be noted that the relative displacement sensor is developed to detect the damage of shear connectors through shifts in relative displacement between two structural points. In practice, the relative displacement between bridge girder and deck under traffic loading is expected larger than 0.1 mm at locations with damaged shear connectors. In this paper, the application of the developed relative displacement sensor is demonstrated by measuring the relative displacement between slab and girder in composite bridges for structural health monitoring.

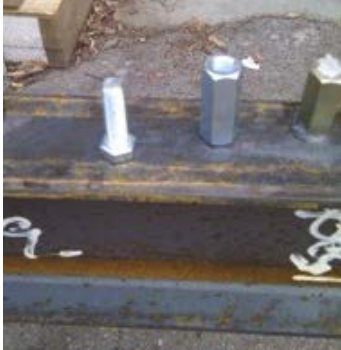
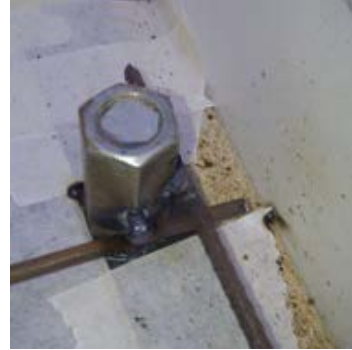
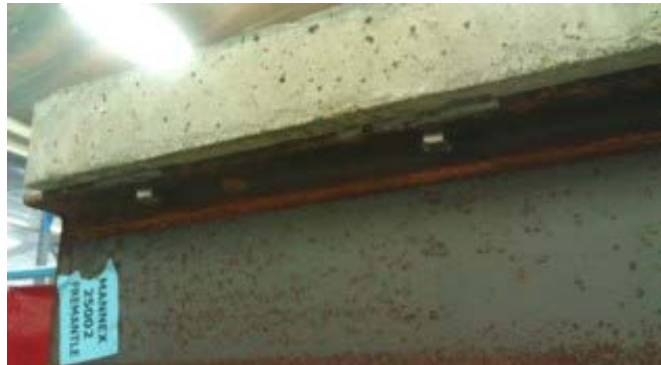
(a) Metric bolt and nut

(b) Bolt screwed into the nut

(c) Plan view of shear connectors
before pour

(d) Shear connector in the structure

Figure 7 - Design of shear connectors and composite bridge

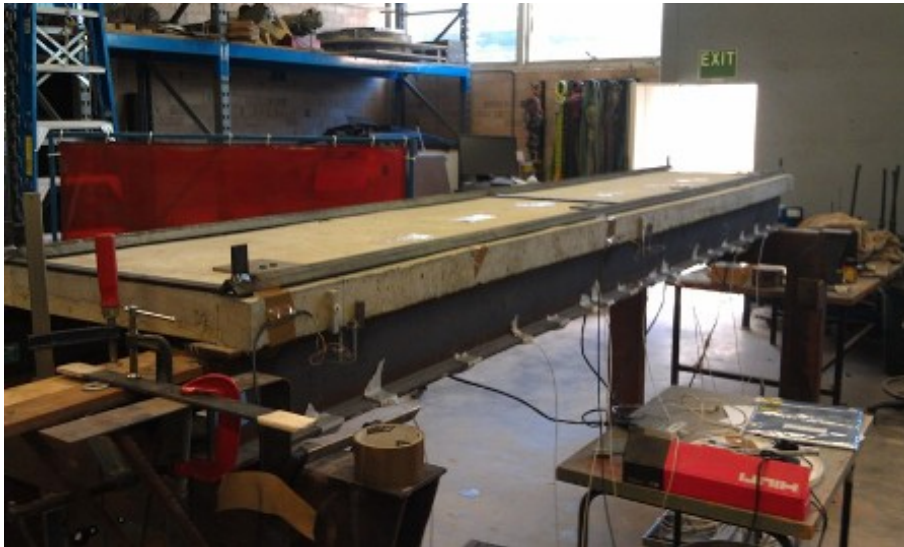
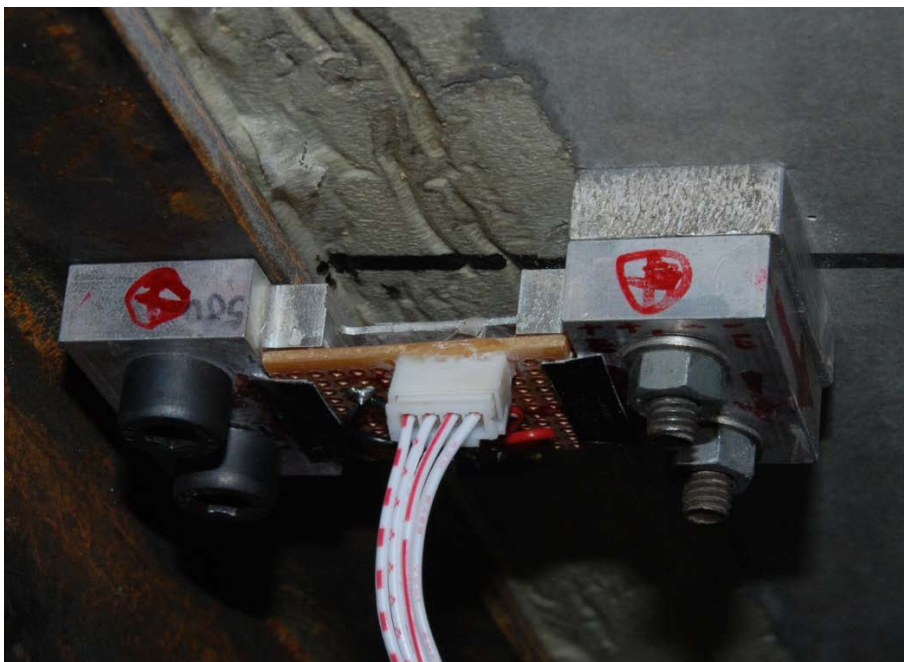
Figure 8 - Experimental setup (a) Composite bridge. (b) Sensor prototype

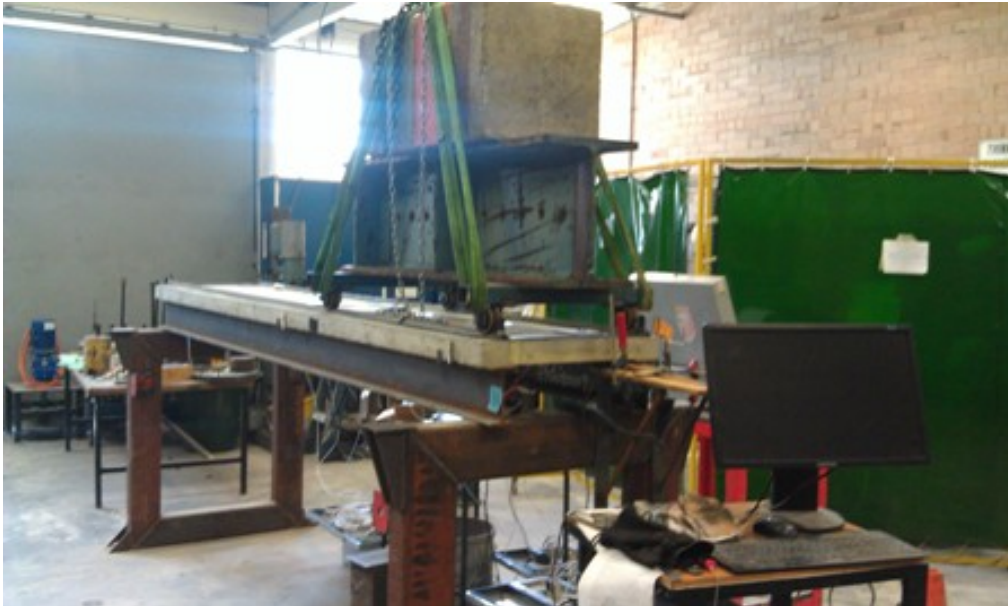
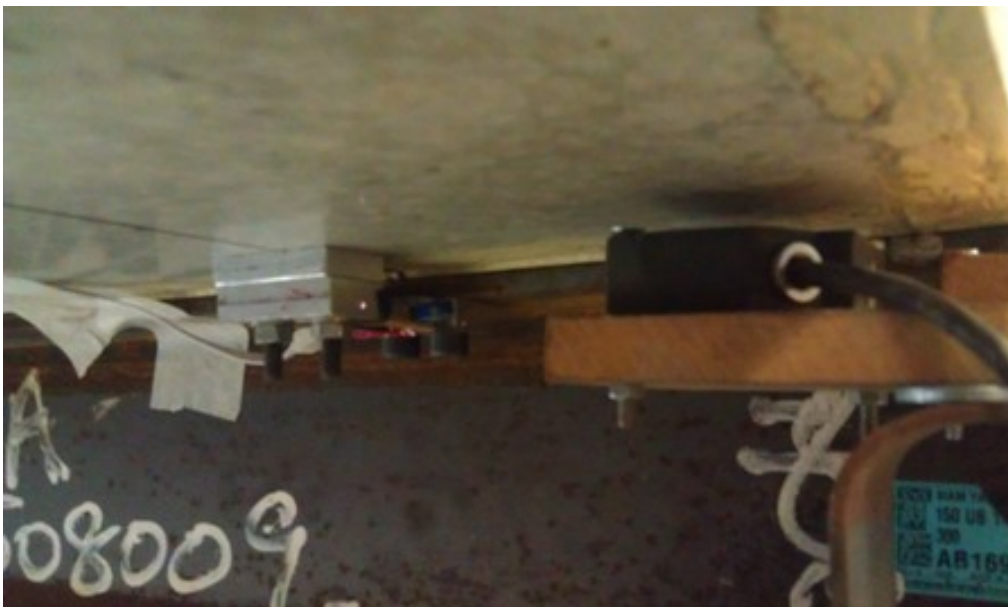
Figure 10 - Experimental test for the accuracy verification of the sensor

A trolley was designed in the laboratory with two concrete blocks placed on it. The trolley was placed on the top of the bridge model as shown in Figure 10(a). Two laser displacement sensors were also installed to target at the two pads of S1, as shown in Figure 10(b), in order to calculate the relative movement between two pads and validate the accuracy of the relative displacement sensor. The difference between the measured displacements from these two laser displacement sensors is obtained and compared with the directly measured relative displacement by the developed sensor.
