Citation: Ajour, M. N., Dissado, L. A., Fothergill, J. & Norman, P. N. (2002). Dielectric spectroscopy of epoxy/glass composite materials. Conference on Electrical Insulation and Dielectric Phenomena (CEIDP), Annual Report, pp. 438-441. doi: 10.1109/CEIDP.2002.1048828

Dielectric Spectroscopy of Epoxy/Glass Composite Materials

M. N.Ajour¹, L.A.Dissado¹, J.C.Fothergill¹, P.N.Norman²

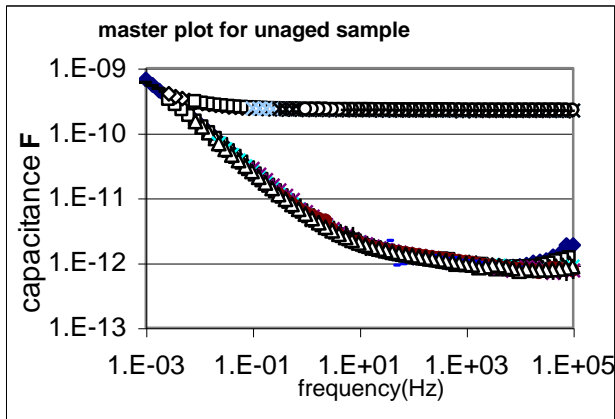
Figure (1). Master plot of the dielectric response of composite, for real (upper) and imaginary (lower) parts of capacitance, for 8 temperatures from 20-90 C

The measurements were performed on disc samples of 54 mm diameter ranging in thickness from 200 to 400 μ m. The dielectric experiments were carried out using a Solartron FRA system with a custom built temperature control accurate to ± 0.1 C. Capacitive and loss components were measured over a frequency range from 1 mHz to 100 kHz and from $T = 20$ C to 100 °C. The results for the composite are shown in Fig 1 in the form of a master plot constructed by translating the data along the $\log \{ \text{frequency} \}$ axis to bring them into coincidence. A broad loss peak was found at high frequencies that were assigned to the β -process of the glassy epoxy. The activation energy of ~0.3 eV found for the characteristic frequency is typical of such processes. A low frequency process was also found that possessed a constant phase angle (CPA) behaviour (i.e. $C'' \propto C' \propto f^{-p}$ with $p \approx 0.8$). This type of process has been termed a quasi-dc transport [2]. A characteristic activation energy of ~ 1.1 eV was found, but it is not possible to separate this into independent carrier concentration and mobility components. The dielectric response of a glass fibre mat showed a dc conductance at very low frequencies ($f < 1.3 \cdot 10^{-2}$ Hz), which transformed into a quasi-dc conductance (CPA) at higher frequencies, Fig 2. Both processes have the same activation energy of 0.46eV implying that the barriers to charge transport are the same in both cases. Measurements were made with two fibre mats as well as one. The results showed that the q-dc process varied with an inverse power of the thickness rather than inversely with the thickness. This result shows that the response observed is truly a bulk response and is what would be expected of a q-dc response originating with a percolation system. [2]. Although the activation energy is much lower than in the q-dc response of the

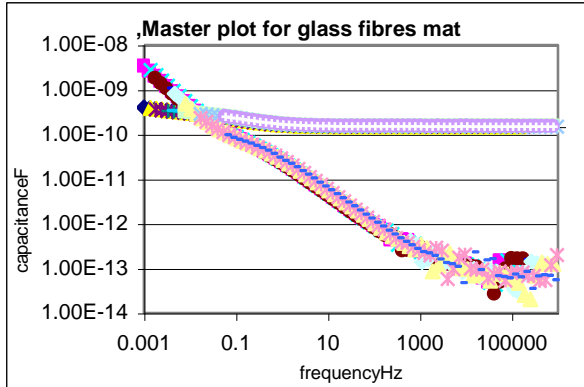
Figure 2. Master plot of the dielectric response of the glass fibre mat, Cr and Cim are real and imaginary parts of the capacitance respectively for the temperatures noted..

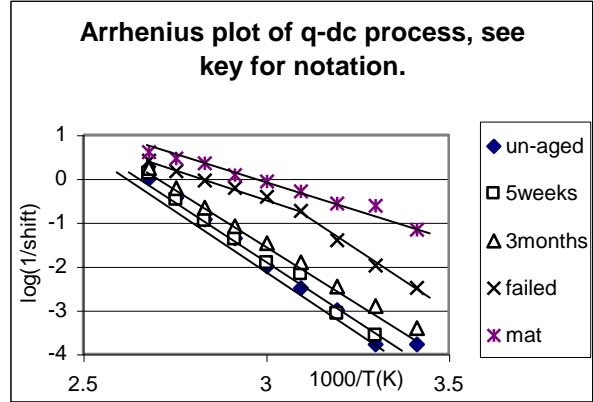
Figure 3. Activation energy of dielectric q-dc response in a range of samples as shown.

Dielectric measurements made on samples removed temporarily from ageing at 5 weeks, and 3months (at $E=62.5\text{kV/mm DC}$, $T=15\pm 5^\circ\text{C}$) and on the sample that failed show the same form of response as for the unaged composite. However, the q-dc process had moved to higher frequencies. Arrhenius plots for the set of samples measured are shown in Fig 3. It can be seen from this plot that except for the high temperature region of the failed sample, the activation energy has not changed with ageing. There is, however, a displacement towards higher frequencies, i.e. the process moves towards the behaviour observed on the fibre mat alone. This is even more marked in the failed sample where the activation energy changes at high temperatures to a value (0.53eV) close to that of the mat.

The dielectric response of the aged sample showed other features in addition to the q-dc behaviour. In part this may be due to the presence of the bored-out breakdown channel. The activation energy plot shows two regions of behaviour: one at low temperatures that paralleled that of the composite and one at higher temperatures that followed the fibre mat behaviour. A possible explanation is that the response is contributed by two systems in series. In this case the one with largest impedance will dominate. Thus the one with the smallest activation energy will dominate at high temperatures, and vice-versa the one with the largest activation energy will dominate at low temperatures. The values of the activation energies obtained indicate that the two systems correspond to regions where the fibre mat has become substantially de-bonded and regions where the fibre mat is still mainly bonded to the epoxy.

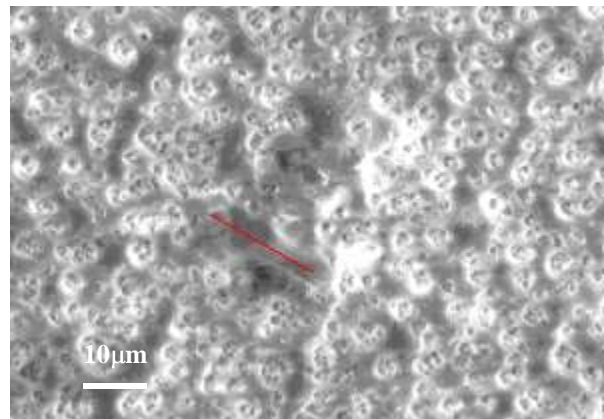
Figure 4. Shows the area near a black line that is indicated by the bar.

The failed sample was noted to have many ‘black lines’ in the plane of the sample (i.e. perpendicular to the field direction) and well away from the breakdown site. It proved impossible to resolve these under the optical microscope, so an SEM analysis was attempted. Figure 4 shows a view of a black line from above and there is little to see. Figure 5 shows the view of such a line in a region where the surface has been removed to expose it to view. The line can be seen to be a $2.5\mu\text{m}$ void running alongside the glass fibre for millimetres. Figure 6 shows an elemental analysis obtained on a sample prior to ageing using an SEM. The carbon peak is quite strong, as are peaks associated with the elemental content of the glass fibres (e.g Si, Ca, Al). The same analysis taken around the ‘black line’ in the failed sample, Figure (7), showed a strong reduction of the carbon peak with respect to the aluminium peak. This indicates that the black lines are not carbonised tracks such as may be produced by partial discharges.

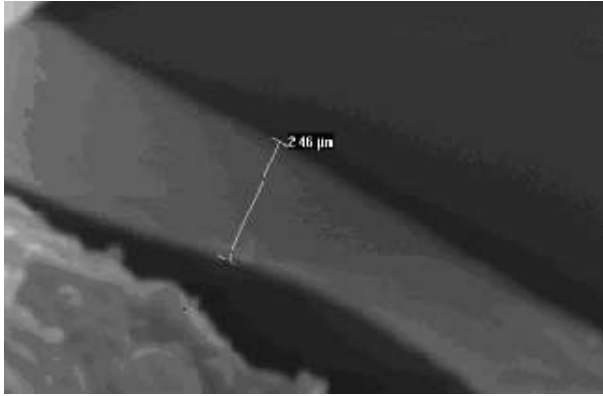
Figure 5 shows the voids (black lines) between the fibres and epoxy. The white line is 2.46 μm long

The generation of the interface voids is likely to be the cause of dielectric breakdown [6] as long as they are aligned with their long axis in the direction of the electric field [7]. Because of the weave of the mat most such voids will be aligned perpendicular to the field direction with a width of around 2-3 μ m, which is insufficient to support discharges at the fields applied [7]. At some stage, however, such voids can be expected to join together to provide a gap in the field direction long enough to support discharges. Once discharges can occur failure will follow rapidly. We believe that this is what happened in the sample that broke down.

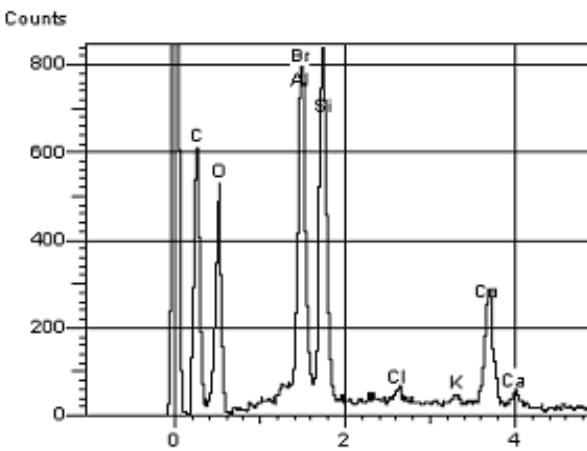
Figure 6 Elemental analysis of un-aged sample (cps vs. keV)

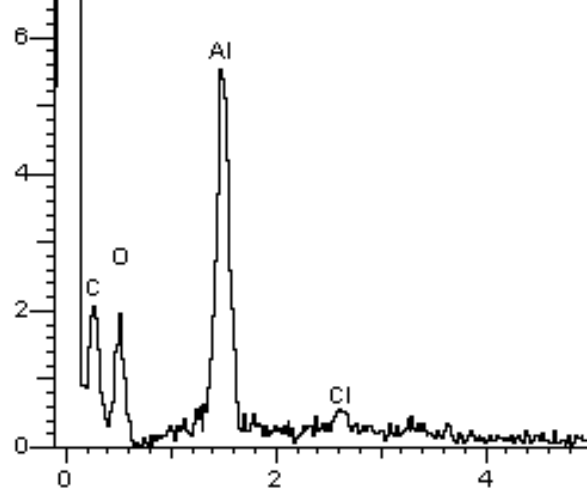
Figure 7. Shows elemental analysis of black line region (cps vs keV).
