# 941. Dislocation avalanches and strain bursts in the boards of electronic equipment

**Abstract.** Dislocation avalanches and strain bursts in the boards of radio-engineering equipment were investigated. For that purpose a cascade of navigation devices boards was installed on the vibration stand and experiments were performed in the 0.5 – 10 Hz vibration range at 0 – +45 °C temperature. Amplitude method was applied to determine the coordinates of localized sources of acoustic emission and research of mechanical stress in local points of material was performed using axial compression tests on tensile machine. The results indicate the initial increase in tension and relative deformation and further their decrement. The acquired experimental data on acoustic emission reflect the formation of microcracks and the instability of mechanical tension, its avalanche and explosive tendency in the material when the micro volumes of material are torn.

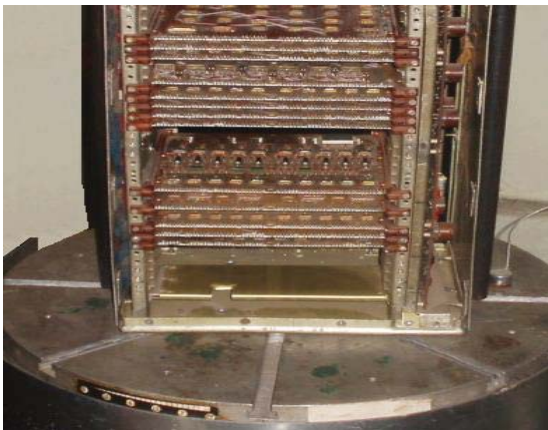
Fig. 1. Cascade of boards on the vibration stand

The investigation of influence of vibrations on the material of the board of radio-engineering equipment can be done using laboratory facilities consisting of source of vibration, transducers, signal registering and data processing apparatus. A cascade of navigation devices boards was installed on the vibration stand as shown in Fig. 1. The tension and compression of the upper and lower layers of the printed circuit boards were taken using the camera.

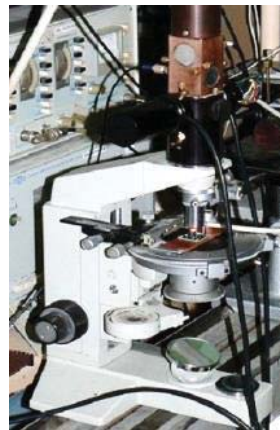
Fig. 2. The experiments with modernised differential-phase scanning laser microscope

The possibility of controlling the form of dislocations before the microcracks occur in the material of the board during exploitation was tested. The microfractures due to Portevin-Le Chatelier PLC effect and microdefects were monitored using modernised differential-phase scanning laser microscope that is shown in Fig. 2. Then, based on the data from 8 localities on the board the initial length of microelement ( $l_1$ ) and the length after deformation ( $l_2$ ) were used in the evaluation  $\varepsilon = (l_2 - l_1)/l_1$ . The data of increase of mechanical stresses was determined using the methodology of smoothing of mechanical stress accumulation in the microlayers and is shown in Fig. 3. The data point were widely scattered along the vertical axis  $\varepsilon$ , therefore the points were connected for data averaging. The signals and noises of different origin can be occurred during local plastic deformation as signals of the friction between the board and mounting points on the stand, the intrinsic noise of the test stand, etc. These factors make the acquisition of data more difficult. This is especially important for devices, which are sensitive to acoustic emission. Therefore for discrete signals various filtering methods are used like discrimination of sources according to location [4], spectral composition [5].

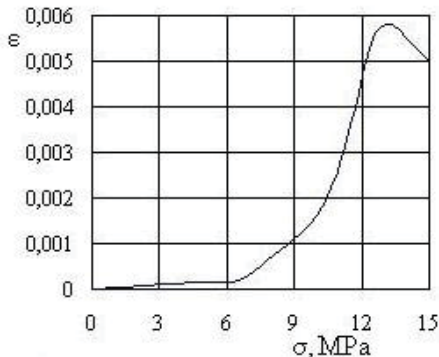
**Fig. 3.** The diagram of increase of mechanical stresses in the microlayers of material

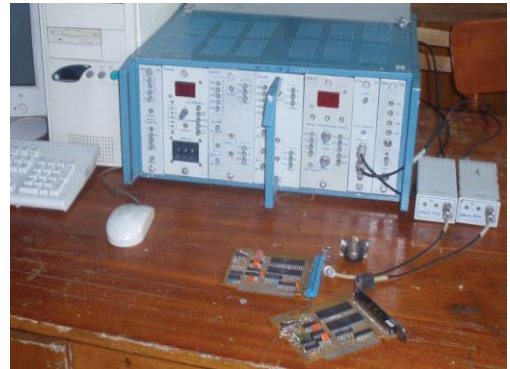
**Fig. 4.** Acoustic emission signal detection and data processing facilities

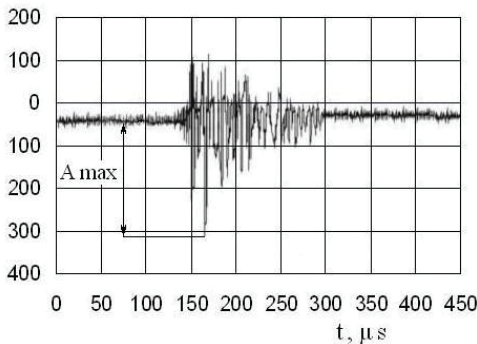
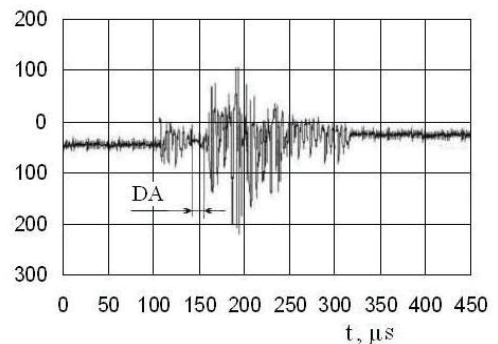
**Fig. 5.** Oscillographic registration of acoustic emission signal and determination of signal parameters: where DA – the difference in the arrival time of signals and its subsequent self-smoothing due to piezoeffects, A max – amplitude of oscillation

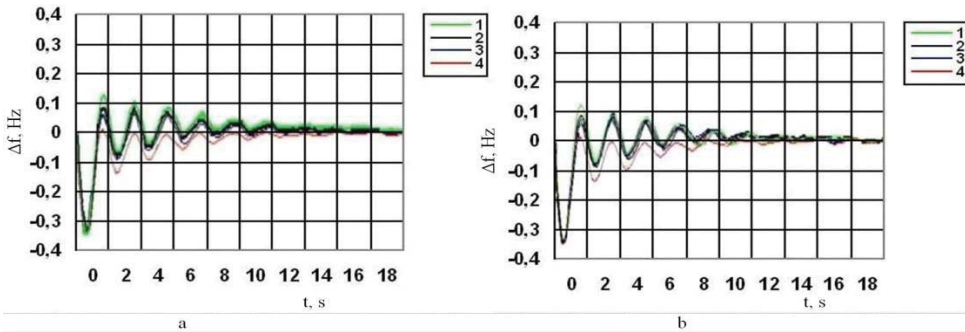
**Fig. 6.** Acoustic spectra of microsensors on local points on the board: a – “smoothing”; b – reduction in avalanche formation and stabilization of difference of acoustic emission (after 10 s); where 1 – +45 °C; 2 – +20 °C; 3 – +8 °C; 4 – 0 °C

temperature are shown in Fig. 6. Mechanical stress and relative deformation of investigated samples are shown in Fig. 7.

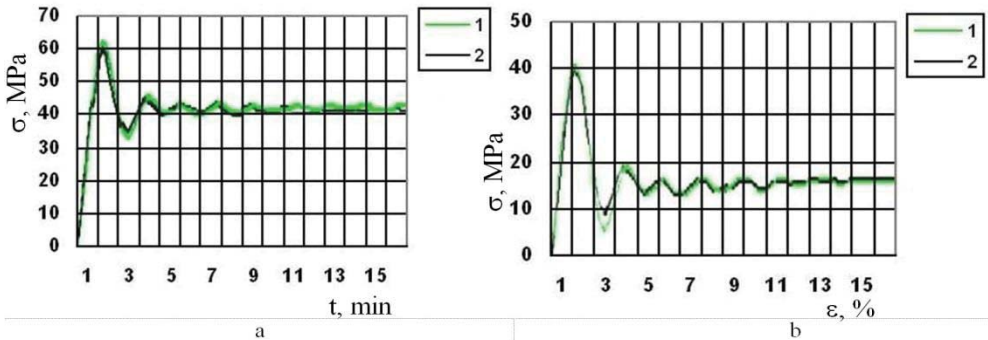
**Fig. 7.** Mechanical stress and deformation curves: a – stress in the material of the board; b – the compression diagram. Curves correspond to the temperature values on Fig. 7

The results indicate the initial increase of mechanical stress and relative deformation and further their decrement. In the region  $\sigma \in [0; 57]$  MPa mechanical tension is practically linear and depends on the relative deformation. The limit of proportionality  $\sigma_p = 20$  MPa (correspond to the relative deformation value of  $\varepsilon_p = 6 \cdot 10^{-4}$ ) is achieved when time value  $t = 1.2$  min. Reduction of growth rate of mechanical stress  $d\sigma/d\varepsilon$  when  $\sigma \geq \sigma_p$  is due to destruction of material structure. The receiving piezo converter and a waveguide which was in acoustic contact with the sample were used during experiments. The data was stored in the memory of personal computer and is shown in Fig. 8.

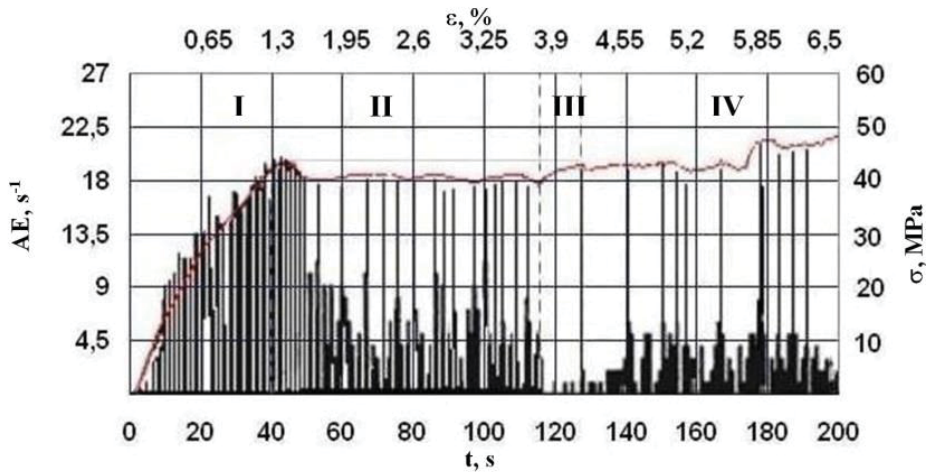
Fig. 8. AE activity when sample is being deformed (dashed lines mark characteristic stages: I – elastic, II – yield plateau, III – “silence zone”, IV – stage of parabolic hardening)

From Fig. 8 it can be seen, that when the plastic deformation at the yield plateau is realized by oncoming movement from piezoeffect of two Chernov-Luders bands, the localization of acoustic emission sources exhibits similar characteristics as was found for well examined samples of low-carbon steel. The data acquired in this work differ only by the order of mechanical stress, but doesn't negate the established pattern of the acoustic emission signals occurring when local points are subjected to deformation. In this case, the motion of the first Chernov-Luders line corresponds to the spatial distribution of acoustic emission sources. The second Chernov-Luders line is moving towards the first and the velocity of lines movement is dropped to zero. This means complete lack of resistance due to complete destruction of the material in the local point, where it was a microcrack filled with air developed. This is confirmed by the fronts of acoustic emission pulses. Then destruction of the neighboring local points begins as can be observed in Fig. 7 after 120 seconds from the beginning of tension-
