Does Surface Topography Improve Electrochemical Behavior of Ti–6Al–4V Alloy in Different Saliva pH Levels?

Abstract The objective of this study was to evaluate the corrosion kinetics and microstructural change of a Ti–6Al–4V alloy with machined and treated surfaces (sandblasted with aluminum oxide or double acid-etched) at three salivary pH levels. For an electrochemical test ($n = 5$), open-circuit potential and electrochemical impedance spectroscopy analyses were conducted in artificial saliva at pH 3, 6.5, and 9 in the three types of Ti–6Al–4V surfaces. The capacitance (CPE) and the polarization resistance (R_p) of the titanium oxide layer were determined. Disk surfaces were characterized using scanning electron microscopy, atomic force microscopy, and profilometry, which provided the surface roughness (Ra) of the disks before (baseline) and after the electrochemical test. The corrosion parameters were compared by two-way ANOVA. One-way ANOVA was applied for analyzing Ra values of the specimens before and after the electrochemical process. For results that were statistically significant, the Tukey HSD test was used. The level of significance used for all tests was 0.05. The hig

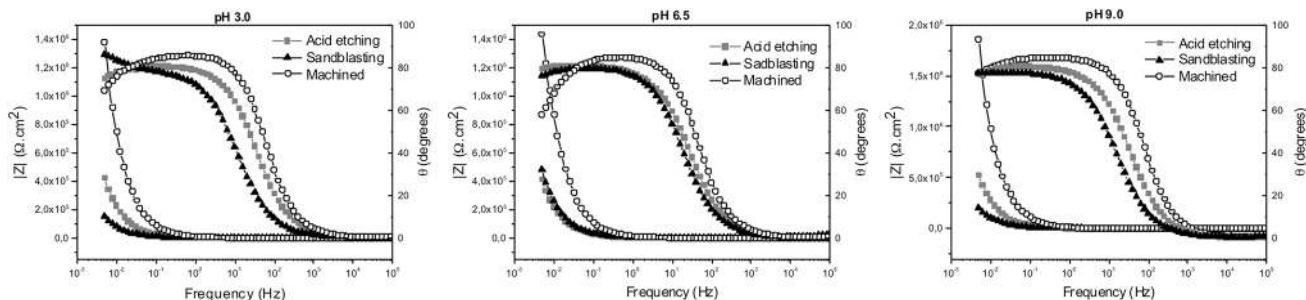
Fig. 1 Electrochemical impedance spectroscopy (EIS) represented by the Bode plot of the Ti-6Al-4V alloy for acid-etching, sandblasting and machined surface in three pH levels (3, 6.5 and 9). Different

phase angle values were noted for the machined surface (approximately 90°), the acid-etched surface (approximately 80°), and the sandblasted surface (approximately 70°)

The Bode plot representing the corrosion kinetics of Ti-6Al-4V showed a constant phase angle in all cases. Different phase angle values were noted for the machined surface (approximately 90°), the acid-etched surface (approximately 80°), and the sandblasted surface (approximately 70°). At low frequency, the total impedance values, $|Z|$, were higher for the machined and etched groups as compared to the sandblasted group, regardless of salivary pH conditions (Fig. 1). Acidic pH tended to reduce total impedance values. The Nyquist plot showed that the sandblasted surface decreased the diameter of the semicircle of the total impedance plot of Ti-6Al-4V (Fig. 2). At pH 3, there was a slight reduction in the diameter of the semicircle as compared to pH 6.5.

In relation to the CPE, the surface treatment condition exhibited a statistically significant effect ($p < 0.001$, ANOVA) (Table 3). In all interactions (sandblasted vs. machined, sandblasted vs. etched, and machined vs. etched), there was a significant change in CPE ($p < 0.05$, Tukey HSD test) (Table 3; Fig. 4). The machined surfaces had the lowest CPE, which were independent of pH, followed by the disks treated with double acid-etching; the greatest CPE values were observed for the sandblasted surfaces. These data corroborate the results of the Bode plots and Nyquist plots (Figs. 1, 2).

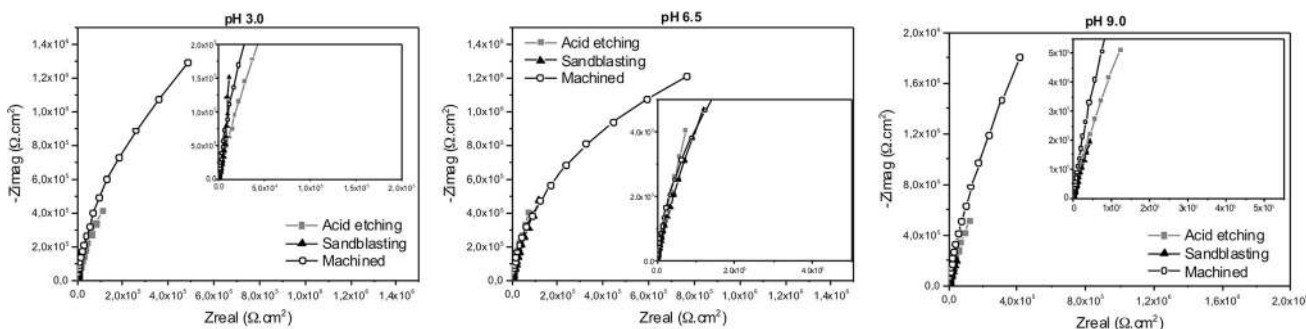
Fig. 2 Electrochemical impedance spectroscopy (EIS) represented by the Nyquist plot of the Ti-6Al-4V alloy for acid-etching, sandblasting and machined surface in three pH levels (3, 6.5 and

9). Sandblasted surface decreased the diameter of the semicircle of the total impedance plot of Ti-6Al-4V

With respect to the corrosion kinetics, the surfaces of Ti-6Al-4V sandblasted with Al_2O_3 had the lowest values of R_p and higher CPE values. Additionally, the Nyquist plot showed that this surface decreased the diameter of the semi-circular "loop" capacitance for all situations tested, indicating poor corrosion resistance. Surfaces with a larger Nyquist plot diameter are fitted to circuits with a larger R_p . Surfaces with a larger R_p have better corrosion resistance and decreased corrosion rates. Surfaces with a higher CPE have an electrical double layer with higher capacitance, promoting higher corrosion rates. Thus, the sandblasted Ti-6Al-4V alloy exhibited poor corrosion behavior as compared to the etched and machined samples. This may have been due an increased surface area and the presence of Al_2O_3 particles, which can decrease the corrosion resistance through passive layer weakening, as observed by Burnat et al. [36].

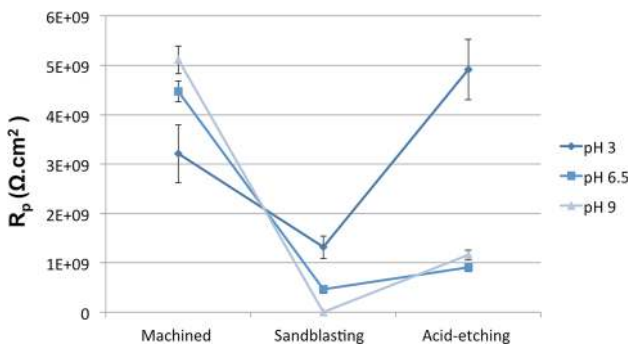
Fig. 3 Means and standard deviations of polarization resistance (R_p) of the Ti-6Al-4V alloy for acid etching, sandblasting and machined surface in three pH levels (3, 6.5 and 9). Machined surface and treated with double acid-etching showed the highest values of R_p , regardless of salivary pH

R_p was influenced only by the surface condition of Ti-6Al-V ($p = 0.023$, ANOVA) (Table 2). The specimens with the machined surface and treated with double acid-etching showed the highest values of R_p , regardless of salivary pH ($p = 0.264$, Tukey HSD test). At pH 3, R_p had a tendency to increase for etched Ti-6Al-4V, whereas at

pH 6.5 and 9, the machined disks had a higher R_p (Fig. 3). The treatment with aluminum oxide decreased the R_p value of Ti-6Al-4V at all pH levels ($p < 0.05$, Tukey HSD).

Surprisingly, salivary pH had no effect on the corrosion kinetics of the Ti-6Al-4V alloy. The corrosion behavior was very similar among the analyzed pH levels (3, 6.5, and 9), as seen from the observed values of R_p and CPE (Figs. 3, 4). It is clear that the surface of the Ti-6Al-4V alloy promoted oscillations in the material corrosion rate. Previously published studies have shown a higher rate of corrosion in acidic saliva (pH 3) [9, 34, 35]. However, these studies evaluated Ti-6Al-4V disks with mirror-like machined surfaces with no changes in microstructural topography. Even if the results of our study did not show statistically significant changes for the salivary pH, the machined surfaces showed a trend toward higher capacitance values and lower polarization resistance values in acidic saliva. CPE refers to the ions exchange between the material and the environment, whereas R_p indicates the protectiveness of the material's surface against corrosion. The higher the CPE value and the lower the R_p value, the greater the corrosion of the material.

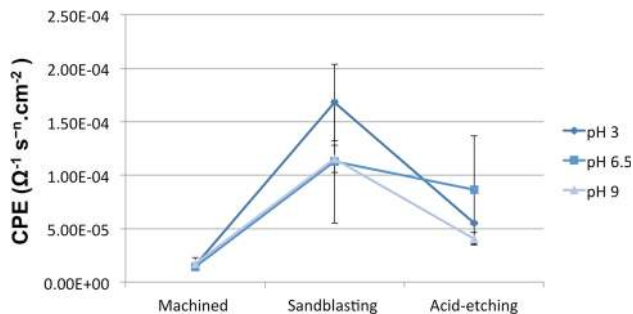
Fig. 4 Means and standard deviations of constant phase element (CPE) of the Ti-6Al-4V alloy for acid etching, sandblasting and machined surface in three pH levels (3, 6.5 and 9). Machined surfaces had the lowest CPE, which were independent of pH, followed by the disks treated with double acid-etching; the greatest CPE values were observed for the sandblasted surfaces

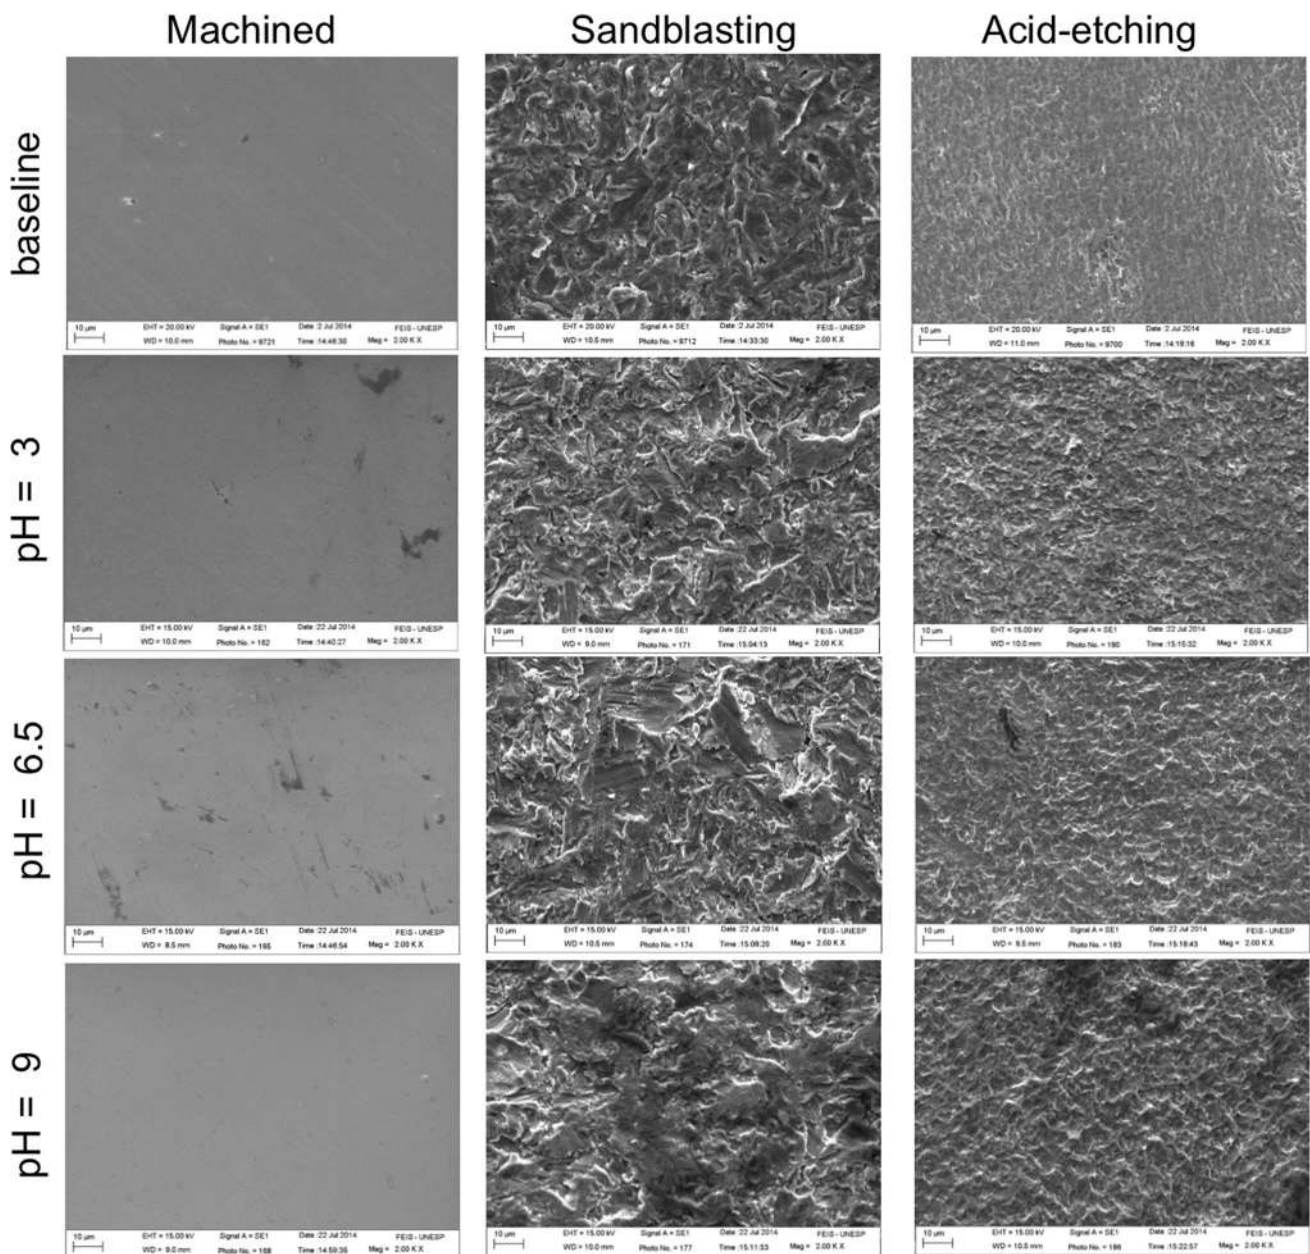
Fig. 5 Scanning electron microscope images (2,000x) of the Ti-6Al-4V alloy with acid etching, sandblasting and machined surface in three pH levels (3, 6.5 and 9), before and after electrochemical assay

The SEM images (Fig. 5) before and after electrochemical assay showed smooth surfaces for the machined samples, good adhesion of the oxide layer on the sandblasted samples, film integrity, and homogeneous morphology. The machined surfaces after electrochemical tests in artificial saliva at pH 3 and 6.5 showed some black spots as a result of artifacts. The sandblasted samples exhibited visible topographic alteration, with the attachment of Al_2O_3 particles of standard shape and size. The acid-etched samples exhibited uniformly pitted surfaces.

The Ra data were not affected by the corrosion process, and no changes were observed in the AFM and SEM images. It is important to note that the release of Ti ions in the corrosion process may not cause a significant increase in Ra. Another factor to consider is the immersion time of the Ti–6Al–4V surface in acid pH and its clinical implications. It is thought that the immersion time (approximately 2.5 h) was too short to cause changes on the Ti microstructure. Additionally, monitoring the open-circuit potential and then performing EIS analysis are not generally expected to change the surface very much for passive alloys. Future studies should investigate the corrosion behavior of titanium material subjected to long-term immersion, thus simulating acidic diets or systemic changes that would modify the salivary pH for a long period of time.

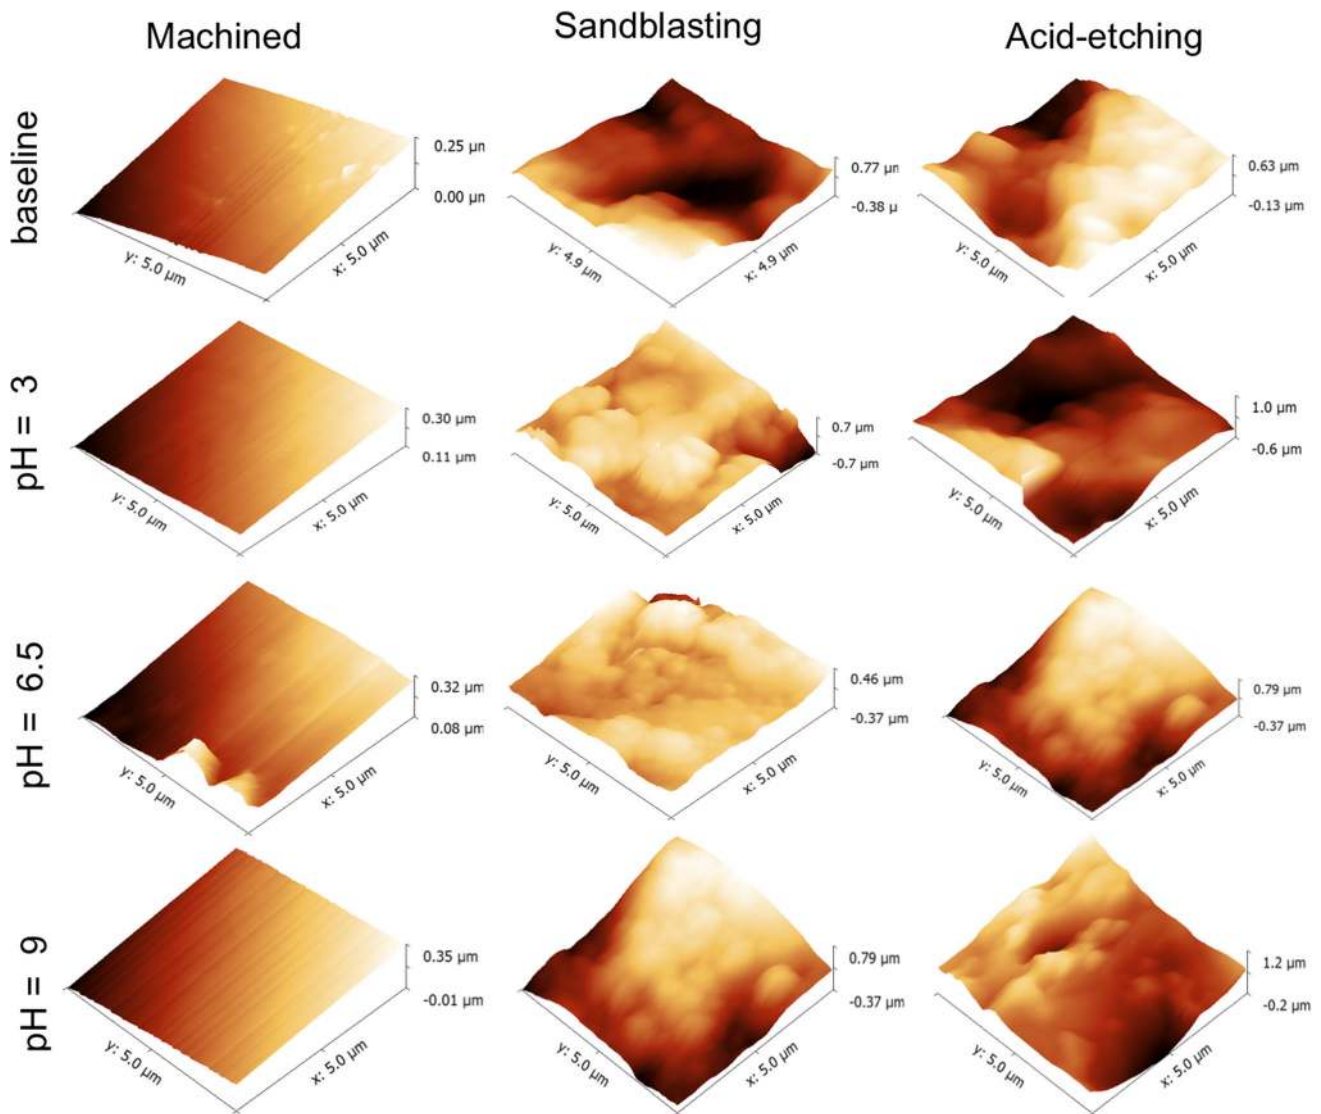
Fig. 6 Tridimensional atomic force microscopy images of the Ti-6Al-4V alloy with acid etching, sandblasting and machined surface in three pH levels (3, 6.5 and 9), before and after electrochemical assay

Figure 6 exhibits the AFM images of Ti-6Al-4V before and after corrosion. The machined surfaces were smooth for all conditions. Sandblasting and acid-etching treatments created peaks and valleys on the Ti surface.

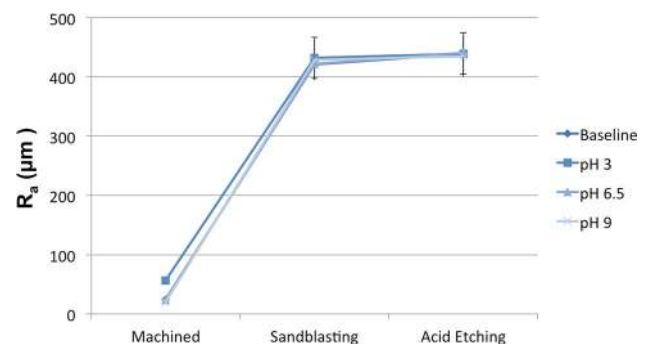
Fig. 7 Means and standard deviations of surface roughness (R_a) for the Ti-6Al-4V alloy with acid etching, sandblasting and machined surface in three pH levels (3, 6.5 and 9), before and after electrochemical assay

Figure 7 shows the mean values of Ra. Although the surface treatment had a significant influence ($p < 0.0001$, ANOVA), the corrosion process had no effect on the Ra values ($p = 0.284$, ANOVA). The machined surfaces exhibited the lowest Ra values before and after corrosion. Similar Ra values were noted for the sandblasted and acid-etched samples.
