1 **Durability performances of carbon fiber reinforced polymer (CFRP) and**
2 **concrete bonded systems under moisture conditions**

3 Justin Shrestha⁽¹⁾, Dawei Zhang⁽²⁾, Tamon Ueda⁽³⁾

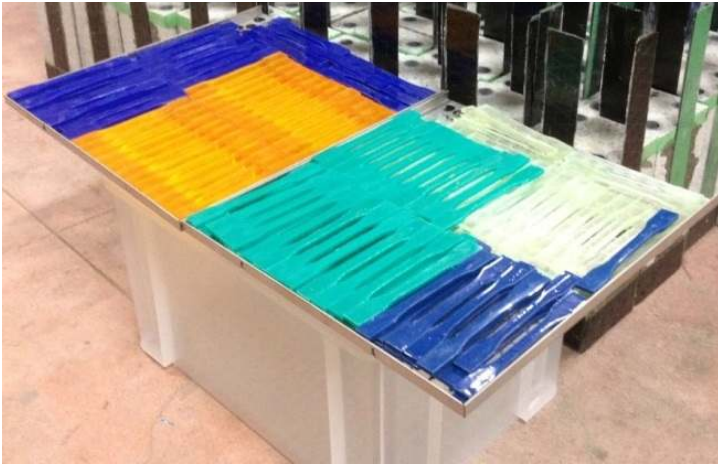
Fig. 1. Epoxy resin specimens for the tensile test

142 The dog-bone shaped resin specimens for the uniaxial tensile test were prepared following
143 JIS.K.7113 (1995). The specimens were prepared using all the 8 kinds of epoxy resin which
144 include 2 types of primer. The base and hardener was mixed in a recommended proportion

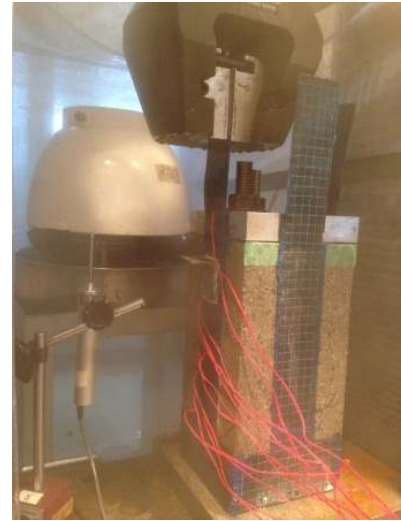
Fig. 5. (a) Test arrangement schematic for the bond specimen inside the environmental testing chamber ; (b) Specimen during the test inside the chamber

179 and humidity. The schematic of the testing arrangement of the shear specimen inside the
180 controlled chamber along with the specimen during the test is shown in Fig. 5. Throughout
181 the test period, the temperature of 20 ± 3 °C and humidity over 85% was maintained in order
182 to prevent the loss of moisture from the specimens. As for the direct pull-off test, shown in
183 Fig. 6, no such arrangement was made to control the temperature and humidity of the testing
184 condition as the setting and testing period was very short which could be assumed to have
185 negligible effect. At the end of 18 months immersion, a set of specimens were removed from
186 the water and transferred into a chamber for the purpose of drying. The specimens were kept
187 inside the chamber for 4 days at a constant temperature of 28 °C. The specimens were
188 assumed to have dried when the change in weight within a day was less than 0.1%. The main

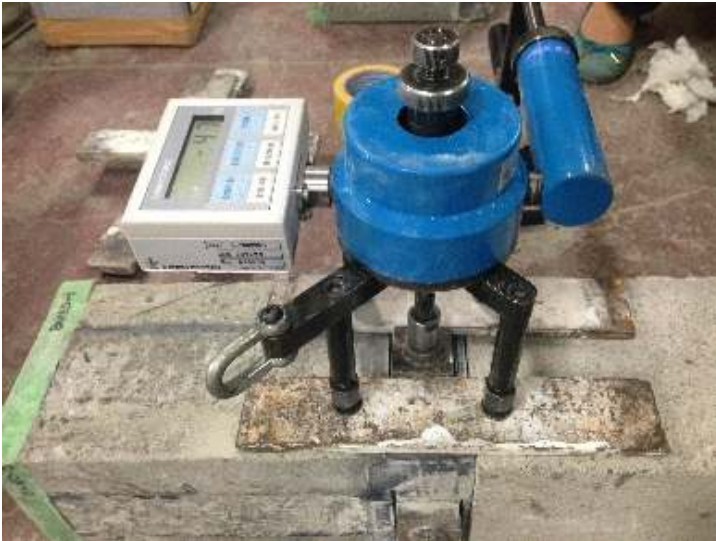
Fig. 6. Direct pull-off test setup

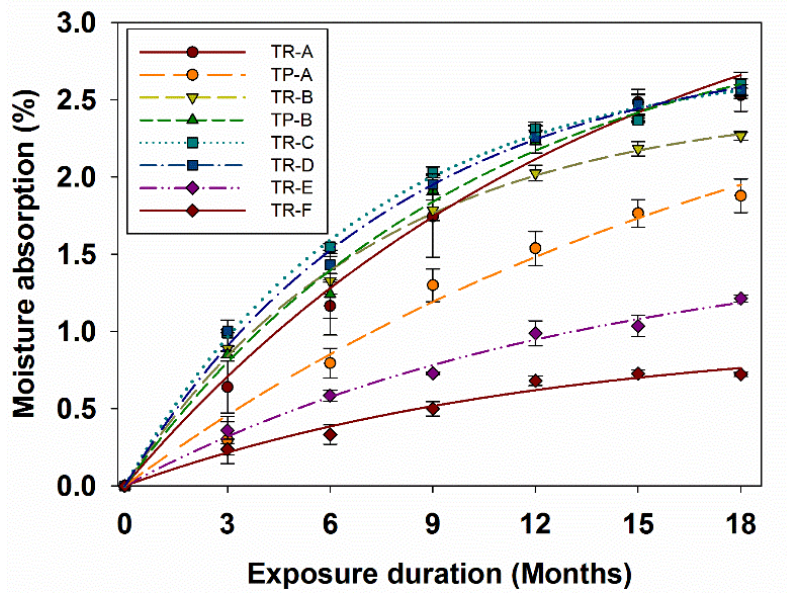
Fig. 7. Moisture absorption by epoxy resin specimens

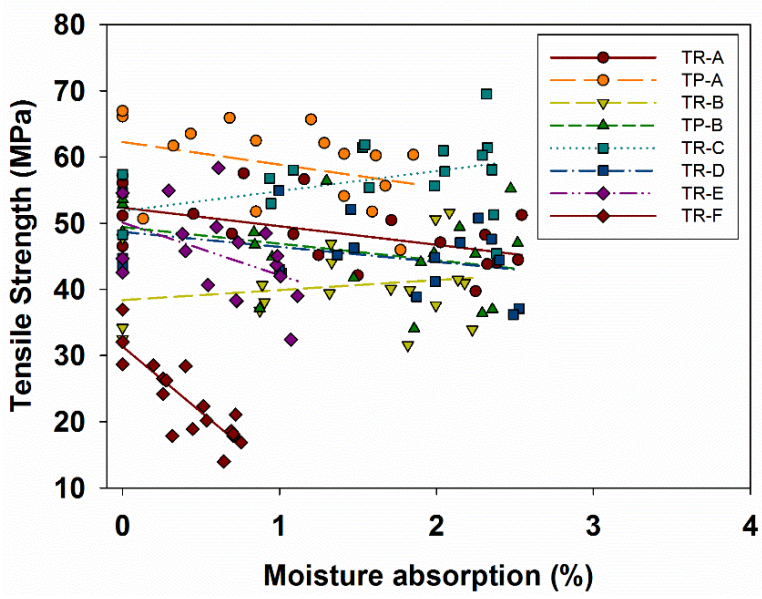
Fig. 8. Relationship between tensile strength with the moisture absorption by the resins

234 In Fig. 8, the relationship between average tensile strength and water absorption shows two
235 distinct trends. Except in two of the cases (TR-B and TR-C), the increase in the moisture
236 absorption resulted in reduction of the tensile strength. However, depending on the resin type,
237 the degree of such effect varied. The highest reduction in tensile strength occurred in the resin
238 TR-F with an average reduction of around 38% after exposure, but, the ultimate water
239 absorption was only 0.71%. Whereas, those with the water absorption of over 2% showed
240 reduction in between 11% to 22%. In two of the cases, TR-B and TR-C, there was no effect

241 despite the water absorption of around 2%. Therefore, all the above results indicate that the
242 durability of the resins are highly dependent on the materials and the amount of water
243 absorption alone cannot be used as an indicator to judge or predict the effects caused by itself.

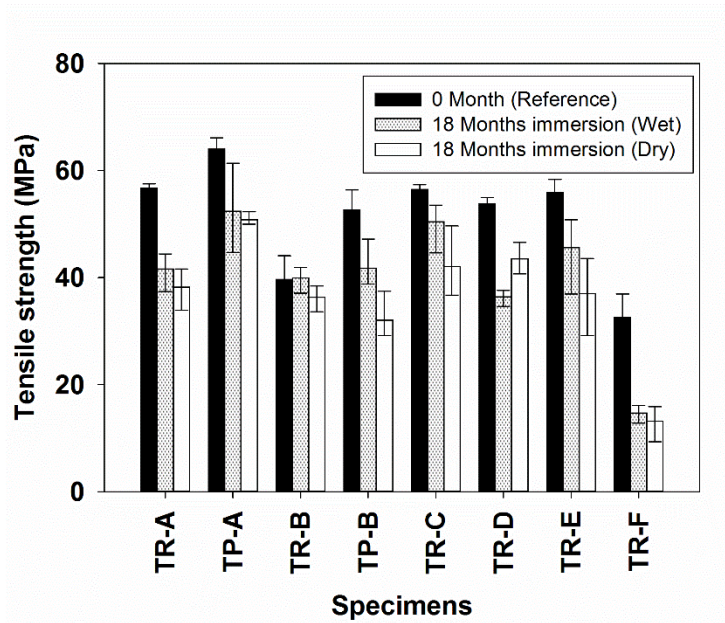
Fig. 11. The effect of testing condition (wet/dry) on the tensile strength of the resins after 18 months of immersion in water

251 Figure 11 and Fig. 12 show the comparison of the tensile strength and modulus of the resin
252 specimens respectively tested under wet and dry condition after 18 months of exposure. The
253 results show that drying of the resins after 18 months of immersion in water does not recover
254 the initial mechanical properties, indicating that the exposure due to the moisture
255 conditioning caused some irreversible effect in the resin properties. These irreversible effects
256 could be due to loss of crosslinking density and permanent swelling of the resins (Tuakta and
257 Büyüköztürk, 2011).

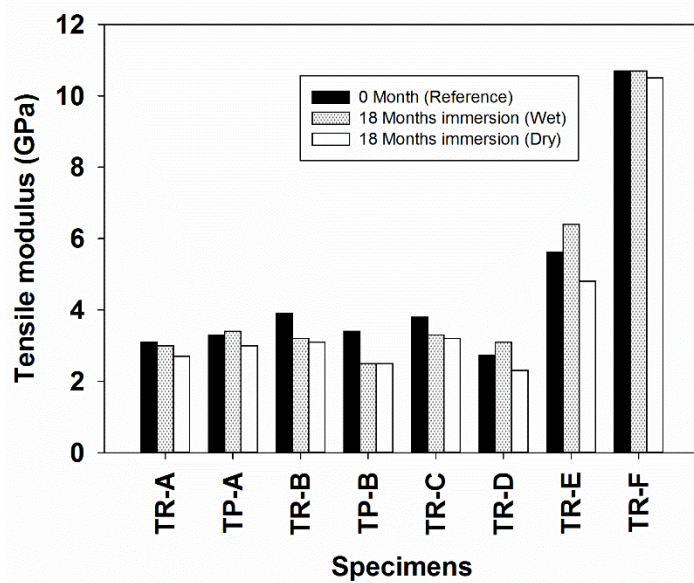
Fig. 12. The effect of testing condition (wet/dry) on the tensile modulus of the resins after 18 months of immersion in water

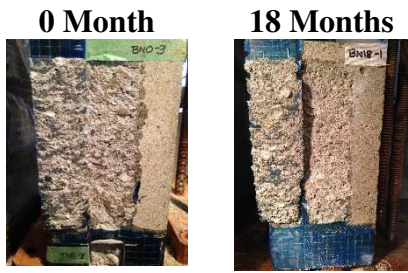
(a) Concrete cohesion failure

(b) Mixed failure

(c) Adhesion failure

Fig. 13. Comparison of three typical failure modes before and after 18 months of exposure

259 Based on the observation of the failure surfaces after the shear test, the failure modes can be
260 categorized into 3 groups. Cohesion failure at the concrete layer (C) (Fig. 13a), mixed failure
261 (M) (Fig. 13b) and finally, the interface failure between concrete and resin layer (I) (Fig. 13c).
262 Among above three, concrete cohesion failure is the common mode of failure under normal
263 environmental condition. This failure mode was common in specimens SB-A, SB-E and SB-
264 F, indicating good adhesion bond between the CFRP and concrete. As for the specimens SB-

265 B and SB-D, the failures were usually of mixed type defined as the partial failure in concrete
266 cohesion and resin-concrete interface adhesion failure. The failure percentage in concrete to
267 the resin-concrete interface varied even within the similar exposure condition, but, no
268 distinction is made between such cases and generalized as a mixed failure mode. The last
269 failure mode was the adhesion failure at the interface between resin and concrete. This failure
270 mode is the least desired implying either insufficient surface preparation or the weak
271 adhesion bonding of the resin with the concrete. The latter could be the reason in specimen
272 SB-C, as similar degree of surface preparation was done in all the systems.

273 Transition of failure mode from the concrete cohesion to either mixed or interfacial failure
274 was observed as an effect of moisture. Most of the specimens within SB-A, SB-B, SB-E and
275 SB-F showed such transitions after the exposure. Likewise, the mixed failure mode before the
276 exposure either retained the same or changed to interfacial failure as in cases of SB-B and
277 SB-D. Lastly, the interfacial failure cases observed in SB-C, retained the same failure modes
278 irrespective of the exposure and its duration. Even drying the specimens after 18 months of
279 immersion did not affect the failure modes. Most of the results were comparable with the wet
280 cases. The distinction of all the failure modes after different exposure durations are
281 summarized in Table 3.

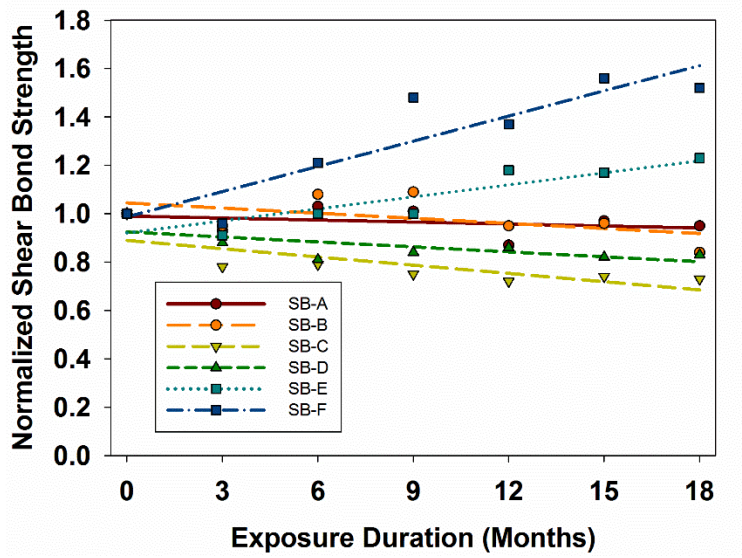
Fig. 15. Relationship between normalized shear bond strength and the exposure duration

299 Figure 14 shows the variation of the average shear bond strength with the exposure duration.
300 Initially, in the first 3 months of exposure, the moisture seems to show significant reduction
301 in the bond strength after which it was retained in most of the cases in extended exposure
302 duration. From the figure, it is also evident that the bond strength increased significantly in
303 case of SB-F system after 3 months of immersion till the 9 months and then remained almost
304 constant till the 18 months. As for SB-E system, the bond strength remained fairly unchanged
305 until 9 months followed by a small increment in 12 months and then remained almost
306 constant until the 18 months. For rest of the cases, it is rather difficult to see the clear trend
307 from the figure due to overlapping of data points. Therefore, Fig. 15 shows the shows the
308 relationship between average bond strength at each exposure duration normalized by the

309 average bond strength for non-immersion case. The average value was calculate based on the
310 results 3 specimens tested for each exposure condition. Based on the changes in the average
311 bond strength with the exposure duration, results could be categorized into 3 groups. The
312 systems such as SB-A, SB-B and SB-E with less than 5% reduction in the average bond
313 strength between non-immersion and immersion is grouped in the first category. As for the

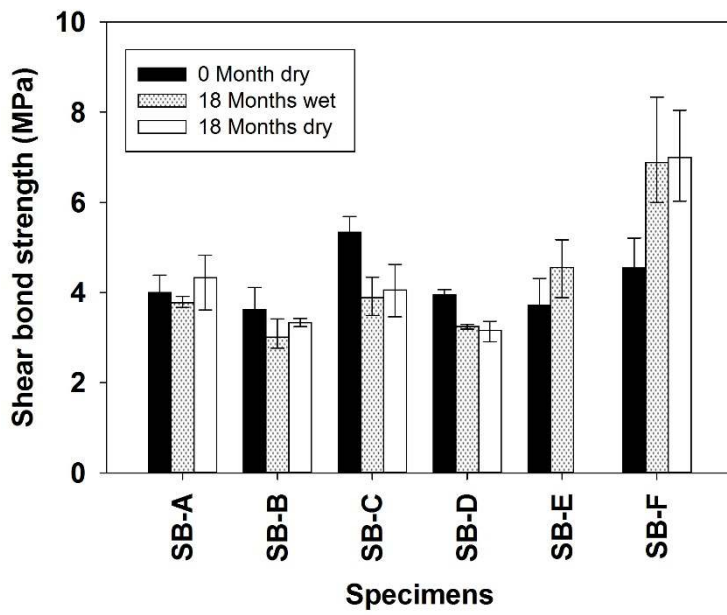
Fig. 17. Effect on shear bond strength after 18 months of immersion and different testing conditions (wet/dry)

386 The effect of wet and dry testing conditions were also examined on the shear bond strength
387 after 18 months of immersion in water as shown in Fig. 17. About less than 5% recovery of
388 average bond strength was found in specimens SB-C and SB-F, whereas the recovery was

389 over 10% in case of specimens SB-A and SB-B but no such effect was observed in SB-D
390 case. The results of specimen SB-E was not included due to some problems associated with
391 the specimen during preparation process. In conclusion, even though slight recovery of bond
392 strength was noticed in some cases after drying, it could not restore back to the original state
393 indicating that the deteriorations due to water causes irreversible effect on the bond properties.

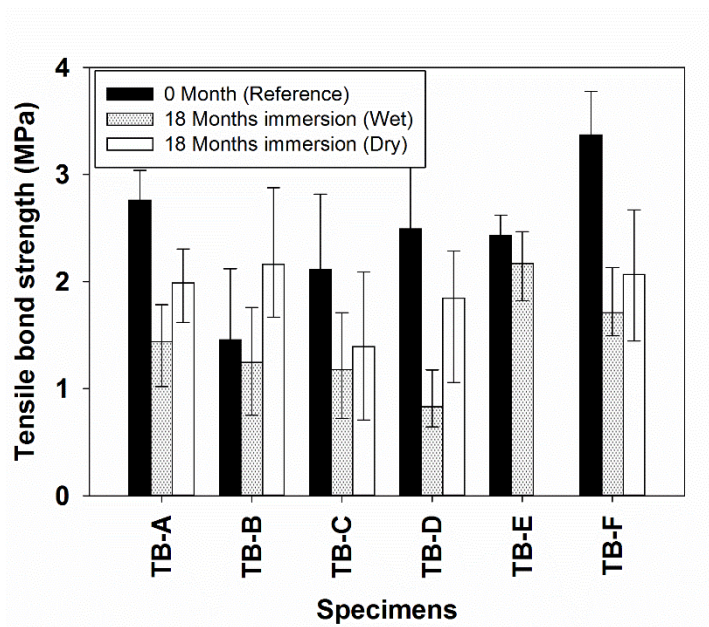
Fig. 19. The effect on tensile bond strength after 18 months of immersion and different testing condition (wet/dry)

421 Figure 20 shows tensile bond strength comparison tested under wet and dry condition after 18
422 months of exposure in water. Similar to the shear bond behavior, drying process helped
423 recovery of the tensile bond strength, but was not able to retain back the original state. Only
424 in the case of specimen TB-B, the resulting strength was higher than the original strength.
425 Even in the failure modes, no distinction could be made between those conditions as most of
426 them failed in concrete.

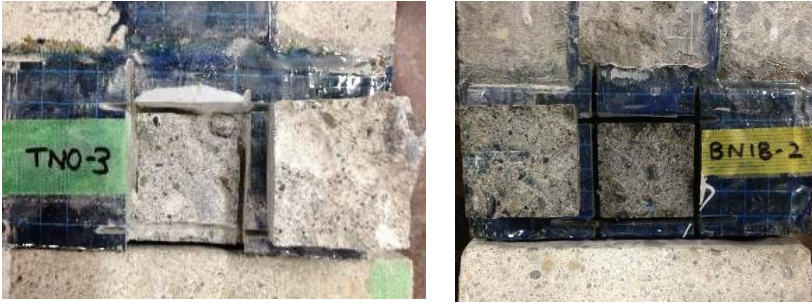
Complete failure at concrete layer

Fig. 20. Comparison of typical failure mode before and after 18 months of exposure
