Dynamic characterization of progressively damaged segmental masonry arches with one settled support: experimental and numerical analyses

ABSTRACT. This paper aims to explore the dynamic behavior of a segmental masonry arch subjected to increasing horizontal displacements of one support. To this end, output-only dynamic identification techniques are first used to track the evolution of the dynamic features of the system under progressive damage scenarios and evaluate their sensitivity to settlement-induced cracks. Considerations on the structural response of the segmental arch up to failure are also included. Then, a numerical procedure coupling linear perturbation and modal analysis is applied to simulate the dynamic behavior of the arch over consecutive scenarios, taking into account the influence of the damage on the structure's dynamic properties in an automatic way. The combination of experimental and numerical analyses allows to fully investigate the dynamics of the cracked masonry arch and to shed light on

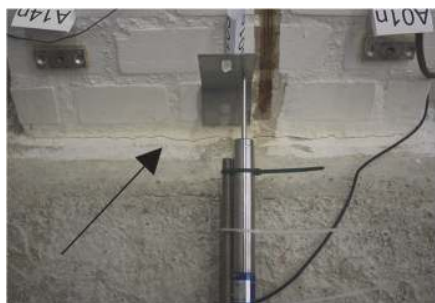
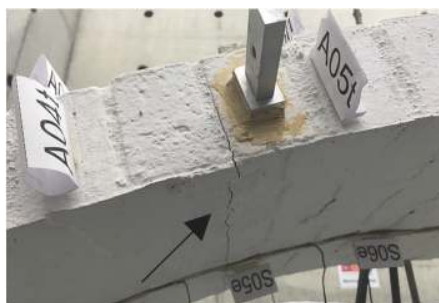
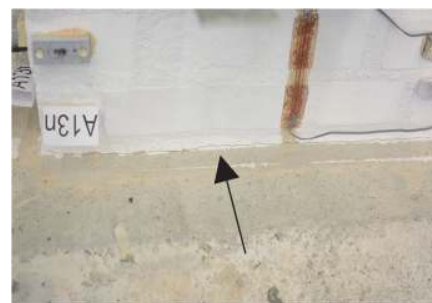
Figure 2: Crack pattern after 3 mm horizontal settlement of the right support: (a) crack location; (b) crack c_2 ; (c) crack c_1 ; (d) crack c_3 .

As the support settles, three passing cracks progressively appear at the mortar-brick interfaces: the first crack c_1 is located at the intrados, in the left region of the keystone; the second and the third cracks, denoted by c_2 and c_3 , appear at the extrados of the left (fixed support) and right (moving support) skewbacks, respectively. The crack pattern observed at the end of the five stages is presented in Fig. 2.

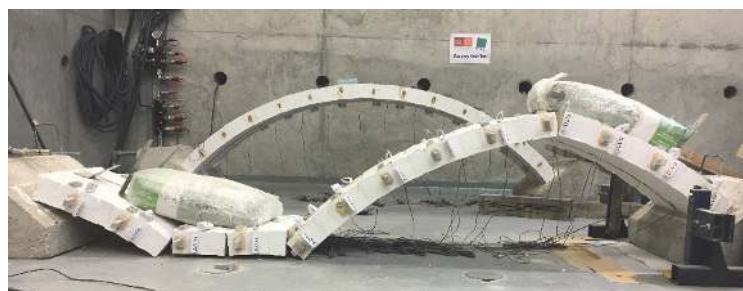
Figure 9: Masonry arch specimen after collapsing due to increasing horizontal settlements of the right support.

The maximum measured displacement before collapse (10.5 cm) was reached with an increment of 5.5% with respect to the nominal span. At this stage, the position of the thrust line still lies inside the profile of the arch (even if it is close to touch the intrados in correspondence of the 11th joint from the right) confirming that the equilibrium of the structure with 10.5 cm settlement is still ensured. Afterwards, the right support is left free to slide horizontally over the clearance remaining between support and actuator (3 cm) with consequent loss of stability of the arch and activation of a pure rotational collapse mechanism when the thrust line becomes tangent to the arch profile in another point [19], presumably the 11th joint (counting from the moving support). The position of both intrados and extrados crack hinges remains unchanged throughout the development of the mechanism. Collapse occurs with a limit displacement capacity of approximately 12 cm, corresponding to an ultimate span increment of 6.3%. In Fig. 9 the instant immediately after the collapse is shown.

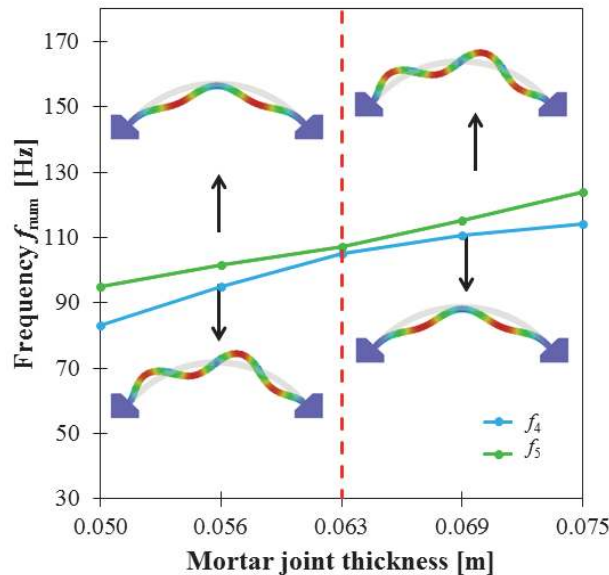
Figure 12: Fourth and fifth mode trend vs mortar joint thickness.

As a second attempt a numerical simulation is performed reducing the mortar joint thickness as done in [3, 43, 44], fact that can be reasonably justified by the necessity to take into account the slight variations in thickness, corner rounding and imperfections typical of a manually assembled geometry. The results obtained by this simulation show that the only way to invert fourth and fifth mode shapes is to reduce the mortar joint thickness at least of 20%. This allows to infer that mechanical uncertainties, geometrical imperfections and block size variations do affect not only the overall capacity of an arch, but also its dynamic properties [45]. Fig. 12 shows the variation of the fourth and fifth vibration mode of the arch as a function of the mortar joint thickness. As clearly discernible in the Figure, when the thickness of the mortar joints is about 0.063 m the two frequencies coincide and the corresponding mode shapes switch. However, this modeling strategy can be exclusively adopted for the RS configuration, as it proves not to be suitable for simulating the arch dynamic behavior neither in the RSW configuration nor in the subsequent damage scenario (DS1), where the sixth experimental mode characterized by a “heart shape” disappears (or it is no longer identifiable). In addition, reducing the joint thickness causes the second and third numerical mode shapes to invert. Due to these reasons, no thickness reduction is applied to the model and only the first four corresponding modes are taken into account for the linear perturbation adopted next. Fig. 13 shows the considered experimental and numerical mode shapes for the RSW configuration; the numerical results are obtained using the parameters provided in Tab. 4 and applying to the FE model (Fig. 10) a total mass of 50 kg to simulate the lime bags symmetrically placed on the arch backs.
