DYNAMIC PERFORMANCE OF LIGHT GAUGE STEEL FRAMED SHEAR WALLS

Reynaud Serrette, Georgi Hall, and Hoang Nguyen
Light Gauge Steel Research Group
Santa Clara University, Santa Clara, CA 95053

Summary

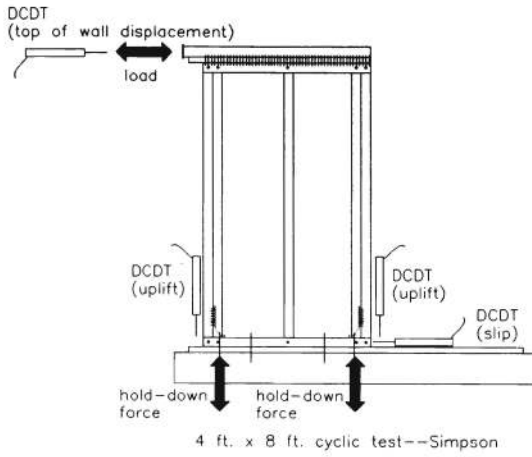
Figure 5 Instrumentation

The instrumentation for the tests is shown in Figure 5. Four displacements--top of wall lateral displacement (in-plane shear displacement), uplift at both ends of the wall, and slip--and three loads--applied load at top of wall, two hold-down loads--were measured and recorded electronically using a special purpose data acquisition and control system. The position of the wall was monitored 300 times a second and data was recorded at a rate of 50 times per second. Each recording included wall displacements and loads.

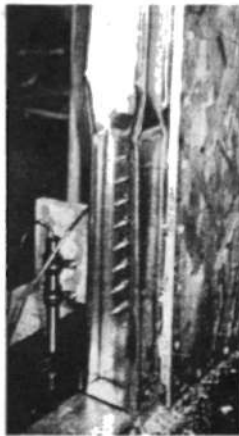
Figure 8 Crippling in chord stud

For all walls with screw schedules of 3 in./12 in. and 2 in./12 in., the chord studs crippled (crushed) locally either at the position of web cut-out above the hold-down or at the hold-down, as shown in Figure 8. Crippling appeared to promote the pull-over behavior of the panels. The walls with 2 in./12 in. schedules also exhibited local/distortional buckling in the flange of the studs adjacent to the compression chord.

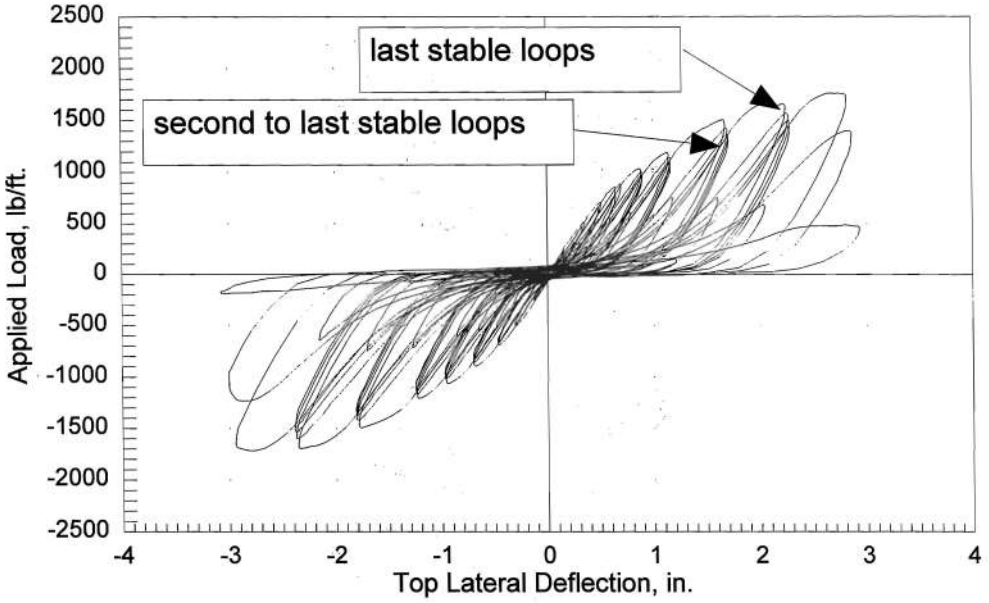
Figure 9 Typical hysteretic loops for cyclically tested wall

Tabulated results from the test program are given in Table 2. Data are presented for the nominal load capacity at the last and second to last set of stable hysteretic loops, and the corresponding level of lateral displacement. The nominal load and displacement values are based on averages from the "push-pull" regimes of the time history. Typical plots of load versus total top of wall lateral displacement are given for 4 representative walls in Figures 9, 10, 11 and 12.
