Effect of blood contamination and decontamination procedures on marginal adaptation and bond strength of composite restorations

Purpose: To evaluate the effect of blood contamination and different decontamination procedures on marginal adaptation and bond strength of a two-step total-etch adhesive system to dentin.

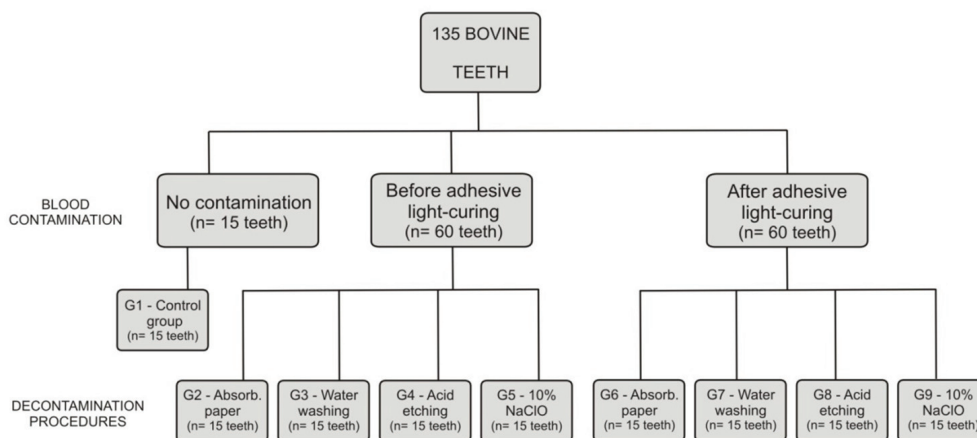
Fig. 1. Schematic diagram of the study design.

Teeth were randomly allocated into 9 groups (n=15), as described in Figure 1. G1 had no blood contamination (control). The other 8 groups were contaminated either before (G2, G3, G4, and G5) or after light-curing of the adhesive (G6, G7, G8, and G9). Decontamination procedures consisted in drying with absorbent paper, rinsing with water, phosphoric acid etching, or application of NaClO (Fig. 1). The materials used in the study are described in Table 1.

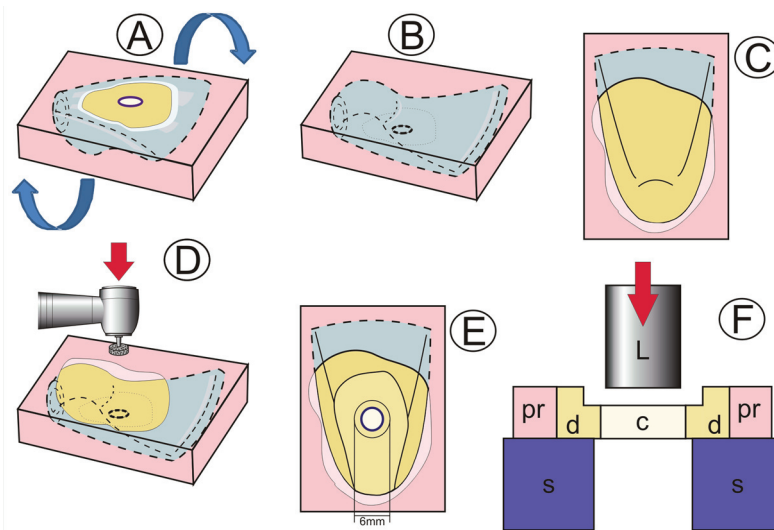
Fig. 2. (A) Specimen embedded in polyester resin after the dye staining gap test. (B) The specimen was turned upside down, and (C) the polyester resin was removed from the lingual side of the tooth. (D) Removal of the lingual face of the tooth and of the floor of the composite restoration using a handpiece attached to a xyz-coordinate table. (E) Amplification of the hole around the restoration margins up to 6 mm. (F) Push-out bond strength test configuration (pr - polyester resin; d - dentin; s - support; c - composite; L - load).

The lingual surfaces of the specimens were removed exposing the cavity floor. The specimens were positioned in a xyz coordinate table with a handpiece attached. The handpiece was positioned over the cavity floor using the same wheel shaped diamond bur and moved in the z axis in order to remove it. The diamond burs were replaced after perform five cavities. Then, the diameter of the hole was expanded to 6 mm, exposing the cavity margins (Fig. 2).

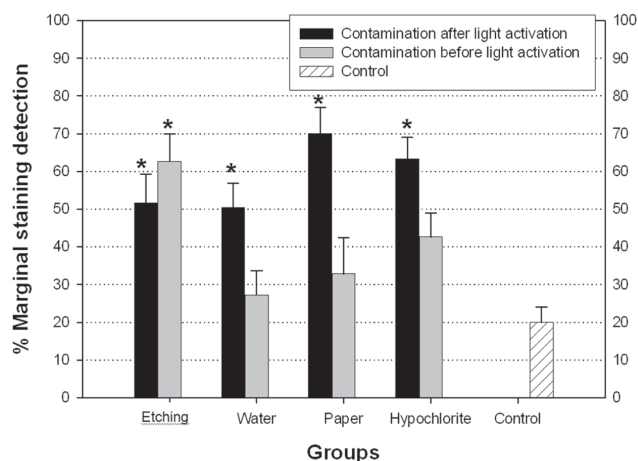
Fig. 3. Mean percentage of dye stained margins and standard error (bar). Asterisks indicate statistically significant difference with the control group.

Results of marginal adaptation are shown in Table 2. The control group presented the lowest mean percentage of stained margins. Contamination after light-curing of the adhesive led to higher percentage of stained margins ($P < 0.001$) than before light-curing, irrespective of the decontamination protocol used. When blood contamination occurred before light-curing of the adhesive, the application of acid etching as decontamination procedure promoted the highest marginal staining, while washing with distilled water caused the lowest values. On the other hand, when contamination occurred after light-curing, no significant differences were detected between the decontamination procedures used. These groups presented marginal staining statistically higher than the control group (Fig. 2).
