## Effect of Tire Rubber Particles on Crack Propagation in Cement Paste

*Nadia Segre\*, Claudia Ostertag, Paulo José Melaragno Monteiro*

*Department of Civil and Environmental Engineering,  
University of California at Berkeley, 725 Davis Hall, Berkeley, CA 94720, USA*

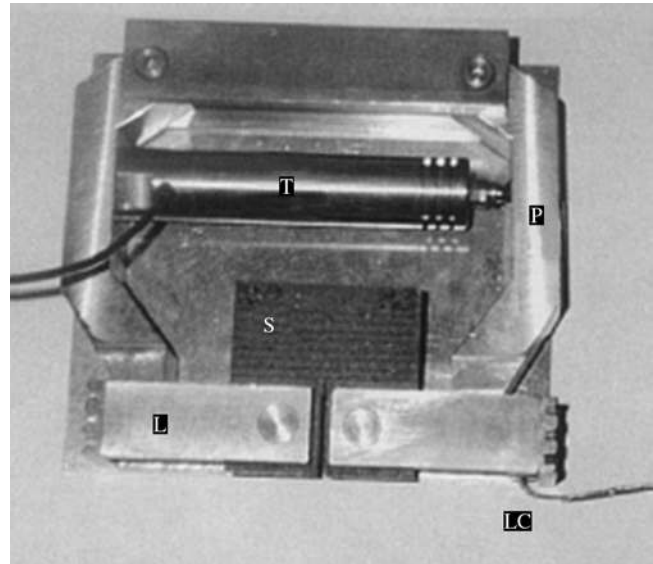
**Figure 1.** Loading device designed for crack propagation measurements. (T) Piezoelectric transducer; (P) Pivot arms; (L) Loading arms; (LC) Load cell, located in one of the loading arms; (S) 50 x 50 x 6 mm compact tension specimen<sup>20</sup>.

The loading device designed for crack propagation measurements is shown in Figure 1. It uses a piezoelectric transducer for load transfer. The piezoelectric transducer is placed between two pivot arms and, after being activated by a high voltage amplifier, delivers opening forces to the compact tension specimen through the loading arms. The input voltage was computer controlled. A load cell is placed in one of the loading arms and monitors the applied load<sup>20,21</sup>.

The crack mouth opening displacement (CMOD) was monitored through a MTS clip gage mounted on the specimen. The loading device was staged under an optical microscope equipped with a video camera connected to a TV screen and a video recorder.

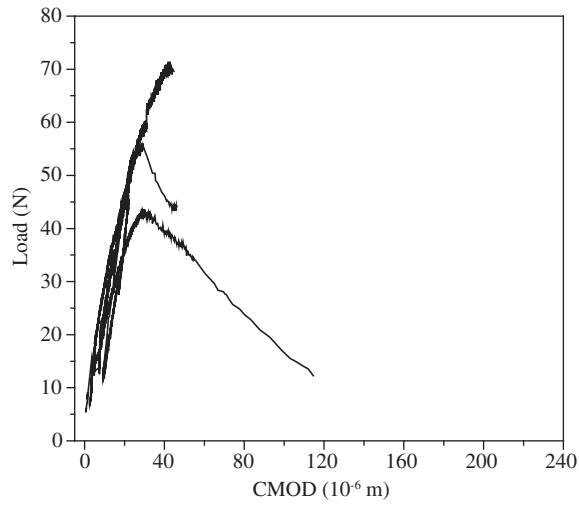
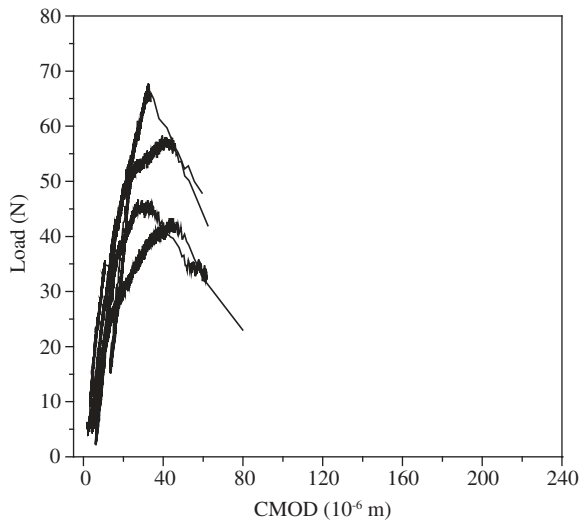
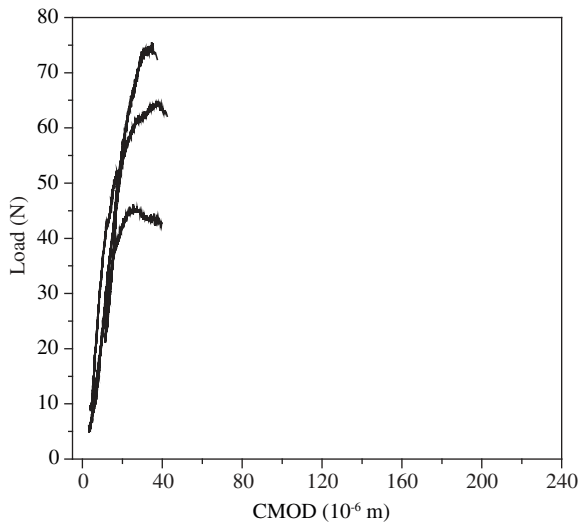
**Figure 2.** Load vs. crack mouth opening displacement curves for ASTM type I/II Portland cement paste specimens. a) untreated rubber particles; b) treated rubber particles; and c) control specimens.

Compact tension tests were performed on Type I/II cement paste specimens containing untreated or treated tire rubber particles to gain information on their crack propagation processes. Load as a function of crack mouth opening displacement (CMOD) for these specimens and the control are shown in Figure 2. Beyond the ultimate load, a

continuous strain softening curve could not be obtained. The deviation from linearity in the load as a function of CMOD curves indicates the extension of the crack from the notch tip. Crack initiation from the notch occurred, in average, at similar load levels for the control and specimens with untreated rubber. For the specimens with treated rubber, known for their better adhesion to the cement matrix<sup>18</sup>, a more pronounced strain hardening regime was observed in the load vs. CMOD plots (Figure 2b). The load level at which the crack initiated from the notch tip was on average reduced compared to the control specimens. The cement paste matrix seemed to be weakened by the treated rubber particles.

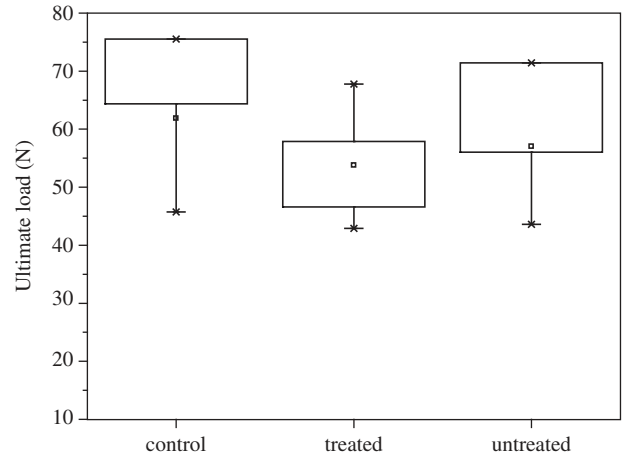
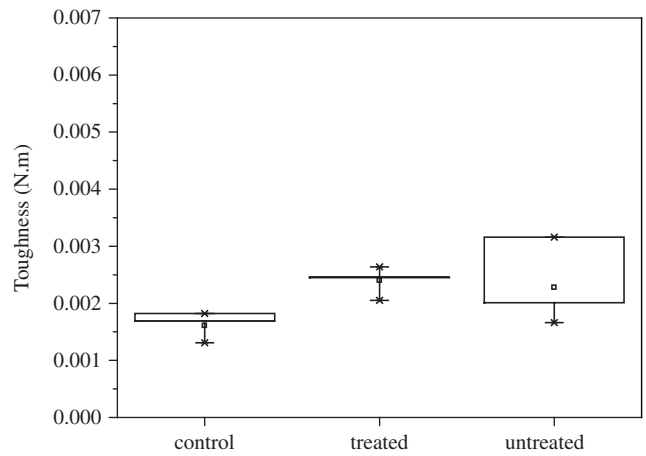
**Figure 3.** Box plots for ultimate load and toughness for ASTM type I/II Portland cement paste specimens control and containing treated or untreated rubber particles.

Box plots were built to gain an overview of data from a statistical perspective. A box plot is an effective visual representation of both central tendency and dispersion. Box shows 50% of the data, the small square indicates the average, the median is shown as a line across the box (or on its horizontal bounds) and the vertical line contains the other 50% of the data and the minimum and maximum data values on its edges. The length of the vertical lines indicates visually how far from the middle of the distribution the extreme values are.

Figure 3 shows box plots of ultimate load and toughness, which is proportional to the area under the entire load-CMOD curves, obtained for the specimens tested. Variability in ultimate load, characterized by the boxes sizes and vertical lines lengths, is common to all sets of specimens, with or without rubber particle. No improvement in strength was observed for the specimens that contain rubber particles, compared to the control. On the other hand, higher toughness is observed for the specimens containing treated rubber particles and a tendency to higher toughness for the specimens with untreated rubber, when compared to the control specimens. Even though no statistical difference, in average, for toughness is observed between the specimens containing rubber, the composites with treated rubber showed less scattered values when compared to the composites with untreated rubber.

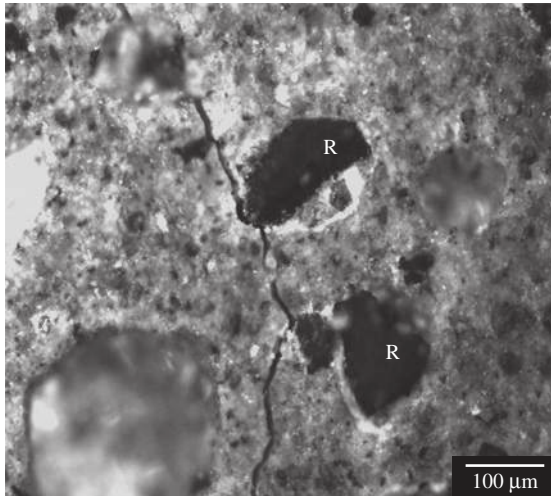
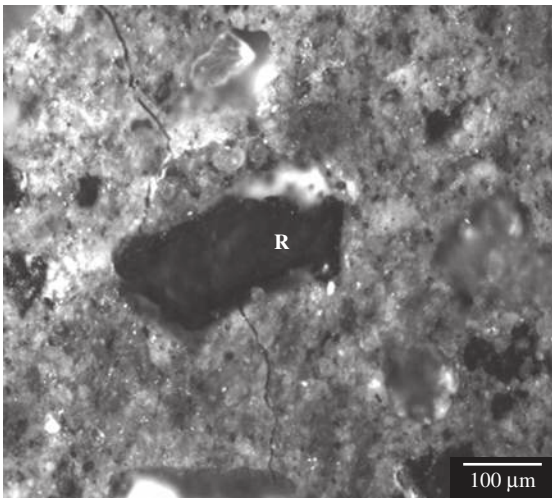
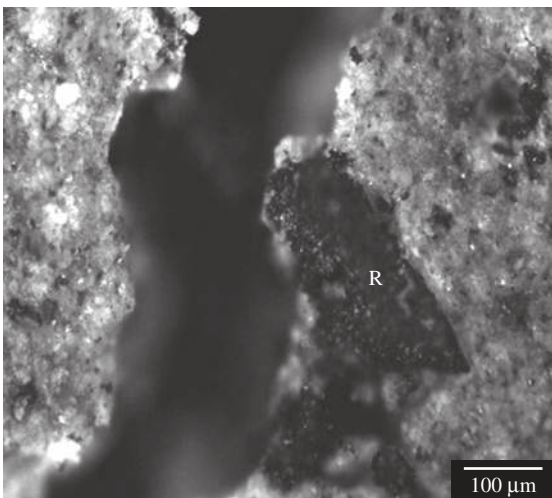
**Figure 4.** Crack/rubber interaction in ASTM type I/II Portland cement paste specimens with untreated rubber particles. The crack propagation occurs from top to bottom of the micrographs. a) the crack is deflected by the untreated rubber particles; b) the crack is bridged by the rubber particle; and c) pull-out of a rubber particle, after specimen failure. Letter R indicates a rubber particle.

manner without considerable crack deflection and the crack became unstable after small increments of crack extension. Crack/rubber particle interactions shown in Figure 4 were observed in the specimens with untreated tire rubber particles. After encountering the rubber particles, the crack was deflected (i.e., changed in fracture path) by the rubber particles (Figure 4a). Rubber bridging sites as shown in Figure 4b, where rubber particles bridge the crack surfaces, were also observed. The micrographs of the crack/rubber interactions in Figure 4a, b could only be obtained after the crack tip was already located far beyond the rubber particles. Pull-out of a rubber particle is shown in Figure 4c. In-situ crack/rubber interactions could not be observed in these specimens.

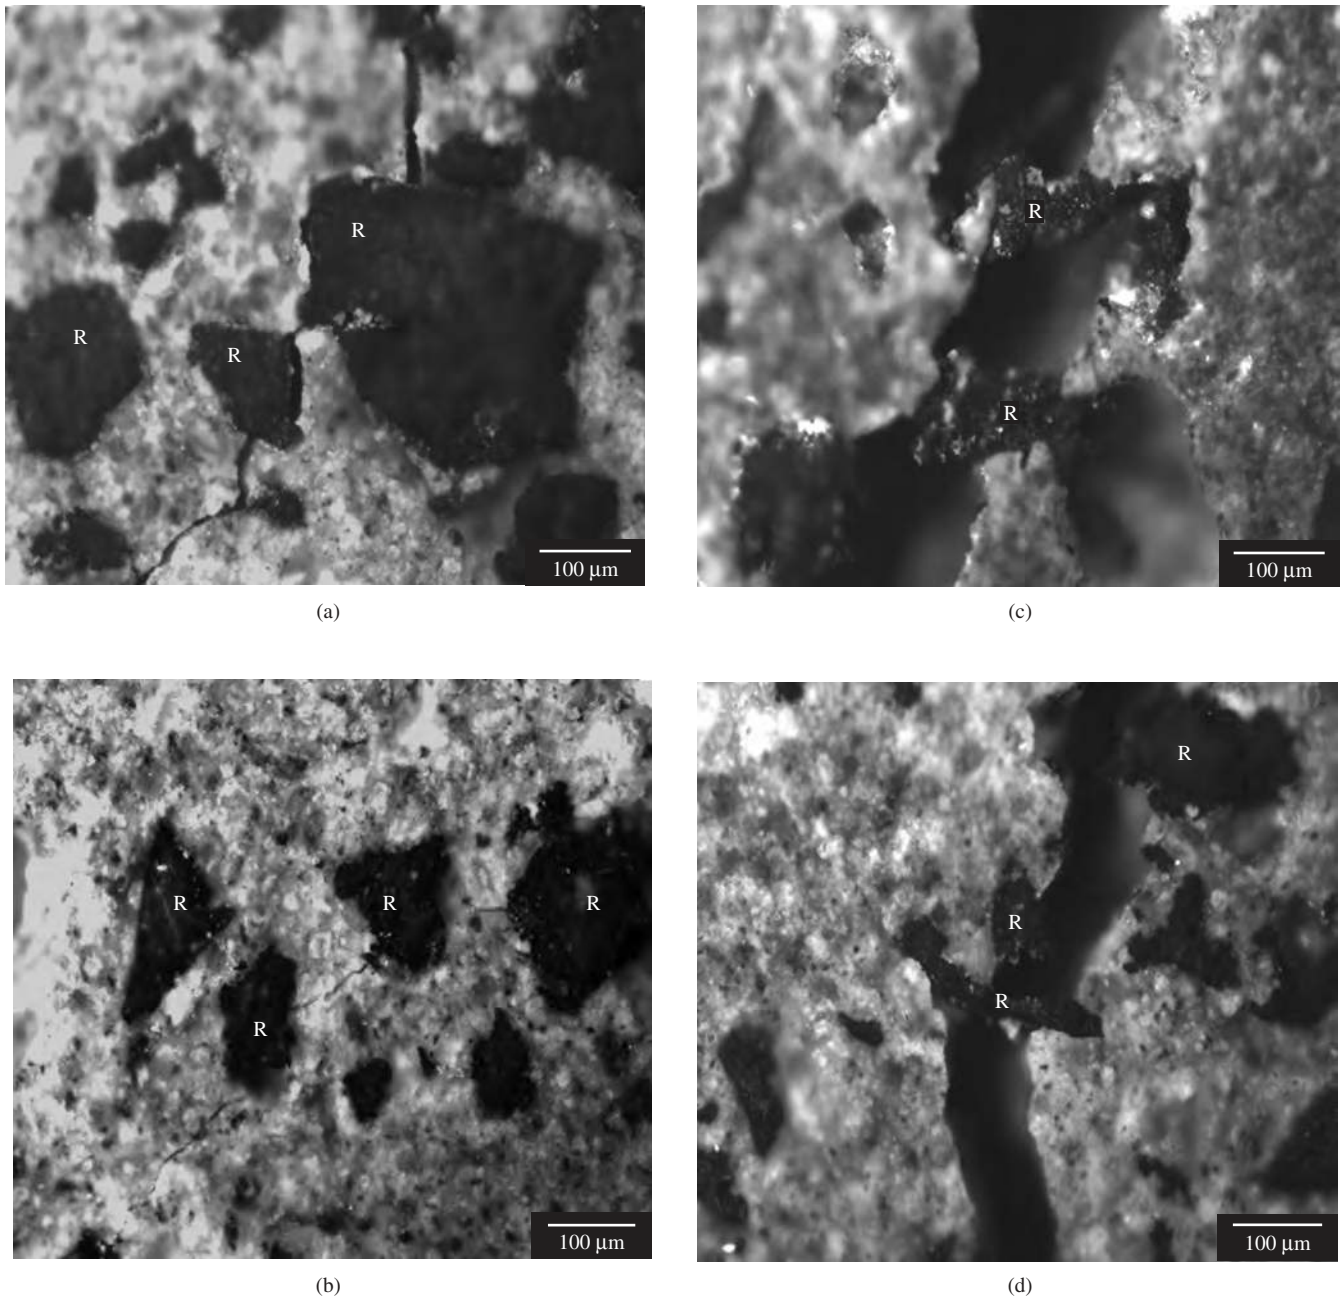
**Figure 5.** Crack/rubber interaction in ASTM type I/II Portland cement paste specimens with treated rubber particles. The crack propagation occurs from top to bottom of the micrographs. In a,b) the crack is attracted by the treated rubber particles and incorporates them in its wake. The crack is deflected from its original path (the original path being from top to bottom of micrograph) in order to interact with the rubber particles; and c,d) rubber particle de-bonded along both sides of the rubber/matrix interface and is being stretched between crack surfaces. Micrographs c and d were taken after failure of the specimen. Letter R indicates a rubber particle.

For the specimens with treated rubber, the in-situ crack propagation measurements revealed that the crack was attracted by the rubber particles. The crack deflected from its original path (Figure 5a, b), where original path would have been from the top to the bottom of the micrograph, to interact with the rubber particles. This attraction allowed a more effective crack/rubber interaction compared to the

untreated rubber particles. Tensile stresses in the matrix due to an elastic mismatch between the rubber particles and the matrix may be responsible for the observed load reduction at crack initiation and for attracting the crack towards the rubber particles. The crack after being attracted by the rubber particles incorporates them in its wake. Crack pinning by rubber particles was also observed. The rubber particles eventually debond along both sides of the rubber/matrix interface (Figure 5c, d) and may stretch between the crack surfaces before being pulled out of the matrix. These crack/rubber particle interactions are responsible for the more prominent strain hardening behavior.

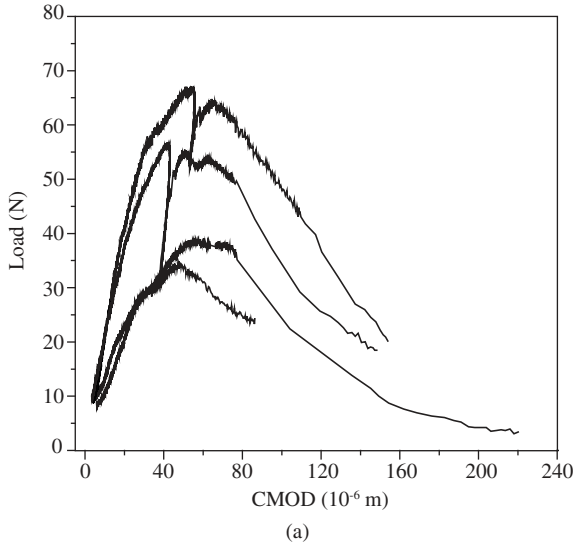
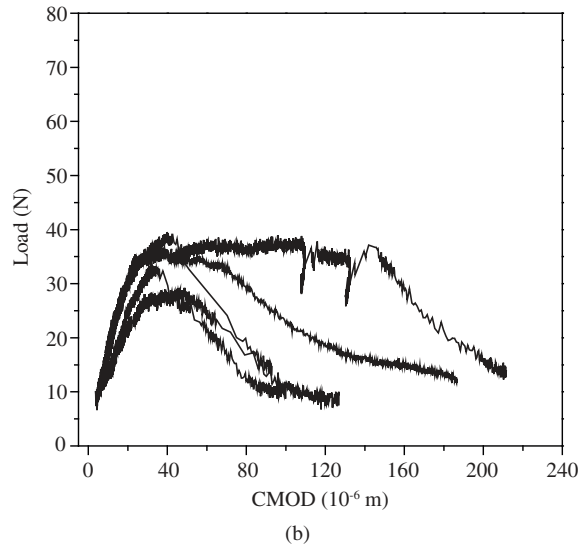
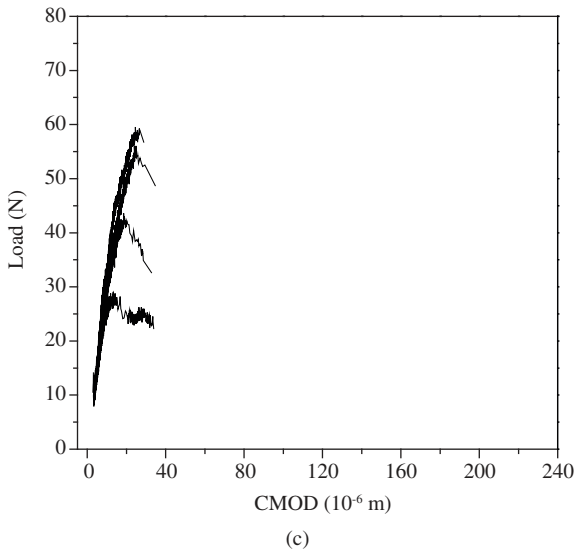
**Figure 6.** Load vs. crack mouth opening displacement curves for Interground Fiber Cement (IFC) paste specimens. a) untreated rubber particles; b) treated rubber particles; and c) control specimens.

The load vs. CMOD plots for the IFC paste specimens control and containing treated or untreated rubber particles are shown in Figure 6. Strain hardening and pronounced strain softening behavior was observed for the treated and untreated rubber IFC specimens, compared to the control. Similar to the type I/II cement specimens with treated rubber particles the load required for crack initiation from the notch was reduced compared to that of the control and with untreated rubber specimens. However, an increase in CMOD at the ultimate load level was observed. Box plots of ultimate load and toughness obtained for these specimens are shown in Figure 7. Although less scattered, lower values of ultimate load are observed for specimens containing treated rubber, compared to the control and to the specimens with untreated rubber. A prominent toughness enhancement is observed for the specimens with rubber, compared to the control. A tendency to higher toughness is observed for the specimens containing untreated rubber, when compared to the specimens with treated rubber. On the other hand, a higher number of data points are observed in the strain softening region of the curves obtained for the specimens containing treated rubber (Figure 6b) indicating more stable crack propagation.

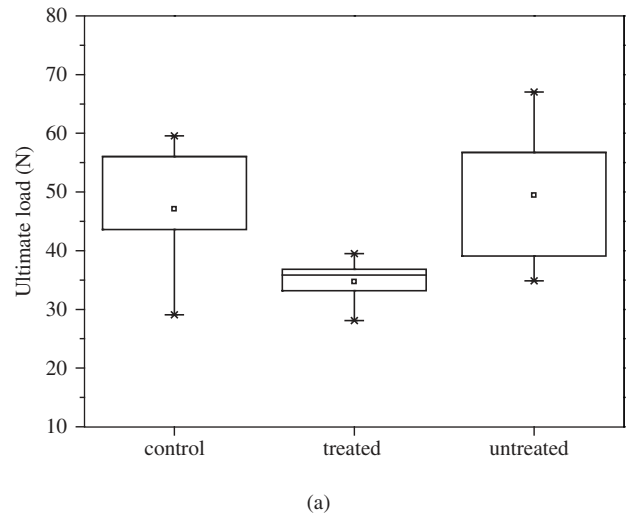
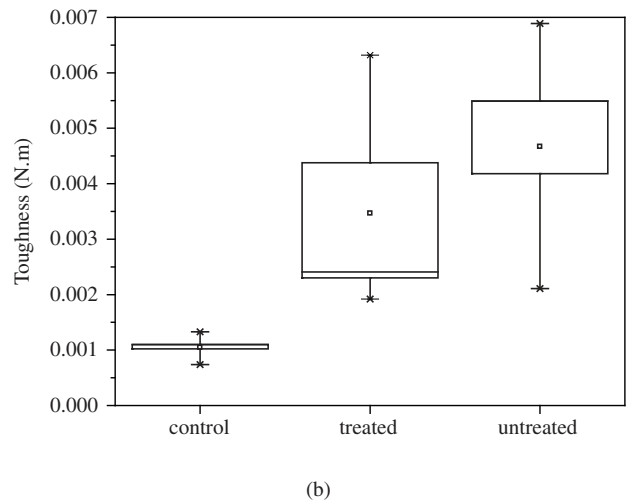
**Figure 7.** Box plots for ultimate load and toughness for Interground Fiber Cement (IFC) paste specimens control and containing treated or untreated rubber particles.

close proximity to the rubber bridging sites are shown in Figure 11. The crack wake bridging mechanisms were replaced by multiple cracking mechanisms, which lead to a toughness enhancement at the expense of weakening the matrix and reducing the hardness. The multiple secondary microcrack formations are responsible for the increase in CMOD at ultimate load level observed in Figure 6. The multiple cracking mechanisms may also be accountable for the reduced variability in ultimate load values shown in Figure 7. All treated rubber specimens failed in a very narrow range of load levels,

In the absence of effective crack tip mechanisms, stable crack propagation can only be assured, and hence toughness increased, if additional bridging ligaments are incorporated into the wake of the crack. This can be accomplished by either increasing the volume fraction of the rubber particles or, as was done in this study, by using IFC as the matrix. The toughness enhancement observed in IFC-rubber specimens, far exceeding the toughness enhancement in type I/II cement-rubber specimens, is attributed to the polypropylene, PP, fibers in IFC. The reduction in crack velocity due to the PP-fibers allows the rubber particles to be incorporated into the crack wake by a crack front that has moved in a stable manner when passed these reinforcements, activating the bridging mechanisms at relatively short crack lengths. It is worth noting here, that the IFC control specimens did not exhibit toughness enhancement due to the PP-fibers compared to Type I/II cement control specimens (Figures 3 and 7).

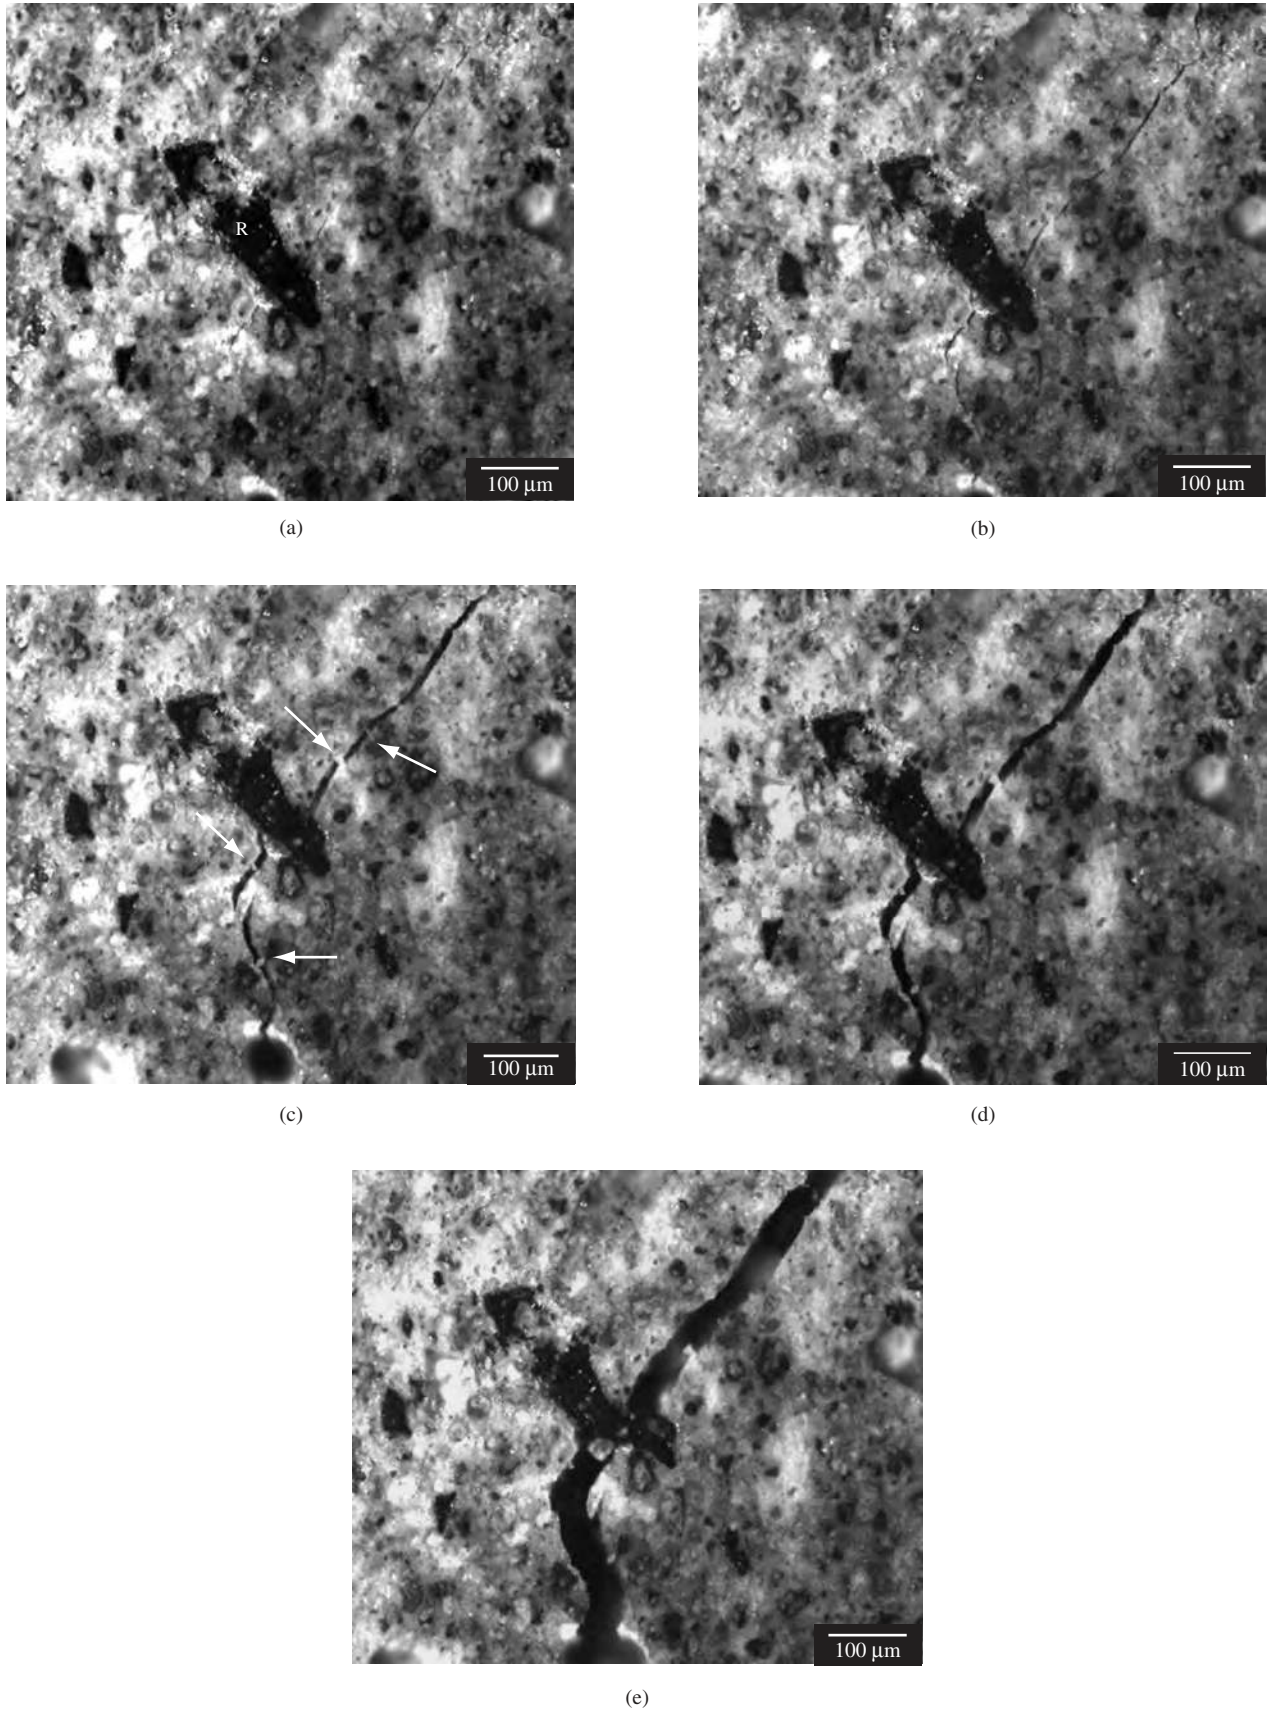
**Figure 8.** Crack/rubber interaction in IFC paste specimens with untreated rubber particles at different applied load levels: a) bridging site in close vicinity to the crack tip at 72% of ultimate load; b) bridging site at 85% of ultimate load; c) close to peak load; arrows indicate the polypropylene fibers bridging the crack surfaces in close vicinity to the rubber bridging site; d) after peak load; and e) after failure. Letter R indicates a rubber particle.

After failure, all specimens remained unbroken. The IFC control specimens revealed intact polypropylene fibers bridging the crack surfaces from the notch tip to the end of the specimen. For the rubber specimens, no cracks could be detected with the naked eye or in the optical microscope unless the specimens were reloaded. The untreated rubber particles constituted bridging sites in the crack wake. A rubber-bridging site close to the crack tip and in the wake of the crack is shown in Figure 8 at different applied load levels. Due to stable crack propagation this crack-rubber interaction could be observed from their early stage of development in close proximity to the crack tip until their disintegration at applied displacements close to failure. Figure 8a reveals the bridging site in its early stage with the crack tip just ahead of the rubber particle. With increasing displacements, the crack opens and reveals the polypropylene fibers (indicated by arrows in Figure 8c) bridging the crack surfaces. The micrograph shown in Figure 8e was taken after failure.

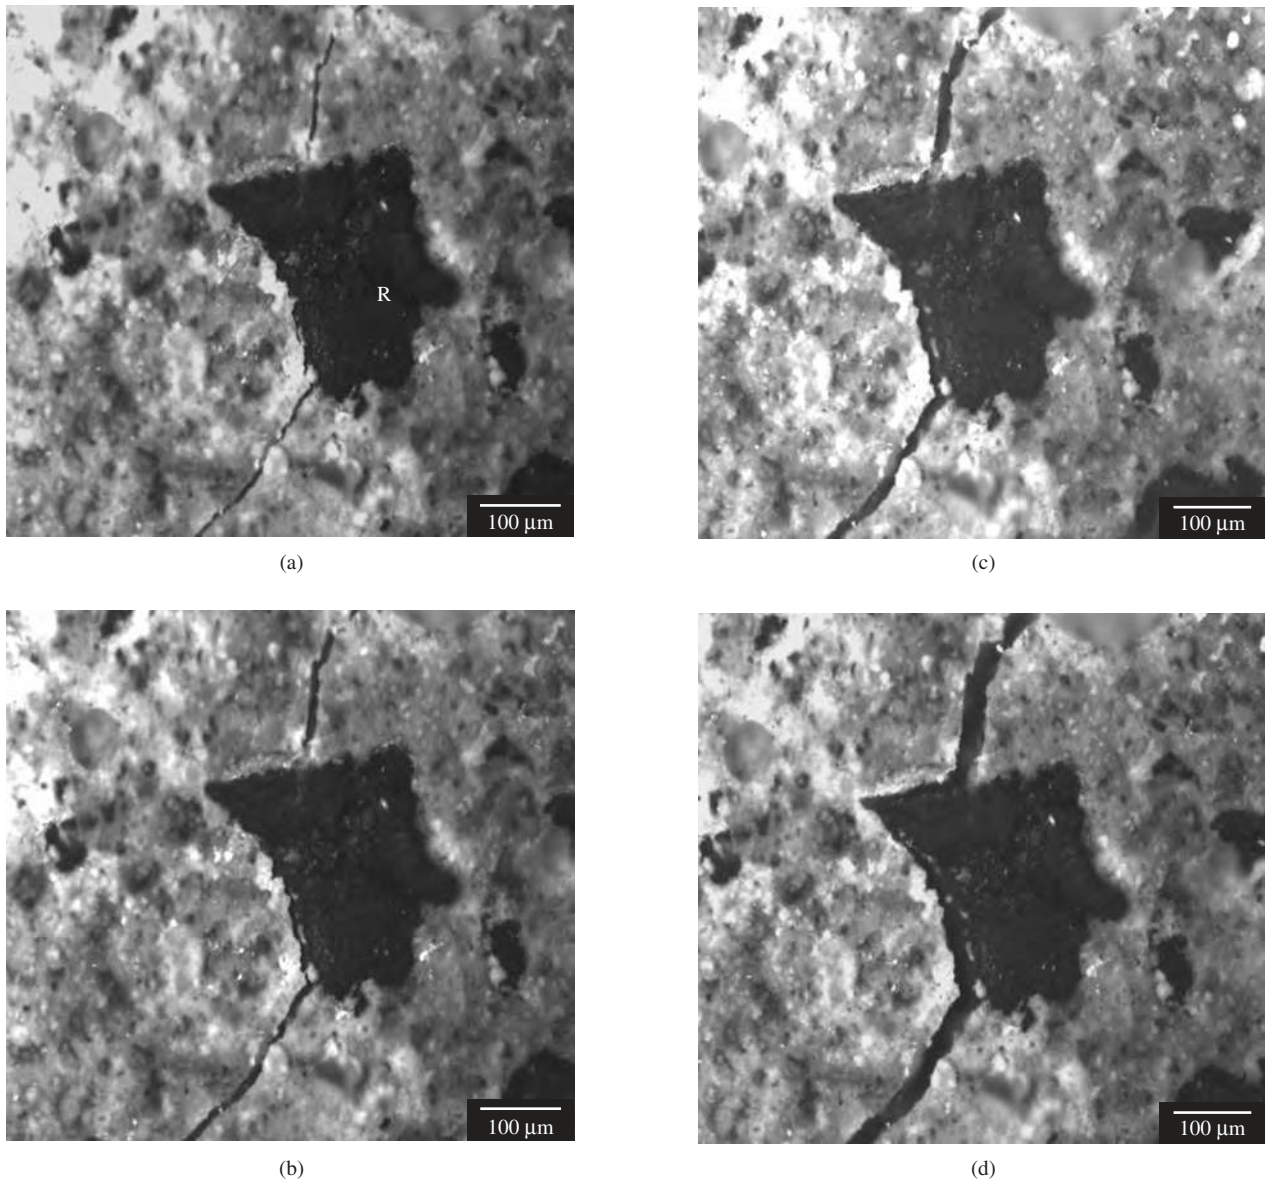
**Figure 9.** Crack/rubber interaction in IFC paste specimens with treated rubber particles at different applied load levels: a) pinning point at 40% of ultimate load; b) pinning point at 50% of ultimate load; c) close to peak load; and d) after peak load. Letter R indicates a rubber particle.

Crack pinning by treated rubber particles was also observed, as shown in Figure 9. For treated rubber particles in IFC matrix, the majority of crack/rubber interactions lead to crack detention at the rubber particles. The initial crack did not remain the dominant crack up to failure as shown in Figure 10. Frequently secondary cracks initiated at the bridging sites at higher applied load levels (Figure 10b) and one of these cracks became the dominant crack as shown in Figure 10c, which reveals the bridging site after failure. On the left of the bridging site, an additional microcrack has formed (indicated by arrow in Figure 10c) probably due to stress redistribution.

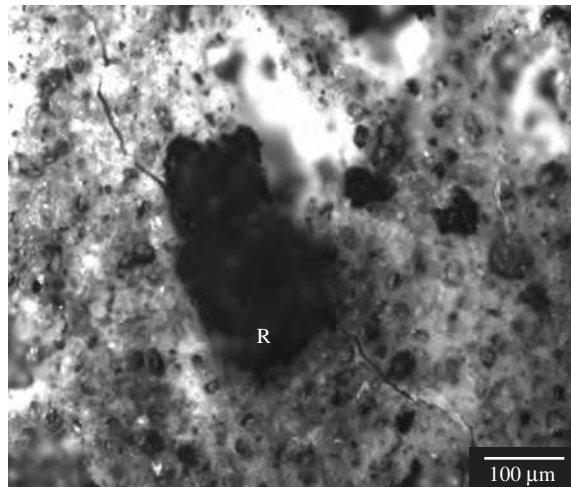
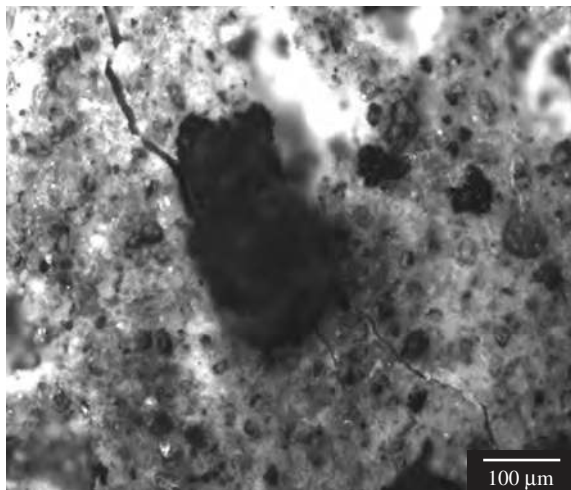
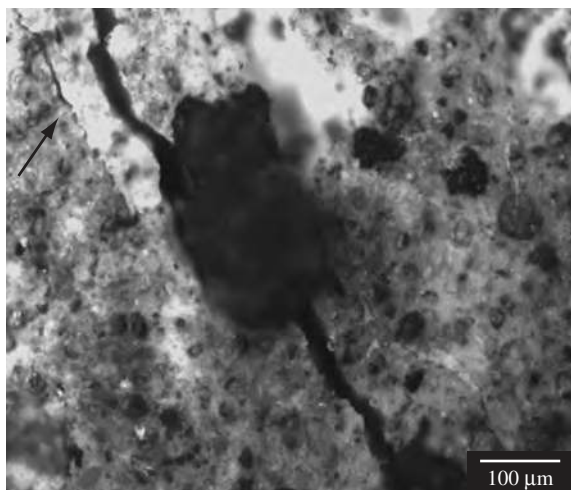
**Figure 10.** Crack/rubber interaction in IFC paste specimens with treated rubber particles at different applied load levels. a) rubber particle is bridging the crack surfaces; b) at higher applied load, a secondary crack initiates in close vicinity to the rubber particles due to high frictional tractions at the rubber/matrix interface; and c) rubber particle after failure of the specimen; the initial crack did not remain the dominant crack at failure; additional microcracks opened up to the left of the rubber particle. Letter R indicates a rubber particle.

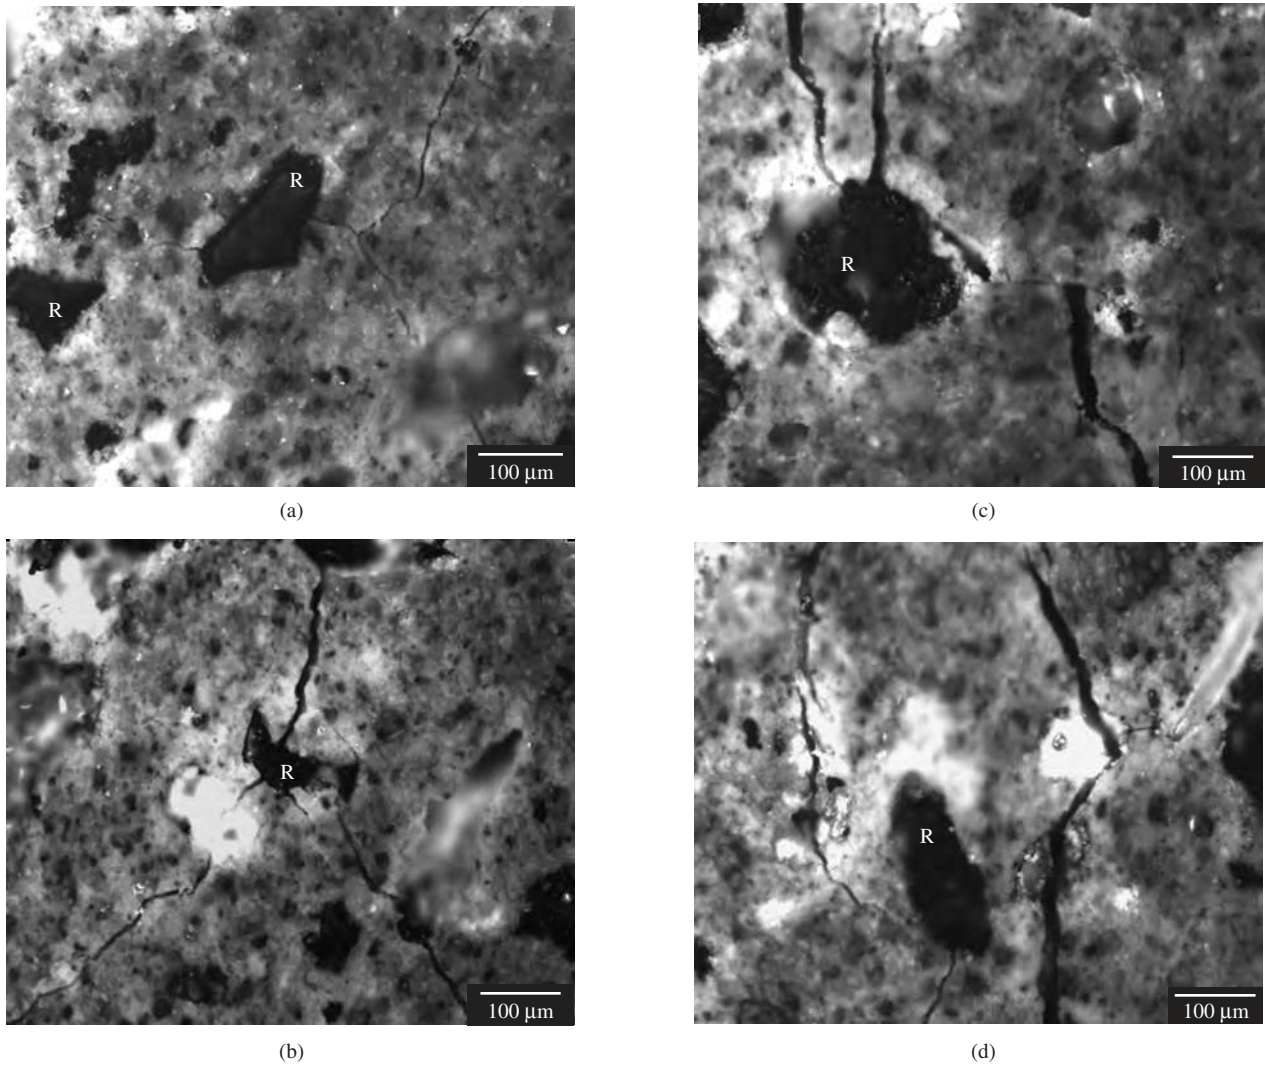
**Figure 11.** a) Crack being attracted by the treated rubber particle in IFC paste matrix; b-d) Various types of secondary cracks that form in close vicinity to bridging sites in IFC paste specimens with treated rubber particles. Letter R indicates a rubber particle.

The crack is attracted by the rubber particles (Figure 11a), like in the specimens with treated rubber in cement type I/II. The crack instead of propagating from top to bottom (i.e. perpendicular to the applied tensile stress) it deflects to the left in order to interact with the rubber particle. Various types of secondary cracks that form in
