NCAT Report 05-08

EVALUATION OF BOND STRENGTH BETWEEN PAVEMENT LAYERS

December 2005

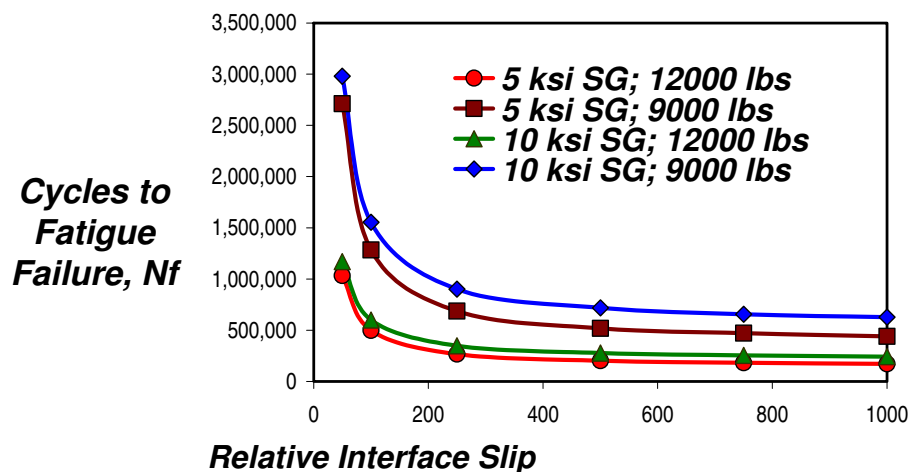
Roffe and Chaignon (3) conducted a similar analysis using the French pavement design program ALIZE. They analyzed a pavement structure consisting of a 2.4 inch (60 mm) surface layer, a 5.1 inch (130 mm) HMA intermediate layer and 7.9 inch (200 mm) aggregate base. The program was run with full bond and no bond between the HMA layers. Their analysis showed that the service life of the pavement was reduced from 20 years to between 7 and 8 years due to the lack of bond between the HMA layers.

Figure 3. Effect of bond of HMA layers on fatigue life

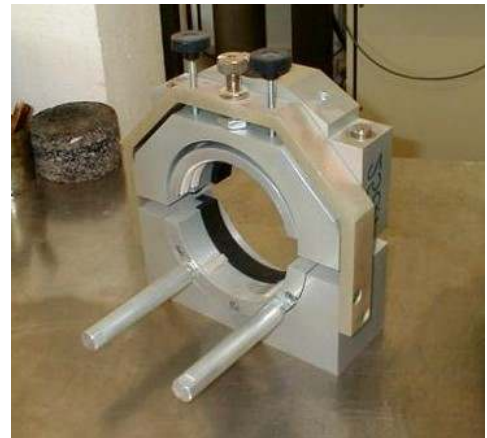
The Swiss Federal Laboratories for Materials Testing and Research has a standard method and criteria for evaluating the bond strength of HMA layers using 6 inch (150 mm) diameter cores (3). The method is Swiss Standard SN 671 961 and uses a device known as the LPDS tester (Figure 4). The test is a simple shear test with a loading rate of 2.0 inches/min (50.8 mm/min). The minimum shear force criteria is 3372 lbf (15 kN) for the bond between thin surface layers and the binder course, and 2698 lbf (12 kN) for the bond between binder courses and road bases.

Figure 4. Swiss LPDS Tester

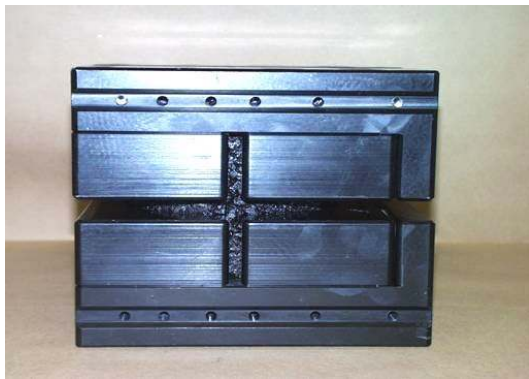
Mohammad et al. (14) evaluated the influences of tack coat types, application rates, and test temperature on the interface shear strength using the Superpave Shear Tester (SST) (Figure 5, 6). Their shear apparatus had two parts that held specimens during testing. The shearing apparatus was mounted inside the SST. Shear load was applied at a constant rate of 50 lb/min (222.5 N/min) on the specimen until failure. Tests were conducted at 77 and 131°F (25 and 55°C). Tack coat materials included four emulsions (CRS-2P, SS-1, CSS-1, and SS-1h) and two asphalt binders (PG 64-22 and PG 76-22M) applied at five different rates from 0.0 to 0.2 gal/yd² (0.0 to 0.9 L/m²). Their work identified the CRS-2P emulsion as the best performer in terms of interface shear strength and its optimum application rate was 0.02 gal/yd² (0.09 L/m²). Their results also show that tests at 77°F yielded shear strengths generally about five times the shear strengths at 131°F. The tests at 77°F were also better at distinguishing differences in the application rates.

Figure 5. Shear Box with Prepared Sample

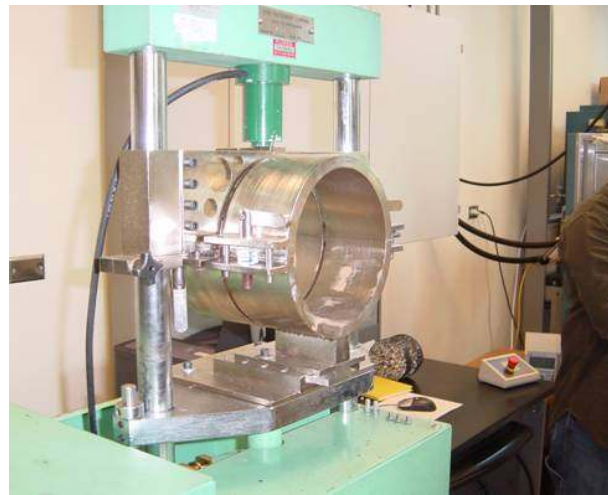
Figure 7. FDOT Bond Strength Device

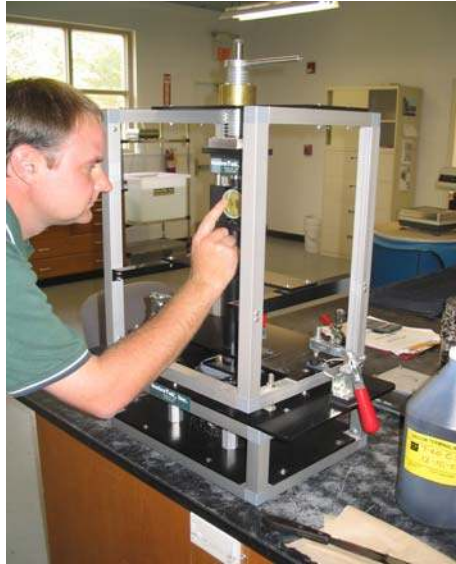
Another test that has recently been used for testing the bond strength of tack coats is the ATACKER™ device (Figure 9) by Instrotek, Inc (20). Tack coat material is applied to a metal plate, an HMA sample, or a pavement surface and a metal disc is brought down to make contact with the tacked surface. The bond strength between the surfaces can be measured in tensile mode or in torsion.

Figure 9. ATACKER™ Device for Tack Coat Bond Strength

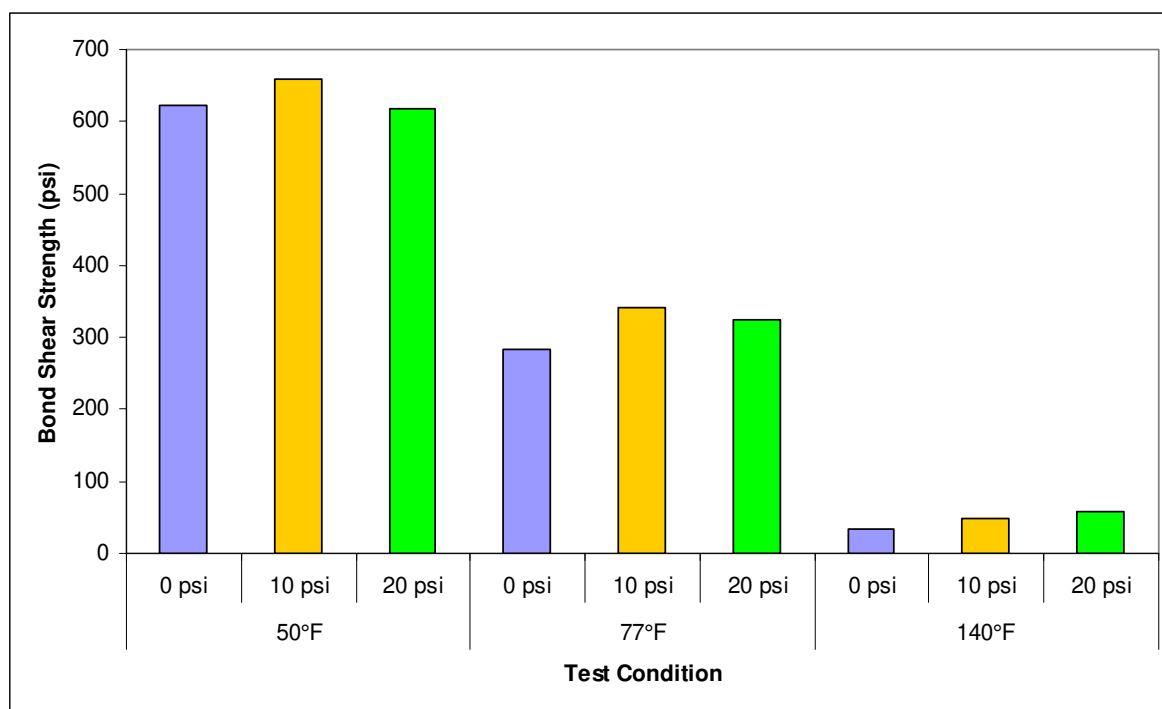
Figure 12 shows the average bond strength for each test temperature and normal pressure combination. As can be seen, when temperature increases, the bond strength decreases dramatically. On average, bond strengths were 2.3 times greater at 50°F (10°C) compared to 77°F (25°C); and the bond strengths at 140°F (60°C) were about one sixth of the bond strength at 77°F. This was expected since the tack coat materials are much stiffer at the lower temperature. For a few tests at 50°F, the bond strengths exceeded the limit of the MTS loading capacity. In these cases, the shear bond strengths are actually higher than the values reported. Due to this occasional over-limit situation and the fact that temperature had a dominant effect on shear bond strength, it was believed that analyzing the data separately was necessary to evaluate the impact of other factors on bond strength. Bond strengths at 77 and 140°F were therefore analyzed separately later in the report.

Figure 12. Effect of Temperature and Normal Load on Bond Strength

The effect of normal pressure on bond strength was different at each temperature, as shown in Figure 12. At 140°F, on average, bond strength increases when the normal pressure increases from 0 to 10 and 20 psi. At 77°F and 50°F, bond strength increases when normal pressure is applied. However, at the moderate to low temperatures, the bond strength does not change much when normal pressure increases from 10 to 20 psi. This is a logical finding since at the higher temperatures, friction at the interface dominates bond strength and frictional resistance is proportional to the normal force.

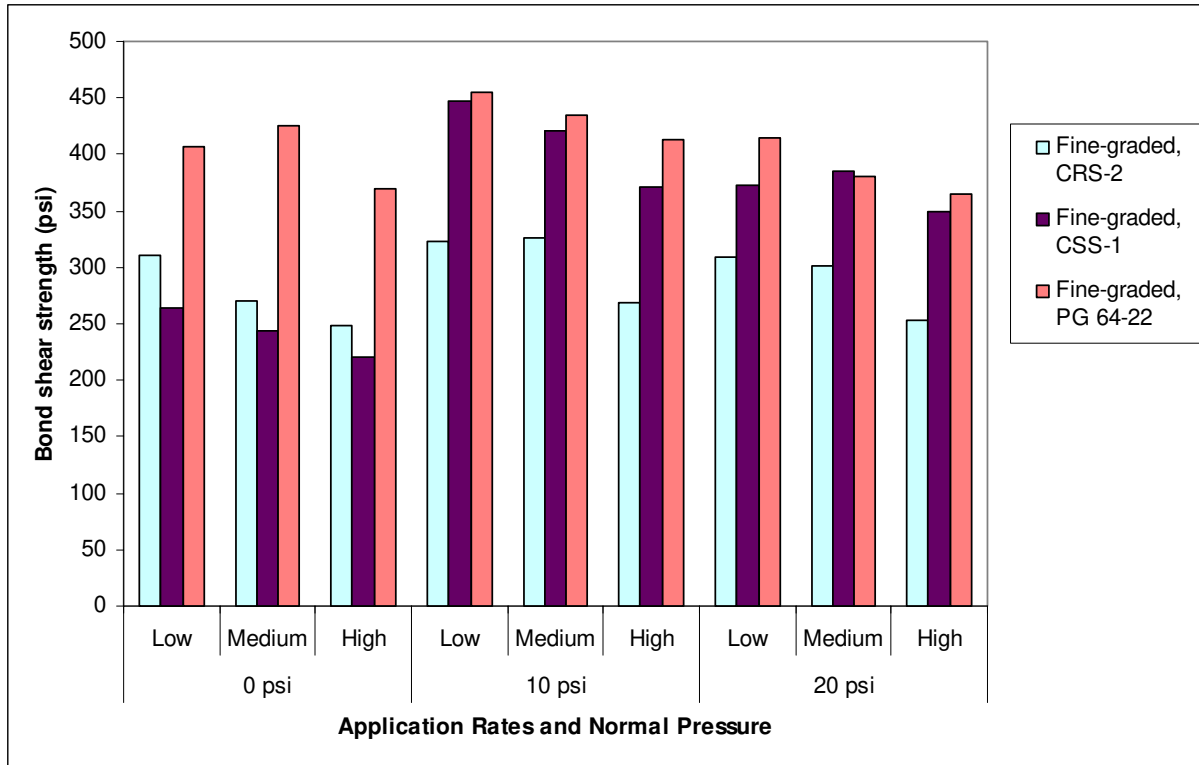
The ANOVA and Figures 15 and 16 show that the coarse and fine-graded mixes have different bond strengths. Generally, the fine-graded mixture provided higher bond strengths than the coarse-graded mixture when tested at 77°F. On average, the bond strength for the fine-graded mixture was 346.1 psi. The average bond strength for the coarse mixture was 287.0 psi. Although, it may be expected that the coarse-graded mixture would provide more friction to shear at the interface, the bond strength results at this temperature do not support that hypothesis. A possible explanation is that the fine textured mixtures have a greater area of contact making the tack coat application more effective.

Figure 15. Bond Shear Strength for Fine-Graded Mixtures at 77°F

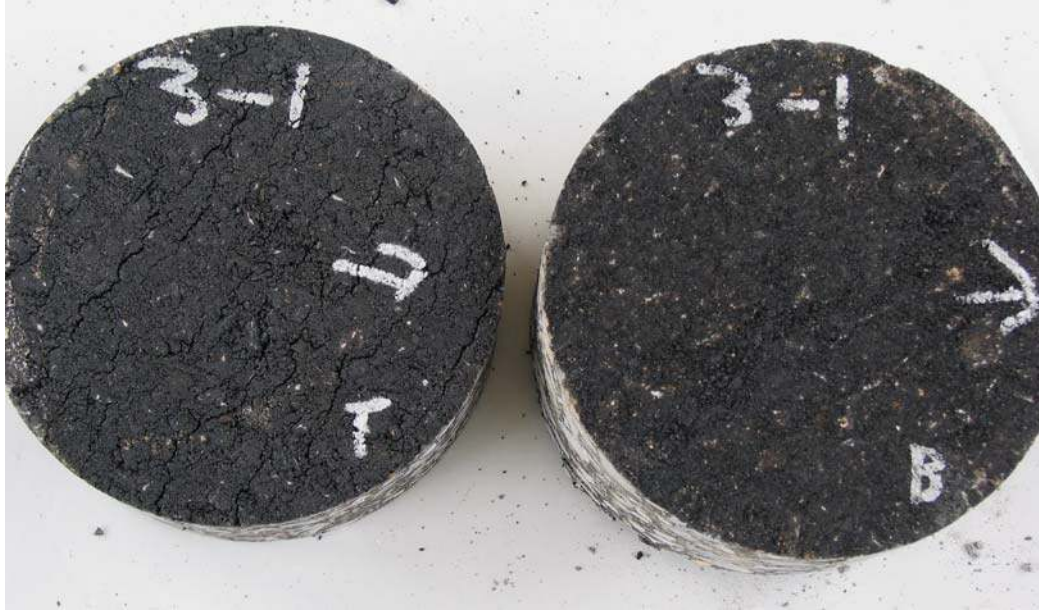
Attempts to obtain cores were unsuccessful the day the sections were set up. The cores debonded at the interface between the overlay and the underlying surface. Since this was the first project, it was thought that this problem may be due to the very high ambient temperatures. So a second attempt was made to cut cores the following morning. No traffic was allowed on the sections overnight. Still, only cores from the third section could be obtained. The average bond strength for these cores, also shown in Table 9, was also very low (37.1 psi). The calculations for the tack application rates were completed later. These very low rates explain the difficulty in getting good cores and the low bond strength for the last section. It is also interesting to note that the contractor had difficulty meeting the required density on the new mat. On a number of the cores, hairline cracks were evident (Figure 18), often called check cracking. Although this type of cracking is often associated with tender mixes, it can also be caused by the lack of a bond between the new mat and the underlying surface.

Figure 18. Core from Project 1 Showing Hairline Cracks in Surface Layer (left)

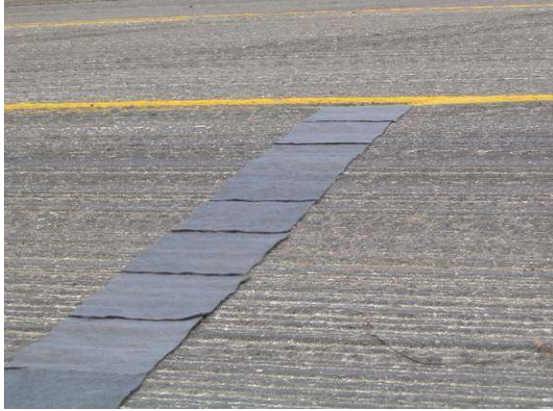
For the remaining field projects, the actual tack coat application rates for the test sections were determined using ASTM D 2995, *Standard Practice for Estimating Application Rate of Bituminous Distributors* (23). NCAT found this to be an effective method. This method is easy to use and applicable to any type of tack material. It can be used to determine transverse and longitudinal uniformity of the tack application rate. This method consists of placing pre-weighed pads of non-woven geotextile fabric across the lane for transverse measurements (Figures 19 and 20), or in the direction the tack truck travels for longitudinal measurements, and then allowing the tack truck to apply the tack coat over the area using the truck's normal application procedure. The pads are then removed and re-weighed. The tack applied to each pad is used to calculate the application rate for the pad area.

Figure 19. ASTM D 2995 Pads Used to Evaluate Transverse Application Uniformity

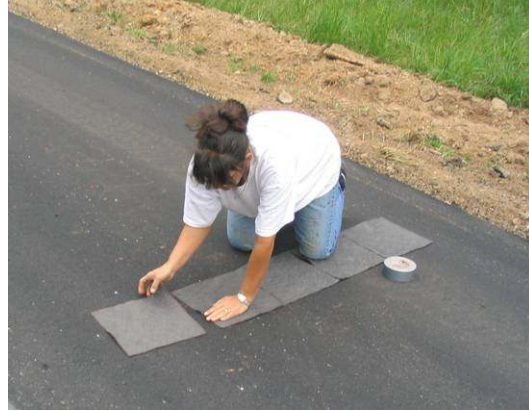
Figure 20. Placing Pads for ASTM D 2995

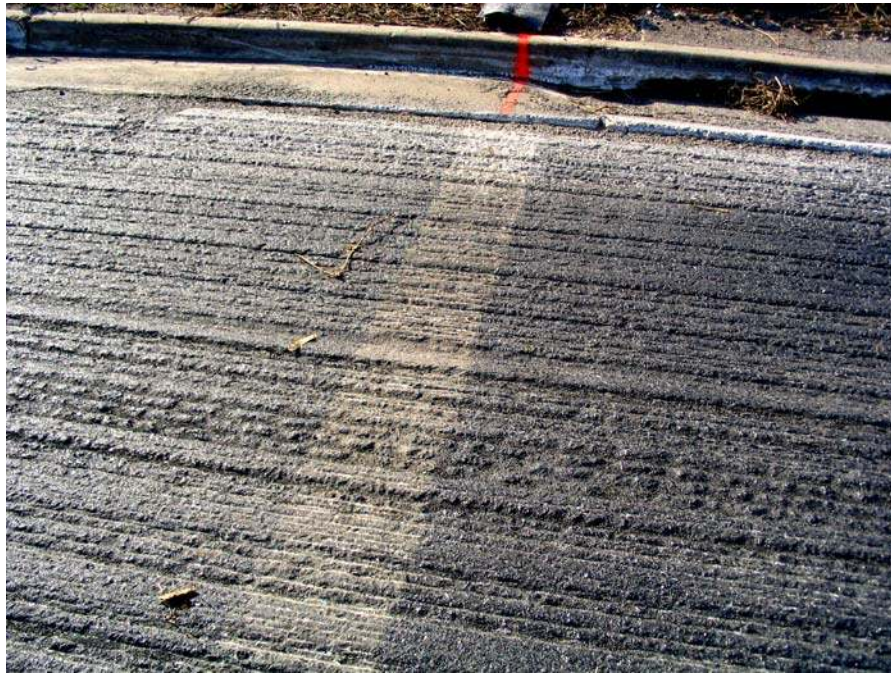
Figure 21 shows a photograph from one of the tack coat test sections. The stripe across the milled surface is where the pads were removed to measure the actual application rate. On most projects, cores were taken at these locations to determine the bond strength between the pavement layers with no tack. In actuality, some tack coat was likely tracked on to this stripe by the construction equipment.

Figure 21. Photograph Showing Location Where Geotextile Pads Were Used to Measure Actual Tack Coat Application Rate

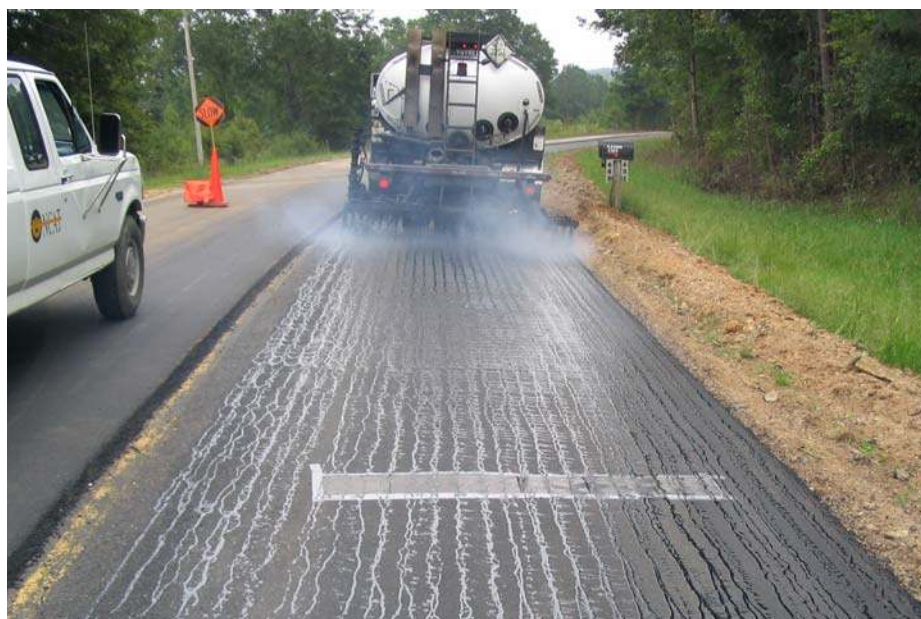
The second field project was located near Lafayette, Alabama in Chambers County on County Road 32 (Figure 22). The tack coat test sections were set up on September 16, 2004. The contractor used a PG 64-22 binder as the tack coat. The tack coat sections were applied over an HMA leveling course that had been placed a few days prior. The tack coat was applied using a distributor spray bar. The measured application rates are shown in the Table 10. The distributor truck operator did not adjust the application rate after the first section, so a second “low” section was constructed.

Figure 22. Application of PG 64-22 Tack Coat Test Section on Project 2

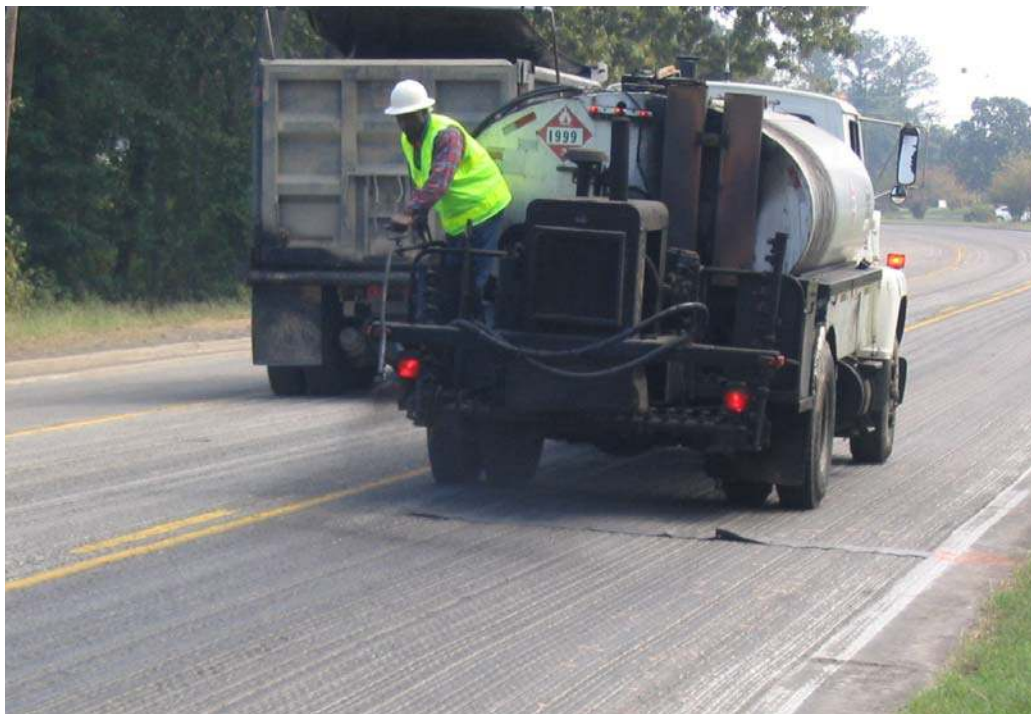
Field project 3 was located on State Highway 22 West in Roanoke, Alabama in Randolph County. Tack coat test sections were set up on September 30, 2004. The contractor used a CRS-2 emulsion as the tack coat. The tack coat was applied over a milled asphalt surface. As shown in Figure 23, the tack coat was applied using a hand wand sprayer due to problems with the spray bar on the distributor truck. The measured application rates are shown in Table 10.

Figure 23. Application of Tack Coat with Hand Wand on Project 3

The application rates measured on this project were about half of the target rates for each section. This difference is not surprising considering the use of the hand wand to apply the tack coat. Accurately calibrating the tack coat application rate using the hand wand sprayer is not possible.

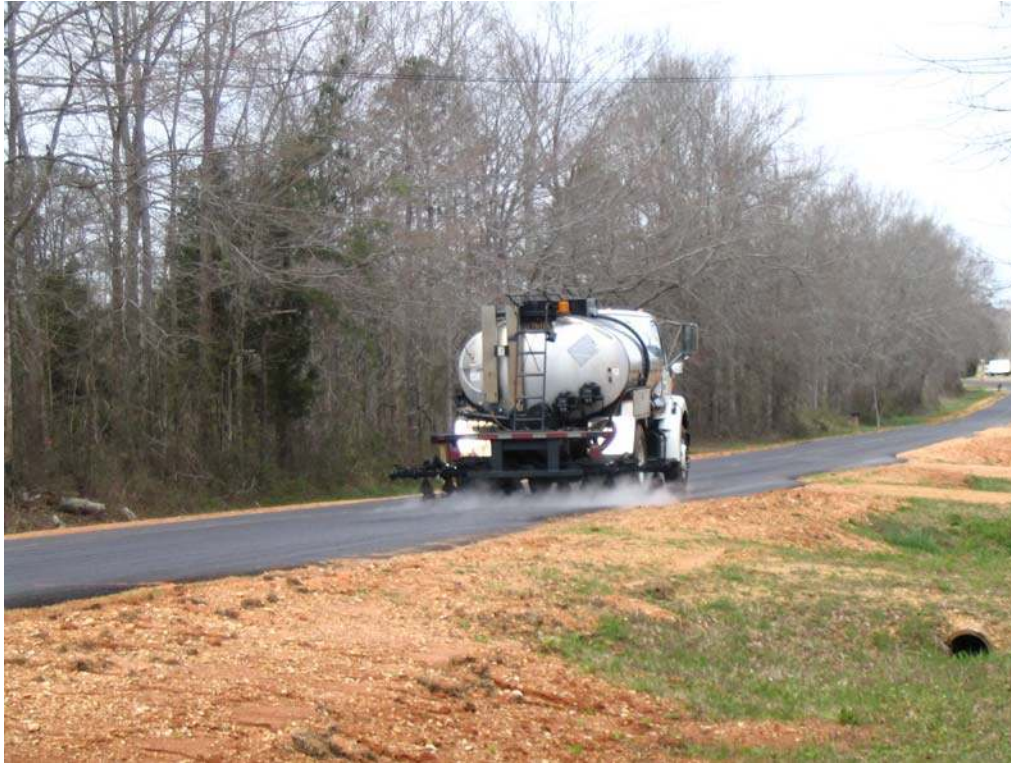
Figure 24. Application of CSS-1 Tack Coat on Project 5

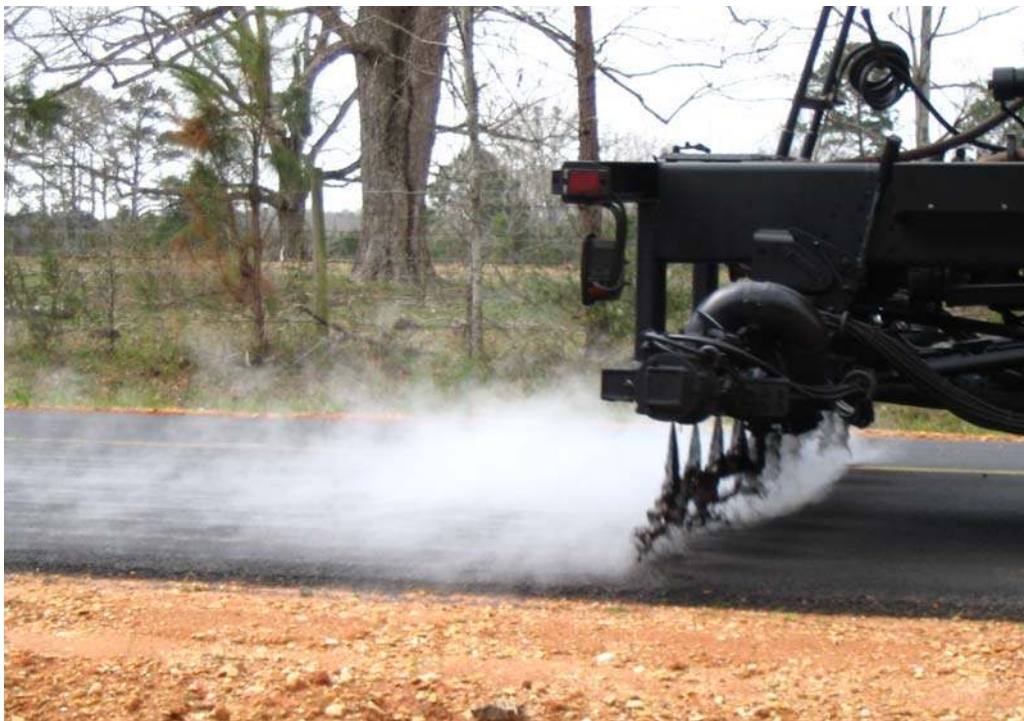
Figure 25. Close Up of Application of Tack coat on Project 5

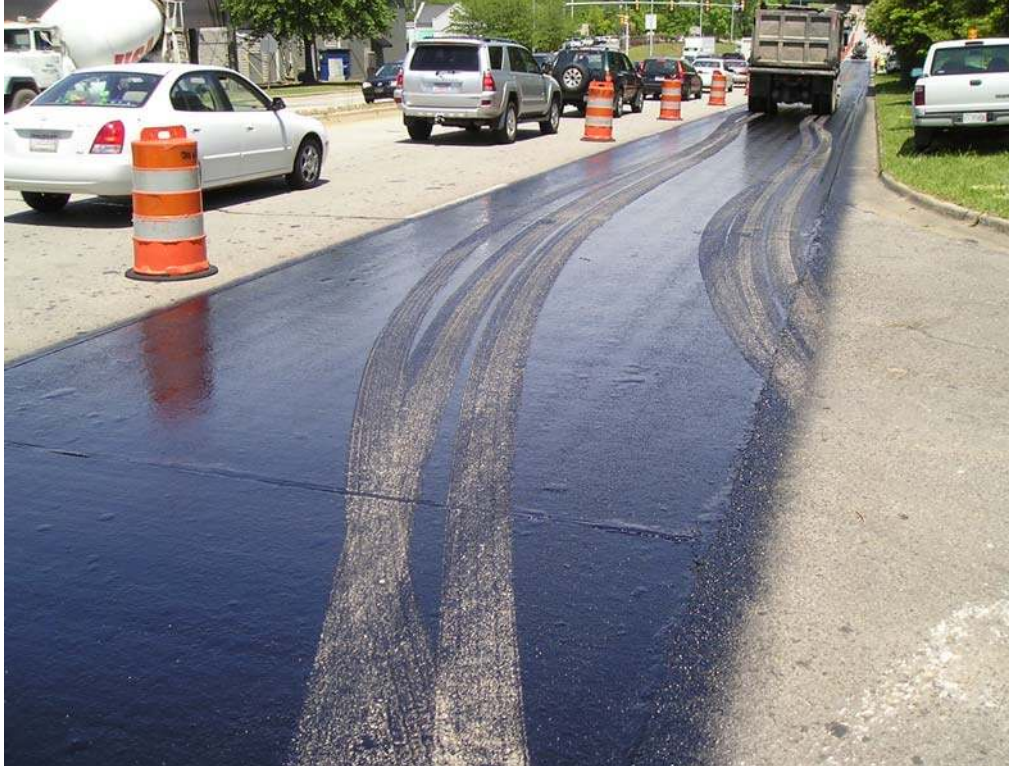
Figure 26. Tack Coat Applied with a Typical Distributor Truck on Project 6

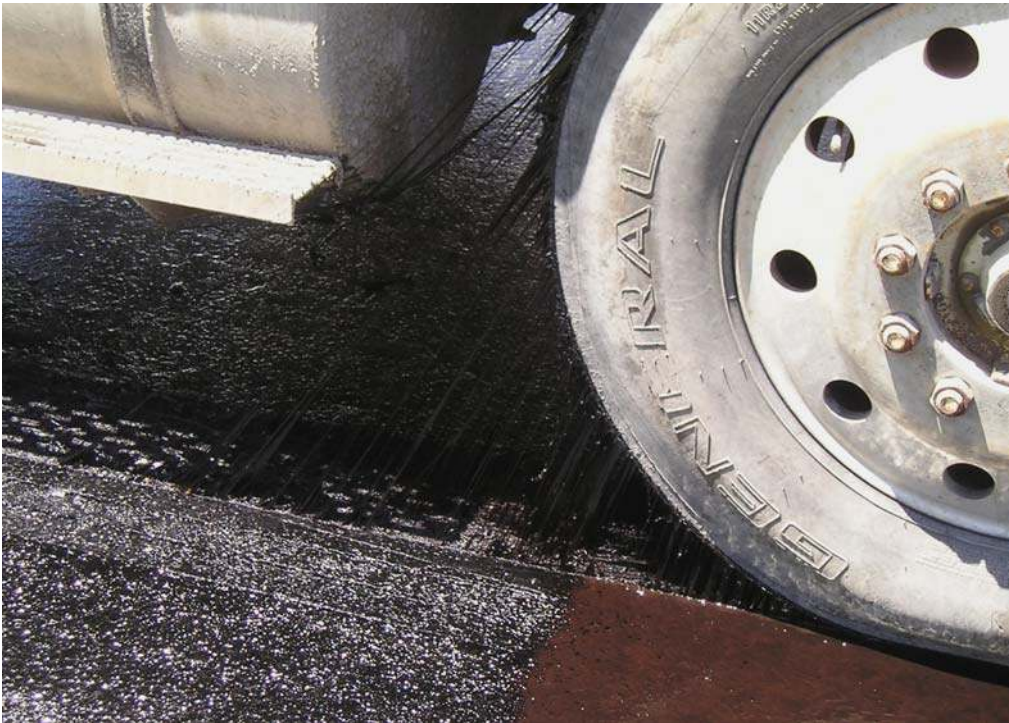
Figure 27. CQS-1HP Polymer Asphalt Emulsion as Applied in Section 1 & 2. Note the Strings of Tack Sticking to the Tire

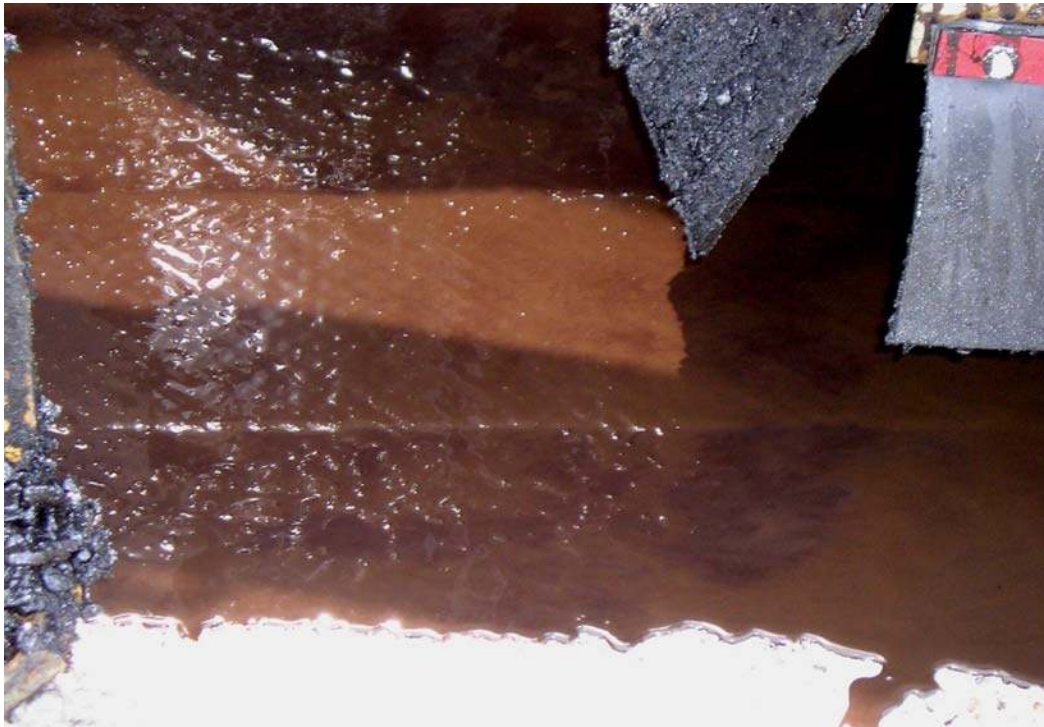
Figure 29. Tack Coat Applied by Novachip Spreader Just in Front of HMA

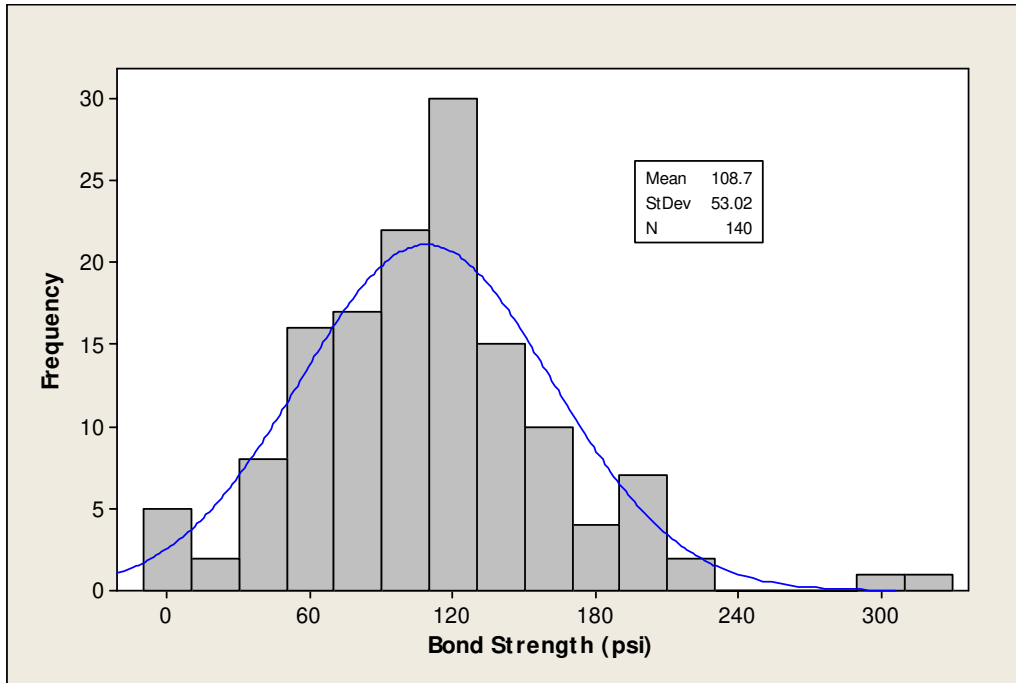
Figure 30. Histogram of Bond Strength Tests for All Samples in Phase II

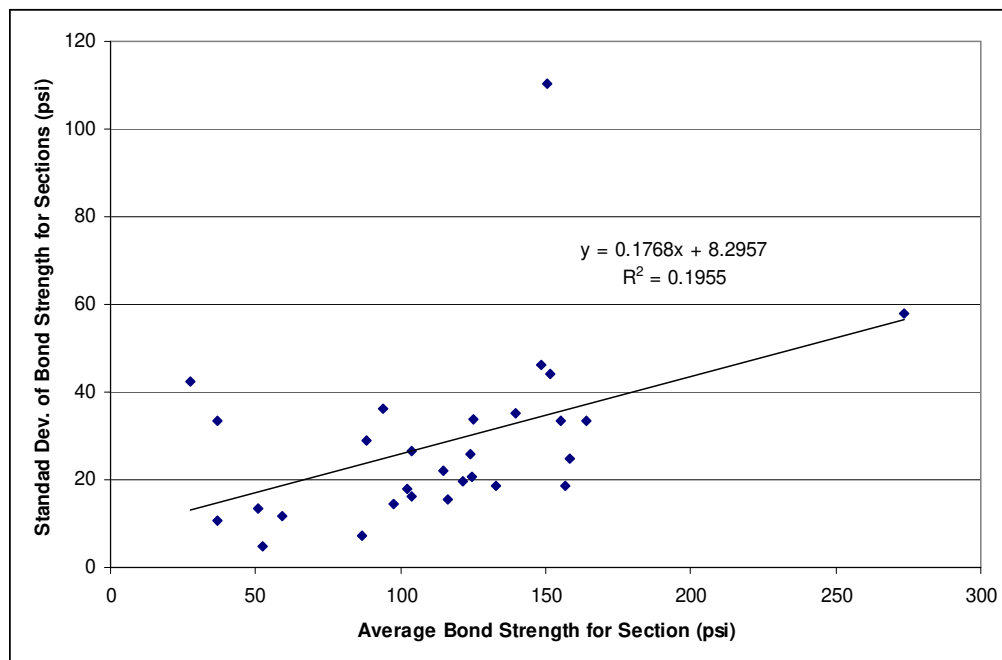
sections, based on at least three samples, was 103.7 psi. The pooled standard deviation for bond strengths calculated for each of the sections was 28.7 psi. Figure 31 compares the average and standard deviation for the bond strength determined for each field section. This graph shows a trend of increasing variation of results as the average bond strength increases. Variability of results were also high for sections with low average bond strengths because some cores debonded (i.e. bond strength = 0) and other cores had some bond strength.

Figure 31. Correlation of Average and Standard Deviation for Bond Strength of Sections
