Evaluation on Ambulance Design and Musculoskeletal Disorders Risk Factors among Ambulance Emergency Medical Service Personnel

Keywords: Musculoskeletal disorders, Ambulance, EMS, Workers, REBA, Risks

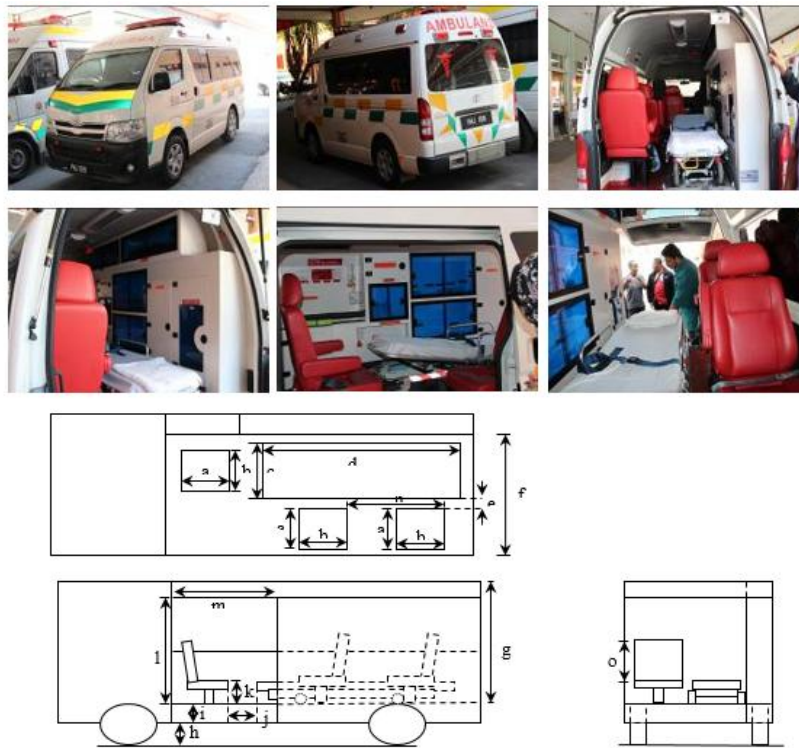
Fig. 1: Photographs and design specifications for Class B type ambulance

Referring to Fig. 1, the dimensions for the Class B ambulance are as follows: $a = 46$ cm; $b = 41$ cm; $c = 53$ cm; $d = 183$ cm; $e = 14$ cm; $f = 109$ cm; $g = 159$ cm; $h = 37$ cm; $i = 26$ cm; $j = 15$ cm; $k = 33$ cm; $l = 125$ cm; $m = 118$ cm; $n = 80$ cm; $o = 184$ cm. In terms of the ambulance's design, several problems have been identified. Based on our interview with the subjects, it seems that the dimension of the workspace for Class B ambulance is considered as narrow. This findings is in-line with past studies (15-17) found similar problem faced by many countries ambulance service is narrow patient's compartment. This is true because many currently used ambulance vehicles were converted from ice

cream small vans, therefore the same problem of narrow space happen again and again (18). Installation of two large seats at side of the stretcher to accommodate the EMS personnel and one family member or close relative is identified to be the cause of the cramp. Furthermore, the seat cannot be adjusted or removed. Inadequate workspace may cause bumping among the emergency medical personnel and injuring the patient (19). The reason for not changing those two large seats is unknown but according to the interview, the subjects believed the reason could be due to the ambulance operating procedure that forbid any occupant to perform any major movement while the ambulance is in motion. Therefore, to prevent

and restrict the movement of all occupants in the ambulance, those two large seats are installed instead of the bench seats. In addition, according to the subjects the geographical condition of Malaysia still consist of many roads with narrow width, which most of the time will act as a shortcut route. So, to make sure the ambulance can pass through the narrow road to get to the incident place, the total dimension width of the ambulance is designed to be smaller than those in western countries.

Other design specifications that increase awkward position are the railing and the seat. In Class B ambulance, it is identified that the interior design of the ambulance got no hand rail. Based on the interview, this matter can cause instability towards the body during standing since most of the time the EMS personnel need to stand in order to reach for equipment or other medical items. Meanwhile, the seat used in Class B ambulance is too large and has narrowed down the workspace's dimension. Even with only a bench seat, the access towards patient in the workspace of the ambulance is still below satisfactory level (10). In addition, placement of the captain's seat for the physician is too far from the patient and it cannot be adjusted. Due to this seat placement, the EMS personnel sometimes need to bend towards the patient even though they have

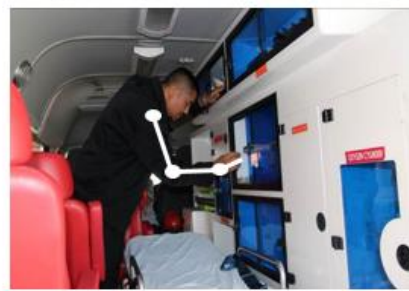
Fig. 5: EMS personnel is trying to get the medical equipment in the middle cabinet; the final REBA scores recorded is 4

REBA scores for Class B ambulance for the above four activities (i.e. Fig. 2-5) showed that without the hand rail, it causes unstable situation for the EMS personnel and thus increase the coupling score and activity score. These two scores have lead towards increased in the risk of developing MSDs. Activity like retrieving medical equipment or items is considered as a frequent activity done in the ambulance, this increase repetitive stretching muscle activity since the shoulder needs to be raised up above the normal raise position; it also increase repetitive twisting and

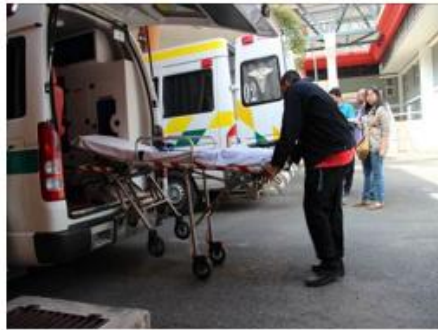
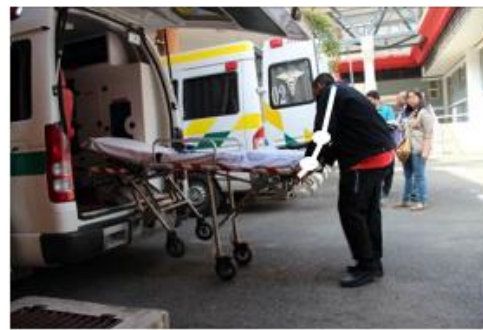
Fig. 6: EMS personnel is pulling out the stretcher from the ambulance; the final REBA scores recorded is 7

The result from Class B Ambulance; Fig. 6 showed that the ambulance EMS personnel has a medium risk of developing MSDs even with just an activity of loading out the stretcher without the patient on it. Meanwhile, the result from Fig. 7

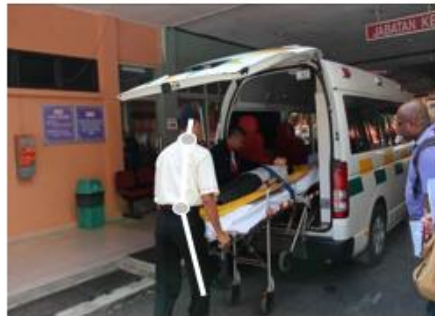
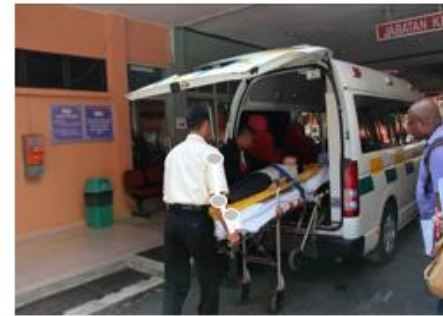
Fig. 7: EMS personnel is pushing in/out with the patient on the stretcher; the final REBA scores recorded is 4

and 8, which involves loading in the stretcher back into the ambulance showed that the risk of developing the MSDs ranges about medium to high risk even with just a small kid weighing around 40 kg.

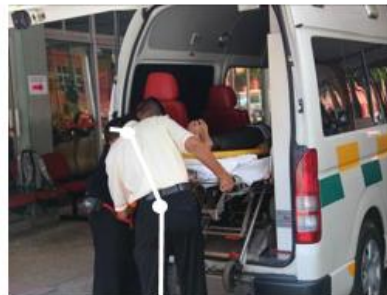
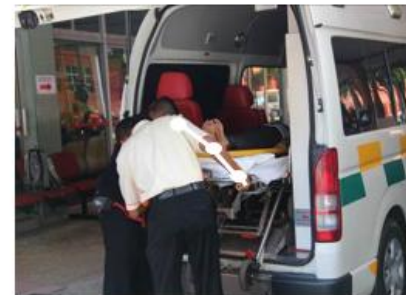
Fig. 8: EMS personnel is lifting up for pushing further the stretcher in the ambulance with the patient; the final REBA scores recorded is 8
