CHAPTER 65

EXPERIMENTAL STUDY OF THE HYDRAULIC BEHAVIOUR OF INCLINED GROUYNE SYSTEMS

Júlio Patriarca Barcelo

SYNOPSIS

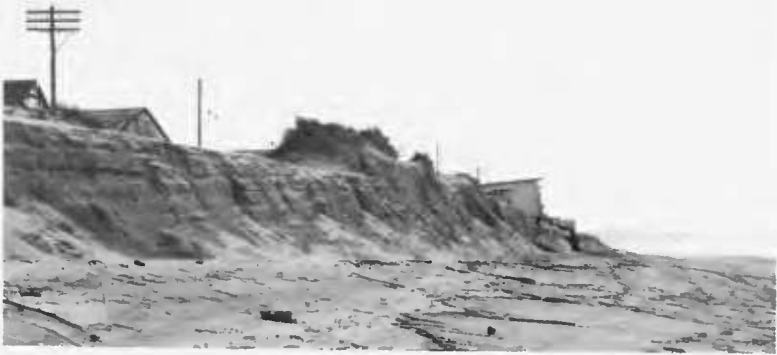
Fig. 1 - Erosion in Caparica beach, January 1970

Groynes are one of the most applied coast protection structures because, owing to their transverse position, they detain long shore drift, which is the main cause of serious coastal erosion phenomena (see fig 1). Groynes have practically no influence on transport normal to the coast but this, in addition to being usually small, tends to balance in the annual wave cycle. Groynes can be used to stop longshore drift, which may cause undesirable depositions in certain zones (case of beaches in dynamic equilibrium), or to protect beaches where the supply of material is exceeded by the losses. In any case, a single groyne or a group of groynes can be used, the latter - called a groyne system - being particularly important owing to applications in long sand shores.

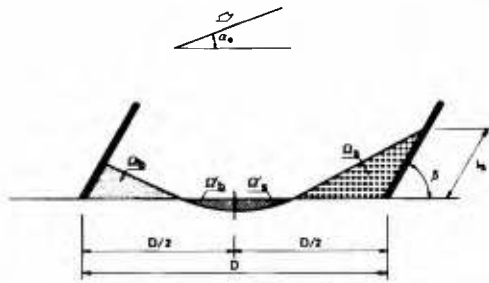
Fig. 3 - Schematic drawing of the testing setup

The tests were carried out in a tank (with a net area of about 8 m x 18 m), fitted with a translation wave machine. The plain sine waves generated had periods from 1.0 to 1.3 s, heights between 3.00 cm and 5.50 cm and obliquities of 20°, 10° and 5° (α_0 - obliquity of the breaking wave - see fig 3). The mobile material used was pumice stone with a unit weight of 1.46 gf/cm³ and a median diameter of about 1.5 mm. The tests began with a beach with a transverse slope of 1 = 8%. The still water level remained constant, i.e. tides were not reproduced. Fixed, high, and impermeable groynes were tested and the beach stretches between them can be considered as independent physiographic units.

On the whole inclined groynes (see fig 3) operate roughly as normal groynes ($\beta = 90^\circ$), i.e. beaches initially with a uniform transverse slope of 8% reach final equilibrium conditions essentially depending on the characteristics of the wave for each value of β . The characteristic parameters of the operation of groynes are those indicated in [1], but the following are particularly relevant in the present study: accretion areas Ω_s and Ω_b , total accretion area $\Omega = \Omega_s + \Omega_b$, evolution l_s of the beach near the downdrift groyne, spacing D between groynes, length c of the groynes, and value

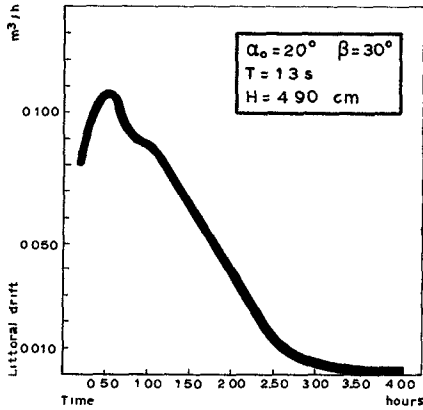
Fig 6

sary to reproduce the area near the downdrift groyne with a fixed bed and to remove mobile material beyond this groyne. The curve of fig 6, plotted from the quantities removed, represents drift at

the end of the groyne versus the duration of the test. It should be noted that the conclusions drawn are not invalidated by the absence of updrift feed, which corresponds to the most adverse conditions in the extreme updrift groyne.

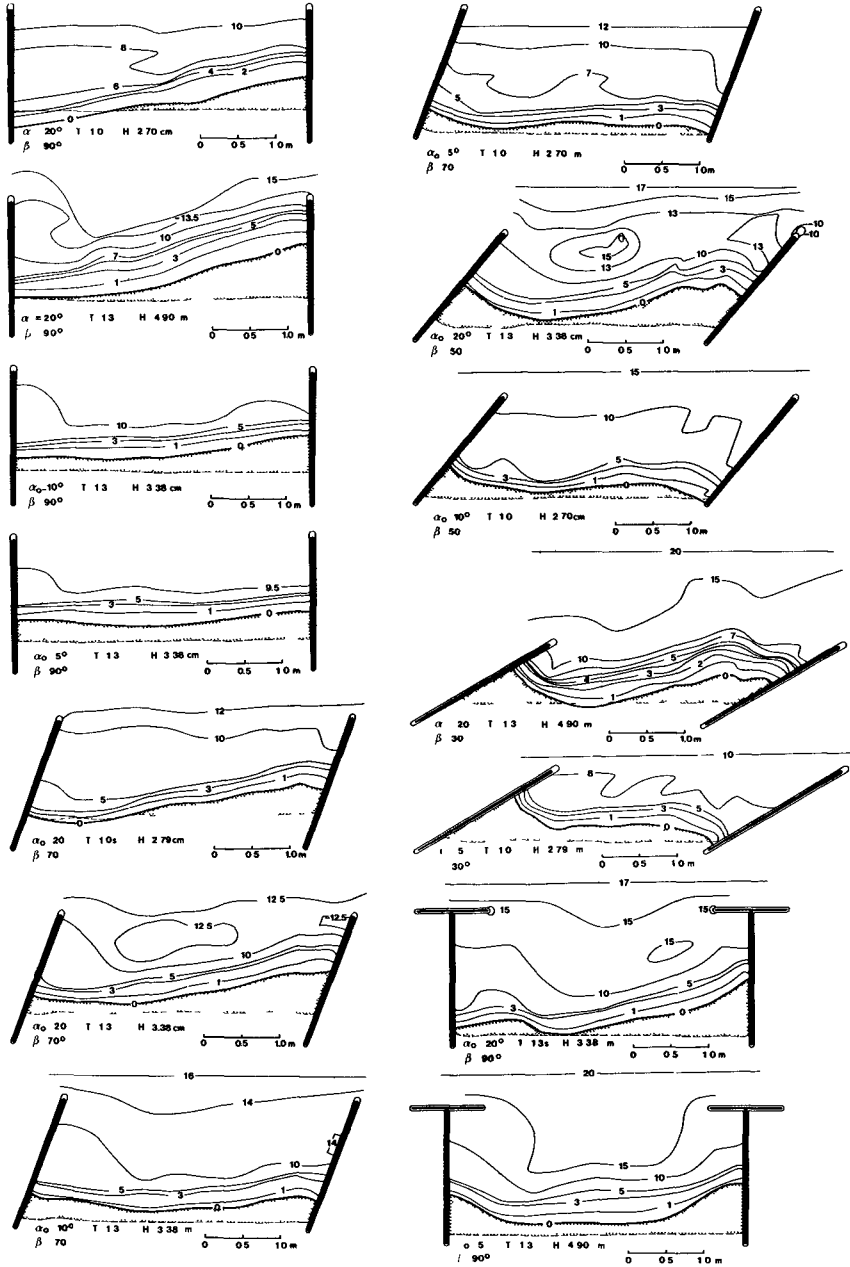
Fig 7 - Typical plans of final equilibrium conditions of the tested cases

The detail characteristics of the evolution of beach stretches are presented in fig 7, which shows the final equilibrium condition for the different typical cases studied, the dotted line represents initial conditions in the beach for a zero water level, the indicated value of the wave height, H , concerns the depth where the wave generator is placed. Groynes with $\beta = 90^\circ$ may cause erosions near the updrift groynes for the maximum obliquities tested, whereas accretions extend throughout the width of the beach stretch for lower obliquities, in which transverse movements predominate. For $\beta = 70^\circ$ the overall behaviour of the groyne system is not changed, but erosion hazards near the updrift groyne decrease, and for obliquities of $\alpha_0 = 20^\circ$ there is even deposition throughout the beach stretch, owing to the shelter afforded by the updrift groyne, for smaller obliquities, the beach retreats near the downdrift groyne and the area Ω_s decreases. For $\beta = 50^\circ$ the increase in the accretion area Ω_b and in the protection afforded by the root of the updrift groyne grow more marked. For smaller obliquities regression increases near the downdrift groyne and the areas Ω_s decrease. For $\beta = 30^\circ$ the beach stretch can hardly be considered as a physiographic unit for large obliquities, for smaller obliquities considerable erosions occur in the root of the downdrift groyne and the areas Ω_s are appreciably reduced. T-groynes operate roughly as normal groynes but the protection afforded to the groyne roots is present in all cases and the symmetry of areas Ω_b and Ω_s is more marked.

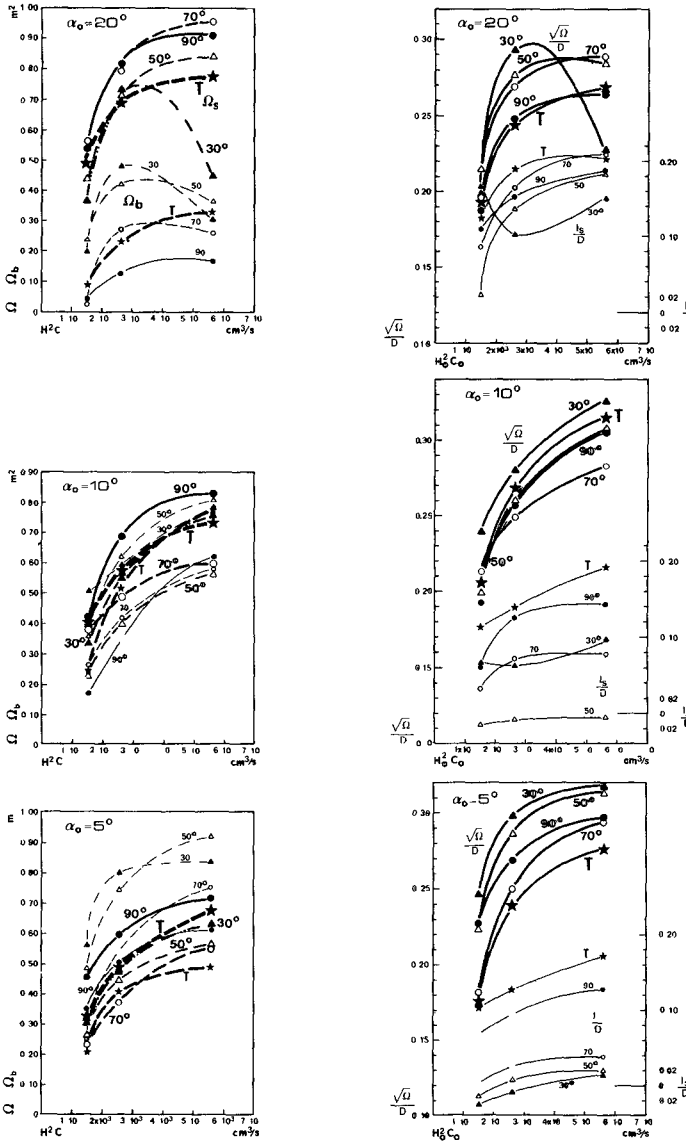
The two most relevant parameters for the definition of the efficiency of groynes (accretion areas and evolution of the beach near the downdrift groyne) are defined in fig 8, which represents

Fig 8 - Curves of the parameter defining the efficiency of groyne in function of the transmitted wave power

the curves of Ω_s and Ω_b (thick and thin lines respectively) with dimensions which give an idea of the values observed in the model tests, and the curves of $\sqrt{\Omega}/D$ together with those of l_s/D (dimensionless values suitable for practical applications) The figure also presents the curves of these parameters in function of the value $H_o^2 C_o$ proportional to the transmitted wave power for each obliquity α_o of the breaking wave It is from these dimensionless values that the efficiency of the groyne types tested will be defined For $\alpha_o = 20^\circ$ the maximum efficiency corresponds to $\beta = 70^\circ$, if the increase not only of $\sqrt{\Omega}/D$ but also of l_s/D is taken into account For $\alpha_o = 10^\circ$ the groynes with $\beta = 90^\circ$ are the most efficient taking into account the fact that l_s/D is larger for $\beta = 90^\circ$ although the values of $\sqrt{\Omega}/D$ are higher for $\beta = 30^\circ$ For $\alpha_o = 5^\circ$, groynes with $\beta < 90^\circ$ yield values of l_s/D which are very low or correspond to erosions, so that the maximum efficiency is obtained for $\beta = 90^\circ$ T-groynes are not more efficient than normal groynes ($\beta = 90^\circ$), their only advantage being the absence of erosions in the groyne roots

- T-groynes are not more efficient than normal groynes, except for $\alpha_0 = 10^\circ$, and even then the difference is small (see fig 8) Their only advantage lies in preventing erosion near the roots of the groynes Nevertheless they are not recommended because, in addition to their construction being more expensive, they disturb the utilization of the beaches for sea baths

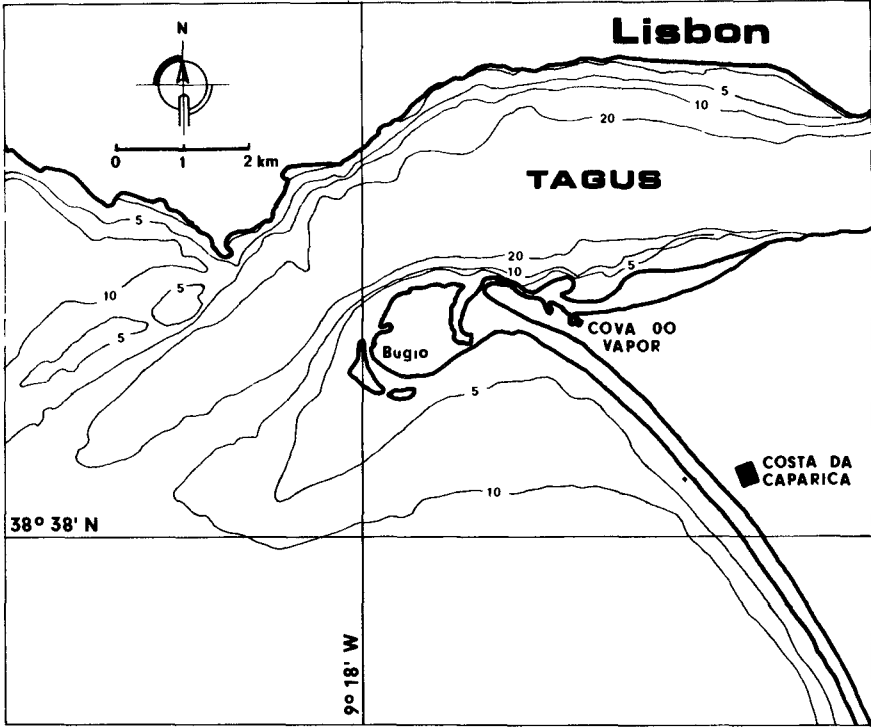
One of the most serious erosion phenomena in the Portuguese coast occurred in the beaches of Cova do Vapor and Caparica, a long sand expansion south of the Tagus estuary near Lisbon From the situation presented in fig 9, which prevailed in 1929, erosion began due to the collapse of the natural protection afforded by the sand formation north of the beaches, which ends at the

Fig 9 - Caparica and Cova do Vapor beaches (1929)

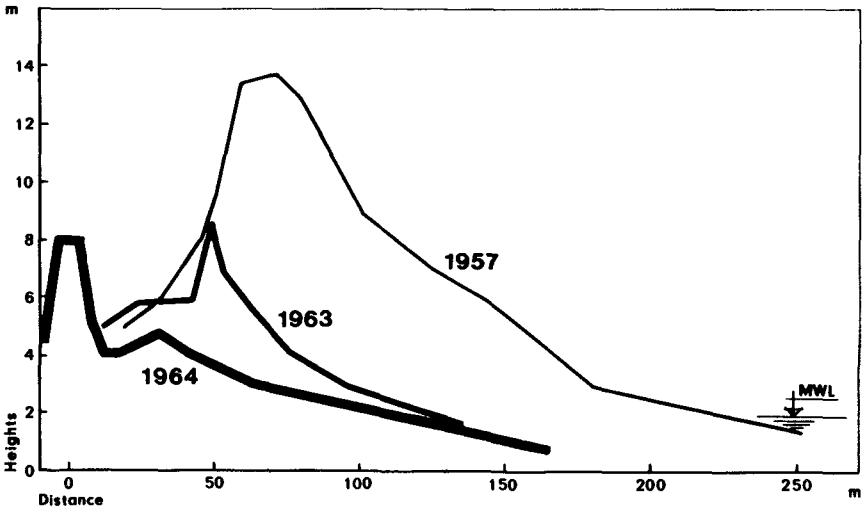
Fig 10 - Evolution of transverse profiles in Caparica (transverse profile in the dike root)

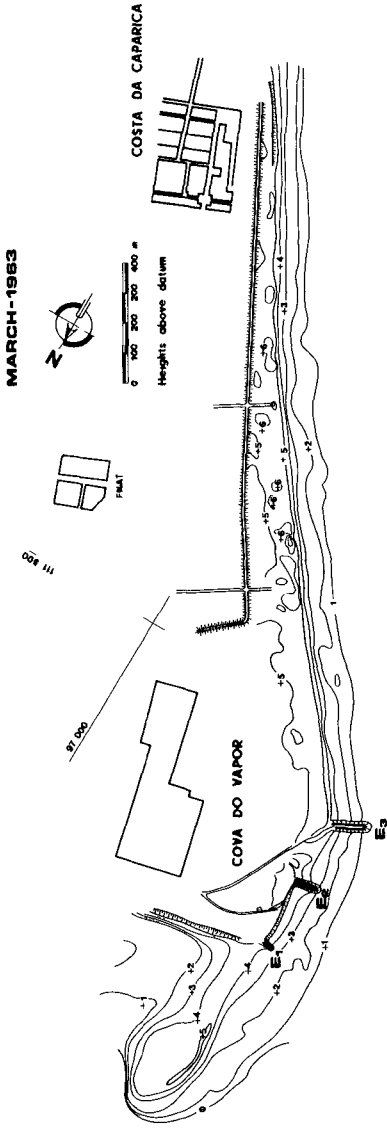
Fig 11 - Plans of Cova do Vapor and Caparica beaches (March 1963)

Figures 13 and 14 give an idea of conditions in Caparica beach before the erosion begun and now (July 1970) The groyne E_2 (fig 11 and 12) is now being extended, and the construction of a groyne system and the strengthening and extension of the frontal protection structure {4} are in preparation The groyne system is made up of units which, although very long, have a reduced effective length and a small spacing and are located at very high elevations With such a system, the restoration of the beach is out of question, as the existing groynes to the north cannot operate efficiently for lack of supply from the south due to the disappearance of the beach On the other hand the southern stretch of the beach will tend to be eroded away up to the extended frontal protection structure, which will have to be exaggeratedly strengthened These measures, planned a long time ago for hydrographic conditions no longer prevailing, are unsuited to the present needs and will never

It should also be noted that an efficient system does not depend on the location of the groynes alone. Their structure and certain constructional details are also essential. As an instance, the case of groyne E_2 (fig 11 and 12) is presented. Excavations shown in the fig 17, occurred at its end, in concentric zones at depths -4, -5, -6, the darker zones corresponding to the last depth. These peculiarities seriously interfered with the construction of the groynes and caused an exaggerated use of rockfill. An adequate base of the groynes protecting the adjacent sea floor against erosion is essential but, as shown in fig 18, these groynes lack such a special base. As can be seen in fig 19 erosions at the end of the groynes occur even in the model tests, those shown having been observed in tests carried out in the first stage of these studies.

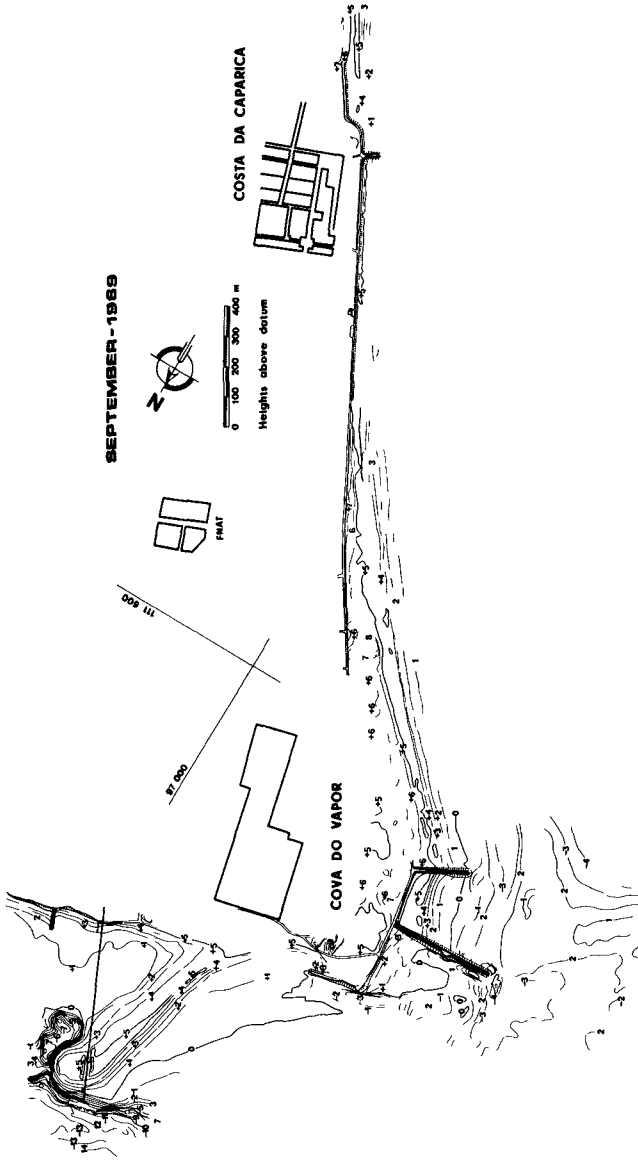
Fig 12 - Plans of Cova do Vapor and Caparica beaches (September 1969)

also shown in fig 12 According to the studies carried out {3} the littoral drift in this zone is estimated in $1\ 000\ 000\ m^3/year$ At the same time, owing to changes in the sea-bottom relief and their influence on the wave action, a rapid erosion started in the central zone of Caparica particularly serious in the beaches to the south (see fig 1) Another emergency structure for frontal protection was built and subsequently strengthened in the central zone of Caparica

The restoration and protection of these beaches requires an artificial feeding and a system of functional groynes, i.e. long very spaced groynes. The artificial feeding would restore e.g. 1963 conditions, as shown in fig 16. The northern spit is represented in the figure, because studies on the touristic development of Cova do Vapor carried out in 1966 for the TECHINT project [3], recommended the construction of a long groyne in the northern end and the creation of an extensive beach mainly at the cost of sand dredged from the spit, in which a pleasure boat port (represented by the dotted line in the figure 16) would also be built. The solution recommended here for the present conditions would require the straightening and protection of the bank, upstream of the root of groyne E_0 , the artificial restoration of the beach being necessary to the south of E_2 alone. This location of groyne E_0 is preferable to the one shown in fig 12, which would leave two groynes very near one another disturbing the operation of groyne E_0 .

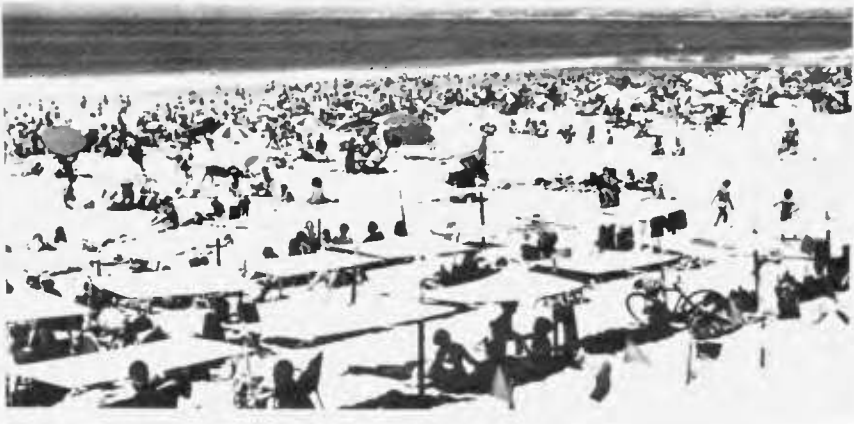
Fig. 13 - Caparica beach before erosion begun

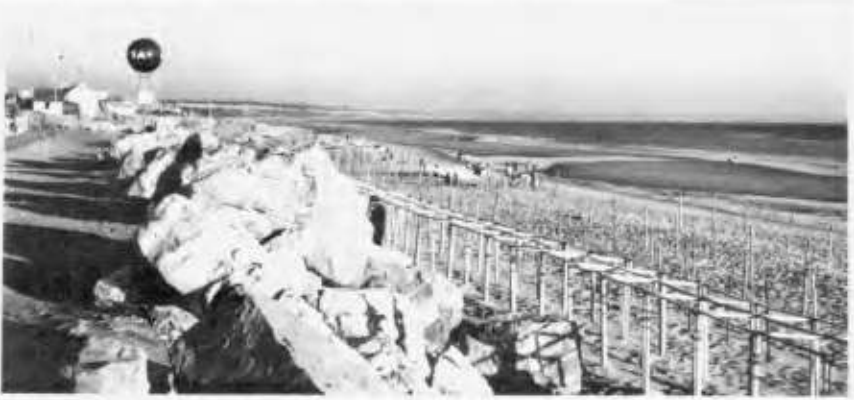
Fig. 14 - Caparica beach in July 1970 (low water level)

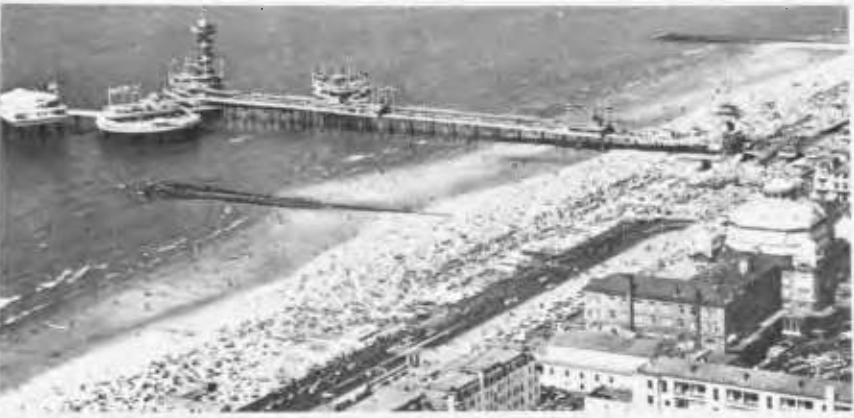
Fig. 15 - Scheveningen beach (The Hague, Netherlands)

provide a beach with real recreational and touristic interest. As an instance of a system of functional groynes, the one built at Scheveningen beach (The Hague, Holland) is presented, the construction was very expensive owing to the extraordinary structural perfection of the groynes, but the results were excellent (see fig 15)

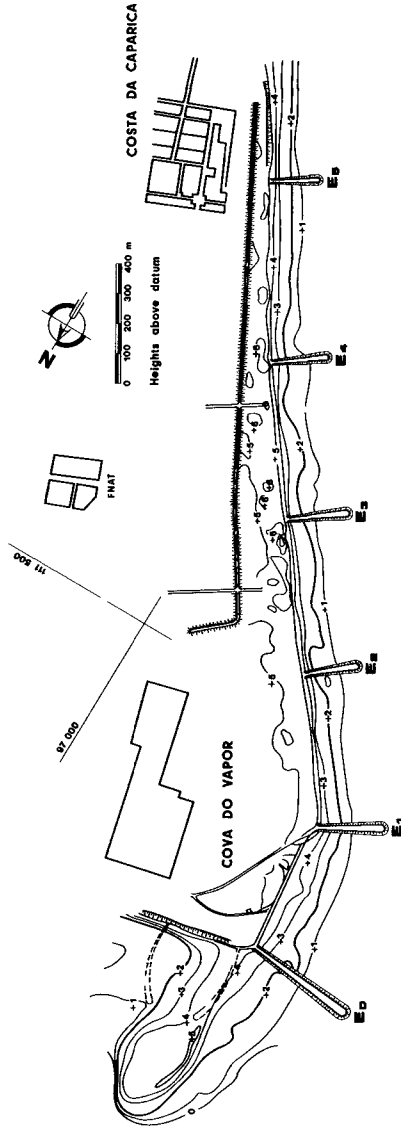
By means of the plan presented in fig 16 it would be possible not only to recover the beaches and protect the coast to the south of Caparica but also to avoid the extension and strengthening of the frontal protection structure. Obviously a more detailed study of this plan (which is no more than a typical solution), could yield a better and more economical solution. A single very long groyne to restore the natural connexion with Bugio together with a large volume of sand to restore the beach (a natural restoration being impossible owing to lack of supply and the irreversibility of erosion) would leave a long stretch of beach without protection making possible local erosions, so that the solution presented is preferable.

Fig 16 - Groyne field drawn on the March 1963 survey (Cova do Vapor and Caparica beaches)

The typical solution presented for the groyne system takes into account the two studies carried out. As wave conditions are variable, groynes with $\beta = 90^\circ$ were chosen. The obliquities α_o considered are 10° in the zone from Cova do Vapor to the middle of the dike, and 5° from this point to the central zone of Caparica. The reference line for calculating the length of the groynes will be the bathymetric curve +2.00 m. For $\alpha_o = 10^\circ$, $c/D = 3.5$ and for $c = 150$ m, $D = 520$ m (groynes E_1 to E_4), for $\alpha_o = 5^\circ$, $c/D = 4.0$, which for $c = 150$ m yields $D = 600$ m (E_5). Groyne E_5 may be shorter ($c = 100$ m, above +2.00 m) because the zone updrift of this groyne would be stable and obliquities are very small, an inversion to the south being even possible with small obliquities.

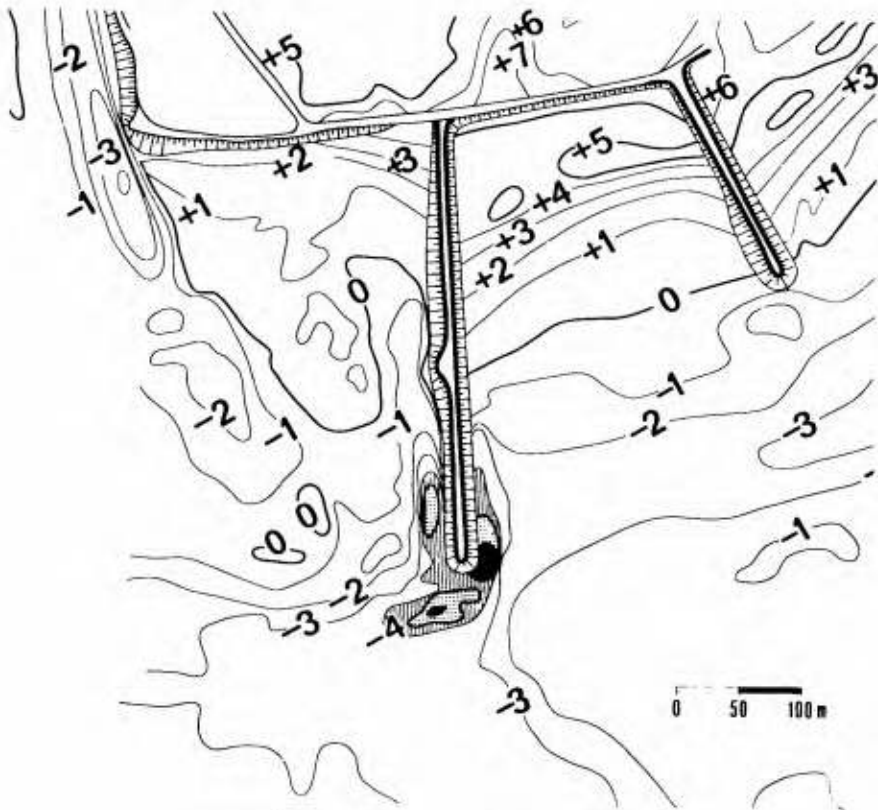
Fig. 17 - Plan of the groynes in Cova do Vapor (September 1969)

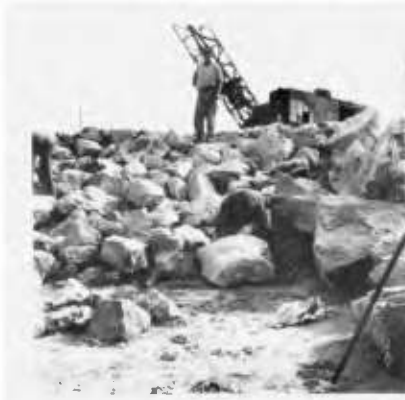
Fig. 18 - Detail of the construction of groynes in Cova do Vapor

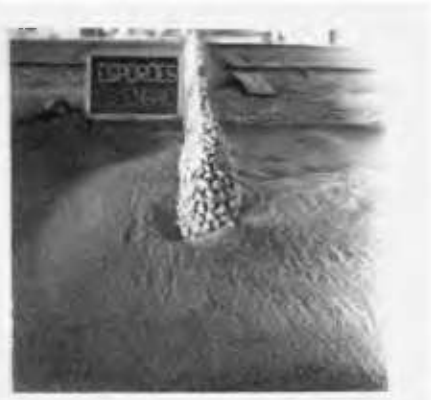
Fig. 19 - Erosion at the ends of the groynes obtained in the models
