Fan Noise Source Diagnostic Test— LDV Measured Flow Field Results

Prepared for the
Eighth Aeroacoustics Conference
cosponsored by the American Institute of Aeronautics and Astronautics
and the Confederation of European Aerospace Societies
Breckenridge, Colorado, June 17-19, 2002

Results are presented of an experiment conducted to investigate potential sources of noise in the flow developed by two 22-in. diameter turbofan models. The R4 and M5 rotors that were tested were designed to operate at nominal take-off speeds of 12,657 and 14,064 RPMC, respectively. Both fans were tested with a common set of swept stators installed downstream of the rotors. Detailed measurements of the flows generated by the two rotors were made using a laser Doppler velocimeter system. The wake flows generated by the two rotors are illustrated through a series of contour plots. These show that the two wake flows are quite different, especially in the tip region. These data are used to explain some of the differences in the rotor/stator interaction noise generated by the two fan stages. In addition to these wake data, measurements were also made in the R4 rotor blade passages. These results illustrate the

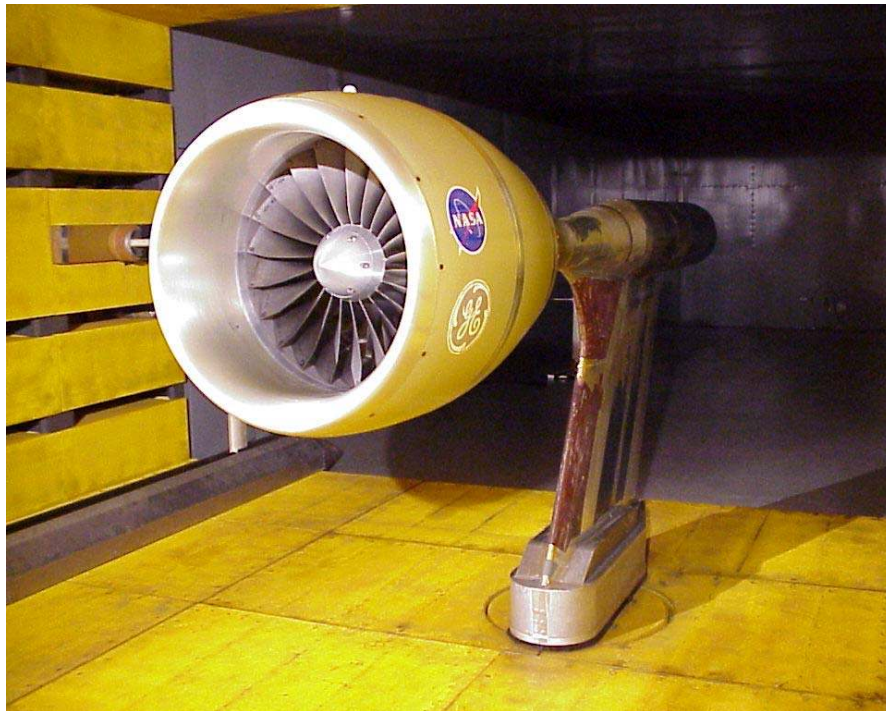
Figure 1. Source Diagnostic Test model installed in the NASA Glenn 9 X 15 Foot Wind Tunnel

Figure 1 shows the 22-inch (55.9 cm) diameter turbofan model installed in the test section of the NASA Glenn 9 X 15 Foot Wind Tunnel. Two different rotors, designated as R4 and M5 by the manufacturer (General Electric), were tested during the flow field diagnostic portion of the test. The R4 rotor was designed to operate at 12,657 RPM; the M5 rotor was designed to operate at 14,064 RPM. Although they were designed to generate the same overall fan pressure ratio

The flow diagnostic studies were conducted with an inlet different than that shown in the photograph of figure 1. The inlet shown in the photo is similar to that which would be used on a full-scale engine during an actual flight. The LDV data were acquired with a bellmouth inlet installed on the model. The bellmouth inlet provided essentially the same flow into the fan as the flight inlet, but allowed the tunnel to be run at a lower speed. This provided the following benefits: 1) the test was conducted at a lower cost and 2) the LDV system components which were mounted in the test section were subjected to lighter air loads. The test section Mach number during the LDV testing was approximately 0.05.

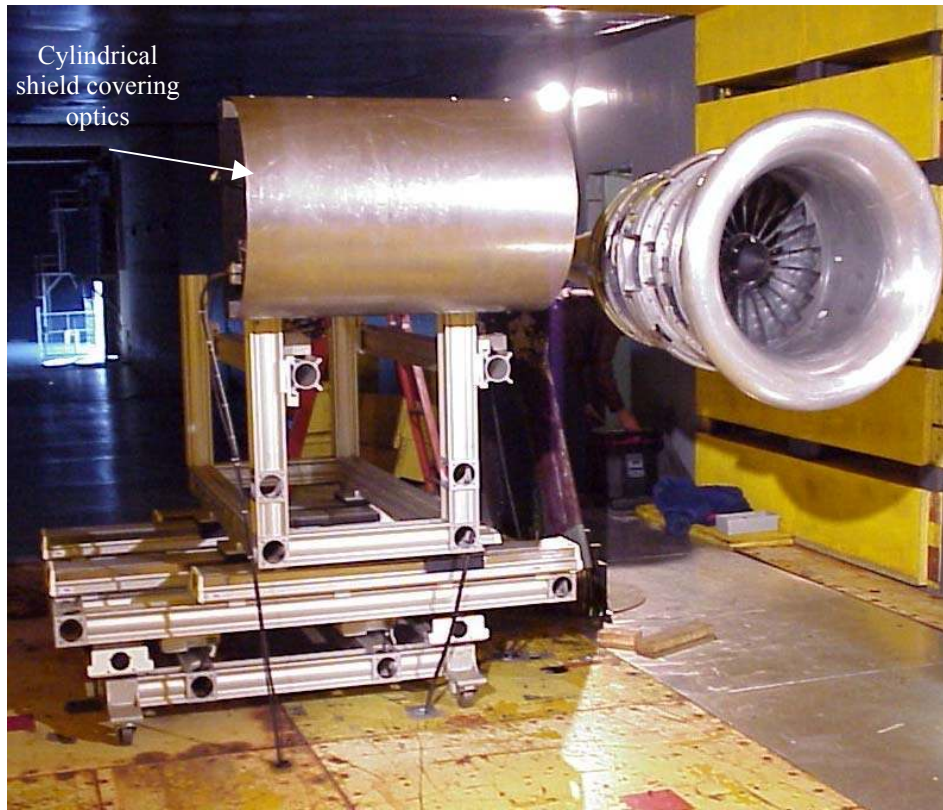
Figure 3. LDV system hardware installed next to the SDT model in the NASA Glenn 9 X 15 Foot Wind Tunnel.

In order to conduct these LDV surveys it was necessary to place part of the LDV system inside the test section of the wind tunnel. Figure 3 shows a photograph of the LDV traverse system located on the side of the turbofan model. In this photo the bellmouth inlet is shown installed on the model. The traverse was used to move the LDV probe volume radially and axially relative to the model. The LDV system optics are located behind the cylindrical shield shown in the photo. This shield was installed to keep the tunnel flow from striking the optics.

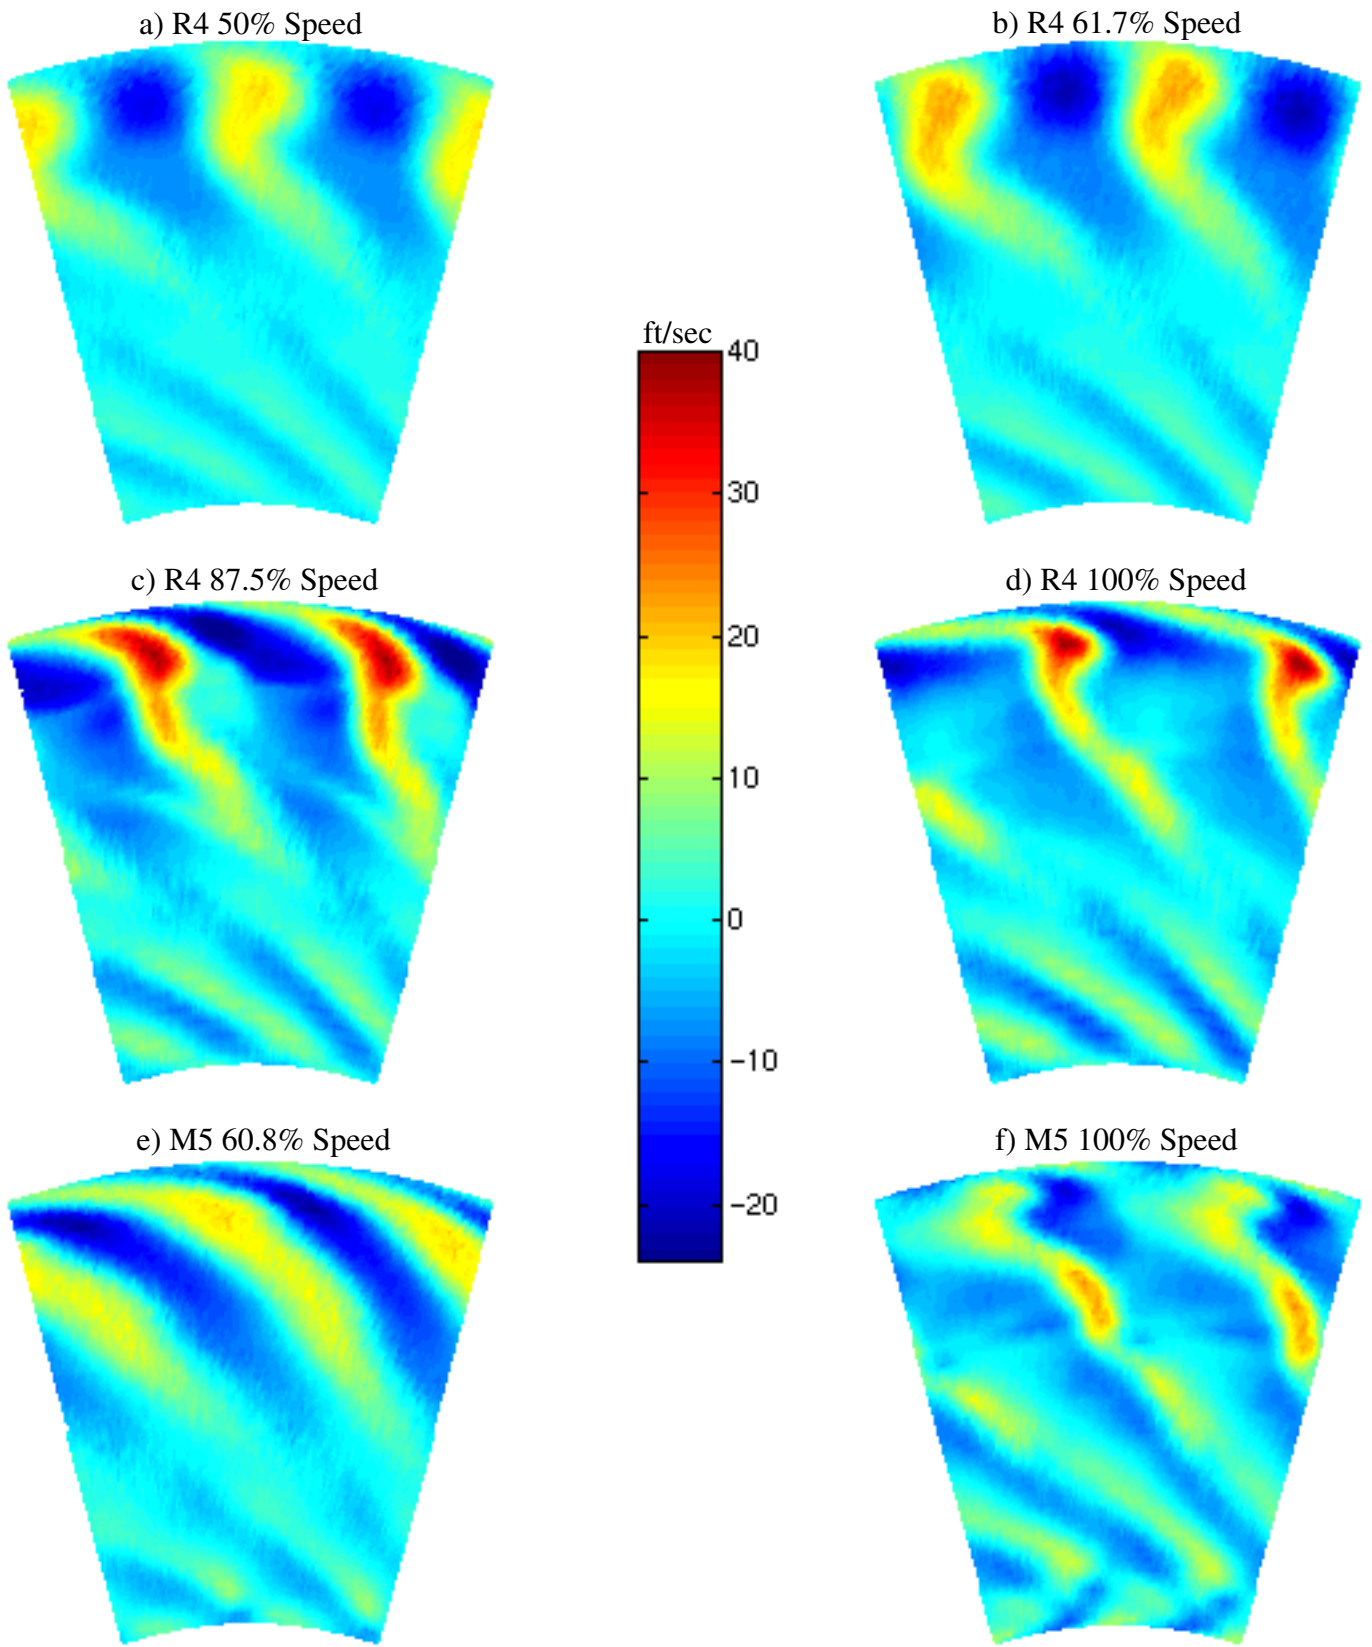
Figure 11. Difference between average passage tangential mean velocities and circumferentially averaged tangential velocities measured downstream of the R4 (parts a-d) and M5 (e-f) rotors at axial station LDV2.

Figure 11 shows this same parameter plotted for the downstream axial location, LDV2. Note that the colorbar used in this figure has a range (max minus min) less than half of that used in the presentation of the upstream station LDV1 data. This indicates that the perturbations in the mean tangential flow downstream of both rotors are dissipating rapidly as the flows move downstream, making the mean flows more uniform. At the approach condition (61.7% speed for R4 and 60.8% speed for M5) the magnitude of the perturbations generated downstream of the two rotors are roughly the same at all spanwise locations. This was not the case at axial station LDV1. At the upstream axial station the perturbations were similar over the inner 75% of the blade span, but in the tip region the M5 wake flow showed a much higher perturbation. The fact that the difference in the perturbations generated by the two rotors seems to disappear by the time the flows reach station LDV2, suggests that the perturbation generated by the tip of the M5 rotor is dissipating more rapidly than that generated by the R4 rotor. Once again, the most noticeable difference in the wake flows generated by the two rotors at the approach condition involves the shape of the wakes. The differences in the lean of the blade wakes of the two rotors noted in the discussion of the upstream data are even more pronounced at this downstream location. The data are showing that the M5 blade wakes get more skewed as they move downstream. The lean of the M5 wakes, which increases with increasing radius, is in the opposite direction to the rotation of the rotor. In contrast, over the outer 20% of span, the R4 wakes are slanted slightly in the direction of rotor rotation.

The faster rate of decay of the mean tangential velocity perturbation occurring at the approach operating condition in the tip region downstream of the M5 rotor relative to that of the R4 rotor may be related to the differences in the orientation of the blade wakes of the two rotors at the outer radial locations. As noted above, the M5 wakes get skewed as they move downstream, resulting in a great deal of lean in the wakes at the downstream location, especially in the tip region. The tip regions of the R4 blade wakes are much more radial. Consequently, the tip regions of the M5 blade wakes get stretched significantly, whereas the tip regions of the R4 wakes do not. A study by Brookfield et. al. (ref. 7) has shown that stretching tends to reduce the wake velocity deficit associated with a wake. Since the mean axial velocity perturbation (the wake deficit) is reduced by stretching, it seems reasonable to expect that the mean tangential velocity perturbation would also be reduced. If it is true that stretching tends to "even out" the nonuniformities in the mean flow, then the perturbations in the tip region of the M5 rotor would be expected to continue to decay more rapidly than those of the R4 rotor as the two flows move downstream from station LDV2. Consequently, at the stator leading edge location the mean wake flow of the M5 rotor would be more uniform than that of the R4 rotor, and the rotor/stator interaction tone noise produced by the M5 fan stage would be expected to be less than that produced by the R4 stage. In addition, there are two other reasons why the M5 wakes could be expected to generate less tone noise: 1) The skewed M5 wakes result in more rotor blade wakes intersecting a given stator vane at a given point in time. This leads to a phase cancellation effect which is thought to result in reductions of tone noise (ref. 8). 2) The intersection of the blade wakes with the tip regions of the stator vanes would be more orthogonal with the M5 wakes. This tends to minimize the speed of the wake intersection point along the stator leading

A comparison of the plots presented in figure 11 for the downstream measurement location, LDV2, at the 100% speed condition (parts d and f) indicates that there are also considerable differences in the wake flows generated by the two rotors at this speed. Recall that in the 100% speed data presented for station LDV1 (figure 10 parts d and f), there were strong disturbances in the mean tangential velocity flows of both rotors at the locations where the tip flows merged with the blade wakes. While it is possible to still identify such a disturbance in the 100% speed, station LDV2 data of the R4 rotor (figure 11 part d), it is not possible to locate such a strong disturbance in the M5 wake data acquired at this speed and axial location (figure 11 part f). It may be that the large amount of stretching of the M5 wake that occurs in the tip region is responsible for making the M5 wake flow more uniform in this region. Based on the differences in the wake flows measured at this speed and axial location, the M5 stage would be expected to produce less rotor/stator interaction tone noise than the R4 stage.

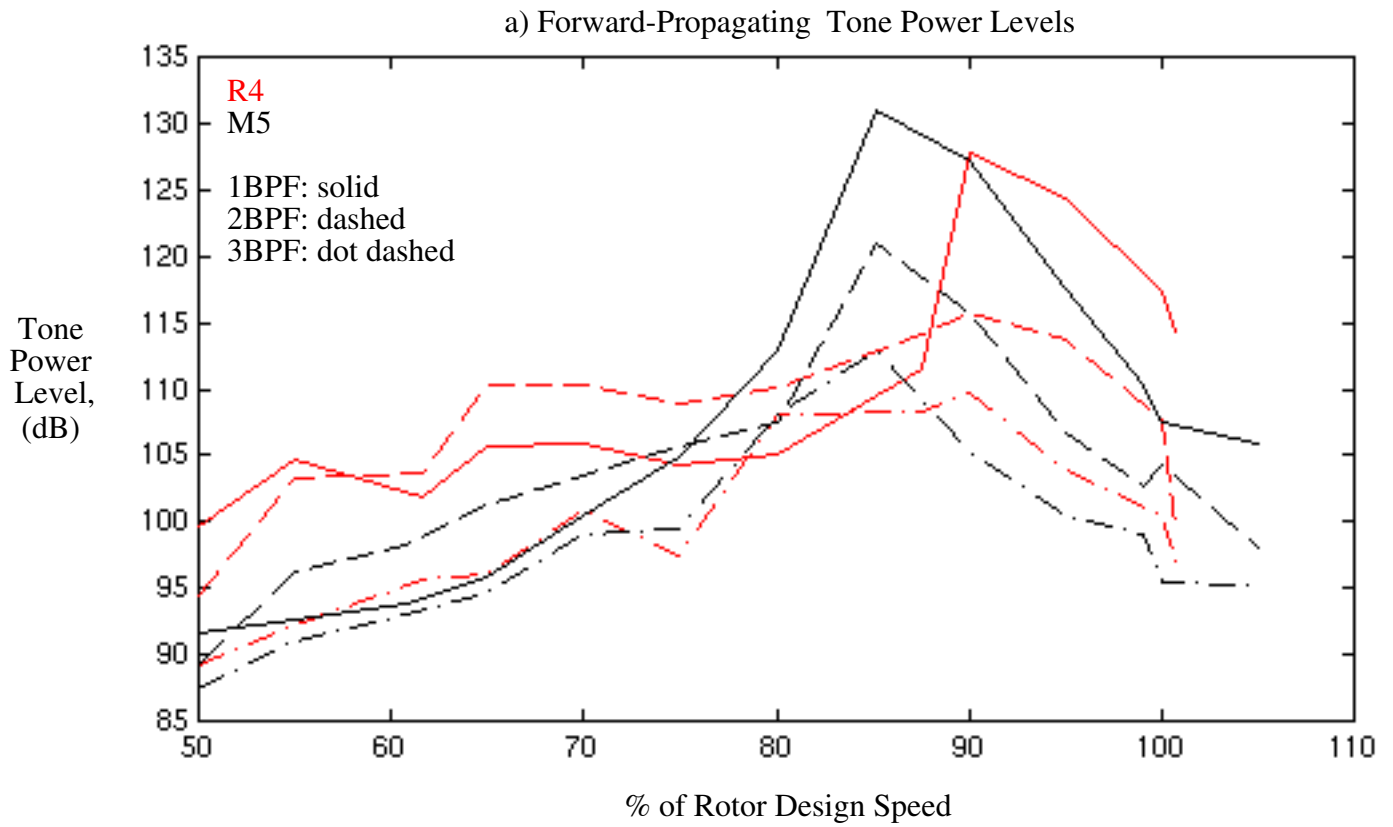
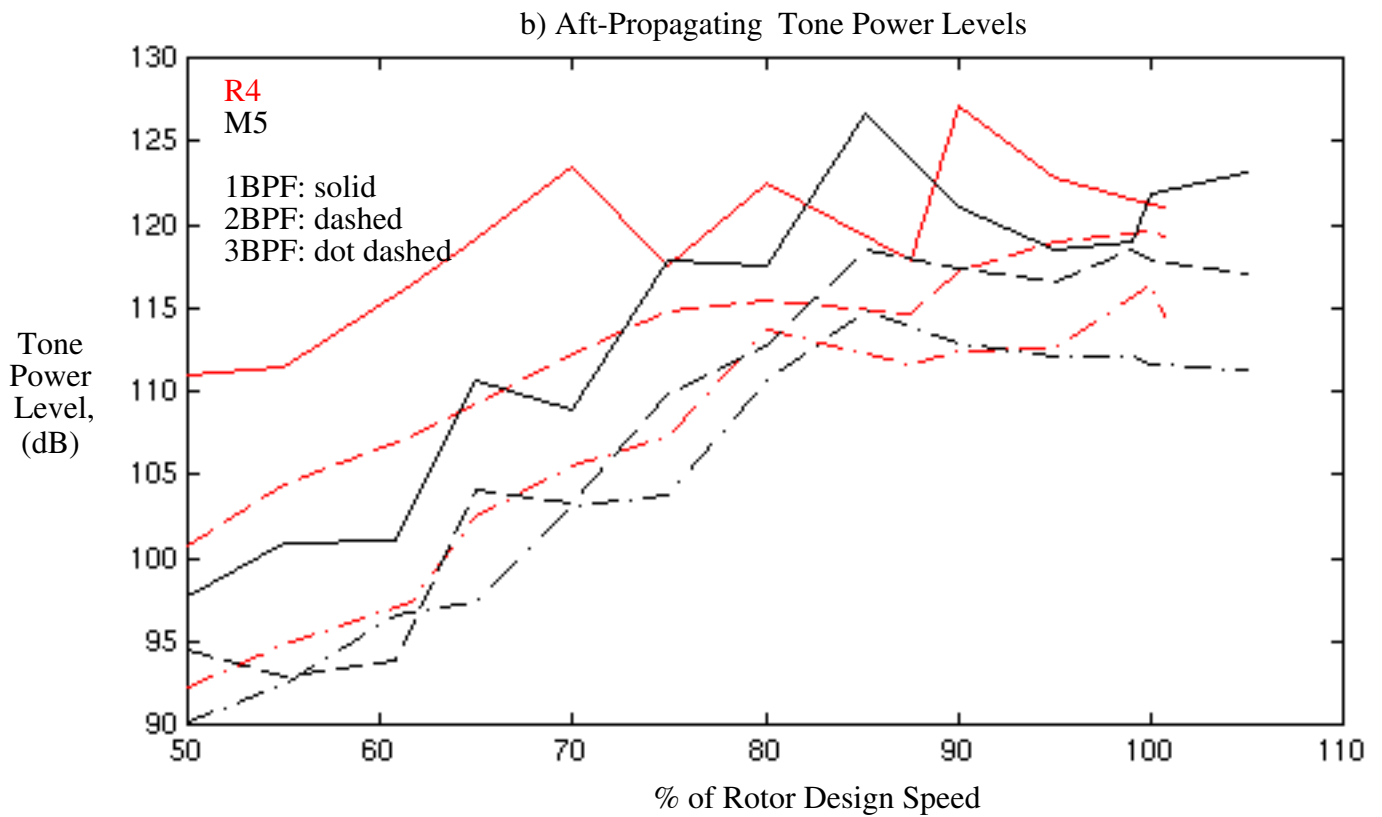
Figure 12. Tone power levels of forward (part a) and aft propagating (part b) noise measured for the R4 (shown in red) and M5 (black) fan stages over a range of operating speeds.

Figure 12 shows plots of the 1BPF, 2BPF, and 3BPF tone power levels generated by both the R4 (in red) and M5 (black) fan stages at speeds ranging from below approach to above take-off. These results correspond to the same rotor/stator configurations tested during the LDV studies (ie. the swept stators were installed). The upper plot (part a) shows forward-propagating tones; the bottom plot (part b) shows aft-propagating tones. As can be seen in the bottom plot, these acoustic results do show the expected lower interaction tone levels for the M5 rotor at the approach condition. Both the 1BPF and 2BPF tones of the M5 stage are over 10 dB lower than those of the R4 stage at this condition. At 100% speed, both stages generate about the same level of the 1BPF tone, while the 2BPF and 3BPF tone levels generated by the M5 stage are about 2 dB and 5dB, respectively, below those generated by the R4 stage. Thus, both the low and high-speed acoustic results show that the M5 stage generates less rotor/stator interaction tone noise than the R4 stage, as expected based on the differences in the mean wake flows generated by the two rotors.

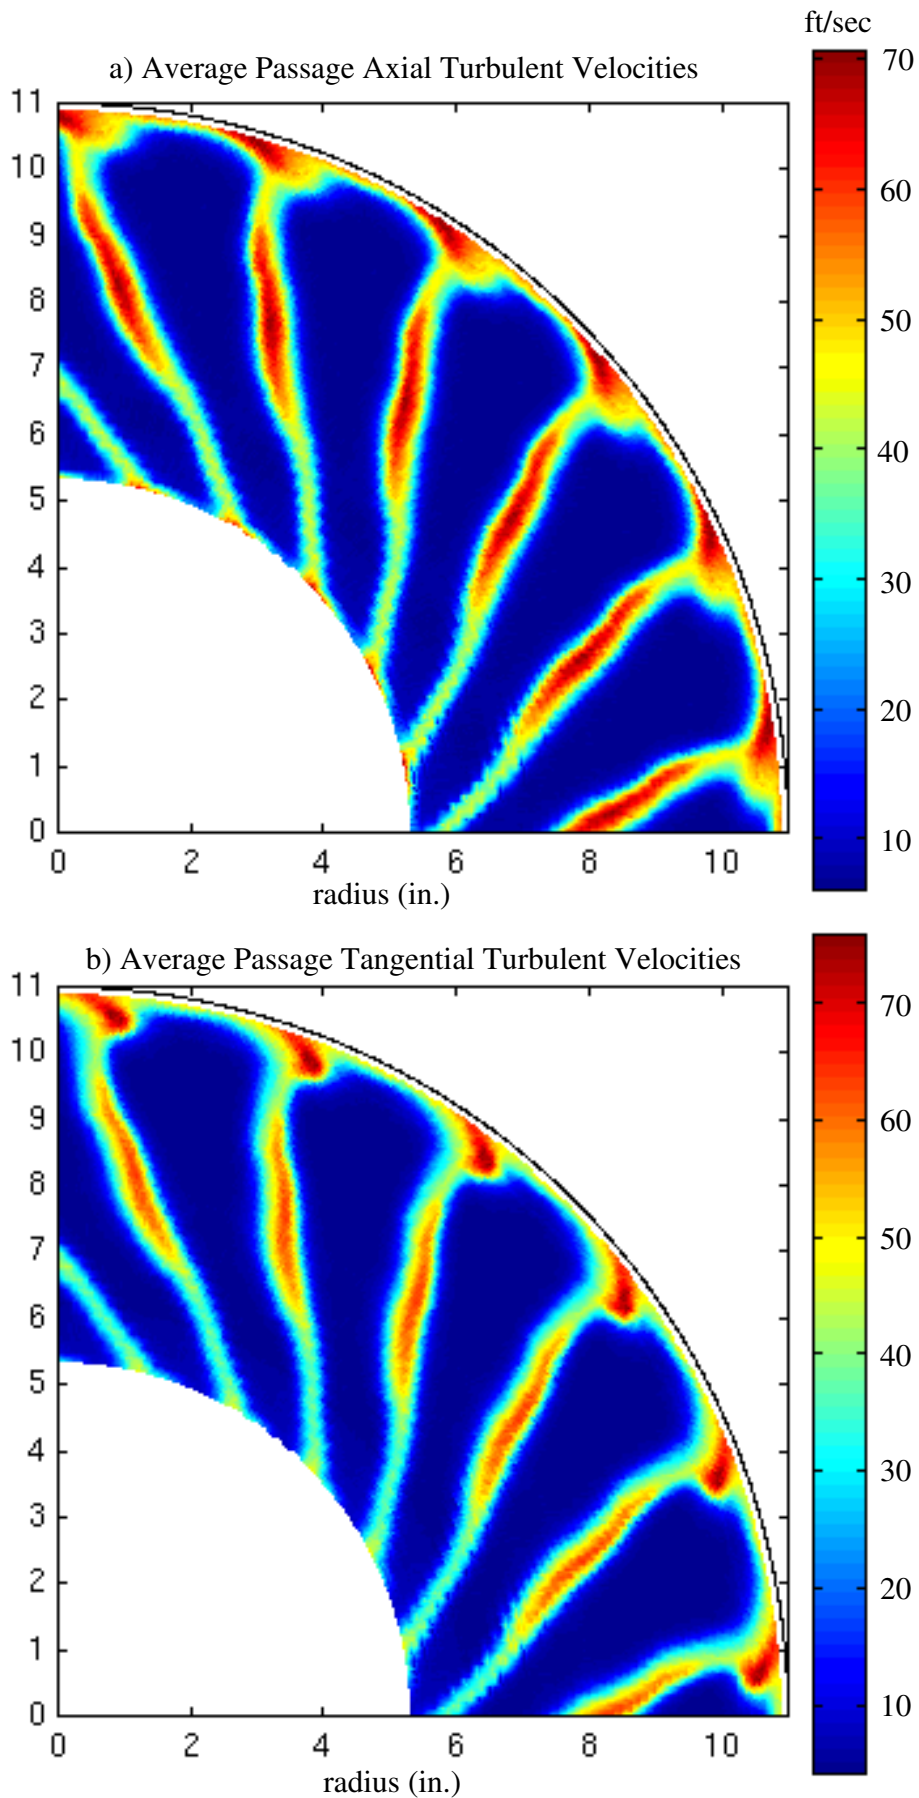
Figure 13. Average passage turbulent velocities measured downstream of the R4 rotor at axial station LDV1 at 100% rotor speed.

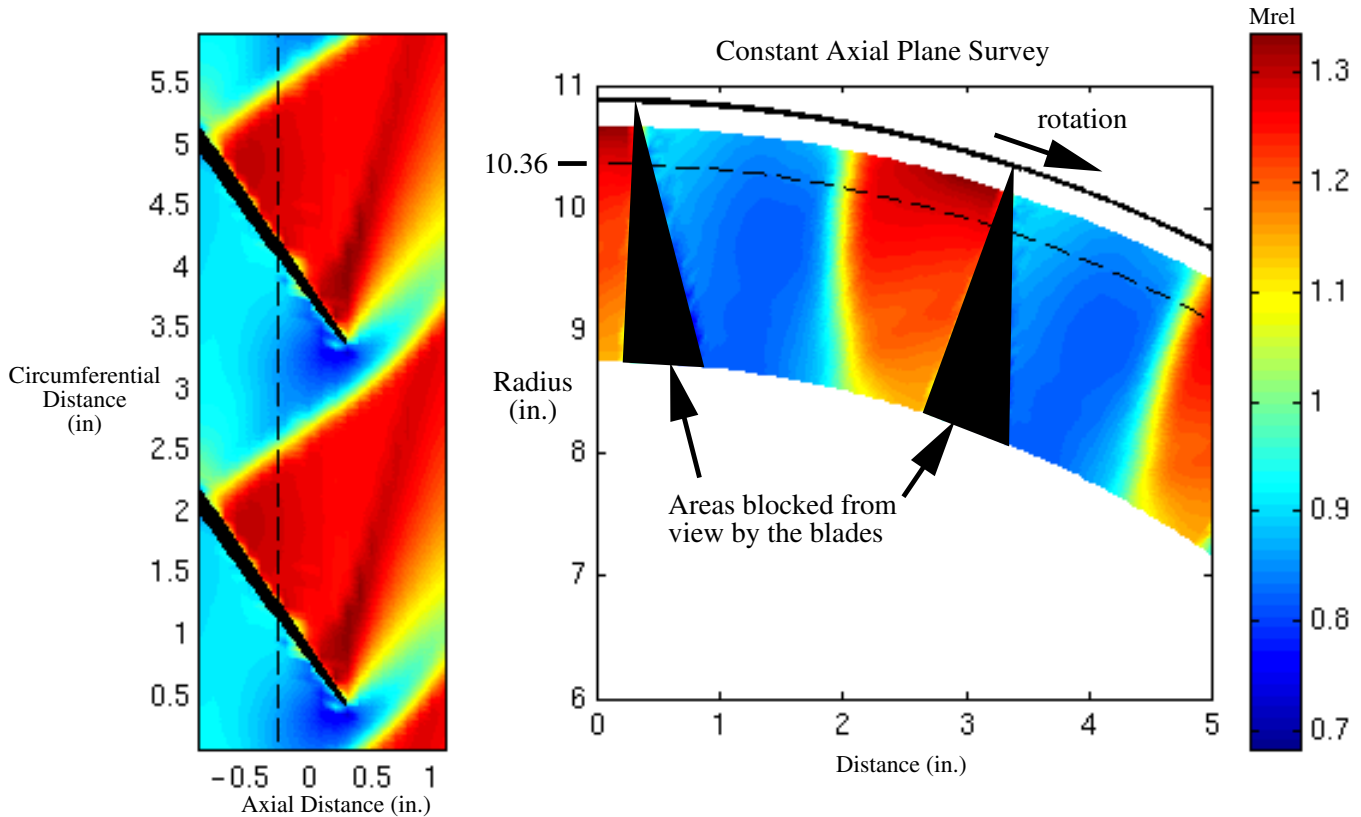
Figure 17. Average passage relative Mach number contours for the R4 rotor operating at 100% speed. Left plot is data acquired from constant-radius survey at $r=10.36''$. Right plot is data acquired from constant axial survey made at approximately 25% chord.

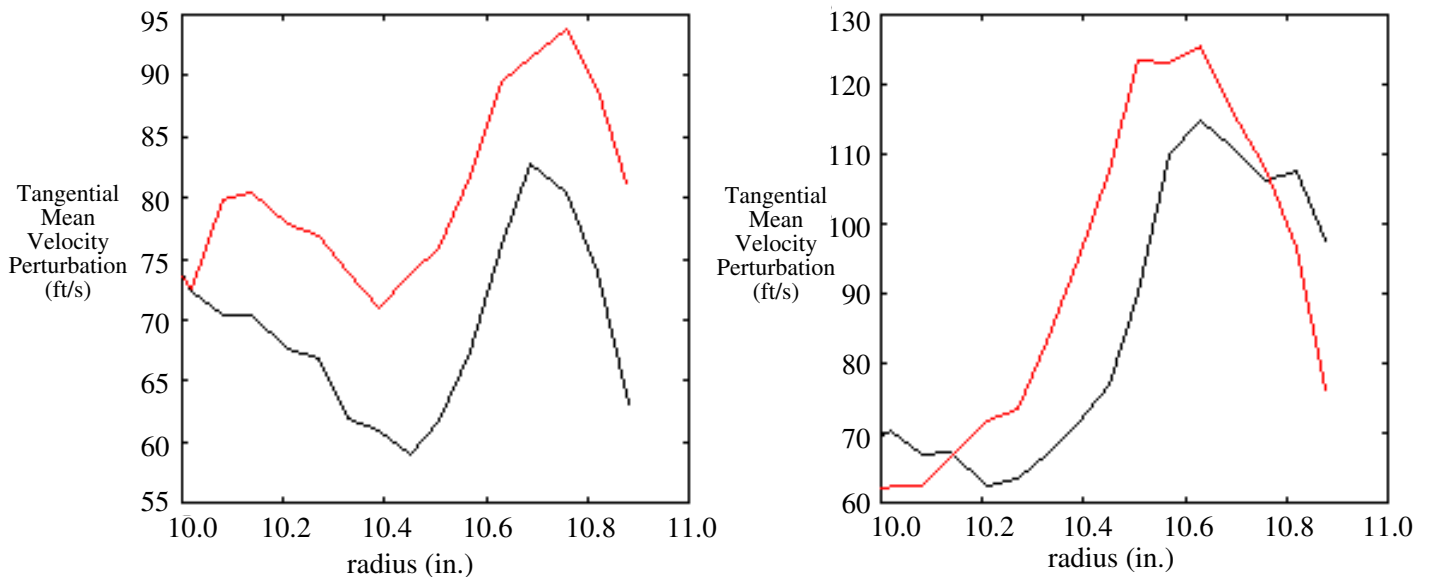
Figure 22. Tangential mean velocity perturbations measured downstream of the tips of the R4 rotor blade with the nominal (shown in black) and 0.020" (red) clearance rubstrips installed in the fan case. Left plot shows perturbations measured at 87.5% speed; right plot shows 100% speed data.

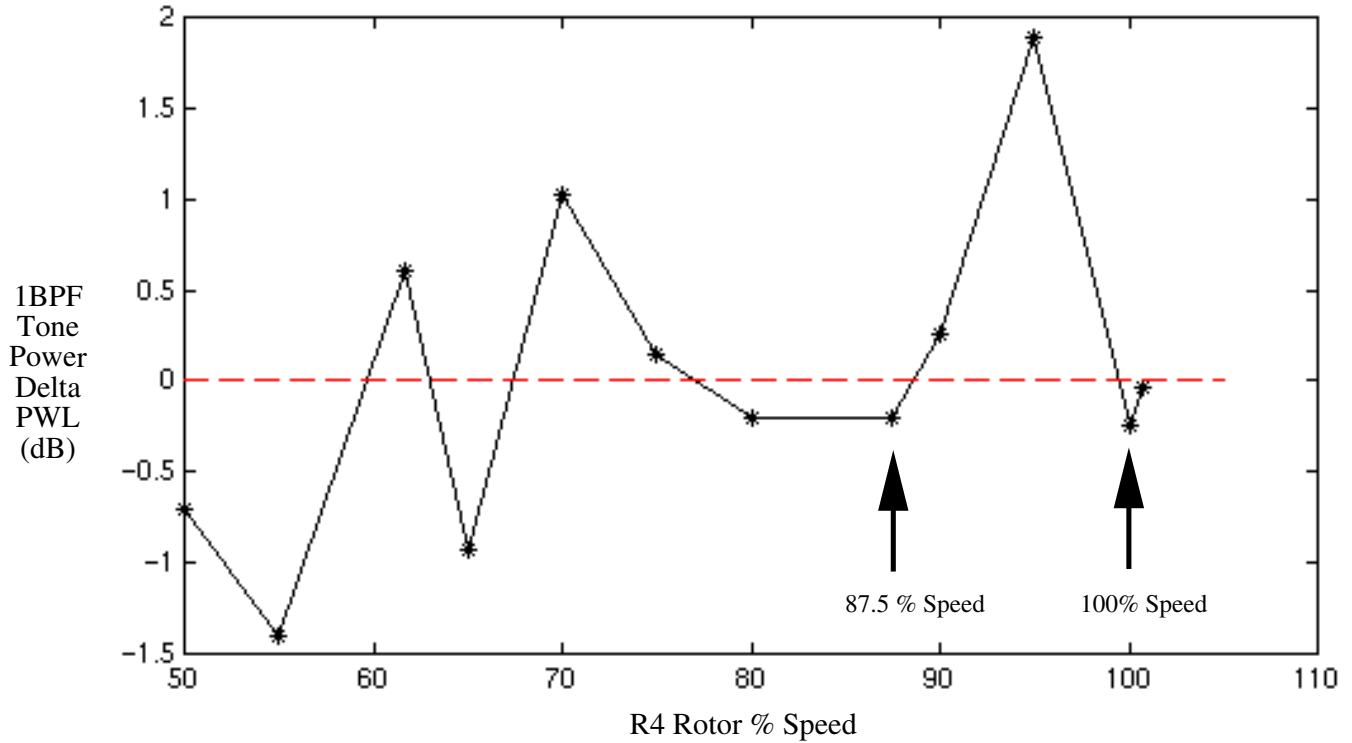
1BPF Tone Power Levels Measured with 0.020" Clearance Rubstrip Minus
 1BPF Tone Power Levels Measured with Nominal Clearance Rubstrip

Figure 23. Difference in 1BPF tone power levels measured with 0.020" and nominal clearance rubstrips installed as a function of R4 rotor % design speed. The tone power levels were measured during acoustic runs in which the barrier wall was not installed next to the model. Thus, the tone levels represent the total noise generated (not just that due to rotor/stator interaction.)

power level is shown as a function of rotor speed. The data points corresponding to the operating conditions at which the LDV data were obtained (87.5 and 100% speed) are marked on the plot. At these two speeds there was almost no difference in the 1BPF tone power levels generated with the two different rubstrips installed. This seems to be indicating that the differences in the mean flows measured at this upstream axial station, LDV1, either 1) are not significant enough to generate measurable differences in the 1BPF tone levels, or, 2) if they are, that these differences diminish as the wake flows move downstream to the point that the two flows become essentially identical (from an acoustics standpoint) by the time they interact with the downstream stator vanes. Another possibility is that the measured tone levels are not controlled by the rotor/stator interaction noise. The acoustic results plotted in figure 23 are based on the total noise generated by the model, not just that due to rotor/stator interaction. The contribution resulting from rotor/stator interaction could not be separated from the total tone noise since acoustic data were not acquired with the barrier wall in place next to the model during the tip clearance studies. If the measured tone levels are controlled by another, more dominant source (such as inlet boundary layer/fan interaction, shock noise, or rotor self-noise), then any reductions in rotor-stator interaction tone noise could be masked by this other source.

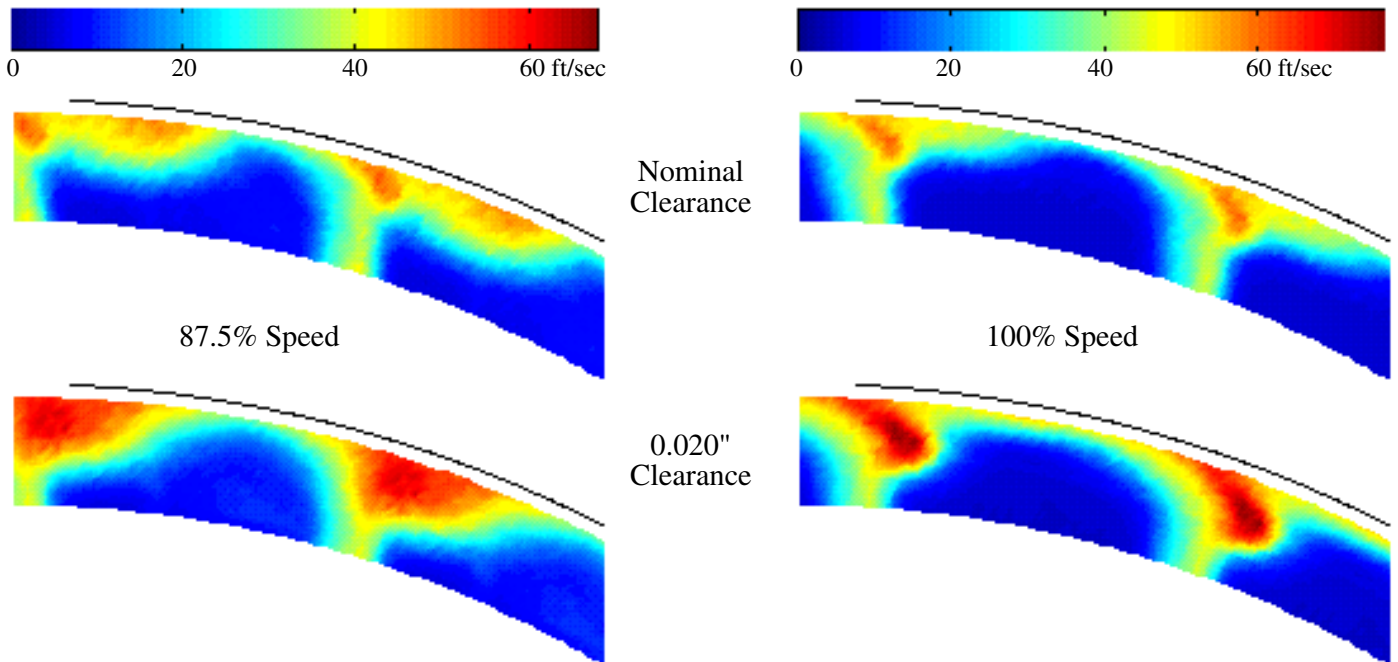
Figure 24. Contours of average passage tangential turbulent velocity showing the tip flow measured downstream of the R4 rotor at axial station LDV1 at two blade tip clearances and two rotor speeds.
