Fatigue crack growth monitoring using high-frequency guided waves

Bernard Masserey and Paul Fromme

Structural Health Monitoring 2013 12: 484 originally published online 18 September 2013

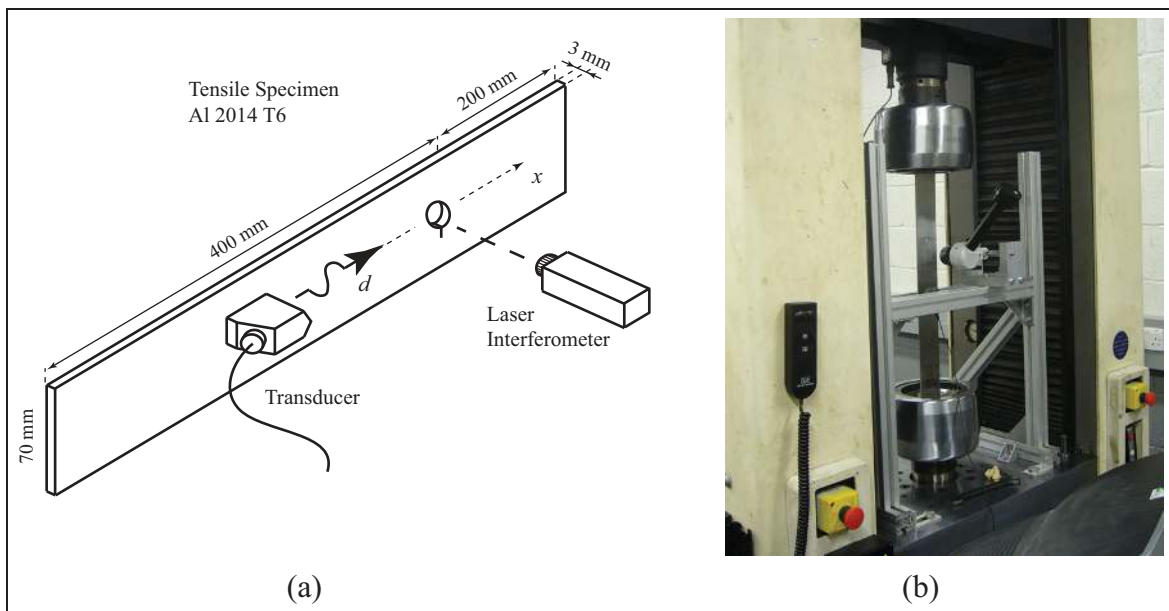
Figure 1. Experimental setup: (a) schematic representation of high-frequency guided wave excitation and measurement and (b) photograph of the cyclic tensile loading setup with optical microscope.

The fatigue crack growth monitoring was performed using four tensile specimens, which are 3 mm thick, 70 mm wide, and 600 mm long, made of aluminum alloy 2014 T6. A $\frac{1}{4}$ -in-diameter hole ($r_0 = 3.17$ mm) was drilled on the center line 200 mm from the specimen end (see Figure 1(a)). The specimen was subjected to cyclic tensile loading in a servo-hydraulic testing

machine (see Figure 1(b)). A maximum load of 26 kN was selected so that the maximum stress in the vicinity of the hole is about 95% of the yield strength (stress concentration factor $K_t \cong 3.1$), in order to remain in the range of elastic deformation. The corresponding maximum nominal stress was approximately 124 MPa. The cyclic loading was performed with a stress ratio $R = 0.1$ and a cycling frequency of 10 Hz. The loading axis was parallel to the center line of the specimen. The crack initiation is expected to occur at the hole boundary at an angle of approximately 90° relative to the loading axis. A small triangular starter notch, approximately 0.2 mm long, was made on one side of the specimen at the hole corner in order to prescribe the position where the crack would start growing. During fatigue testing, the crack grew quarter-elliptically from the starter notch position to a length (and depth) of about 3 mm. At that depth, corresponding to the specimen thickness, the crack quickly developed into a through-thickness crack.

A standard Rayleigh wave angle beam transducer and wedge (Panametrics A540S/ABWML-5T-90°) with a center frequency of 2.25 MHz (Rayleigh wavelength $\lambda_R = 1.3$ mm) were clamped (propylene glycol couplant, screwed clamp) at a distance $d = 125$ mm from the hole center on the specimen surface opposite to the side where the starter notch was made. The distance, corresponding to half a beatlength at center frequency ($L = 250$ mm), was selected so that the energy is mainly concentrated on the notched specimen side when reaching the hole. The transducer was positioned in such a way that the main propagation line crossed the center of the hole, as displayed in Figure 1(a). The specimen was wide enough so that the sides did not significantly affect the propagation of the incident wave field. The transducer was driven using a standard ultrasonic pulser/receiver. The frequency content of the generated ultrasonic pulse was wide band up to about 3.5 MHz. A noncontact heterodyne laser interferometer (Polytec OFV 5000/505) was used to measure at a spot approximately 1 mm sideways from the hole and 1 mm behind the expected fatigue crack location on the same side of the plate as the starter notch. At this measurement location, the energy of the wave pulse that propagates past the fatigue crack is expected to be highly affected by the crack growth. The out-of-plane component was measured using a displacement decoder. The laser demodulator output was band-pass filtered (1–5 MHz) around the center frequency and averaged (100 averages). The noncontact measurement allows for a very sensitive measurement with high spatial resolution (measurement spot diameter less than 0.1 mm) of the influence of the fatigue crack on the propagating high-frequency guided wave pulse. The measurement was repeated every 1000 cycles, holding the specimen under maximum tensile

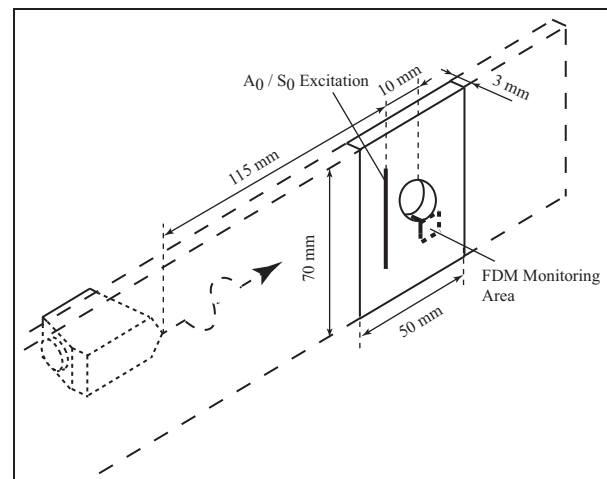
Figure 2. Specimen geometry implemented in the FD (Finite Difference) simulation: excitation position and monitoring area behind the fatigue crack.

To reduce the computational effort, the 600 mm \times 70 mm specimen was reduced to a 50 mm \times 70 mm aluminum plate as displayed in Figure 2. The simulation was performed separately for A_0 and S_0 Lamb modes using a 5-cycle sinusoid in a Hanning window with a center frequency of 2.25 MHz as the excitation signal. The incident wave was generated 10 mm from the hole

center by imposing the displacement field for the A_0 or S_0 mode in the two initial simulation steps as described in Munasinghe and Farnell.²⁴ The simulation was repeated for crack sizes from 0 to 4 mm with a step size of 0.5 mm. The out-of-plane displacement component was recorded on the specimen surface where the crack was initiated for all grid points in a square area of 2 mm \times 2 mm with center point corresponding to the laser spot (1 mm sideways from hole and 1 mm behind the fatigue crack location) as shown in Figure 2. To be consistent with the measurements, the evaluation of the corresponding time signals as a function of the crack size was done on the basis of the combined results from the A_0 and S_0 simulations. As the 5-cycle tone burst used as excitation signal has a bandwidth $\Delta f = 1.8$ MHz (width of the main lobe), the dispersive behavior of the first Lamb modes was considered in the reconstitution of the time signal. Fast Fourier transform (FFT) was applied to the out-of-plane displacement signals recorded for the A_0 and S_0 simulations. The resulting complex, discrete frequency spectra were subsequently phase shifted to take into account the additional propagation distance of 115 mm. The phase shift was calculated for every frequency of the discrete spectra as the product of this distance with the wave number of the corresponding mode at that frequency. The resulting frequency spectra for the first anti-symmetric and the first symmetric Lamb mode simulations were added together and transformed back into the time domain by means of inverse FFT. Neglecting the influence of the beam spread, the resulting time series corresponds to the experimental configuration with the out-of-plane displacement component measured behind the crack for a Rayleigh-like wave generated at 125 mm from the hole center on the specimen surface opposite to the side where the crack initiated.

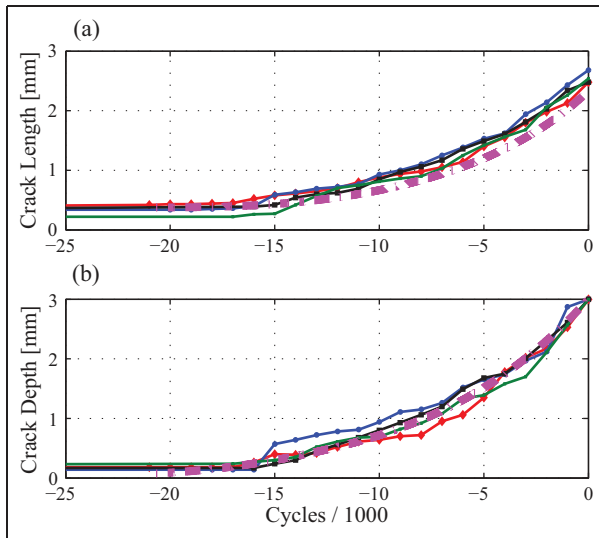
Figure 3. Optically measured fatigue crack growth for four specimens (solid lines) and predicted fatigue crack growth (dash-dotted): (a) crack length on specimen surface and (b) crack depth in fastener hole interior, plotted against number of cycles before crack grown through thickness.

The crack growth calculation for crack length and crack depth is shown in Figure 3 (dash-dotted line). For each specimen, the number of cycles when the crack was first observed optically both on the specimen surface and in the hole thickness was taken as reference to define the initial crack length and depth. The resulting crack sizes for all specimens were averaged to obtain initial values of 0.34 mm for crack depth and 0.45 mm for crack length. As the fatigue crack growth was comparable between the four specimens, a value of 15,500 was taken as the average number of cycles before a through-thickness crack was observed (observed range: 15,000–17,000 cycles). Based on these data, the fatigue crack growth was computed until the quarter-elliptical crack had grown through the specimen thickness. The resulting curves show excellent agreement for crack depth and good agreement for crack length. Similar to the measured crack growth, the predicted crack growth rate is more pronounced for the crack depth in the hole thickness, becoming larger than the crack length 12,500 cycles before a through-thickness crack is observed. Starting from the same initial values, a backward crack growth calculation was performed to estimate the defect size before the crack was observed optically. The calculation was stopped 21,000 cycles before a through-thickness crack was observed, as the criterion based on the ratio between crack length and crack depth was not satisfied anymore, and thus, the crack geometry was out of the valid range for stress intensity factor calculations. Based on the available backward prediction, an estimation of the crack size 20,000 cycles before a through-thickness crack (and 3000–4000 cycles before a

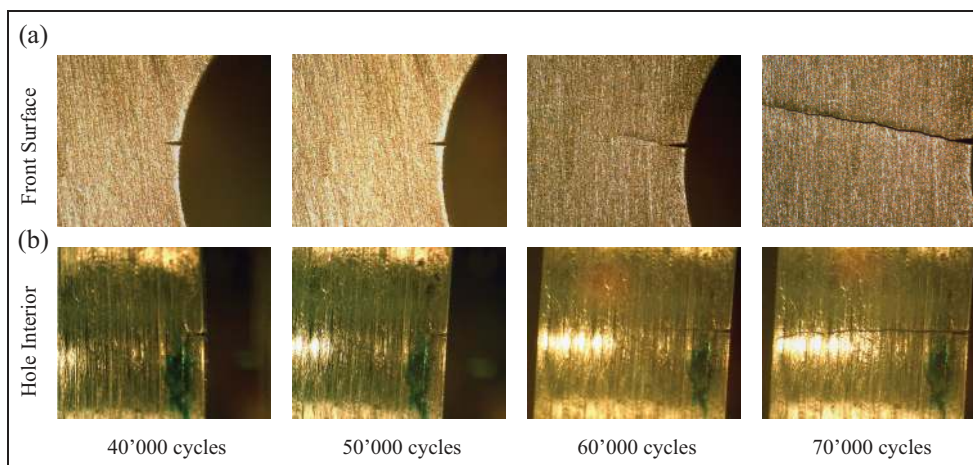
Figure 4. Photographs for one specimen of starter notch and fatigue crack growth (a) on front surface and (b) in hole interior.

0.17 mm) is visible in the pictures for 40,000 and 50,000 cycles (28,000 cycles and 18,000 cycles, respectively, before a through-thickness crack was observed), while in the pictures for 60,000 cycles (8000 cycles before a through-thickness crack was observed), the quarter-elliptical crack can be seen with a length of 1.05 mm on the front surface and a depth of 1.06 mm through the thickness. The crack had grown through the thickness of the specimen at 68,000 cycles (length on front surface: 2.48 mm) and then continued to grow as a through crack with similar lengths on the front and back

surfaces. The through-thickness crack is shown at 70,000 cycles with a length of 3.13 mm on the front surface.

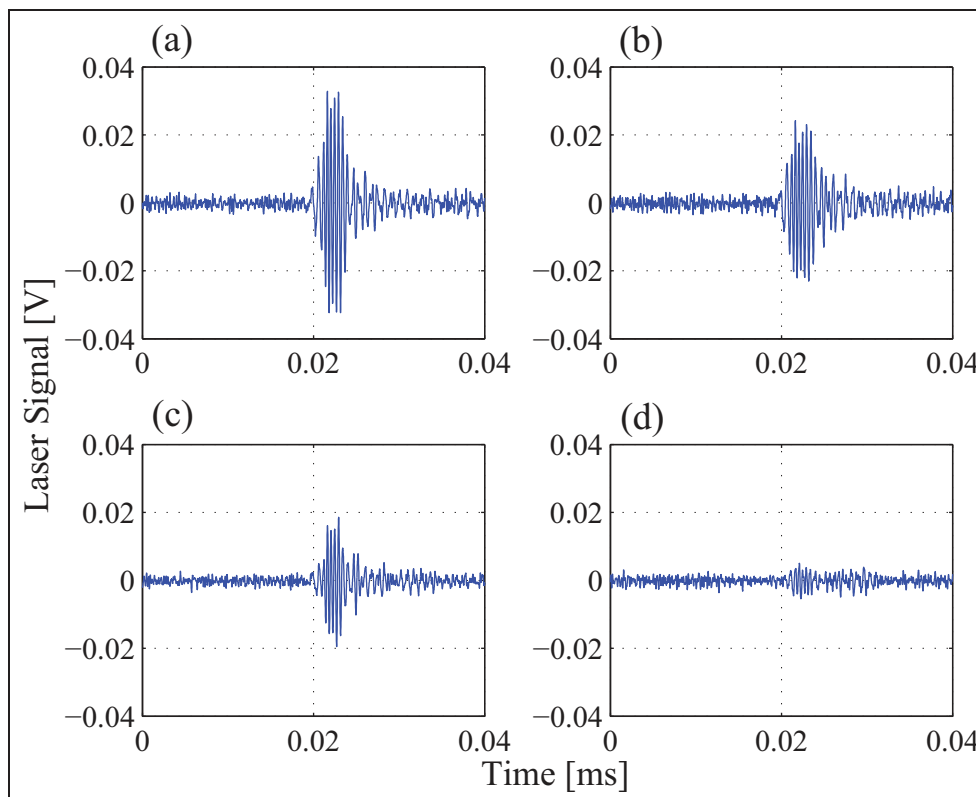
Figure 5. Time traces of high-frequency guided ultrasonic wave pulse measured on same specimen as in Figure 4 with laser interferometer at location behind fatigue crack close to hole ($f_0 = 2.25$ MHz, $d = 125$ mm): (a) 40,000 cycles, (b) 50,000 cycles, (c) 60,000 cycles, and (d) 70,000 cycles.

The measured high-frequency guided wave pulses behind the fatigue crack location are shown in Figure 5 for the same specimen and the same number of cycles as shown in Figure 4. The signal measured using the noncontact laser interferometer showed some variations and noise, partially due to a not perfect reflection of the laser beam from the specimen surface. Another potential source would be a movement of the measurement spot relative to the hole as the specimen moved or expanded (due to heat) in the clamps of the testing machine, while the laser interferometer was fixed to an external positioning system. The maximum amplitude of the ultrasonic pulse measured with the laser interferometer showed small variations of up to 5% until 40,000 cycles (Figure 5(a), 28,000 cycles before through-thickness crack). A significant reduction of the pulse amplitude can be seen in Figure 5(b) at 50,000

cycles (18,000 cycles before through-thickness crack), when no crack was observed optically. The decrease in pulse amplitude and energy continues for a part-through crack as can be seen for the pulse at 60,000 cycles (8000 cycles before through-thickness crack) in Figure 5(c). When the crack has grown through the thickness, almost no guided ultrasonic wave pulse can be measured any more directly behind the fatigue crack (Figure 5(d), 70,000 cycles). In principle, the drop in amplitude of the measured pulse is the expected behavior, as the noncontact monitoring location is behind the crack location from the excitation point and the growing fatigue crack blocks the path of the ultrasonic wave, leading to a shadow area behind the crack.

where $x_0(t)$ is the baseline signal (averaged from the first 10 measurements). Calculating the energy parameter instead of taking the peak amplitude was found to be less sensitive to noise in the signal and to more accurately represent the signal, for example, between Figure 5(b) and (c), the significant drop in the pulse energy can be well quantified. This showed less short-term fluctuation between consecutive measurements with a variation of up to 7% until $-40,000$ cycles and 15% until $-30,000$ cycles. Furthermore, the amplitude of the pulse at the center frequency of 2.25 MHz was extracted using FFT. This showed a variation of up to 5% until $-40,000$ cycles and 11% until $-30,000$ cycles, and overall, this gave very similar results to the energy calculation. The increased variation after $-40,000$ cycles was due to the measurements for one specimen, with a drop in both energy and amplitude of the frequency spectrum. The reasons for this drop could not be related to any measurement variations or optically observed crack growth.

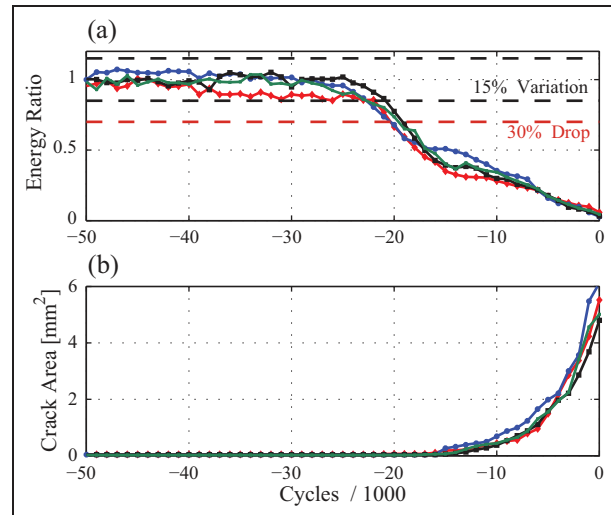
Figure 6. (a) Energy ratio of high-frequency guided ultrasonic wave pulse measured with laser interferometer at location behind fatigue crack close to hole for four specimens (solid lines), with 15% variation and 30% drop shown (dashed) and (b) optically measured crack area for four specimens, plotted against number of cycles before crack grown through thickness.

The energy ratios of the pulse measured with the noncontact laser interferometer for the four tensile specimens are shown in Figure 6(a). The energy ratio and the approximate optically measured crack area

(Figure 6(b)) are shown against the number of cycles before the crack grew through the plate thickness as detailed above to account for variations in the crack initiation. In Figure 6(b), it can be seen that the crack growth was repeatable between the four specimens, with the crack optically visible 15,000–17,000 cycles before a through-thickness crack was observed. Evaluating the energy ratio of the signal from the start of the fatigue experiments until 30,000 cycles before a through-thickness crack, a variation of the energy ratio of up to 15% can be observed, as described above. However, for all four specimens, a significant drop in the ultrasonic pulse and thus energy ratio can be seen from about 25,000 cycles before a through-thickness crack was observed. After 6000 cycles (at $-19,000$ cycles), this drop was at least 30% for all specimens and therefore significantly larger than the maximum variation observed (twice as large). For none of the specimens, the crack could be observed visually at this stage; the fatigue defect was only detected using the optical microscope 2000–3000 cycles later. From the averaged data of the smallest optically measured crack length for the four specimens, a backward calculation was performed to estimate the crack size when the amplitude drop was observed in the guided ultrasonic wave signal. As mentioned in section “Fracture mechanics prediction of crack growth,” this predicted a maximum macroscopic crack area of less than 0.05 mm^2 at this stage ($-20,000$ cycles, 3000–4000 cycles before a crack was observed optically). It appears that

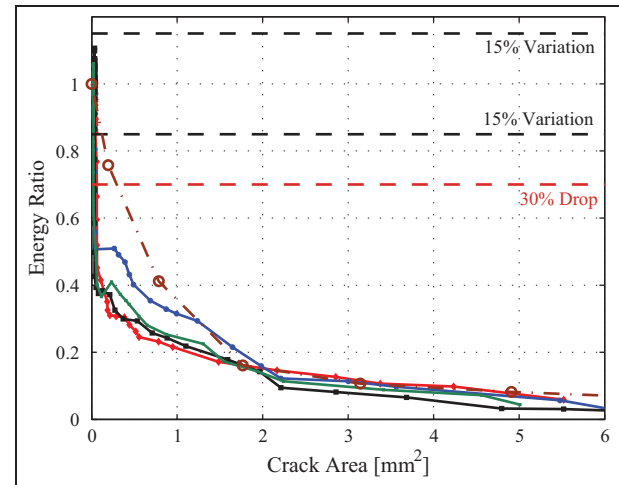
Figure 7. Energy ratio of high-frequency guided ultrasonic wave pulse measured with laser interferometer at location behind fatigue crack close to hole for four specimens (solid lines), with 15% variation and 30% drop shown (dashed), and with FD calculation (dash-dotted, circles), plotted against approximate optically measured crack area.

The energy ratio drops to about 0.5 when the crack was first seen using the optical microscope and then drops close to 0 when the crack has grown through the thickness of the specimen and blocks the path of the guided ultrasonic wave pulse. This phenomenon can be seen more clearly in Figure 7, where the energy for all four specimens was plotted against the optically visible crack area. This was observed consistently for the four tensile specimens, with some variation between the four specimens for small, part-thickness cracks (up to 2 mm²) and very good repeatability for larger fatigue cracks. The interesting observation was the significant drop in pulse amplitude and thus energy ratio before the crack had grown large enough to be observed optically. A 30% drop in amplitude occurs around the number of cycles when an estimated macroscopic crack area of less than 0.05 mm² was predicted from the crack growth model. This drop is twice as large as the maximum variation of the measurements without damage (15%).

Using the FD model described earlier, the high-frequency guided ultrasonic wave signal was predicted in the vicinity of the hole and crack. For the location of the noncontact laser interferometer measurement just behind the fatigue crack location, the evaluated energy ratio against the crack area is shown in Figure 7 as the dash-dotted line. The predicted drop in ultrasonic signal due to the shadow effect of the crack can be observed. For small fatigue cracks (up to 2 mm²), the FD simulations predict a smaller energy drop than measured experimentally. It is expected that this is due to fatigue damage that has not been observed and modeled. Micro-structural damage typically occurs around the macroscopic fatigue crack. Combined with the small (less than 0.05 mm²) macroscopic fatigue crack predicted from the crack growth model (but not observed optically), this leads to the observed drop in ultrasonic pulse amplitude. This is consistent with the observed drop in the ultrasonic signal before the fatigue crack was detected using the optical microscope. This noncontact measurement close to the defect location gives an early indication of the fatigue crack before the crack is large enough to be observed optically with the

employed microscope. From Figure 7, it can be seen that for a crack area larger than 2 mm², the predicted and measured energy ratios for the fatigue cracks correlate well, when plotted against the crack area. This allows in principle an approximate sizing of the fatigue damage for a known configuration.
