Final Report

Advanced Traffic Control System Field Operational Test

Evaluation Task C

Video Traffic Detection System

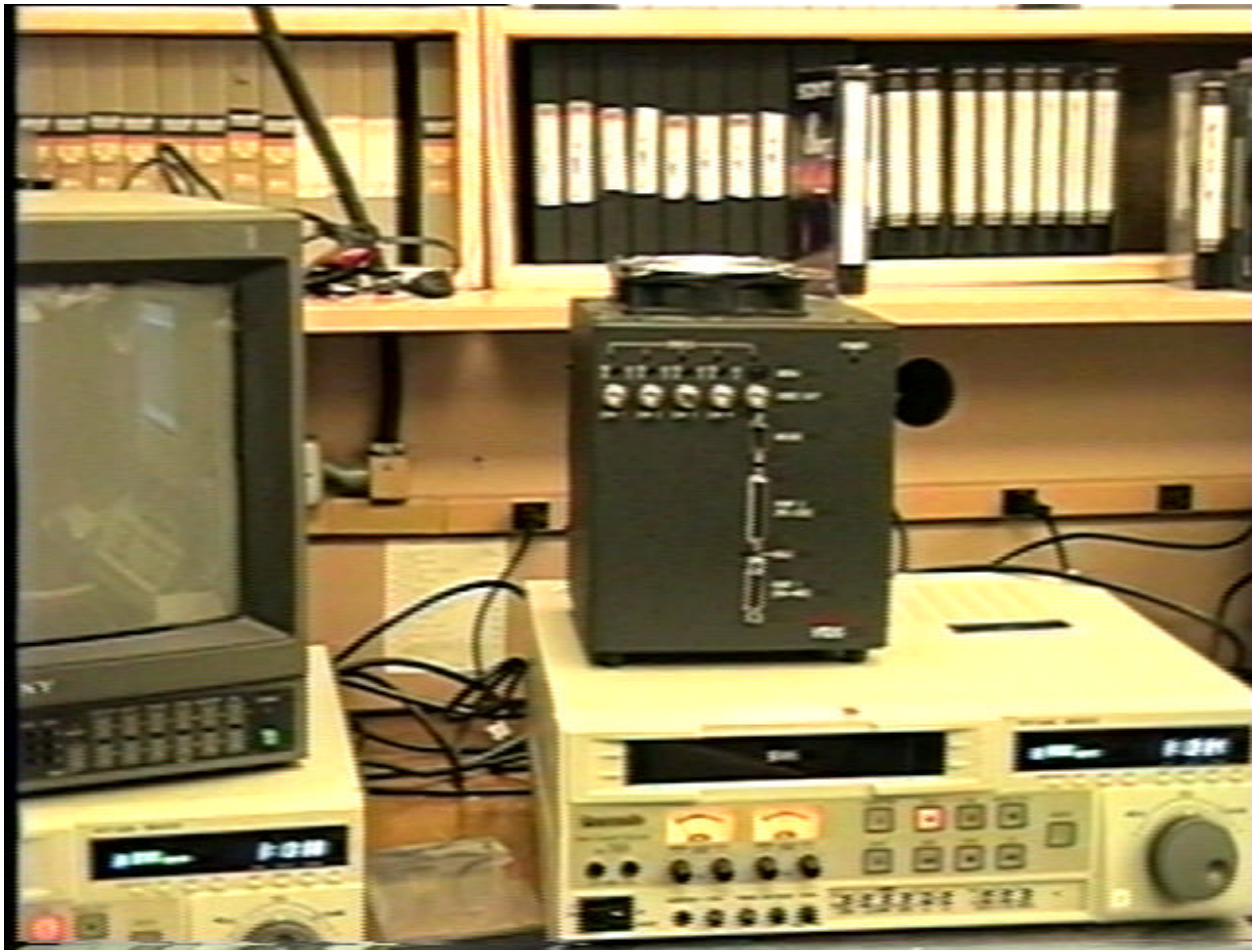
Figure 1. Odetics VTDS Evaluation Unit (on top of video tape recorder).

Following the November 1996 EOT meeting, we took delivery of a VTDS evaluation unit at Odetics' Anaheim facility. Odetics staff confirmed that the unit was fully operational, with the most recent firmware available, and was properly calibrated. Figure 1, below, is a single video frame from our documentary video records showing the evaluation unit prior to setup for testing at the Cal Poly Transportation Electronics Laboratory.

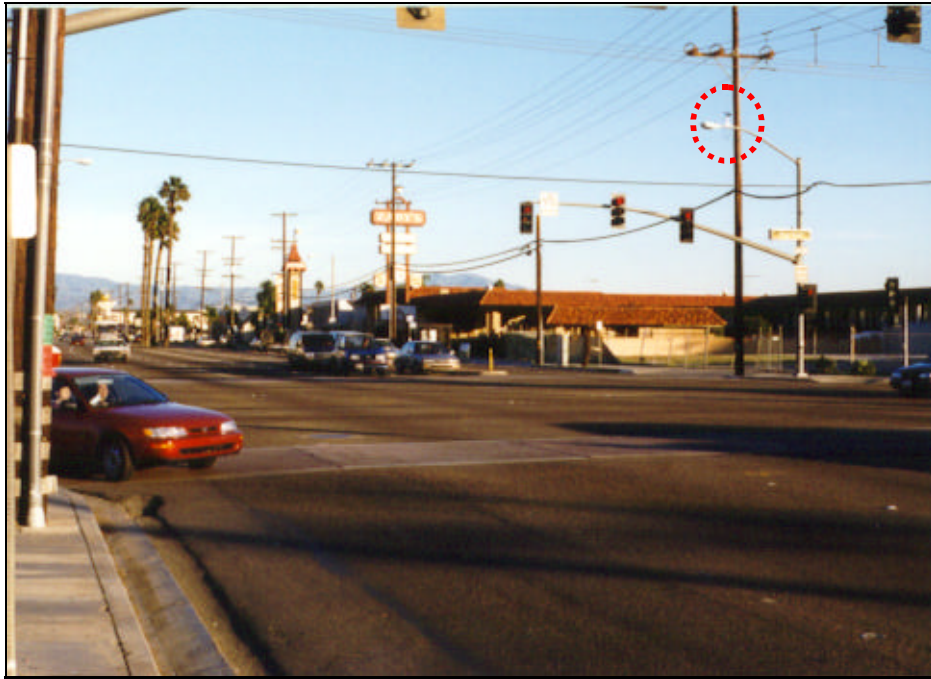
Figure 5. Harbor and Katella Test Intersection.

Figures 5 and 6 below are ground-level photographs of the Harbor/Katella and Clementine/Freedman test intersections, at which most of the test conditions were recorded. The positions of the VTDS cameras in each photograph are highlighted by dashed circles.

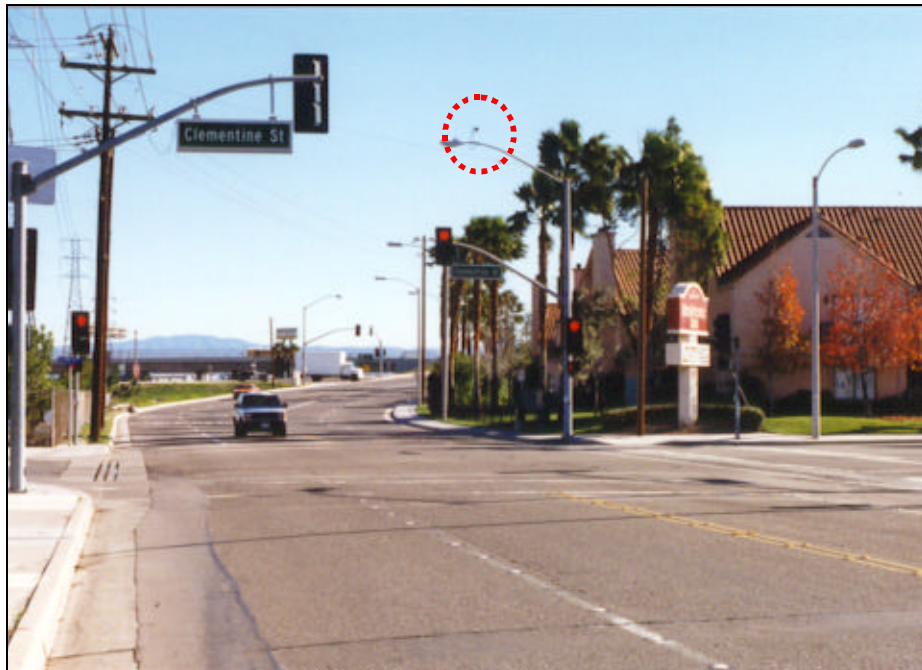
Figure 6. Clementine and Freedman Test Intersection.

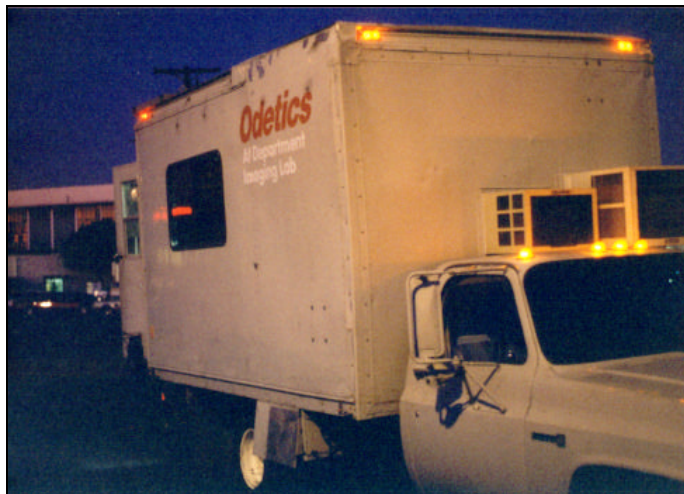
Figure 9. Mobile Laboratory Exterior.

At the Odetics facility we also inspected the mobile surveillance laboratory, as required under FOT Task 9. At the time of our inspection, the vehicle appeared to no longer be in use for this application. Two monitors, one VTR, and a few other unconnected equipment items in a rack mount frame and miscellaneous materials storage were observed. The interior and exterior of the vehicle were photographed for documentary purposes, and are shown respectively in Figures 9 and 10 below. It does not appear from our inspection that this trailer was being employed in the field testing of the VTDS Intersection Product. Since the vehicle can only be parked on the side of a roadway, it could not be used for acquisition of video sequences usable by the VTDS Intersection Product, which requires camera placements in the roadway centers of intersection approaches. It is suitable for and was probably utilized for the development of the earlier version of the VTDS, which was specified as a general purpose data collection and signal actuation detection system.

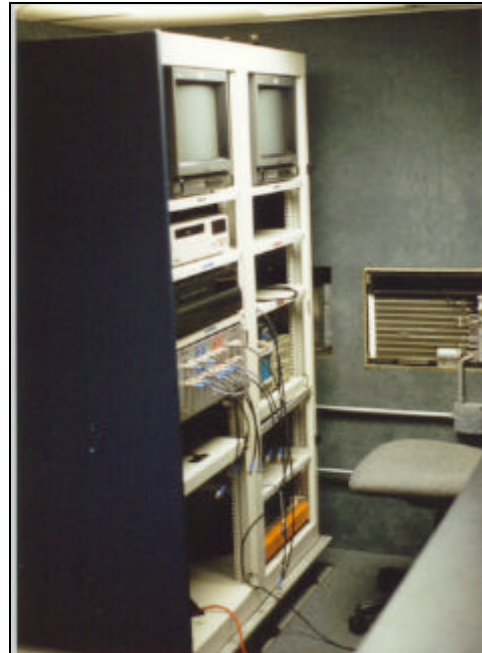
Figure 10. Mobile Laboratory Interior.

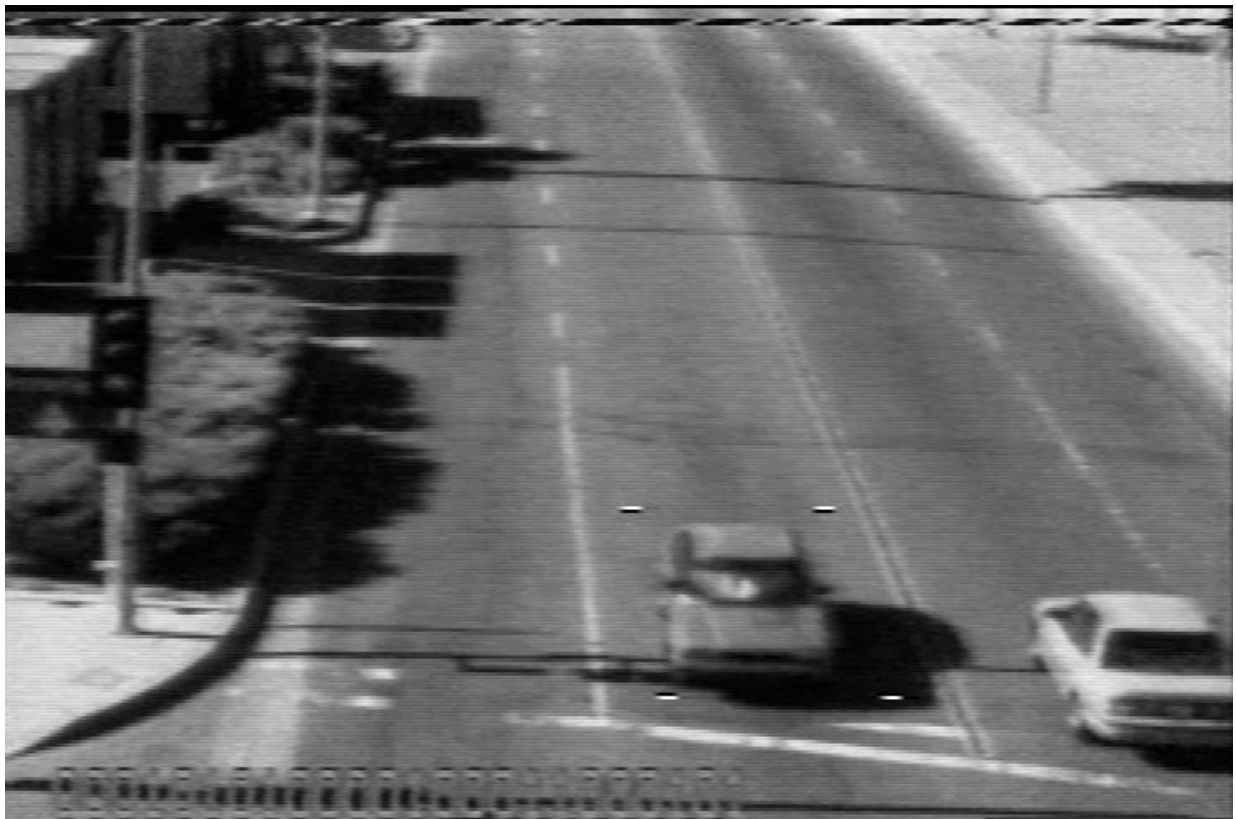
Site Plan:

Event Class 2: Detection w/ Latch

Location: Harbor & Katella, NB

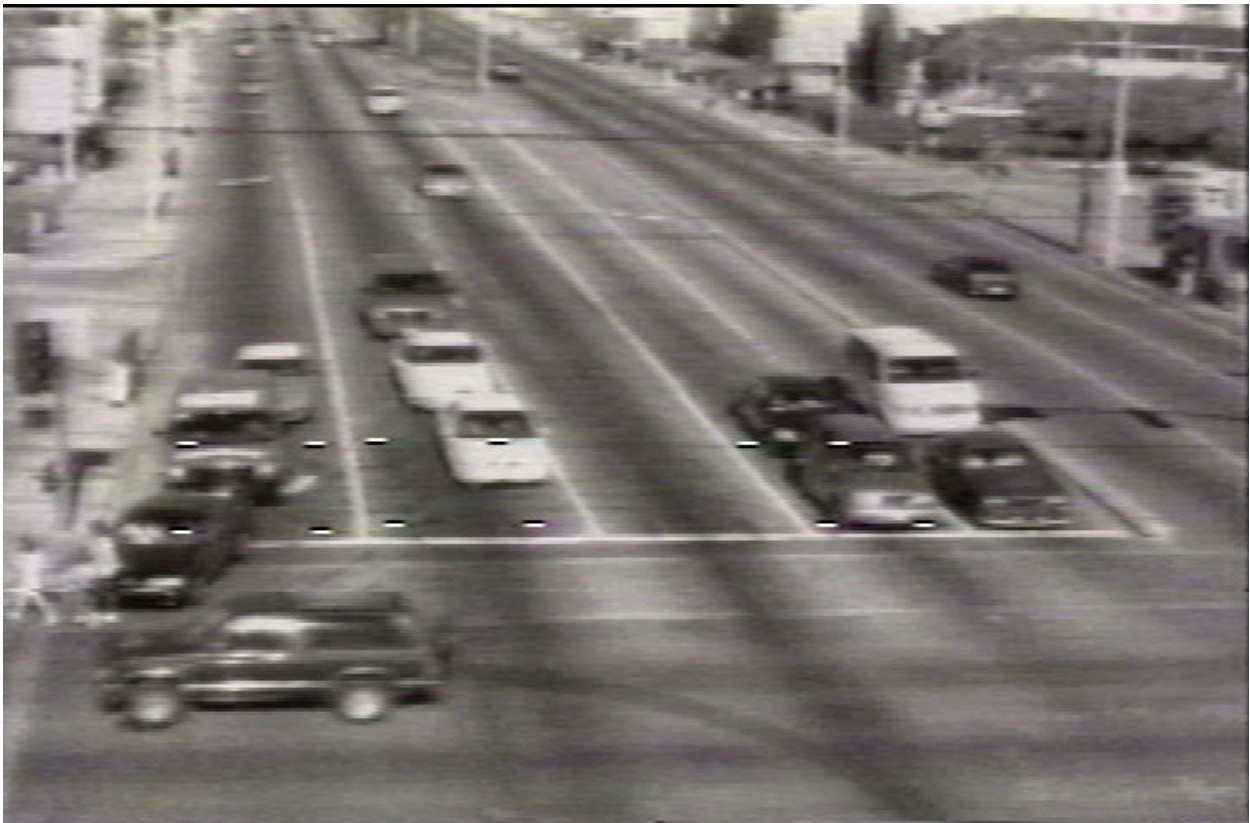
Event Class 3: Multiple Detection

Location: Harbor & Katella, SB

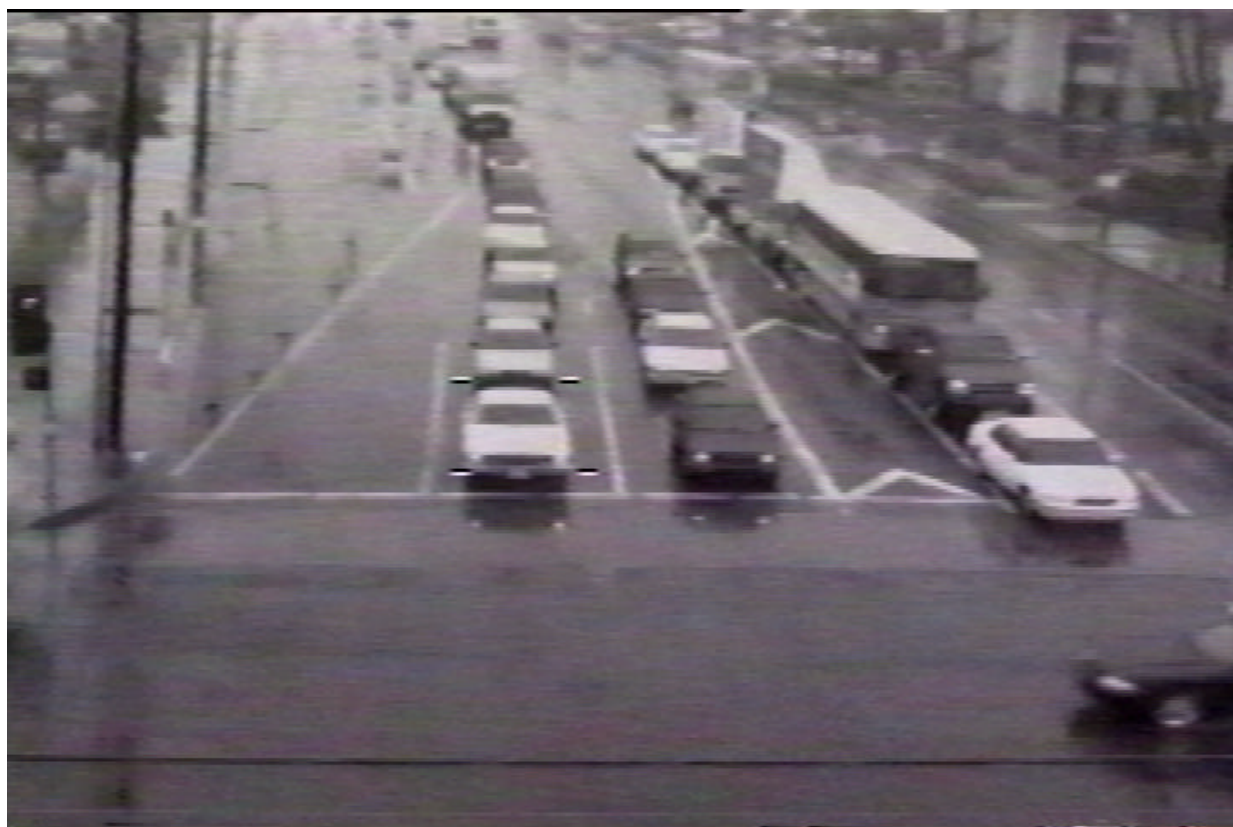
Event Class 5: Dropped After Detection

Location: Harbor & Katella, NB

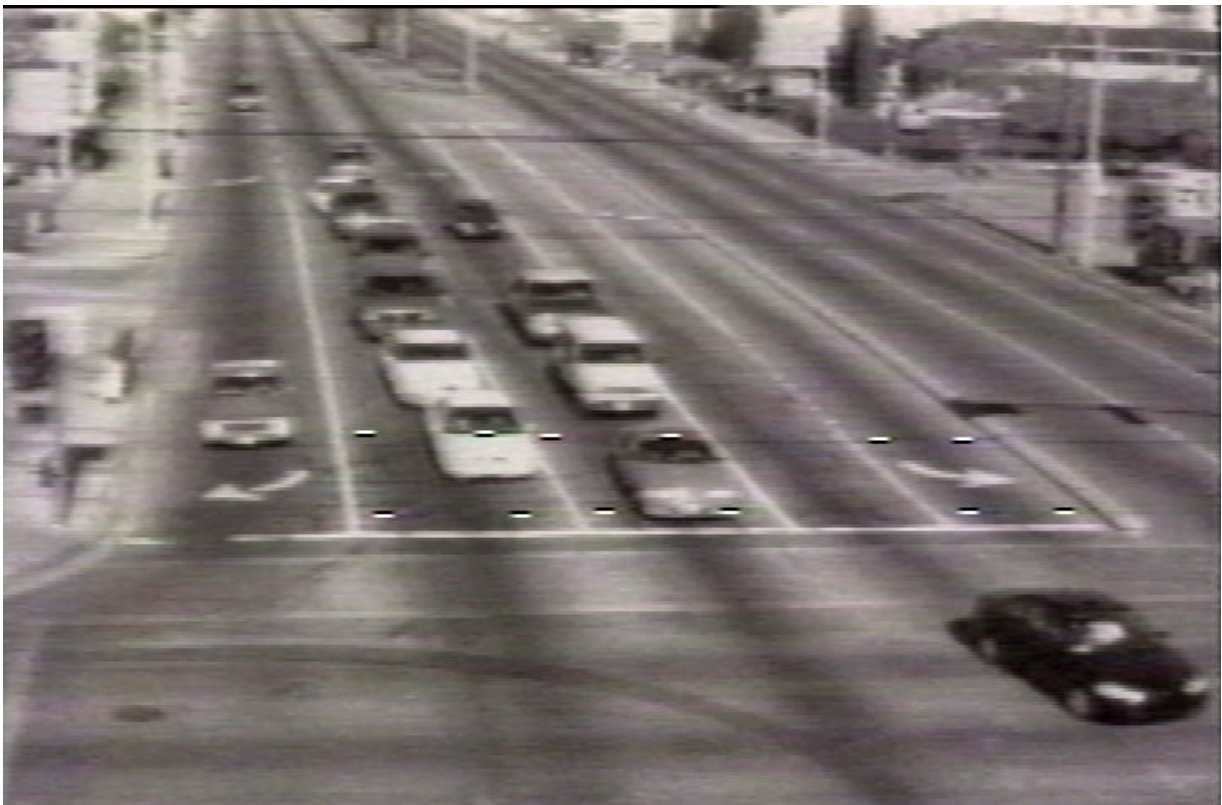
Event Class 7: Tailgate w/ Latch
(Tailgate with Latch after Final Vehicle)

Location: Harbor & Katella, SB

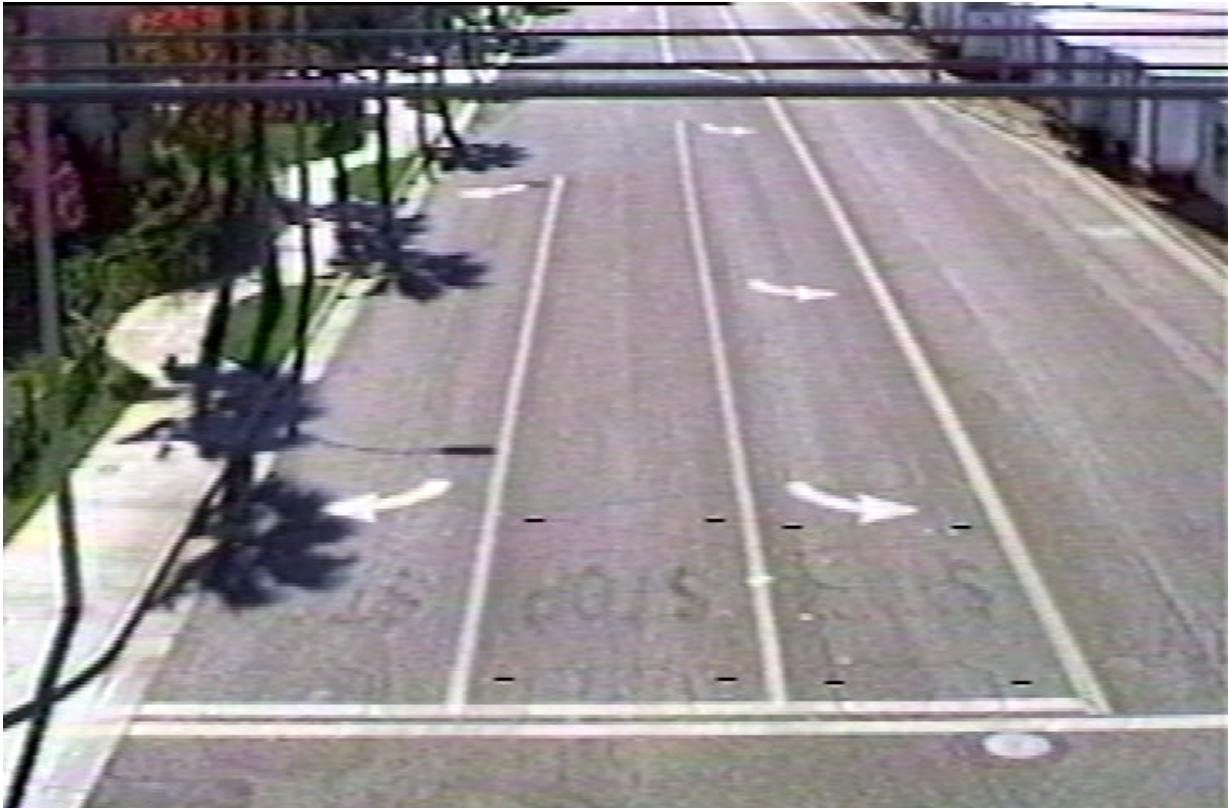
Event Class 8: False Detection

Location: Freedman & Clementine, NB

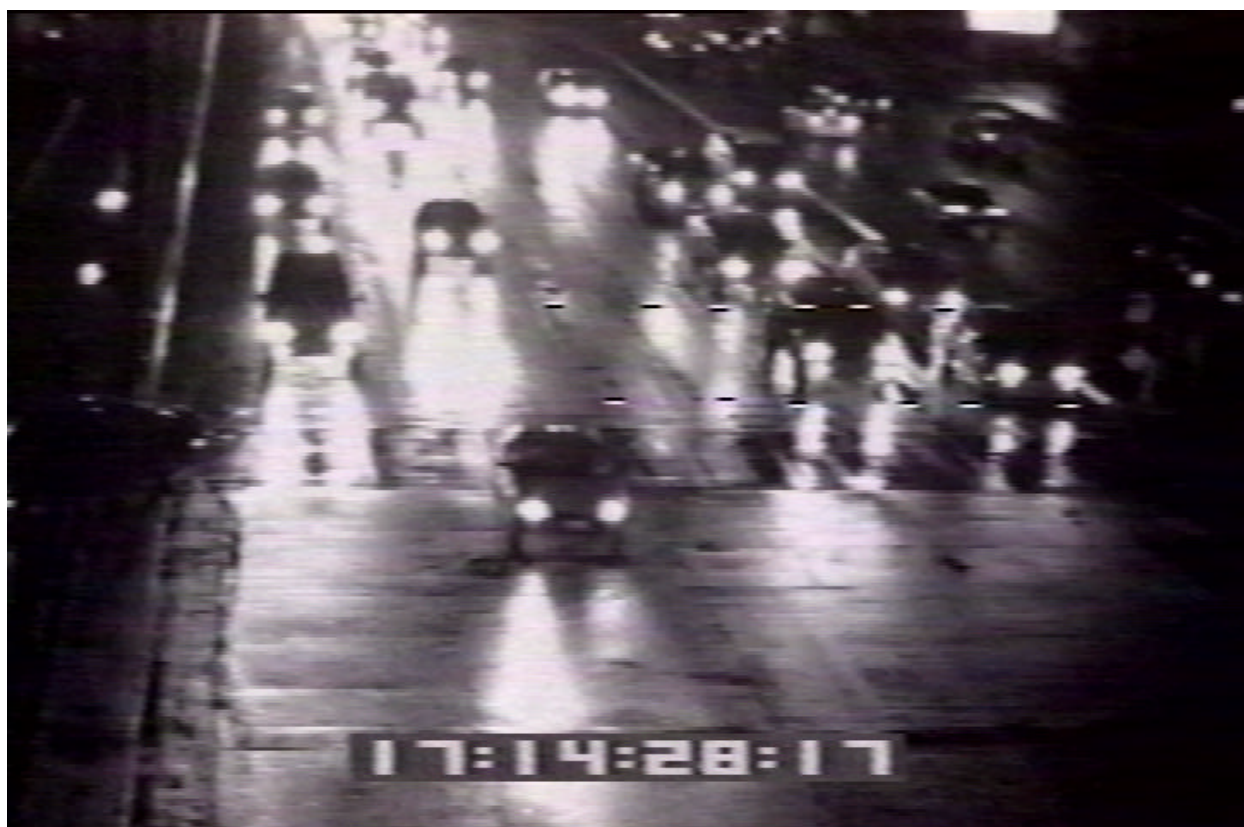
Event Class 9: False Detection w/ Latch

Location: Harbor & Katella, EB

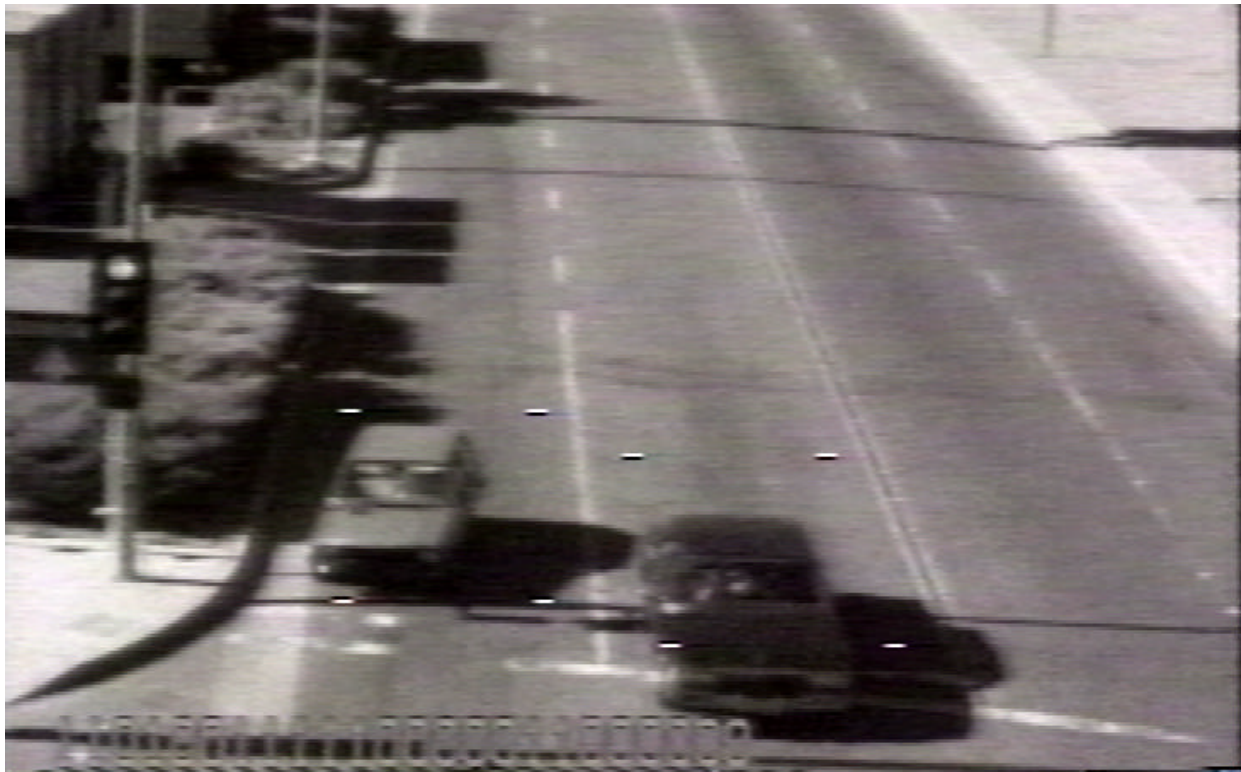
Site Plan:

Phase Detection Class 2:
Red Interval (Call for R/G Transition)
Incorrect Actuation:
Failure to Actuate Correctly

Location: Harbor & Katella, SB

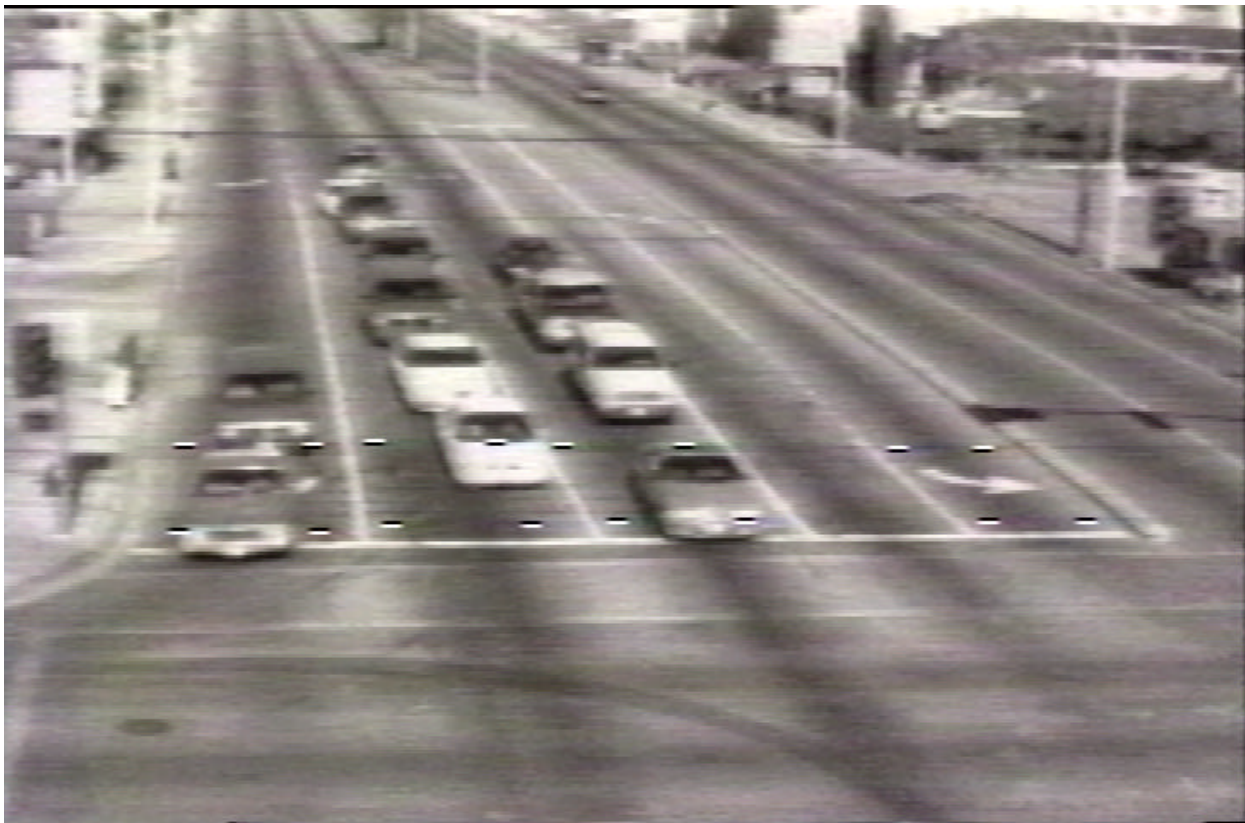
Phase Detection Class 3:
Red Interval (Call for R/G Transition)
Incorrect Actuation:
Potential False Actuation

Location: Harbor & Katella, SB

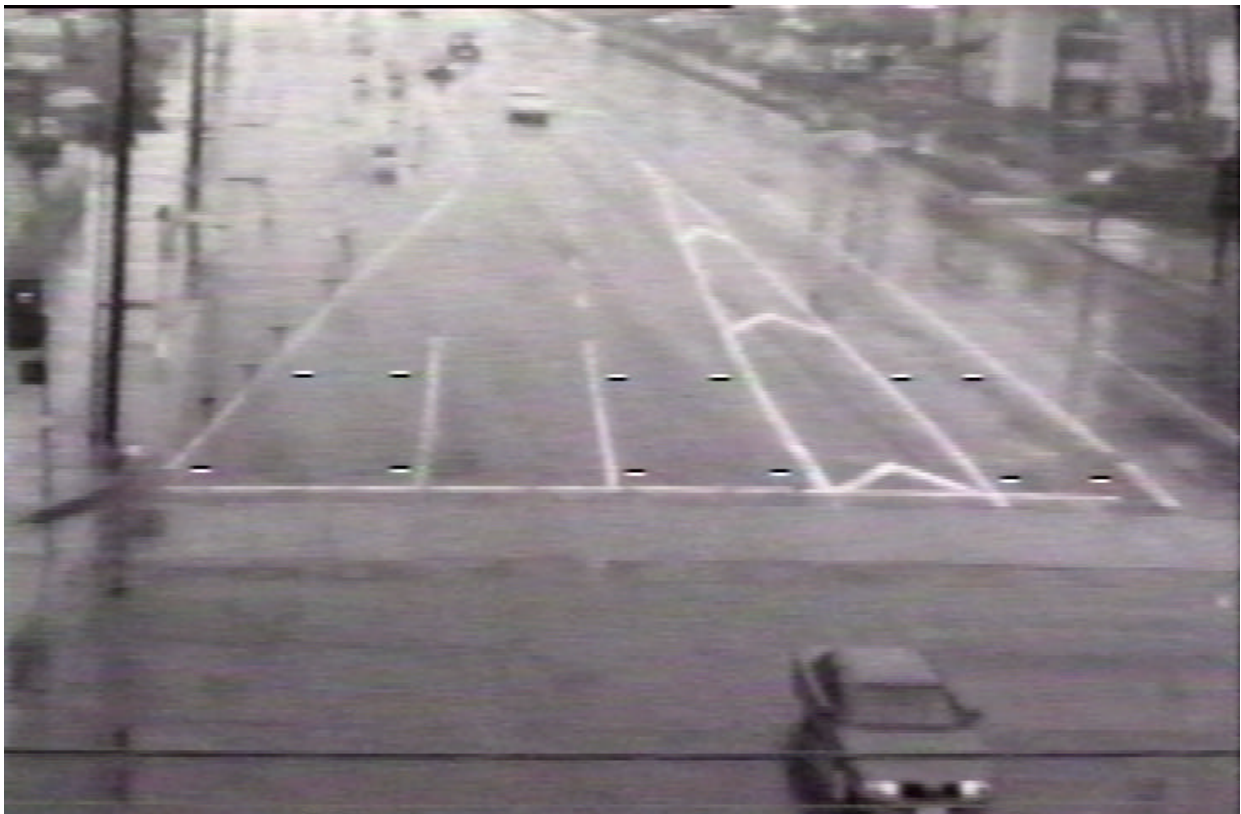
Phase Detection Class 6:
Green Interval (Green Extension)
Incorrect Extension:
Potentially False Green Extension

Location: Harbor & Katella, NB
