NASA Technical Memorandum 4084

Flight Test Experience and Controlled Impact of a Remotely Piloted Jet Transport Aircraft

Timothy W. Horton and Robert W. Kempel

NOVEMBER 1988

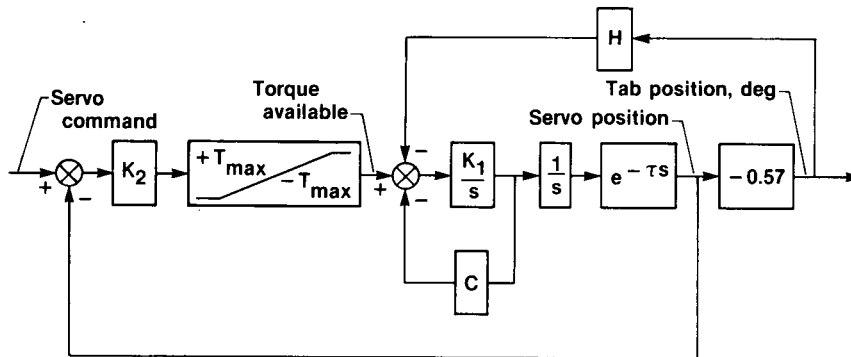
$$\tau = 0.25 \text{ sec} \quad K_1 = 7.89$$

$$T_{\max} = 75 \quad K_2 = 12.7$$

Figure 12. Autopilot elevator servo model.

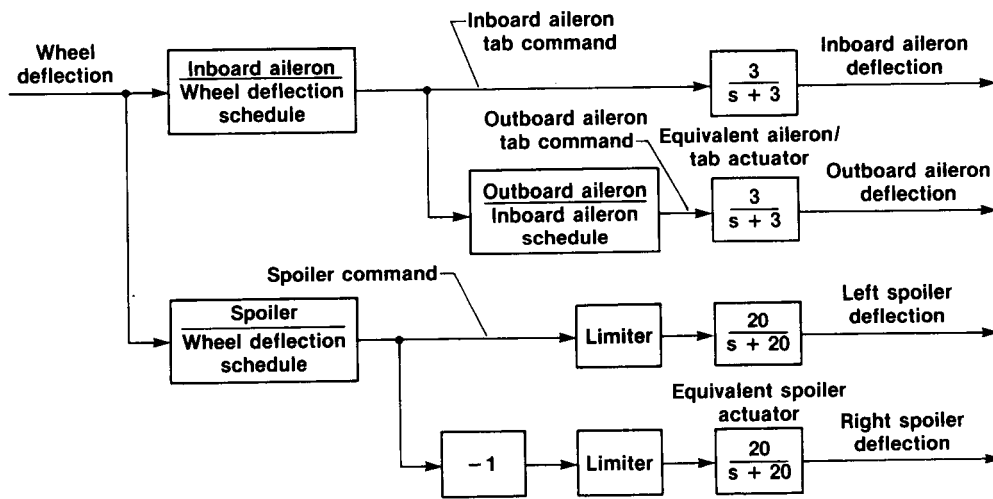
(a) Control wheel command path.

(b) Aileron and spoiler command path.

Figure 13. Controlled impact demonstration roll control system.

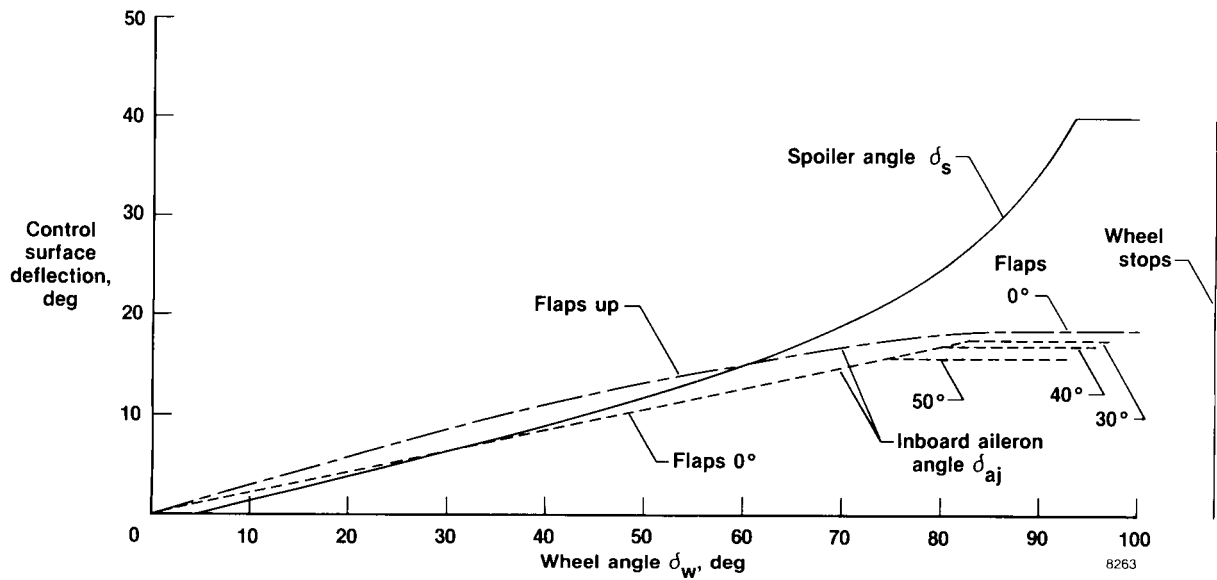
Figure 14. Inboard aileron and spoiler deflection schedules.

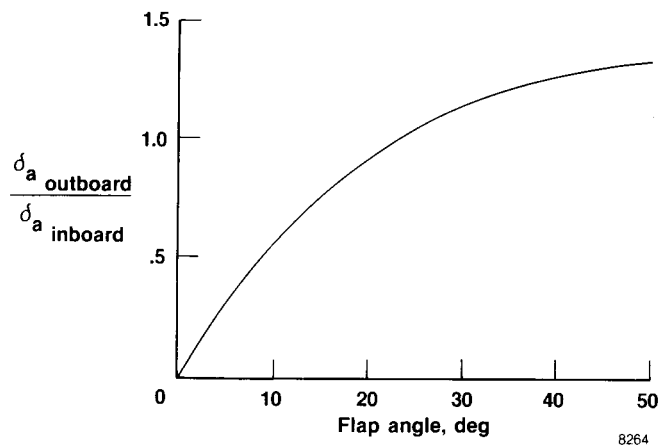
Figure 15. Outboard to inboard aileron schedule.

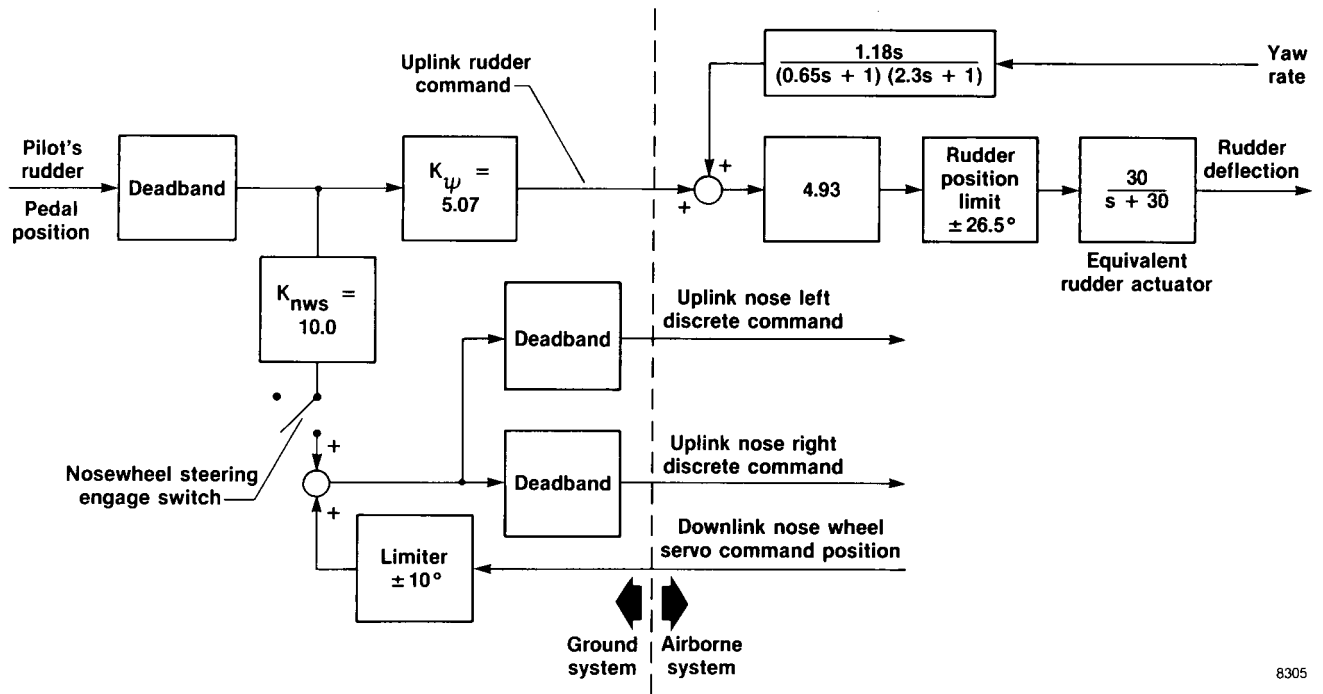
Figure 16. Controlled impact demonstration yaw control system.

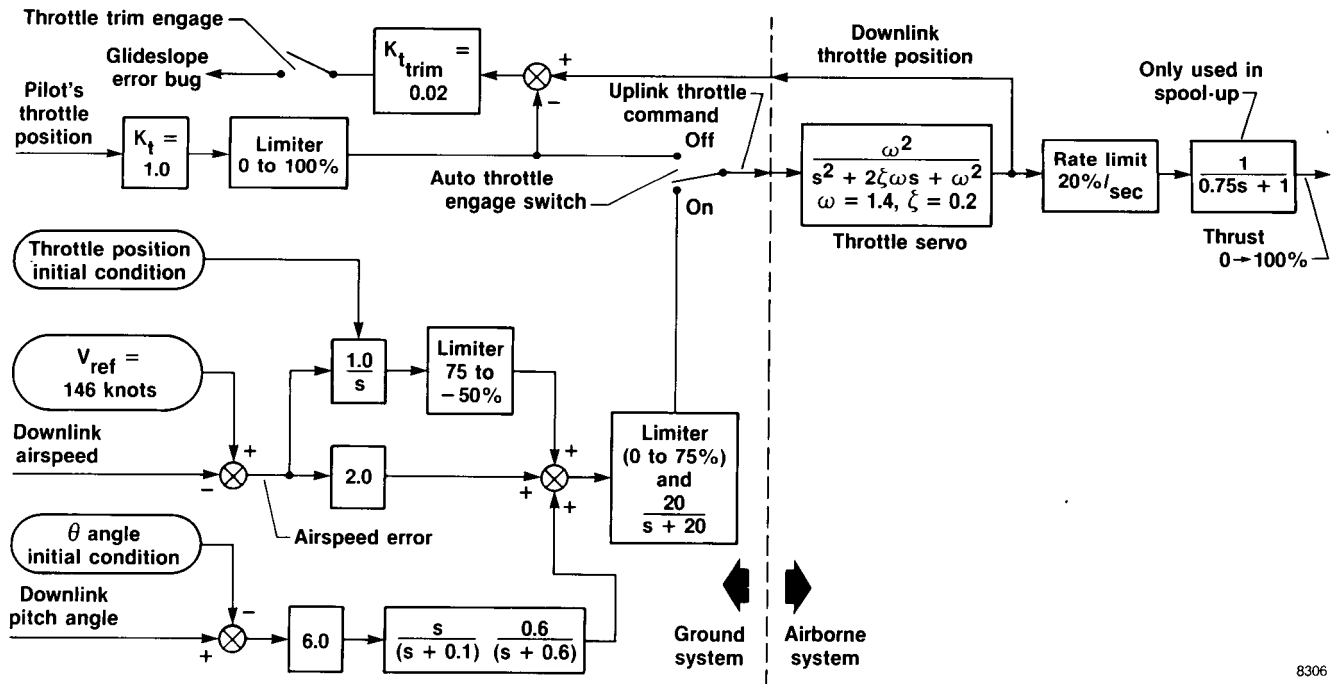
Figure 17. Controlled impact demonstration throttle control system.

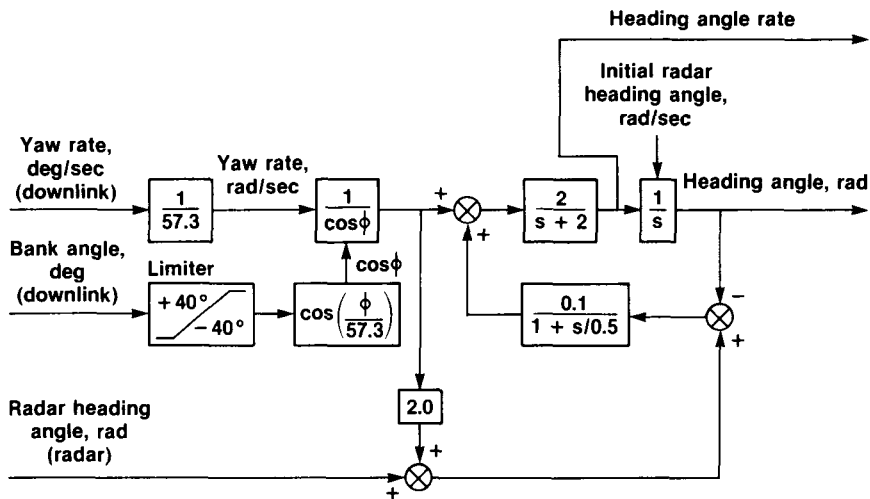
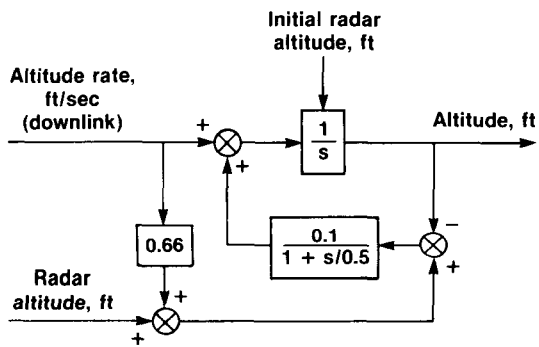
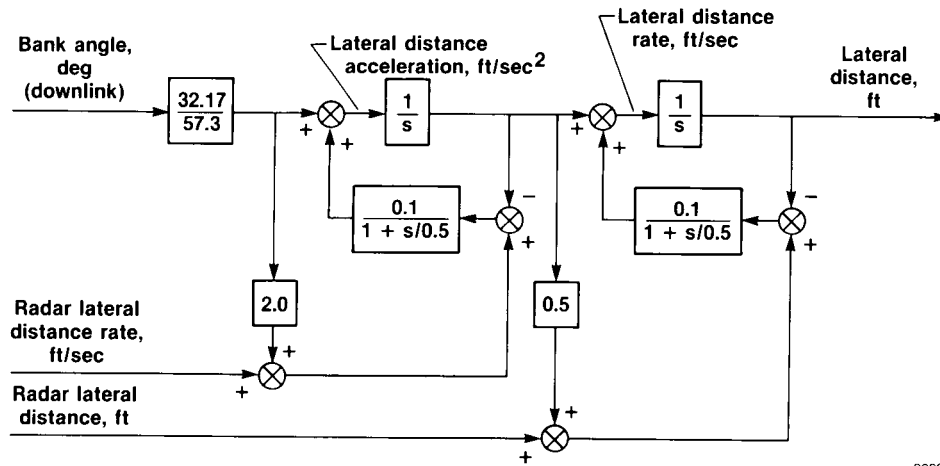
(a) Heading angle calculation.

(b) Downrange position calculation.

(c) Altitude calculation.

Figure 19. Guidance parameter calculations.

(d) Lateral distance calculation.

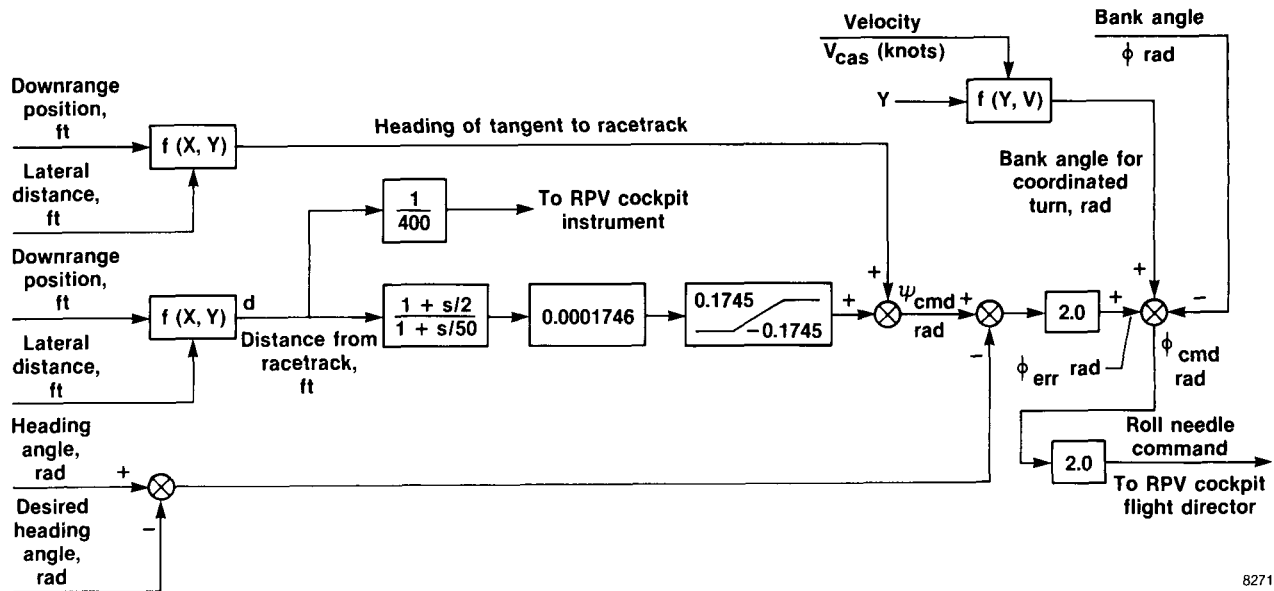
Figure 21. Lateral racetrack guidance control law.

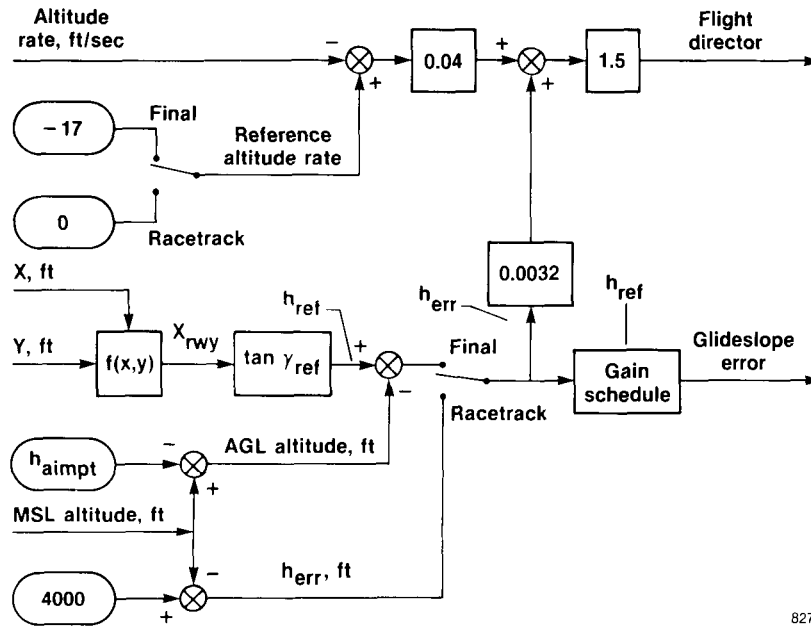
Figure 23. Downrange racetrack and final approach control law.

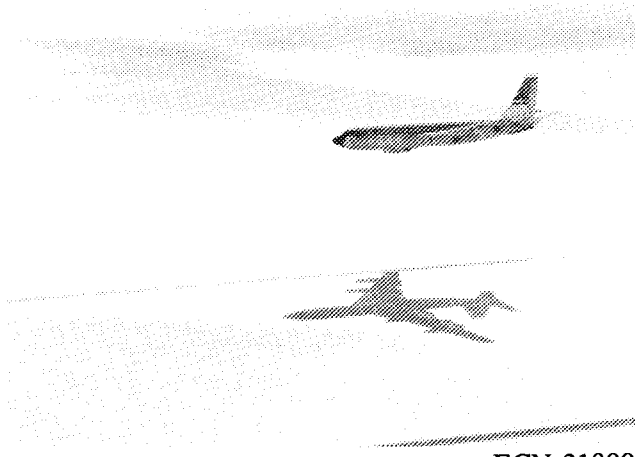
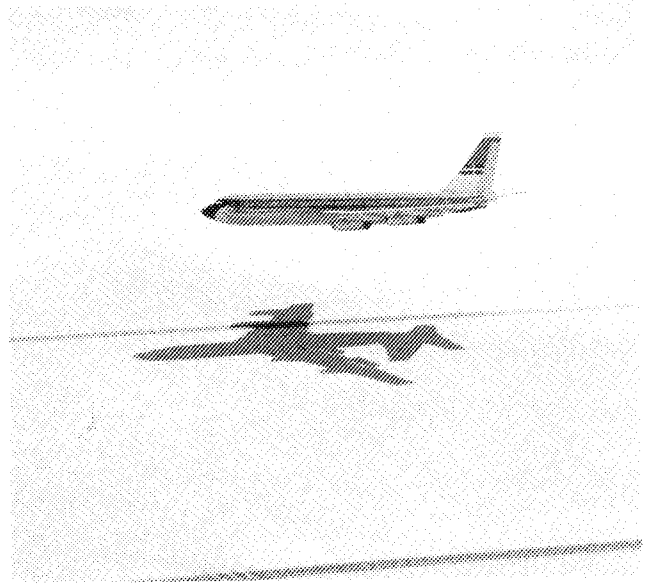
Figure 25. B-720 aircraft approach during impact flight.

The final CID flight was made on December 1, 1984. Figure 25 shows the B-720 aircraft approaching the impact site during the last flight. Figure 26 shows the actual impact, while figure 27 shows the slideout of the airplane after impact. During the impact flight, some of the desired impact conditions were not achieved. The events that occurred during the final approach and an evaluation of the significance of these events on the impact conditions that were achieved are reviewed as follows. The analysis is based on recorded downlink parameters and on the radar and computer-generated guidance information.

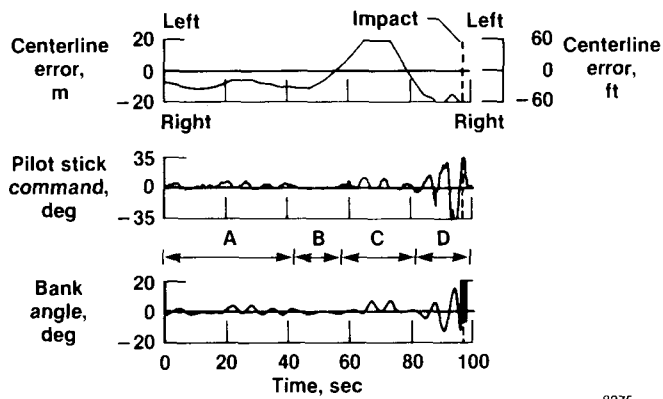
Figure 28. Lateral-directional time response from 1630 ft aboveground level to impact.

Some of the pertinent lateral-directional parameters near impact are shown in figure 28, and the longitudinal parameters are shown in figure 29. The time histories are broken into four regions (A to D), based on lateral activity, as shown in the figures.

Region B. In region B, the RPV pilot stopped making any significant lateral corrections for about 10 sec while he was working the longitudinal task since the altitude error was increasing significantly immediately before region B and was reduced to an acceptable level by the end of the region. It could have also been caused, in part, from the need to change between the video display and the cockpit instruments to cross-check the validity of the guidance information. Whatever the reason, in this period without any pilot inputs, the roll bias produced a left turn (about a 2° bank). This, in turn, caused the lateral deviation to start moving rapidly to the left (rapidly in terms of the 15 ft constraint). The actual crossrange drift rate was about 3 ft/sec at the end of region B.

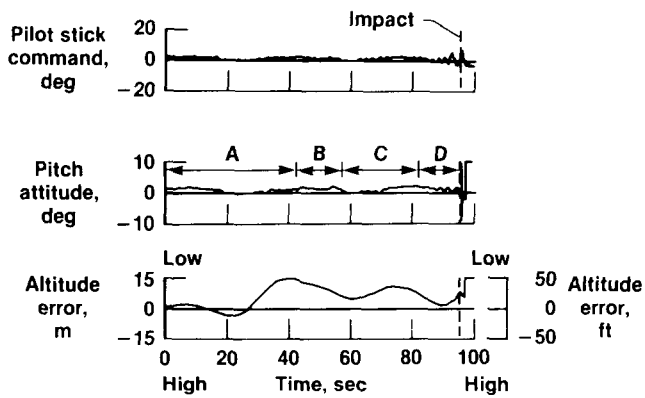
Figure 29. Longitudinal time response from 1630 ft aboveground level to impact.

In the pitch axis, the pitch attitude was held within the desired range (0 to 2°) during this final region, although it was oscillating. The pitch command was oscillatory and diverging. The altitude error was converging on the desired value until the large bank angles occurred. At this point, altitude was lost due to a slight pushover (about 1°) and the lift loss caused by the banking, resulting in the impact short of the desired point.
