High Temperature Gas-Cooled Reactors Lessons Learned Applicable to the Next Generation Nuclear Plant

J. M. Beck
L. F. Pincock
April 2011

**Idaho National Laboratory
Next Generation Nuclear Plant Project
Idaho Falls, Idaho 83415**

INL/EXT-10-19329
Revision 1

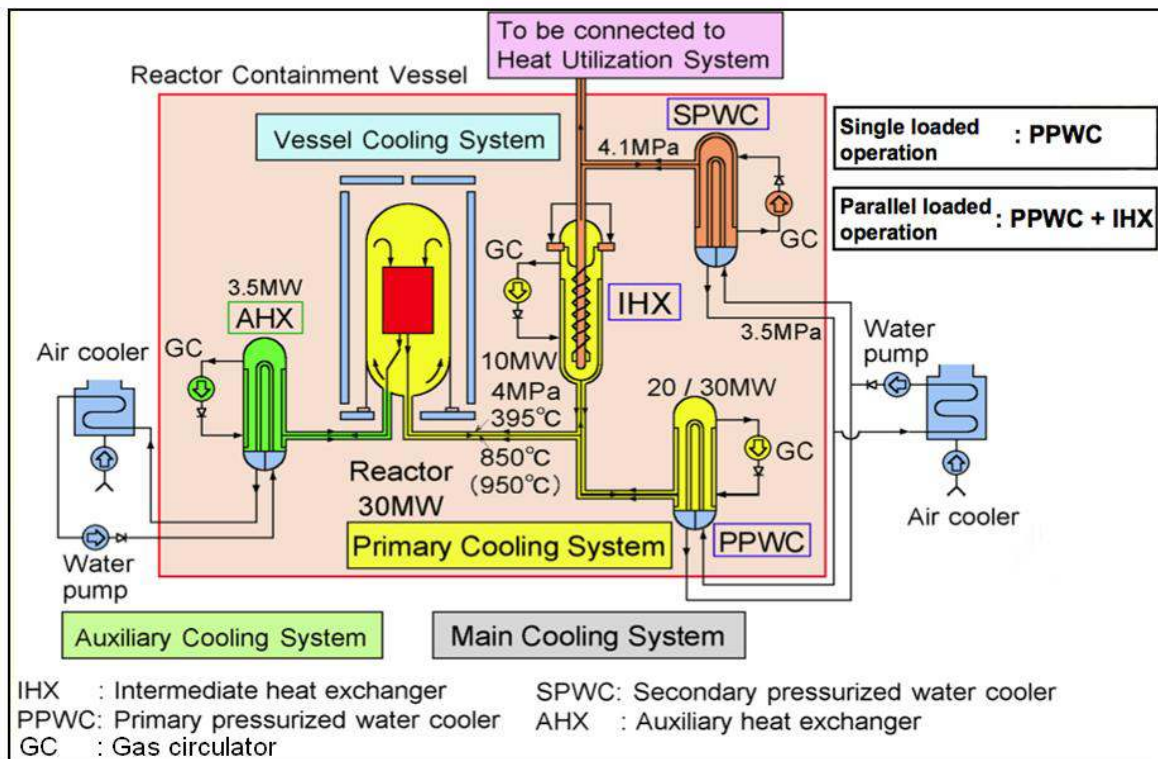
Figure 8. Basic HTTR plant layout schematic.

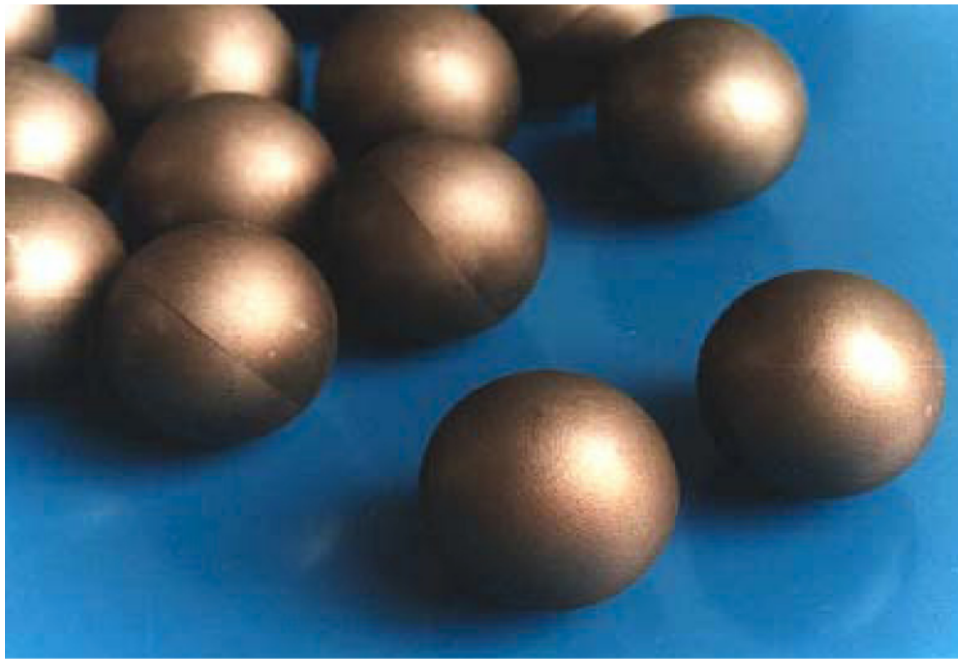
Figure 13. HTR-10 fuel.

An irradiation test of the first batches of fuel for HTR-10 (see Figure 13) was reported in 2006. The report discusses specific tests of four spherical fuel elements conducted at the Russian reactor IVV-2M.⁴³ Results for the tests focused on fission product releases, specifically releases of Cs, Ce, and Xe.

During these irradiation tests, some positive and negative attributes were found in the different batches of fuels. One set of fuel elements in the experiment was the SFE7. A conventional high-temperature furnace that can reach 1600°C was not available for use at the irradiation facility for these experiments. Instead of using the usual furnace testing method, researchers determined to heat the fuel spheres within the reactor itself by increasing the thermal neutron flux; however, the actual temperature was not recorded because a thermocouple failed. The SFE7 temperatures were instead calculated based on the fission power of the SFE7.

This inpile heating test led to failures in coated particles within SFE7. Post irradiation examination determined that the fuel temperature had gone much higher than the intended 1600°C, resulting in the failure of coatings on the fuel particles. A large portion of the particles that encountered the high-temperature inpile testing were observed to have defects. The type of defects observed include radial cracks, tangential cracks, cracks in the buffer PyC layer, and through failures in the PyC and SiC layers.

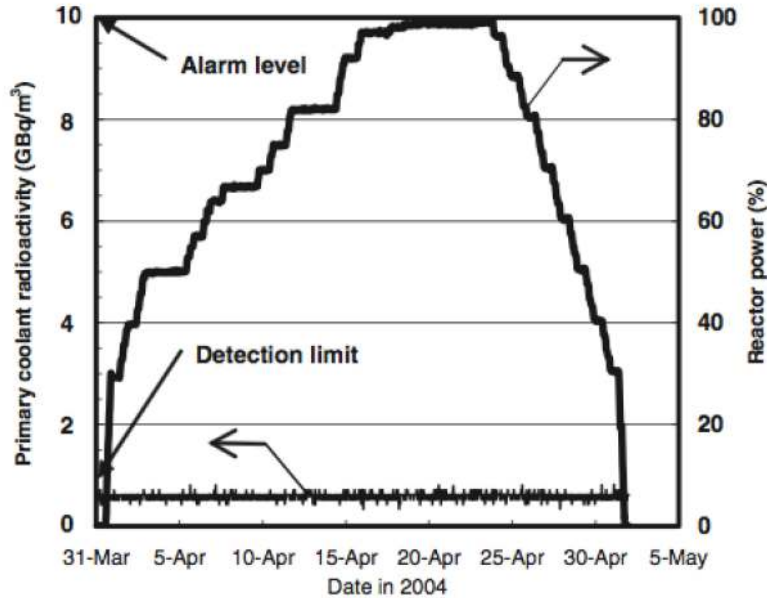
Fuel and fission product gas behavior was monitored to evaluate the release behaviors of the fission product gases and to confirm that the levels of the released fission product gases were within their limits during the operation. Primary coolant radioactivity instrumentation, a fuel failure detection system, and a primary coolant sampling system were installed in the HTTR to measure primary coolant radioactivity. Over the course of numerous years, HTTR had a goal to achieve an operational state with a reactor outlet temperature of 950°C. On April 21, 2004, the HTTR was able to achieve operation at full temperature of 950°C. Primary coolant radioactivity was measured continuously during this full temperature operation, as shown in Figure 15. Results show that not only were all signals less than the alarm level of 10 GBq/m³, which corresponds to 0.2% of fuel failure, but all signals were also less than the detection limit (1 GBq/m³).¹⁰

Figure 15. Primary coolant radioactivity signals during HTTR operation.¹⁰

Lessons Learned: HTTR experience shows a positive example that an HTGR can be run at full power (at 950°C) without releasing any detectable amounts of fission products. The successful use of instrumentation, detection, and sampling systems at HTTR will be of benefit to the NGNP design.
