## High temperature mechanical performance and micro interfacial adhesive failure of textile reinforced concrete thin-plate\*

Shi-lang XU, Ling-hua SHEN, Ji-yang WANG<sup>†‡</sup>, Ye FU

(College of Civil Engineering and Architecture, Zhejiang University, Hangzhou 310058, China)

**Abstract:** The mechanical performance of textile reinforced concrete (TRC) thin-plate under high temperature conditions was investigated using three-point bending tests. The influence of polypropylene (PP) fiber addition on the out-of-plane load capacity of TRC thin-plate after high temperature treatment was also studied. The results showed that the thermostability of TRC thin-plate with textile impregnated with epoxy resin was not good, but that the out-of-plane load capacity of TRC thin-plate after high temperature treatment could be improved by increasing the plate thickness or the textile distribution rate. Under normal temperature and a high temperature of 120 °C, the out-of-plane load capacity of specimens could be increased and cracks better distributed by mixing the TRC with PP fiber. However, the out-of-plane load capacity of TRC thin-plate under a continuous high temperature of 200 °C was no

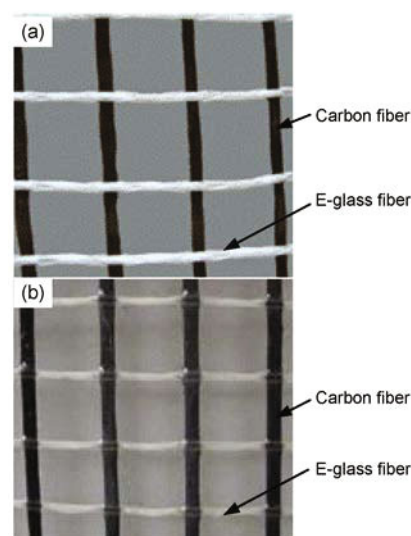
**Fig. 1 Carbon/glass woven fiber net**  
(a) Non-impregnated with the epoxy resin; (b) Impregnated with the epoxy resin

The fiber adopted in this experiment was a 2D woven net made by mixing carbon fiber bundles and E-glass. The two fiber bundles were made of multifilaments which were not twisted, and the meshing size was 10 mm×10 mm (Fig. 1). The mechanical properties of the monofilament fibers are listed in Table 1. The ultimate tensile strength of the glass fiber was lower than that of the carbon fiber, but the cost was higher. Thus, the carbon/glass mixed fiber not only had a reinforcing effect, but also had a better economic efficiency.

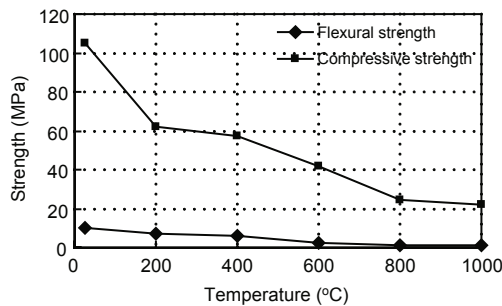
**Fig. 2** Influence of temperature on the mechanical properties of fine concrete substrate

The raw material of the fine concrete substrate included Portland cement (PII 52.5R), coal ash, silica fume, water reducing agent (3rd generation of Sika), and sand in the proportions listed in Table 3. Experimental tests showed that the prepared fine concrete satisfied the working performance requirements of self-compacting concrete (Li and Xu, 2006). The influence of temperature on its mechanical properties is shown in Fig. 2.

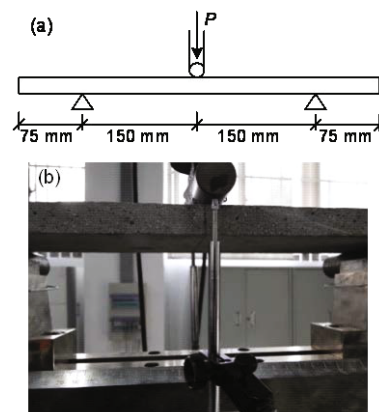
**Fig. 3** Three-point bending test (a) Loading schematic diagram; (b) Loading system

The specimens were placed on two pin supports with 300 mm clear span. Experimental tests were conducted with a 250 kN Instron universal testing machine. The loading method is shown in Fig. 3a. The load *P* was measured by a load transducer. The mid-span deflection of the thin plate was measured by two displacement sensors (LVDTs). The loading device is shown in Fig. 3b. Displacement control was adopted in the loading test with a velocity of 0.5 mm/min.

**研究方法：**通过三点弯曲试验（见图 3），对高温后试件的力学性能（见图 4、5）进行测试。通过微观扫描电镜观测（见图 8~10），了解高温下纤维编织网、环氧树脂及基体混凝土的形态。

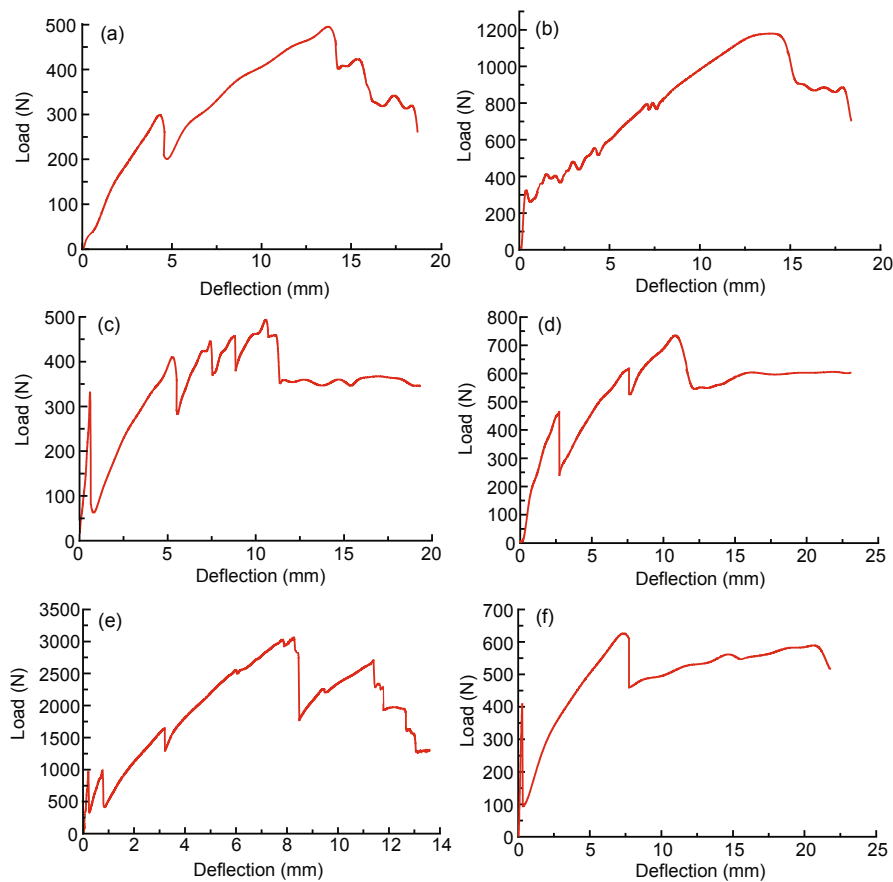
**Fig. 4 Load-displacement relation of three-point bending test**

(a) Specimen A (room temperature); (b) Specimen B (room temperature); (c) Specimen C (120 °C, 30 min); (d) Specimen D (120 °C, 30 min); (e) Specimen E (120 °C, 30 min); (f) Specimen F (200 °C, 30 min)

The load-midspan displacement curves for the TRC thin plate after treatment at different temperatures and duration times are given in Fig. 4. The first cracking load, ultimate state load, and mid-span deflection under the three-point bending test are shown in Table 5. The temperature and duration time of the process were set on the muffle furnace, and all the

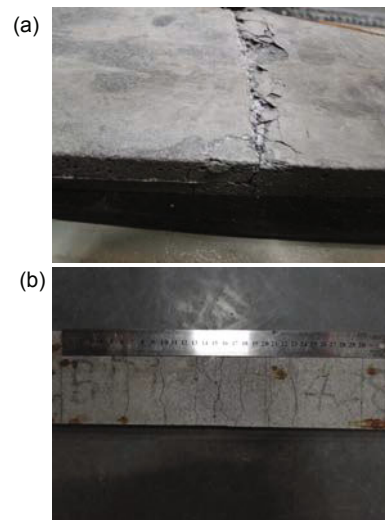
**Fig. 5 Failure mode of TRC specimens**  
(a) Specimen A; (b) Specimen B

Comparison of the bearing capacities between specimens A and B, and C and D showed that under normal temperature and 120 °C, the addition of PP could greatly increase the ultimate out-of-plane load capacity of the thin plate. This was likely to have been the result of the bridging and load transfer effects of the short fibers on the crack development sites. As the first crack of the plate occurred, the bridging effect of the PP fiber may have delayed crack development, reduced the crack width, and optimized the stress transfer between the woven fiber net and the concrete substrate. The failure modes of specimens A and B are shown in Fig. 5. The concrete on the upper edge of the thin plate was crushed. However, the PP fiber mix may have helped the member present a multi-crack failure mode. The fracture interval was between 2 and 4 cm, and the distribution was uniform.

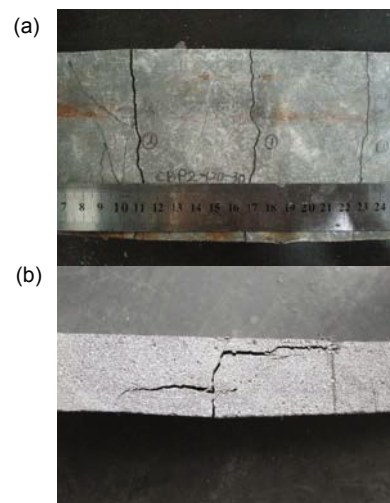
**Fig. 6 Failure mode of specimen E**  
(a) Crack width; (b) Transverse cracks

crushing failure mode. The formed macro-crack number was 3, as specimen E was damaged. The width of the third crack reached 1 mm and a transverse crack was found on the sublayer of the woven fiber net on the side of the specimen. This indicated that the woven fiber net and the concrete substrate had separated. As more loading was added, two horizontal fractures were found, which led finally to shear failure of the specimen. The failure mode is shown in Fig. 6.

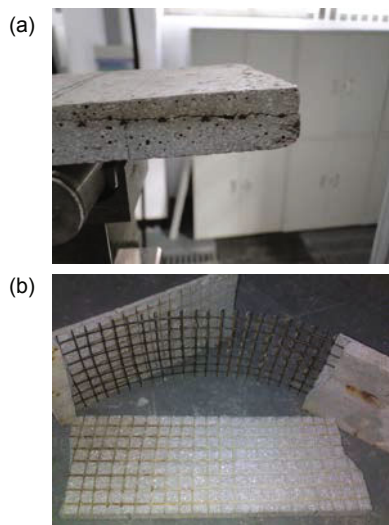
**Fig. 7 Degradation of epoxy resin**

(a) Epoxy resin interface crack; (b) Adhesion failure

was the early separation of the woven fiber net and the concrete substrate. After treatment at 200 °C for 90 min, the integrity of the thin plate was maintained, but its ultimate out-of-plane load capacity was only 400–500 N. The out-of-plane load capacity of specimen G was lost quickly during the initial stage of the loading, which showed its obvious brittle failure characteristic. Regardless of whether the TRC was mixed with PP fiber, the crack number was 1, as the specimen was damaged. The reasons were: first, the PP fiber had already melted under 200 °C. Thus, the influence of the mixed PP on the out-of-plane load capacity of the plate was not big; second, the color of the epoxy resin on the surface of the woven fiber net had already turned from transparent to deep yellow (Fig. 7). This indicated that the performance of the epoxy resin had already degenerated and the fragility had increased greatly. This damaged the adhesion between the woven fiber net and the concrete substrate, and they quickly became separated.

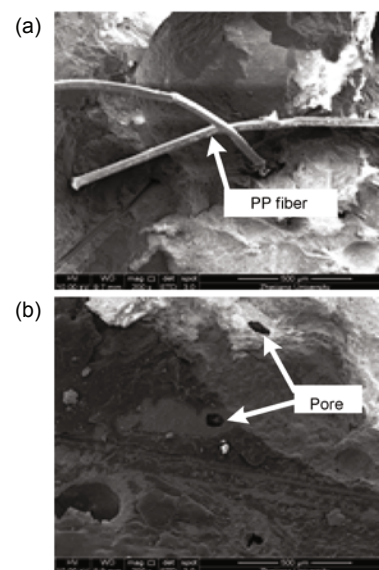
**Fig. 8 Polypropylene (PP) fiber after exposure to high temperature for different durations**

(a) 200 °C, 30 min; (b) 200 °C, 90 min

To visualize the morphology of the woven fiber net, the epoxy resin, and the concrete substrate at high temperature, an FEI Quanta FEG650 electron microscope and energy disperse spectroscopy were adopted to observe the damaged section of the plate member. The existing form of the PP fiber treated with high temperature is shown in Fig. 8. PP fiber was still found in the thin plate after treatment at 200 °C

for 30 min. The melting point of the PP fiber was 160 °C (Table 4), indicating that the inner temperature of the concrete did not reach 160 °C. However, as the duration of the high temperature reached 90 min, the PP fiber melted, and only a few holes remained (Fig. 8). Thus, if the heating time of a plate member was long, the mixed PP fiber had little influence on the out-of-plane load capacity of the member. However, the porosity of the specimen could be increased with mixed PP fiber, favoring the elimination of vapor and heat from the concrete substrate, thereby reducing pore pressure.

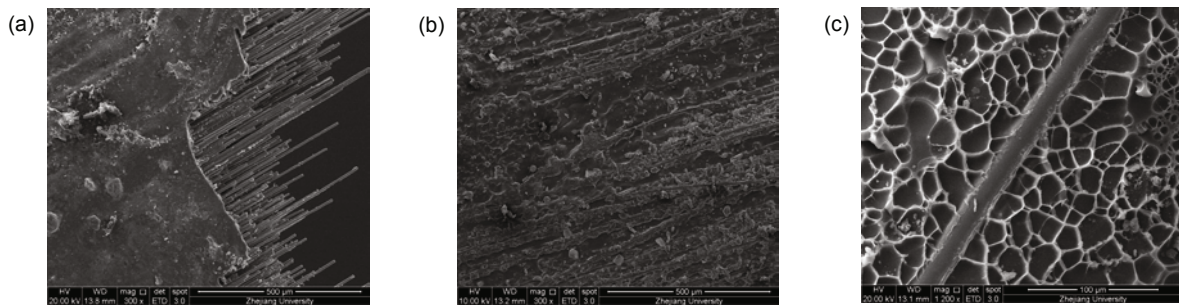
**Fig. 9 Epoxy resin on the surface of fiber**  
 (a) Normal temperature; (b) 120 °C, 30 min; (c) 200 °C, 90 min

The morphology of the surface epoxy resin in the woven fiber net after high temperature treatment is shown in Fig. 9. As the temperature and the high temperature duration increased, the morphology of the epoxy resin changed greatly. At 200 °C for 90 min, the surface became uneven, and performance of the specimen was obviously degraded (Fig. 9c). The interfacial condition of the fiber surface and the substrate after treatment at 200 °C for 90 min is shown in Fig. 10. The fragility of the epoxy resin on the fiber net surface increased greatly, and obvious cracking was observed on the epoxy layer of the fiber surface. Unevenness was already apparent at the interface between the fiber and the concrete substrate, which would lead to the easy separation of the plate and a great drop in its out-of-plane load capacity.

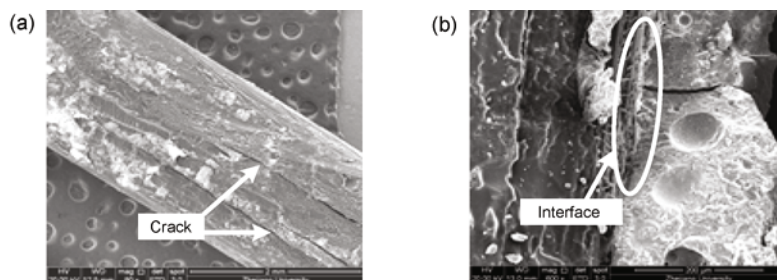
**Fig. 10 Interface condition after treatment at a high temperature of 200 °C for 90 min**  
 (a) Cracks in epoxy resin; (b) Separation at the interface

4. After treatment at a high temperature of 200 °C for 90 min, the degradation of the epoxy resin was serious, and led to unevenness in the surface layer,

interfacial adhesion damage between the fiber net and the cement substrate and finally, a great reduction in the out-of-plane load capacity of the member. Although the strength utilization rate of carbon fiber bundles is greatly improved with epoxy resin impregnation at room temperature, the interfacial adhesive performance of epoxy and concrete is not good at high temperature, and leads to premature damage of thin-plate and bonding failure. Therefore, the out-of-plane load capacity of TRC thin-plate without epoxy will be worse.
