Hydrogen embrittlement susceptibility of a high strength steel X80 — [Source link](#)

Published on: 25 Oct 2010 - [Materials Science and Engineering A-structural Materials Properties Microstructure and Processing](#) (Elsevier)

Hydrogen embrittlement susceptibility of a high strength steel X80

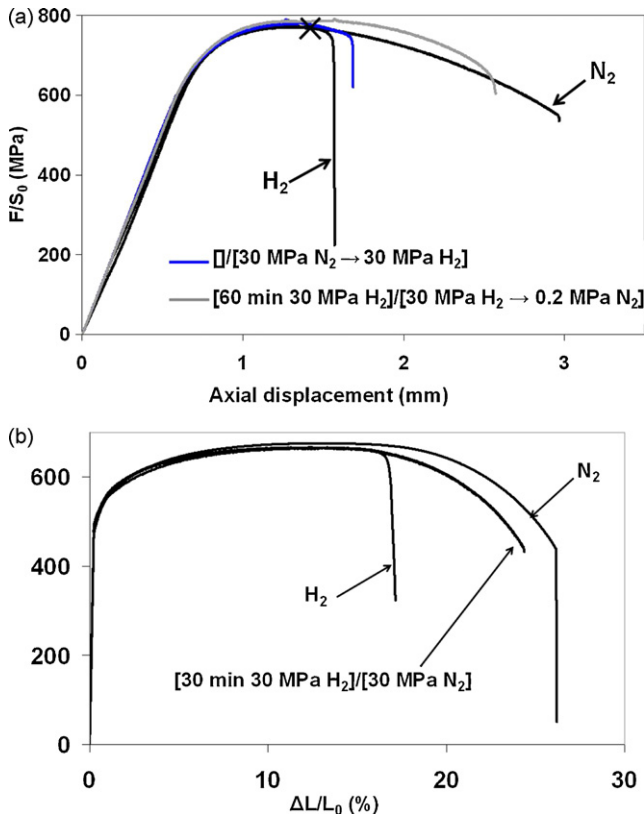
Fig. 3. Interrupted tests on notched axisymmetric specimens ($\rho = 10 \text{ mm}$) (a) and on smooth axisymmetric specimens (b).

- For Test 1 (Fig. 3a), referenced as [60 min 30 MPa H₂]/[30 MPa H₂ → 0.2 MPa N₂], the sample was first precharged for 60 min in 30 MPa hydrogen. Then, the test was started in 30 MPa of hydrogen gas at 0.05 mm/min and stopped just before estimated failure in hydrogen gas alone. Hydrogen gas was removed and replaced by 0.2 MPa of nitrogen gas in about 8 min. It was assumed that there was no residual hydrogen in the atmosphere after the gas switching from hydrogen to nitrogen. The tensile test was then restarted at 0.05 mm/min until failure. The purpose of this test was to investigate the part of trapped hydrogen on embrittlement. While hydrogen precharging and mechanical loading in hydrogen gas let hydrogen penetrate into the specimen, adsorbed hydrogen (hydrogen present in the first atomic layers on the

- For Test 2 (Fig. 3a), referenced as []/[30 MPa N₂ → 30 MPa H₂], the specimen was not submitted to any hydrogen precharging before the mechanical loading. It was loaded in 30 MPa of nitrogen gas till failure displacement in hydrogen gas (dark cross in Fig. 3a). Then nitrogen gas was replaced by 30 MPa of hydrogen gas and test was continued till specimen failure. This test was designed to study the promptness and the magnitude of hydrogen embrittlement when material was not precharged and since hydrogen was introduced in the atmosphere during mechanical test. Correlated to Test 1, it investigated the contribution of near surface diffusible and adsorbed hydrogen on embrittlement.

Finally, a tensile test called Test 3 (Fig. 3b) and referenced as [30 min 30 MPa H₂]/[30 MPa N₂], was carried out to investigate the influence of the hydrogen precharging step on the hydrogen embrittlement. A smooth axisymmetric specimen was precharged in 30 MPa of hydrogen gas during 30 min. Then the mechanical loading was carried out in nitrogen gas at $5 \times 10^{-5} \text{ s}^{-1}$.

Fig. 3a and b showed the tensile curves obtained for the three different tests taking into account that, for each condition, experiments were reproducible so that representative results were given
