IMPACT OF COASTAL INUNDATION ON ECOLOGY AND AGRICULTURAL LAND USE CASE STUDY IN CENTRAL JAVA, INDONESIA

MARFAI M.A., 2011. Impact of coastal inundation on ecology and agricultural land use case study in central Java, Indonesia. *Quaestiones Geographicae* 30(3), Bogucki Wydawnictwo Naukowe, Poznań, pp. 19–32, 22 Figs., 4 Tabs. ISBN 978-83-62662-75-3. ISSN 0137-477X. DOI 10.2478/v10117-011-0024-y

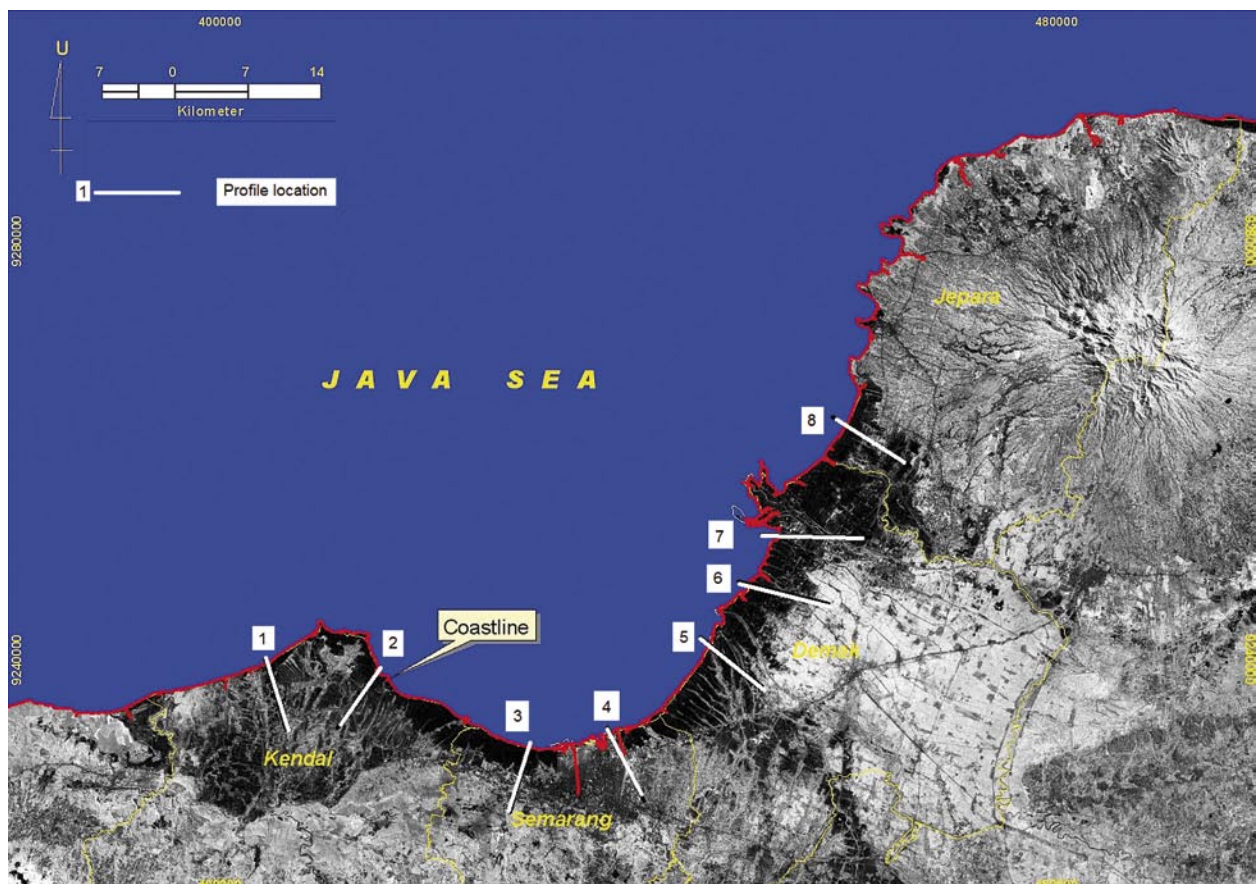
Fig. 4. Cross profile location.

Cross profiling has been designed for 8 transect routes representing entire research areas (Figure 4). During the investigation, meticulous assessment and observation in each geo-ecological unit was carried out. Information from local community and key persons (head of village) during the profiling and interview activity were very valuable in order to get a description of the ecological and environmental problem associated with inundation.

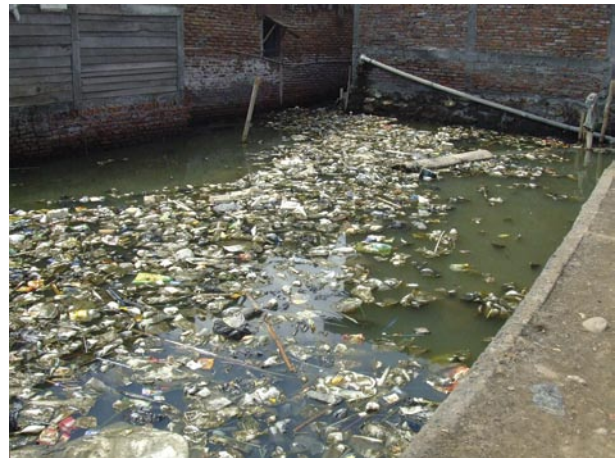
Fig. 6. Garbage and waste disposal problem in coastal area.

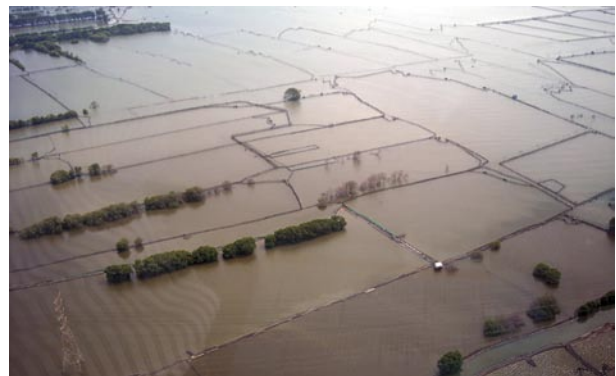
Fig. 7. Inundated paddy and crops (Photo courtesy: Helmi).

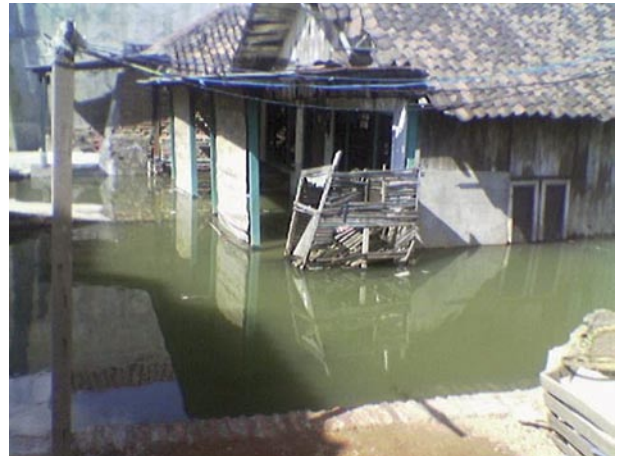
Fig. 10. House damage due to tidal inundation.

in Figure 9). Significant damage of house structure in coastal settlement will also occur due to frequent inundation (Figure 10). Foundations of houses are badly damaged since they are inundated. Moreover, inundation will also accelerate dry farming destruction (Figure 11). Dry farming is the type of farming that does not require much water. When it is too wet or inundated, the crops will be damaged.

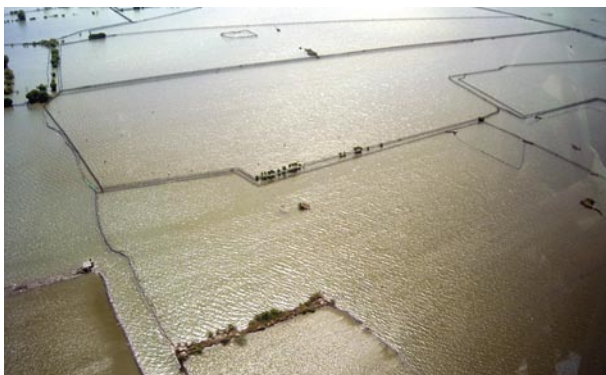
Fig. 9. Loss of fishpond area (Photo courtesy: Helmi)

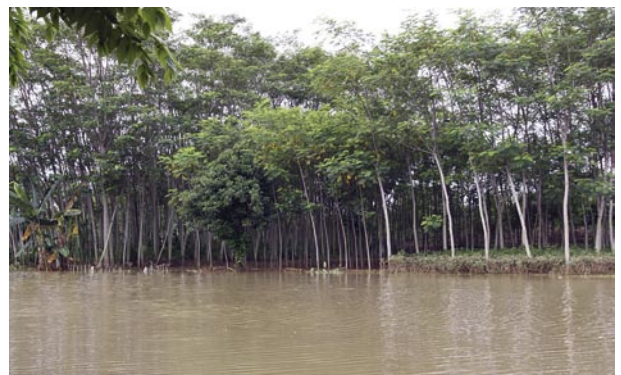
Fig. 11. Flooded dry farming.

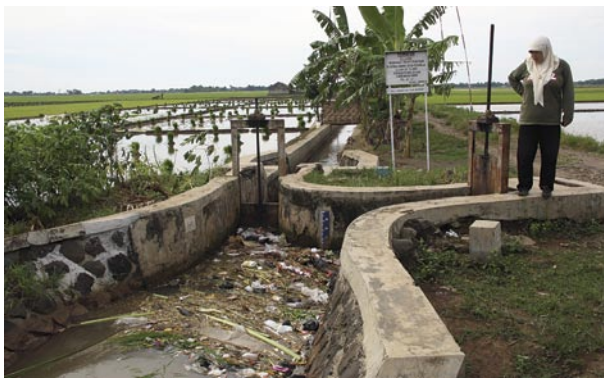
Fig. 13. Garbage and waste disposal in channel.

Coastal inundation impact in the third cross profile (Figure 12) is obviously the same as that found in the previous profile. Garbage and disposal waste directed to channel will be harmful to coastal settlement and crops since this channel flows surrounding settlement and crops areas (Figure 13).

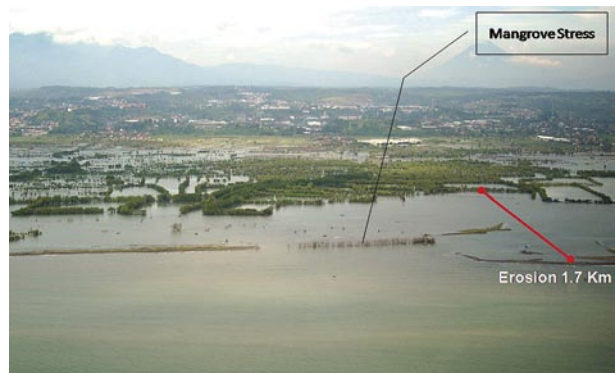
Fig. 17. Mangrove damage due to tidal inundation and abrasion (Photo courtesy: Helmi)

abrasion. Vegetation damage in the sixth Profile occurred not only in crops production but also in mangrove vegetation. Moreover, mangrove as a coastal protector, can be damaged because of coastal inundation and abrasion. This ecosystem is actually the primary barrier in this coastal area (Figure 17). As an example, the number of mangrove area in Semarang coastal area during 1999–2005 declined about 14, 3 Hectares.

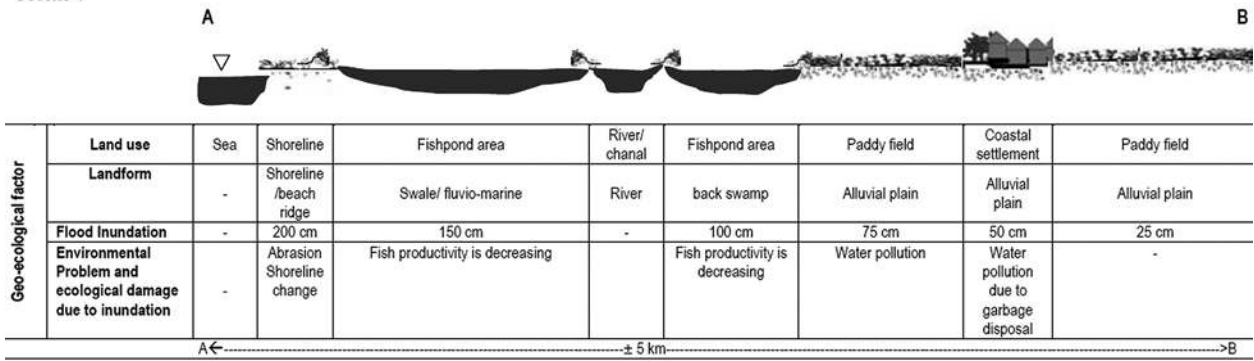
Profile 7

Fig. 18.7th cross profile.

Abrasion and erosion conditions in coastal area due to inundation can be seen in the seventh cross profile (Figure 18). The rate of abrasion and erosion will speed up due to continuous coastal inundation. This condition causes damage of houses and infrastructure in this area (Figure 19). To provide an example for this is the erosion rate in 1999–2005 in a spot of Semarang coastal areas, located in Genuk District which reached 215.2 Hectares (Irwani *et al.* 2010).

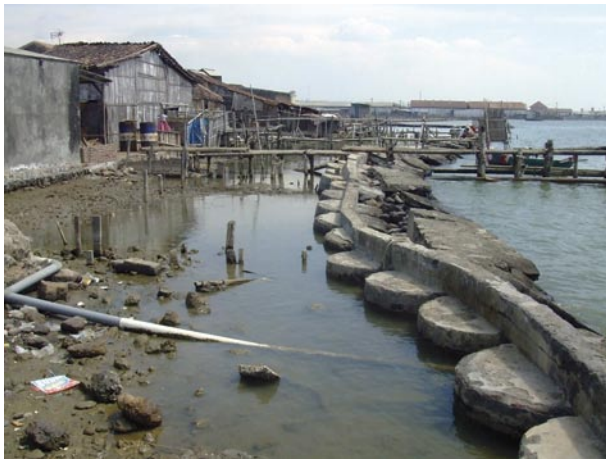
Fig. 19. Damaged infrastructure due to erosion and abrasion.

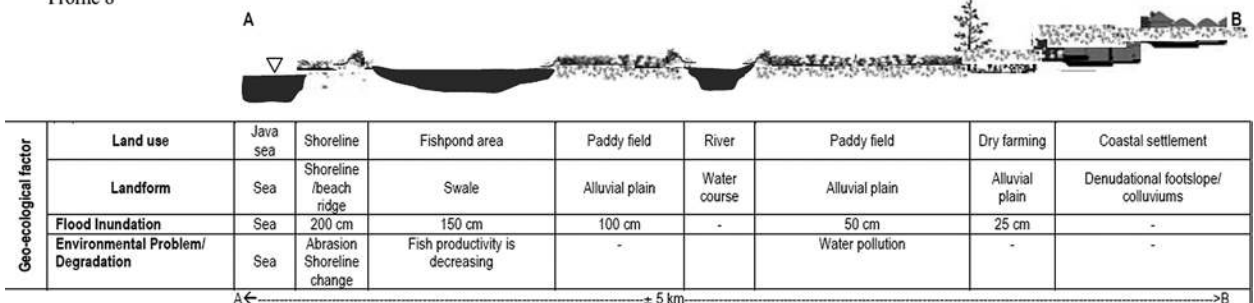
Profile 8

Fig. 20. 8th cross profile.

The last cross profile (Figure 20) gives an example of the water pollution as an environmental problem (Figure 21). Intensive water pollution particularly surface water pollution occurs in this area due to the erosion process taking place on the upper part area. This pollution can threaten ecosystem lying below this water.

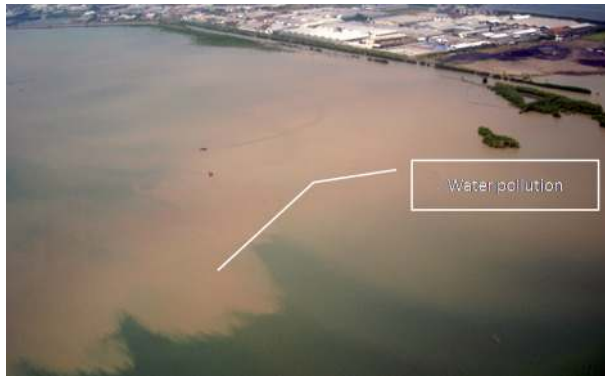
Fig. 21. Surface water pollution (Photo courtesy: Helmi).

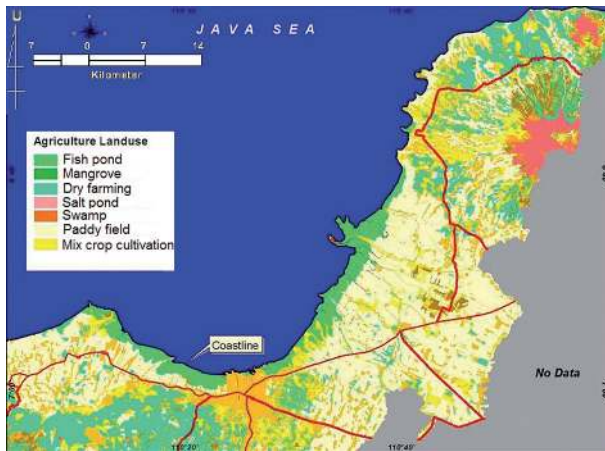
Fig. 22. Agricultural Landuse map of the study area.

map in the study area has been generated using interpretation of satellite images on the area of Kendal, Demak, and Jepara. Moreover, additional information of the landuse map has been compiled from the previous research of Marfai & King (2008a) for the Semarang coastal area and. Land use map of the study area is shown in Figure 22. Overlaying the inundated areas and agricultural landuse map allows an assessment of the impact of the inundation. Table 3 and 4 reveal the agricultural area affected by inundation of the 100 cm depth and 150 cm depth respectively.
