Impact of dams, dam removal and dam-related river engineering structures on sediment connectivity and channel morphology of the Fugnitz and the Kaja Rivers

Ronald E. Poepl¹, Saskia D. Keesstra², Margreth Keiler³,
Tom Coulthard⁴, Thomas Glade¹

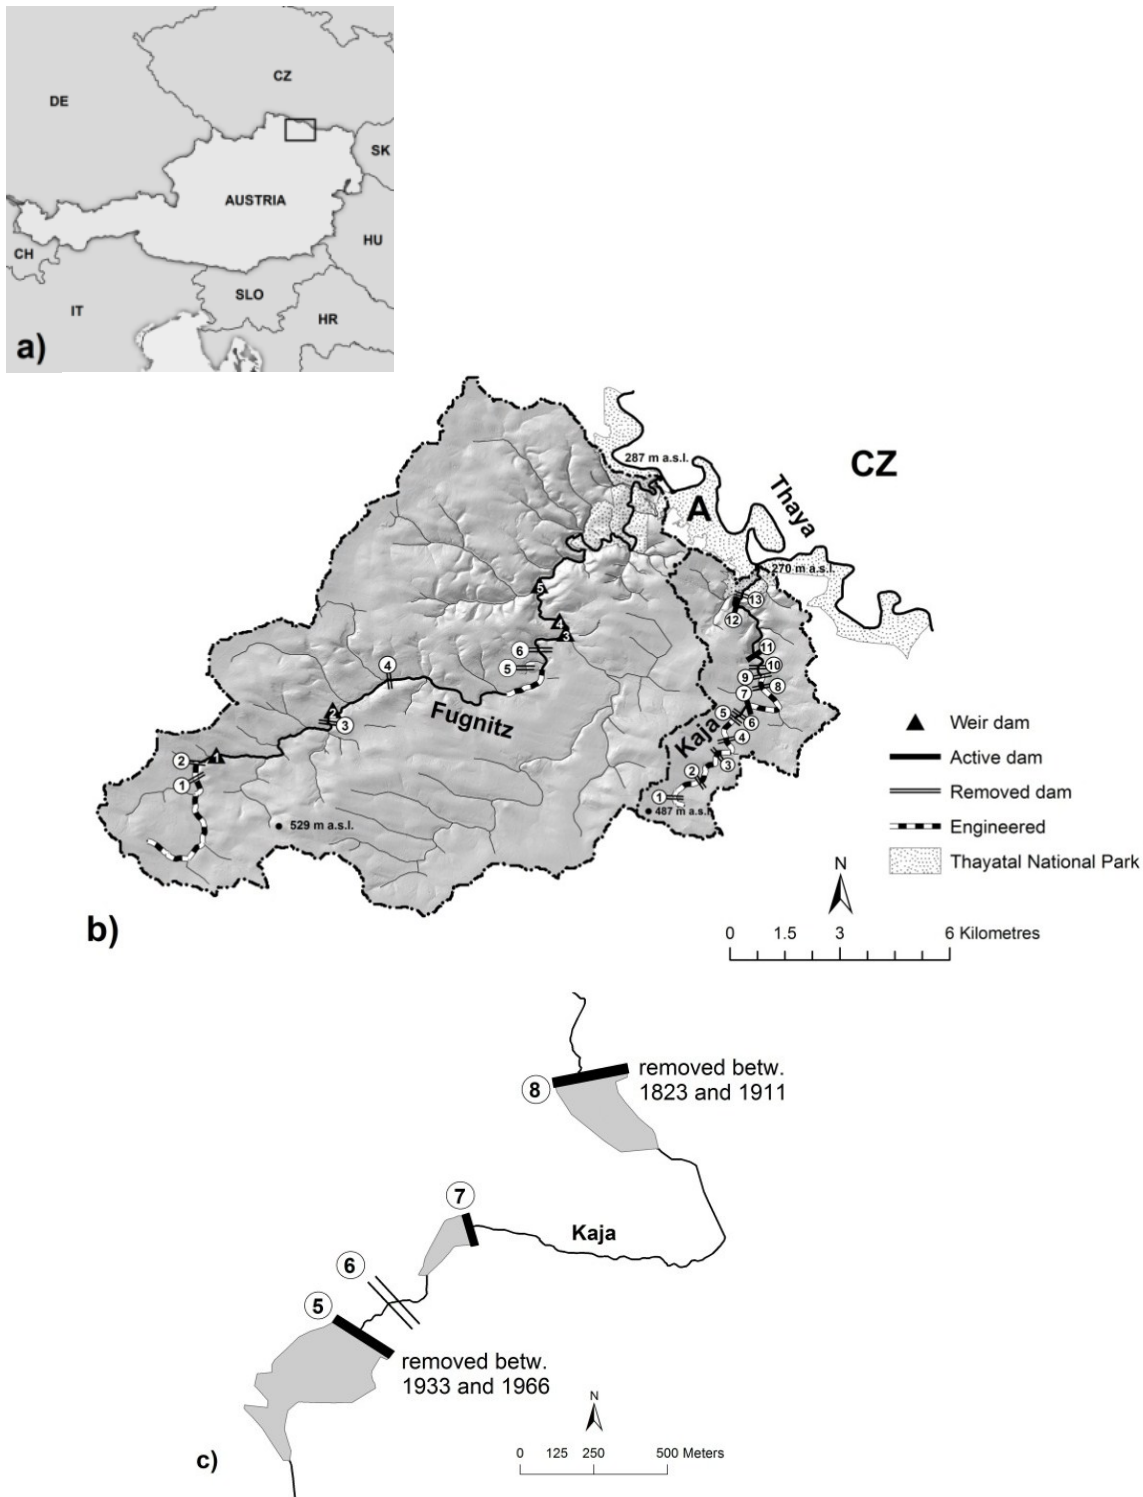
Figure 1; Study area; a) Location of the study area. b) Fugnitz and Kaja River with type and location of dams and river engineering structures. Data source: Provincial Government of Lower Austria, 2010. c) Study area for the modelling approach: situation in 1823 (derived from historical cadastral maps of the "Land register of Francis I" 1823)

The rivers Fugnitz and Kaja are located in the Northeast of Austria (Fig. 1a). Both rivers are mixed-load single-thread perennial streams that enter the Thaya River within the boundaries of the Thayatal National Park (Fig. 1b).

Both rivers have been impacted by multiple dams which were built as overflow dams between 1425 AD and 1782 AD (KNITTLER 2005). They range from three to six meters in height with a rather small storage capacity and are or were mainly used for fish farming purposes (POEPPL 2010). In 2013, three dams are still active along the Kaja River, while all others had been removed (Fig. 1b). Five weir dams are currently present along the Fugnitz River. These were built as mill dams or for water diversion and extraction for the water supply of fish ponds. Some sections of the upper and middle reaches have been engineered by installing river bed and bank protection measures which are still present in the systems. In the middle reaches of the Kaja River a river section has been impacted by three active dams which were built before 1782 AD (Fig. 1c). Two of them had been removed between 1823 AD and 1966 AD.

The CAESAR-Lisflood 1.2 landscape evolution model was used to simulate the effects of dam construction and dam removal on channel morphology (incl. sediment budgeting) and sediment input/output rates (sediment connectivity) for a specific reach of the Kaja River (see study area, Fig. 1c). CAESAR-Lisflood 1.2 (freely available via <http://www.coulthard.org.uk/CAESAR.html>) is a new hydrodynamic version of the CAESAR model developed by COULTHARD (1999) and COULTHARD et al. (2007). CAESAR is a cellular model that allows the simulation of geomorphic processes (erosion and deposition) as well as the calculation of sediment input/output rates for different grain sizes at fine-resolution temporal and spatial scales. Two scenarios, each over an experimental time period of 1000 years were modelled: 1) presence of 3 active dams (see also Fig. 1c), 2) removal of all dams after scenario 1. For this, the DEM was adapted to the physiographic settings of 1823. Water and sediment input arriving from the catchment area upstream the studied river reach were simulated using hourly rainfall data over a period of 10 years (data source: Hydrographischer Dienst Niederösterreich 2001-2010). Sediment particle size data were obtained from river bed sediment samples and soil samples in spring 2010 (POEPPL 2010).

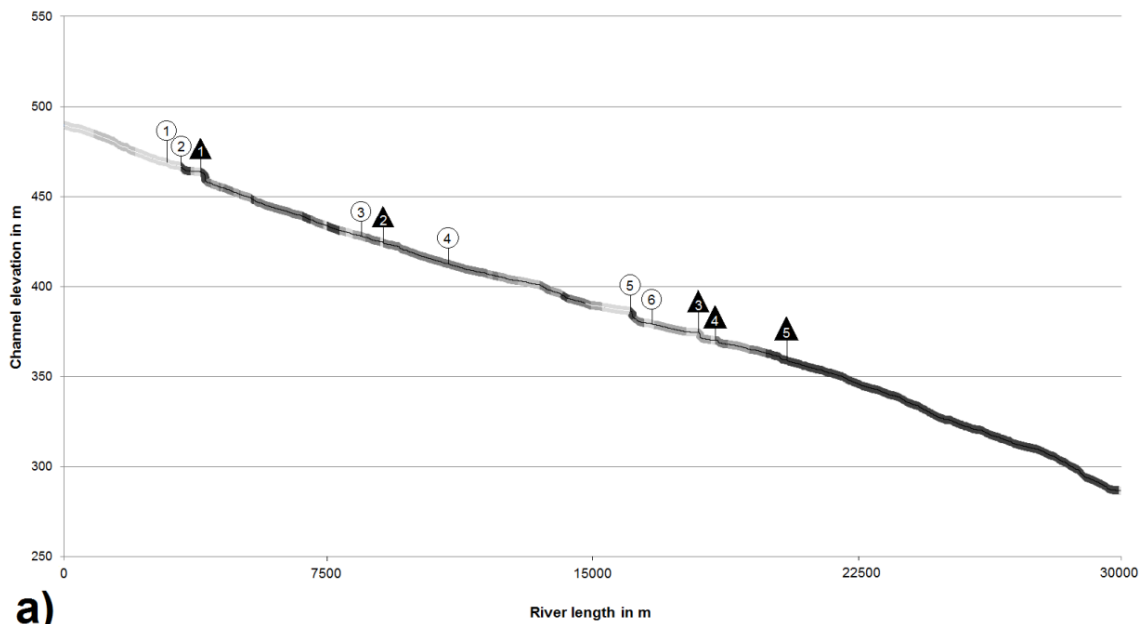
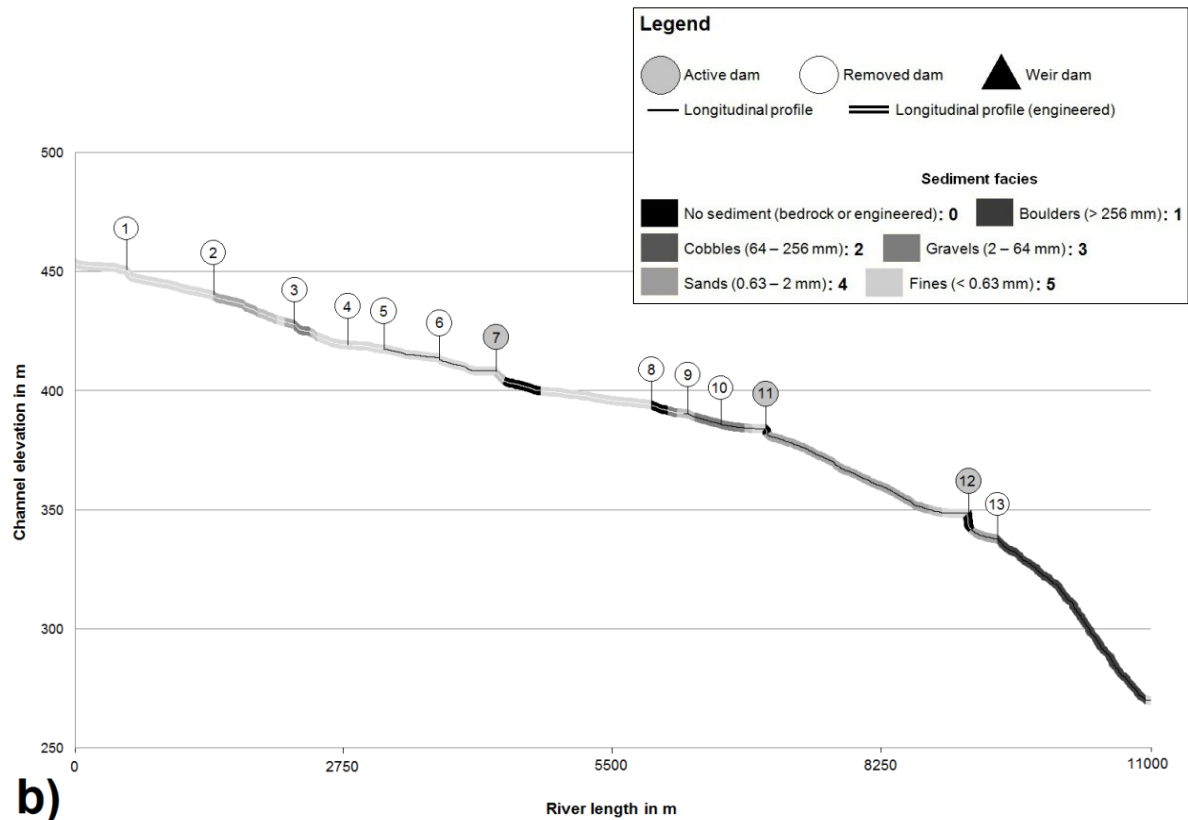
Figure 2 Longitudinal profile, river engineering and sediment facies along the rivers a) Fugnitz and b) Kaja.

The Fugnitz River has an overall channel slope of 0.068 ‰ and generally shows a nearly straight longitudinal profile in the upper and middle reaches and slight convexity in the lower reaches before entering the deeply-incised Thaya River (Fig. 2a; see also Fig. 1b). However, a multiplicity of knickpoints is present, mainly related to the presence of weir dams (e.g. weir dams 1 and 3) as well as to the presence of removed dams in river sections exhibiting upstream engineering (e.g. dams 2 and 5). The Kaja River has an overall channel slope of 0.172 ‰ and shows a very diverse longitudinal profile with alternating concave and convex sections in the upper reaches and convex steeply sloping lower reaches before entering the deeply incised Thaya River (Fig. 2b; see also Fig. 1b).

Sediment facies mapping resulted in the delineation of 50 river sections along the Fugnitz River showing all types of grain size categories except category 0 (Fig. 2a). The channel slope of the different river sections varies between 0.009 ‰ (section 5) and 0.264 ‰ (section 4). All river sections with low channel slope values showed a sediment facies of either category 5 or 4 which indicates low sediment connectivity (see Fig. 2a). Contrarily, all river sections with high channel slope values exhibited a sediment facies of category 1 indicating high sediment connectivity. All river sections within the coarsest sediment facies class 1 and high channel slope values are located downstream of either active dams or removed dams with upstream engineering. Whereas all sections exhibiting a fine sediment facies (i.e. grain size category 5 or 4) and low channel slope values are located upstream of active dams, within their backwater reaches, removed dams with upstream bed and bank protection measures, or at the river mouth.

Following the results of sediment facies mapping, 24 river sections were delineated along the Kaja River showing all types of grain size categories (Fig. 2b). The channel slope of the different river sections varies between 0.007 ‰ (section 16) and 1.118 ‰ (section 21.). Three river sections with the highest channel slope values exhibited a sediment facies of either category 0 or 1 which indicates high sediment connectivity. However, one river section within the range of the highest channel slope values (i.e. section 7) showed a sediment facies of 4 indicating low sediment connectivity which might be caused by the backwater effect of dam 7. All river sections within the range of low channel slope values exhibited a sediment facies of category 5 or 4 which indicates low sediment connectivity. All river sections within the coarsest sediment facies class 1 and high channel slope values are located downstream of either active dams or removed dams with upstream engineering. Whereas all sections exhibiting a fine sediment facies and low channel slope values are located upstream of active dams, within their backwater reaches, removed dams with upstream bed and bank protection, or at the river mouth.

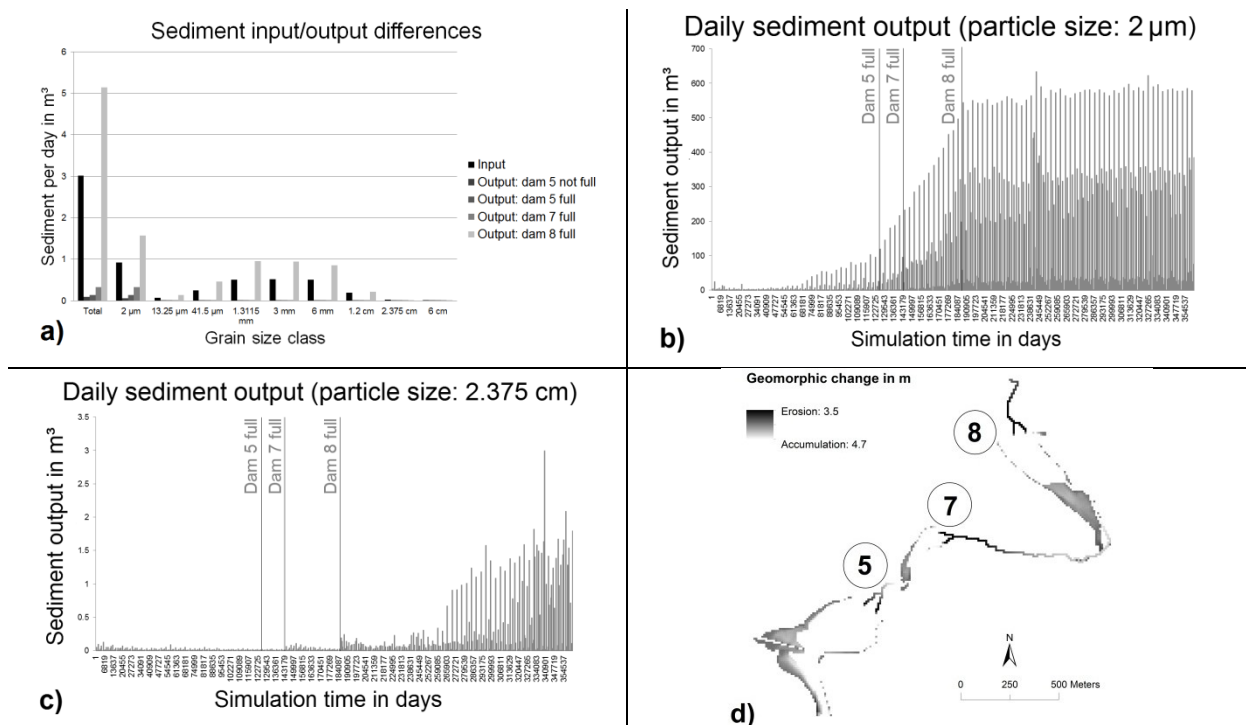
Figure 4: Modelling results for the dam construction scenario (examples): sediment outputs for a) all grain size classes, b) suspended sediments, c) bedload sediments; d) geomorphic channel changes

After dam construction, modelled sediment output rates (= sediment connectivity) declined for all grain size classes, but then increased with time due to an infilling of the reservoirs (Fig. 4a, 4b, 4c) indicating a recovery of sediment connectivity due to aggradation processes. The suspended sediment output rates showed a continuous increase with time (Fig. 4b), while a stepwise increase after infilling of all reservoirs was observed for bedload sediments (Fig. 4c). Simulation of channel changes due to dam construction exhibited aggradation in the reservoirs as well as in the upstream reaches affected by backwater, while channel degradation was observed in the downstream reaches. Sediment budgeting showed a net balance of plus 542,200 m³ indicating high sediment deposition rates due to dam construction. Nevertheless, after infilling of all reservoirs, sediment output outweighs sediment input which suggests increased channel erosion rates downstream of the dams (Fig. 4d).

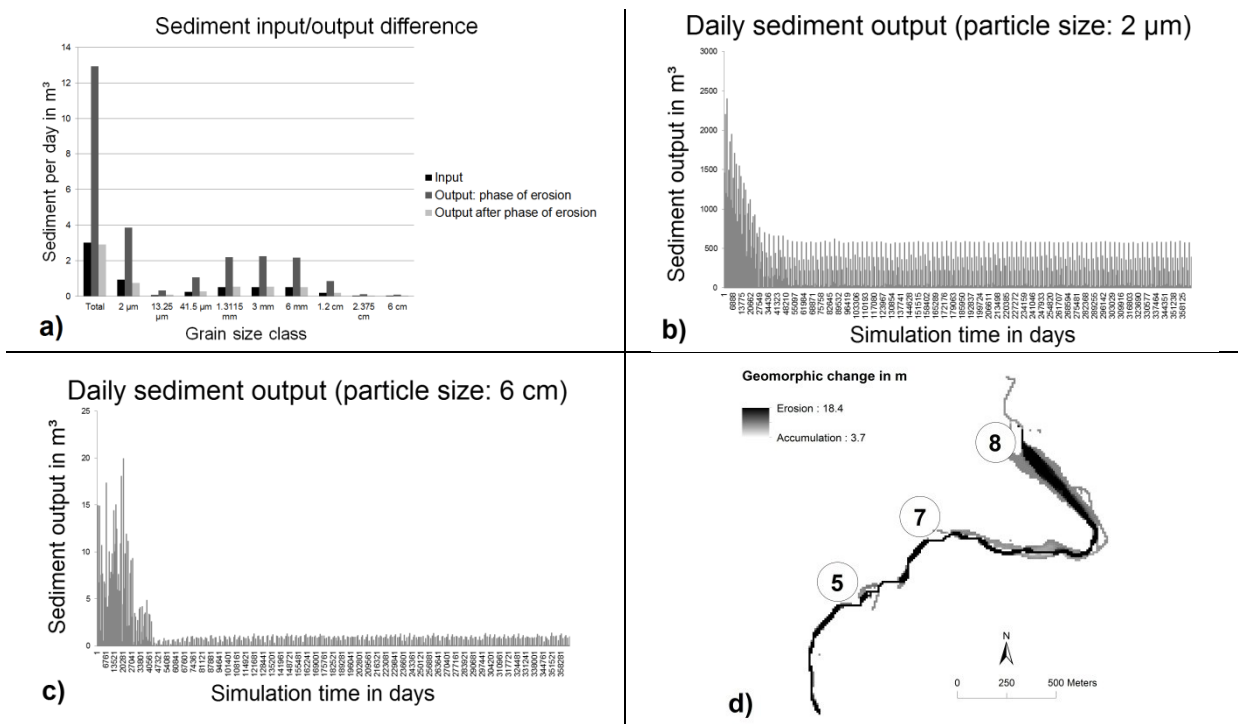
Figure 5: Modelling results for the dam removal scenario: sediment outputs for a) all grain size classes, b) suspended sediments (example), c) bedload sediments (example); d) geomorphic channel changes

After the removal of all dams, modelled sediment output rates outweighed sediment input rates (Fig. 5a, 5b, 5c) indicating a phase of high erosion rates removing most of the sediment volume which was accumulated during the dam construction scenario. This is also reflected by the results of the simulated channel changes during dam removal (Fig. 5d) exhibiting high erosion rates especially in the former reservoir areas as well as by the sediment budget calculations which resulted in a net balance of minus 529,700 m³ of sediment. However, 12,500 m³ of sediment are still stored in the system which shows that not all deposited sediment has been eroded after dam removal. It is interpreted that after a phase of high erosion rates the establishment of bed armoring prevented from further bed erosion processes. This assumption is also strengthened by sediment output rates that equal sediment input rates after the phase of erosion which indicates a system in equilibrium (see Fig. 5b, 5c).
