## Impact of fertilizer plant effluent on water quality

**ABSTRACT:** The impact of National Fertilizer Company of Nigeria outfall effluent on the physicochemistry and bacteriology of Okrika creek was investigated during the sampling period from May to December, 1998. The National Fertilizer Company of Nigeria outfall effluent, the Okrika creek water and the Ikpukulubie creek (control) water samples were collected. The physico-chemical parameters analyzed for all the samples included temperature, pH, total chloride, total dissolved solids, dissolved oxygen, conductivity, free ammonia, total phosphate, urea, zinc and iron, while the bacteriological determinations were total culturable aerobic heterotrophic bacteria count and identification of representative isolates. The Okrika creek recorded higher concentrations for all the physico-chemical parameters and bacteria load than the control creek. The higher values of pH, Free NH<sub>3</sub>, urea, TDS and the conductivity of the National Fertilizer Company of Nigeria outfall effluent above the FEPA standards reflect the poor effluent quality generated by National Fertilizer Company of Nigeria. The bacteria species isolated from the s

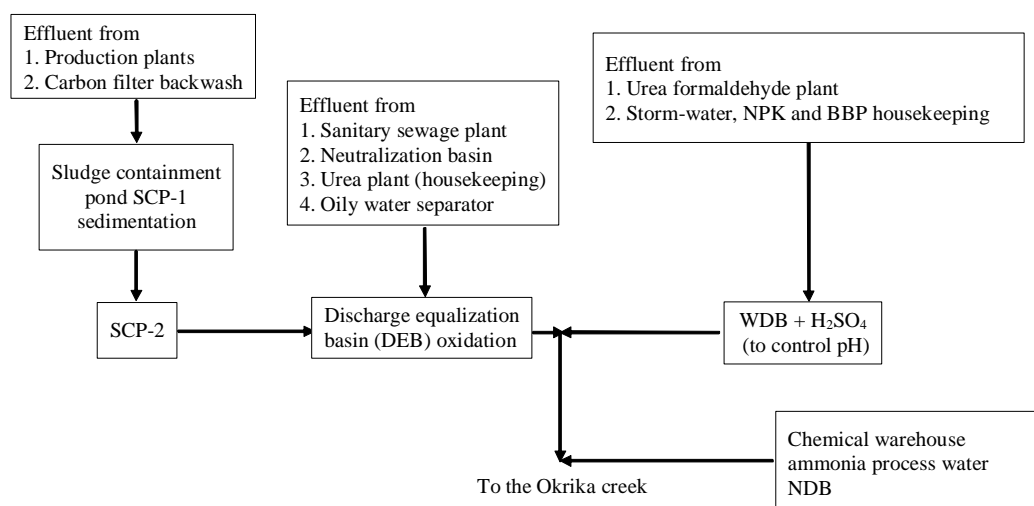
Fig. 1: Diagram of NAFCON effluent treatment and channelization into the Okrika creek

The study area from which the water samples were collected is the Okrika creek in Okrika Local Government area of Rivers State, which lies in the coastal fringes of Niger Delta (Fig. 1). It stretches from the NAFCON jetty through the Okrika jetty. The Okrika creek is bounded on its eastern bank by the NAFCON complex (in Onne, Eleme Local Government Area), the Okochiri community (in Okrika Local Government Area) and mangrove plants of different species and on the West by sand deposit from the dredged Okrika creek and different species of mangrove plants. The Okrika creek is confined in the salt water swamp zone and is influenced by tidal fluxes. The flow of the Okrika creek is only slightly swift and bidirectional. The creek is characterized by tall mangrove plants of different species having tangled mass stems and aerial roots of about 20-60 ft tall. The vegetation mostly consists of red mangrove. Frequent precipitation is a common occurrence in the study area and in rivers state as a whole. During the study period, i.e. 1998, the time lag of May to September was considered as the rainy season, while the dry season included the period of October to December when sampling ended. The control creek (Ikpukulubie creek) was chosen due to its relative distance from the Okrika creek and the NAFCON effluent outfall (Fig. 1). It is situated at the coastal fringes of the core south of Port Harcourt. Its vegetation is essentially the same as that of the Okrika creek. It has a fishing settlement and a rapidly

Based on the peculiarities and features observed around the study area, four sampling stations were established along the Okrika creek (Fig. 1). The sampling stations were chosen 50 m. from the banks of the creek and 100 m apart from each other.

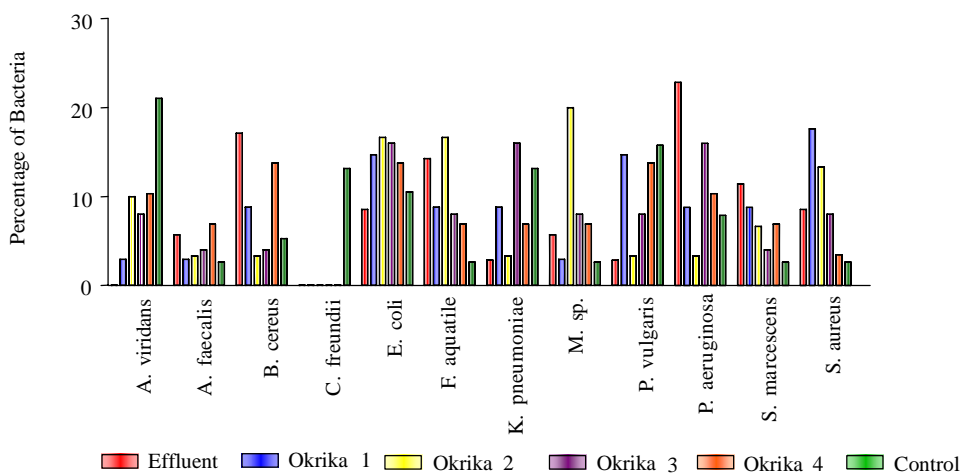
Fig. 2: Occurrence and abundance (%) of representative bacterial isolates of the NAFCON outfall effluent, the Okrika creek and the control creek

The occurrence and abundance (%) of representative bacteria isolated from the NAFCON outfall effluent, the Okrika creek and the control creek are as presented in Fig. 2. All of the bacterial types were isolated from the control creek, whereas *Citrobacter freundii* was not isolated from the NAFCON outfall effluent and from the Okrika creek. *Aerococcus viridans* was also from the control creek and Okrika creek but from the NAFCON outfall effluent. With the exception for *Aerococcus viridans* and *Citrobacter freundii*, all of the bacterial types isolated in this investigation occurred in the NAFCON outfall effluent. It could be affirmed that the outfall effluent exerted a bactericidal effect on *Aerococcus viridans* and *Citrobacter freundii*; it had an inhibitory effect on *Aerococcus viridans*, *Bacillus cereus*, *Klebsiella pneumoniae* and *Proteus vulgaris* and exerted an enrichment effect on *Alcaligenes faecalis*, *Bacillus*
