Influence of Horizontal and Vertical Barriers on Fire Development for Ventilated Façades

Abstract. Although using various innovative materials for ventilated facade systems positively contribute to the energy efficiency of buildings, the application of such materials can also pose a certain risk of fire propagation through the façade. In the last decade, medium and large-scale tests, as well as numerical analysis have been performed to assess the impact of fire barriers on fire propagation through ventilated façades. However, the number of fire barriers and their specific positions can also have an effect on the fire safety of facades, which has not been studied. Consequently, the question arises whether real fire exposure on a façade can be adequately simulated and analysed in sufficient detail, by using large-scale testing methods. This paper aims to conduct a parametric analysis on a broader range of large-scale samples by using the procedure given in the standard BS 8414-1:2015 + A1:2017. To understand better the impact of the number and position of cavity barriers for different types of insulation materials (stone wool/PIR/phenolic foam) used in modern façade systems with non

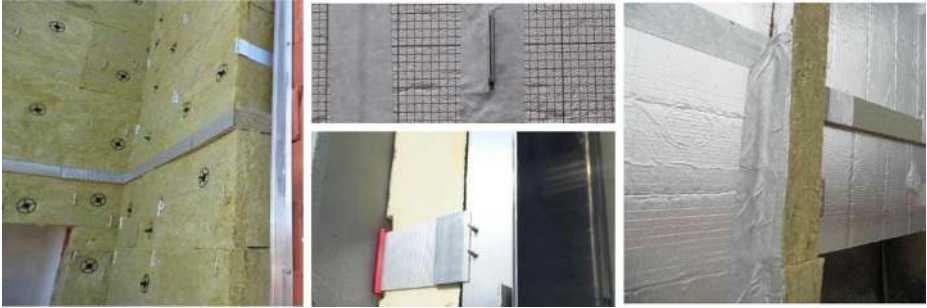
Figure 2. Stone wool (left: Sample 1-2), PIR (middle Sample 3-5), Phenolic foam (right: Sample 6-7).

Each sample was built following the list of materials listed below in Tables 2, and 3. For all samples the insulation varies (the third component in the Table 2) while other components, apart from their dimensions, remain the same (Fig. 2).

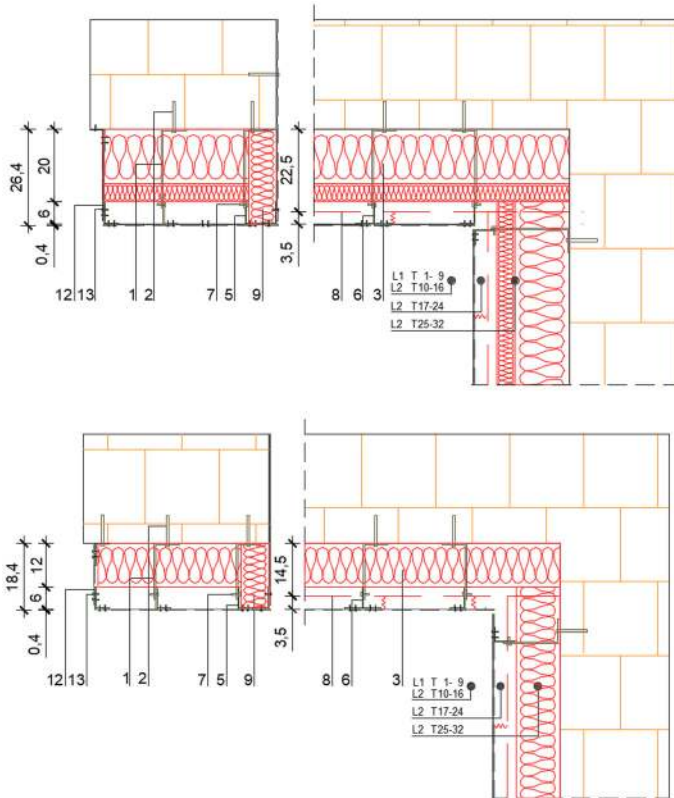
Figure 3. Wall corner detail with material specifications (Table 2) and with thermocouples; Sample 2 (above), Sample 4,6 (below) (dimensions in cm).

Figures 1 and 3 show the position of the thermocouple relative to the position of the barrier for easier result monitoring. Samples 1 and 3 are not shown because they do not have any horizontal nor vertical barriers. Thermocouples are positioned as follows: Tn-1–Tn-8 are 50 mm from the external panel on level one, Tn-9–Tn-16 are 50 mm from the external panel on level two, Tn-17–Tn-24 at the midpoint of the air cavity layer on level two and Tn-25–Tn-32 at the midpoint of the insulation on level two. To describe a thermocouple position, following abbreviations will be used (Fig. 3).

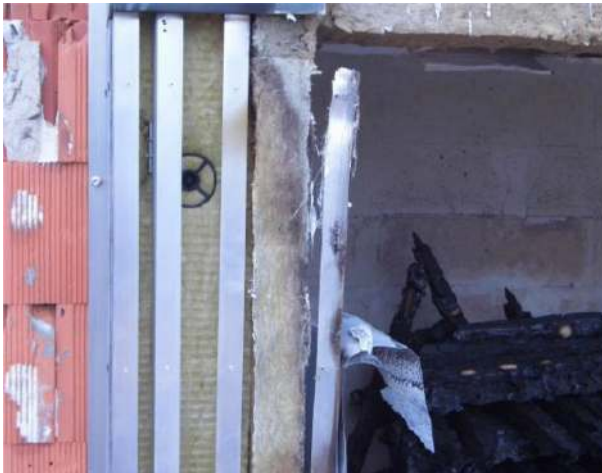
Figure 6. Sample 2- influence of vertical barrier on fire spread.

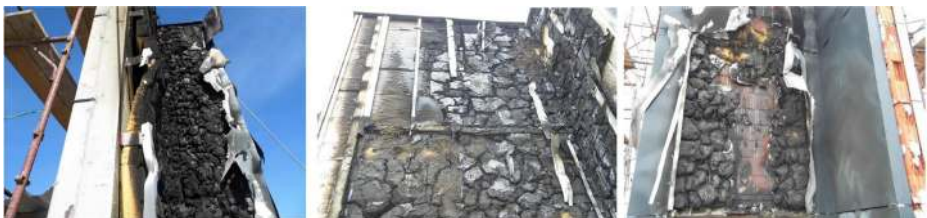
Figure 8. Sample 3,4,5—influence of vertical barrier on fire spread.

The influence of the vertical barrier on the left side of the chamber is visually demonstrable. The combustible insulation on the left side of the vertical barrier that was not protected has lost its properties (Sample 3) and it has partially burned out while ones protected by a vertical barrier (Sample 4 and 5) remained undamaged in both cases Fig. 8.

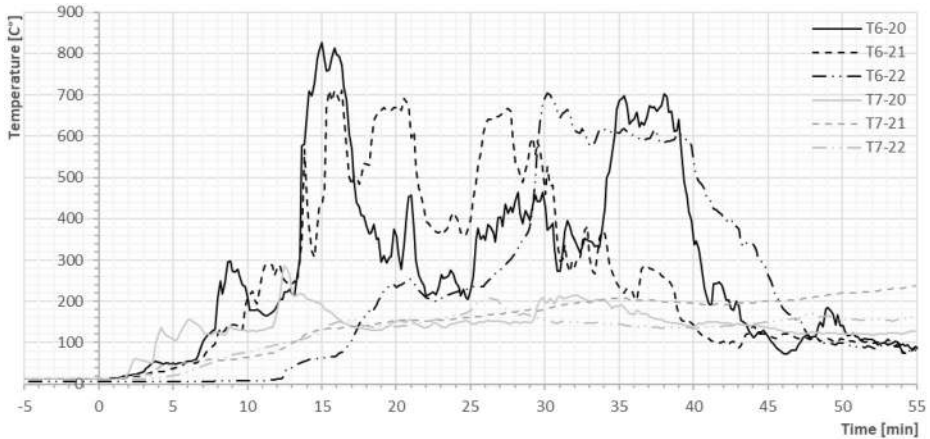
Figure 11. Thermocouple Tn-20-21-22_cavity_Sample 6 and 7.

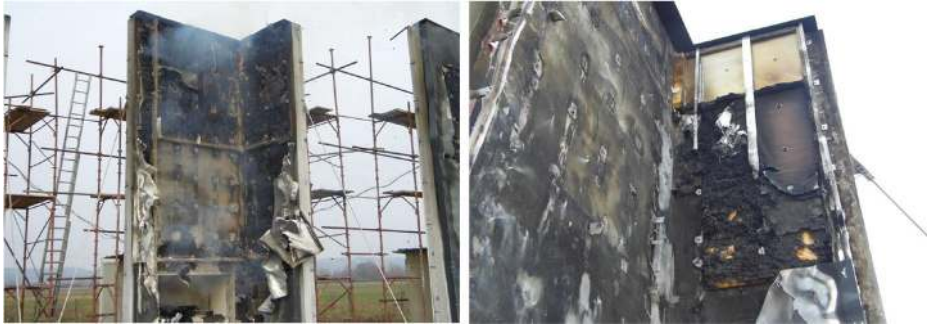
Figure 12. Sample 6 and 7- influence of vertical barrier on fire spread.

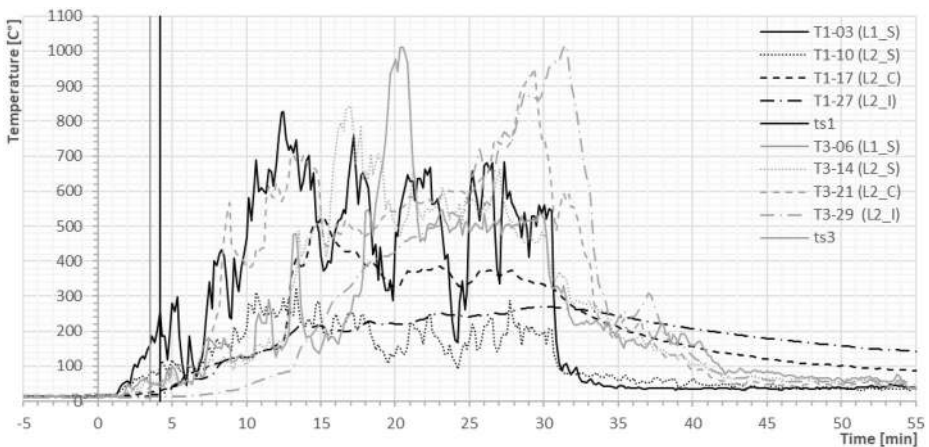
Figure 13. Sample 1 and 3_Non-comustible and combustible insulation_No barriers_Tmax thermocouples.

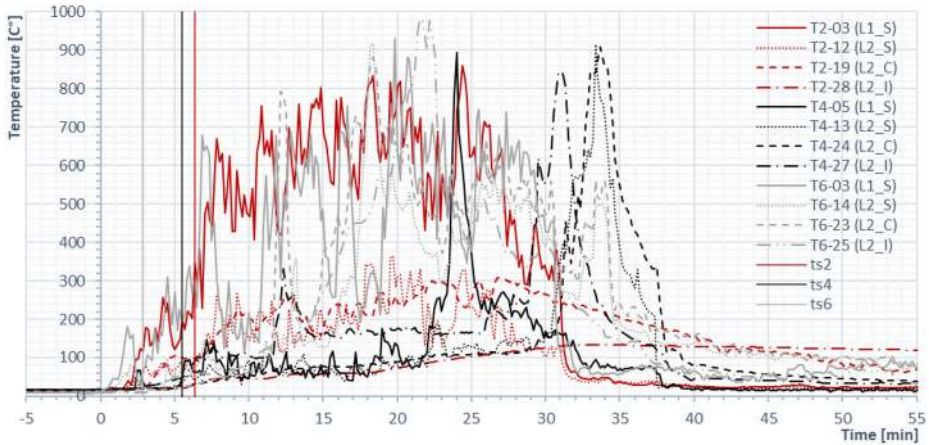
Figure 14. Sample 2, 4, 6—Non-combustible and combustible insulation with two horizontal barriers and two vertical barriers.

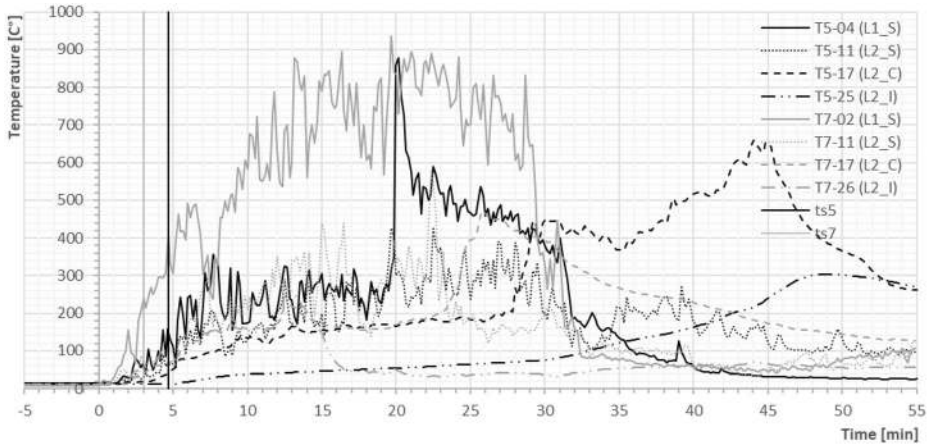
Figure 15. Sample 5, 7 Combustible insulation with four horizontal barriers and three (Sample 5)/four (Sample 7) vertical barriers.
