# 3D investigation of steel fiber distribution in reinforced concrete by X-ray microtomography

## *Investigação 3D da distribuição de fibras de aço em concreto reforçado por microtomografia de raios X*

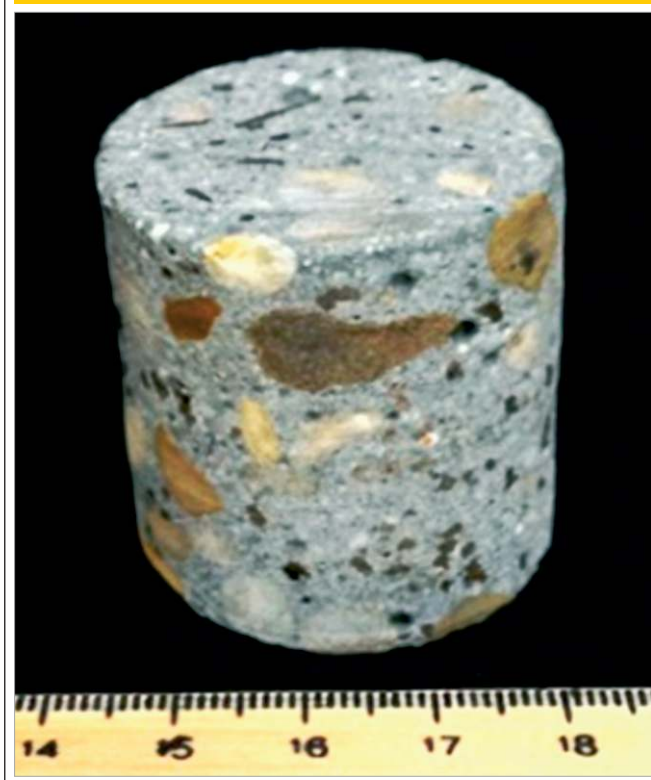
Figure 1 - Sample photography

The sample used in this study was a steel fiber reinforced concrete cylinder with  $(38.3 \pm 0.25)$  mm of height and  $(37.5 \pm 0.25)$  mm of diameter, shown in figure [1]. Other characteristics of the

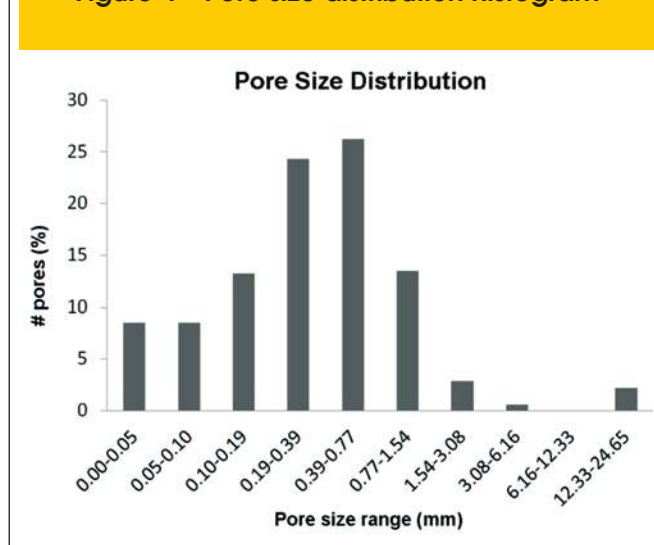
**Figure 4 – Pore size distribution histogram**

However, total porosity is not the only parameter important for characterizing the pore space. Pore size distribution is also essential for understanding concrete durability. Figure [4] illustrates this result obtained through microCT, evaluated slice-by-slice. Ten pore size intervals are evidenced (0.00-0.05; 0.05-0.10; 0.10-0.19; 0.19-0.39; 0.39-0.77; 0.77-1.54; 1.54-3.08; 3.08-6.16; 6.16-12.33; 12.33-24.65) mm. Most pores are not within the highest or lowest intervals, they concentrate within the (0.19-0.39) and (0.39-0.77) mm intervals. This distribution shows that more than 77% pores lie within the range from 0.10 to 1.54 mm. The highest pore size range found (12.33 to 24.65 mm) represents just 2.2% of total pores, and the lowest pore size range (between 0.00 and 0.05 mm) only 8.53%.

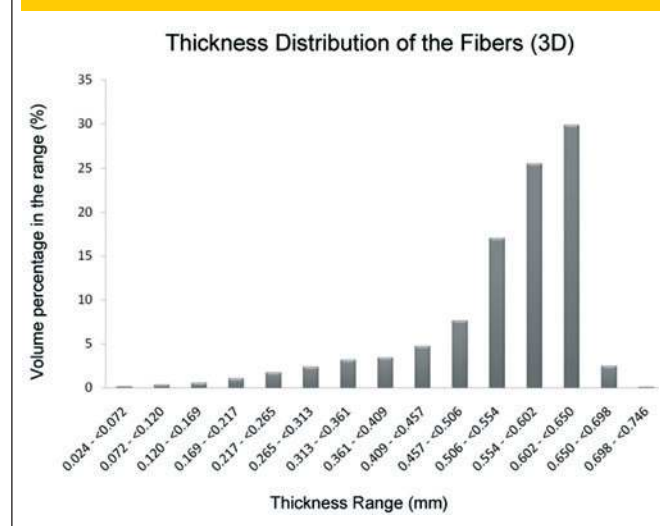
**Figure 5 – Thickness distribution of the fibers histogram**

significant plastic deformation which makes it adequate for construction. To this end, fibers must be added in adequate volume, length and shape [5]. In this manner, fiber morphological characterization is essential in the evaluation of reinforced concrete quality. Fiber thickness distribution, figure [5], was directly analyzed in 3D. The method begins with a skeletonization, identifying the medial axis of all the structures. In this manner an adaptive sphere will help local thickness calculation for all the voxels along the identified medial axis. This adaptive sphere is a sphere inscribed in the binarized solid to maximize the tangency of its surfaces [22; 23]. The result indicates steel fiber thickness uniformity, i.e., most fibers (more than 70% fiber volume) included in the sample lied in the thickness range between 0.50 and 0.65 mm.
